# National Transportation Safety Board

CEN24LA162

## **MATERIALS LABORATORY**

Factual Report 24-070

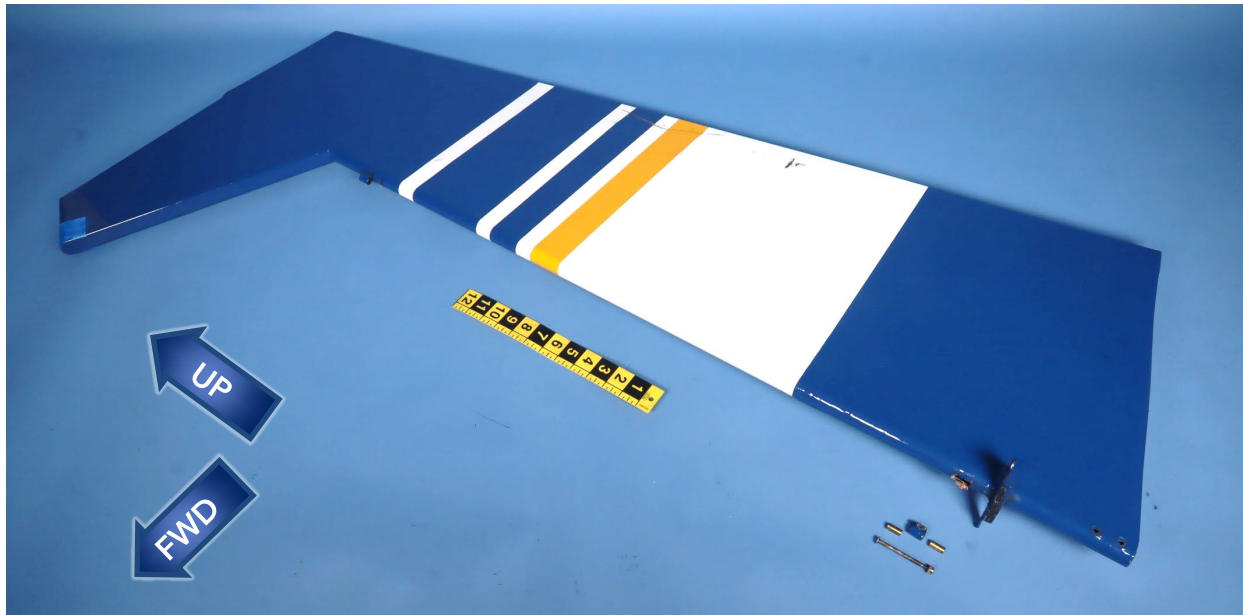
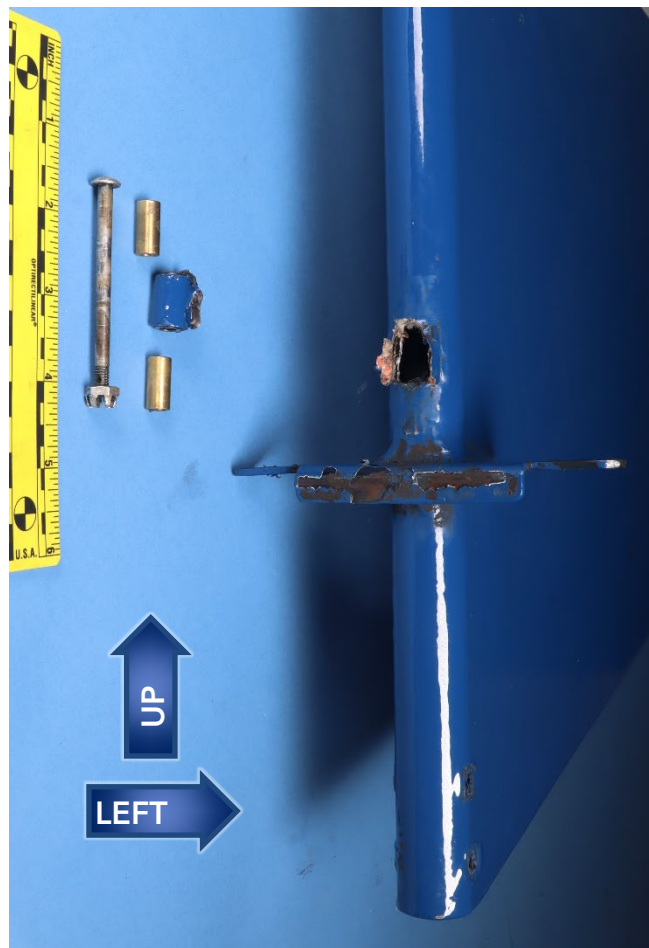
An overall view of the submitted rudder and lower hinge attachment hardware is shown in figure 1. The middle knuckle was fractured from the rudder post at the lower hinge location as shown in the lower image in figure 1. The lower hinge attachment bolt was intact, and the nut was received with the attachment bolt. Two bushings from the upper and lower knuckles (vertical stabilizer side) of the lower hinge were also received as shown.

The bushings from the upper and lower knuckles on the vertical stabilizer side of the lower hinge are shown in figure 1. One of the bushings had a worn end consistent with being positioned in the lower knuckle, and closer views of the worn bushing are shown in figure 7. The lower bushing had a groove worn into one side consistent with contacting the lower end of the bearing on the fractured middle knuckle piece. At the inside diameter of the worn groove, material was deformed and lipped up over the original machined surface. Blue paint with a glossy surface finish was observed within the wear groove around approximately 1/3 of the circumference. Additionally, blue paint with a rubbed surface was observed lodged under the paint with the glossy surface near the 3 o'clock position in the view shown at the right in figure 7. The opposite end of the lower bushing and both ends of the upper bushing had flat machined surfaces that appeared free of wear or deformation.

**Figure 1.** Overall view of the submitted rudder (upper image) with a closer view of the fractured lower hinge area and submitted hardware (lower image).

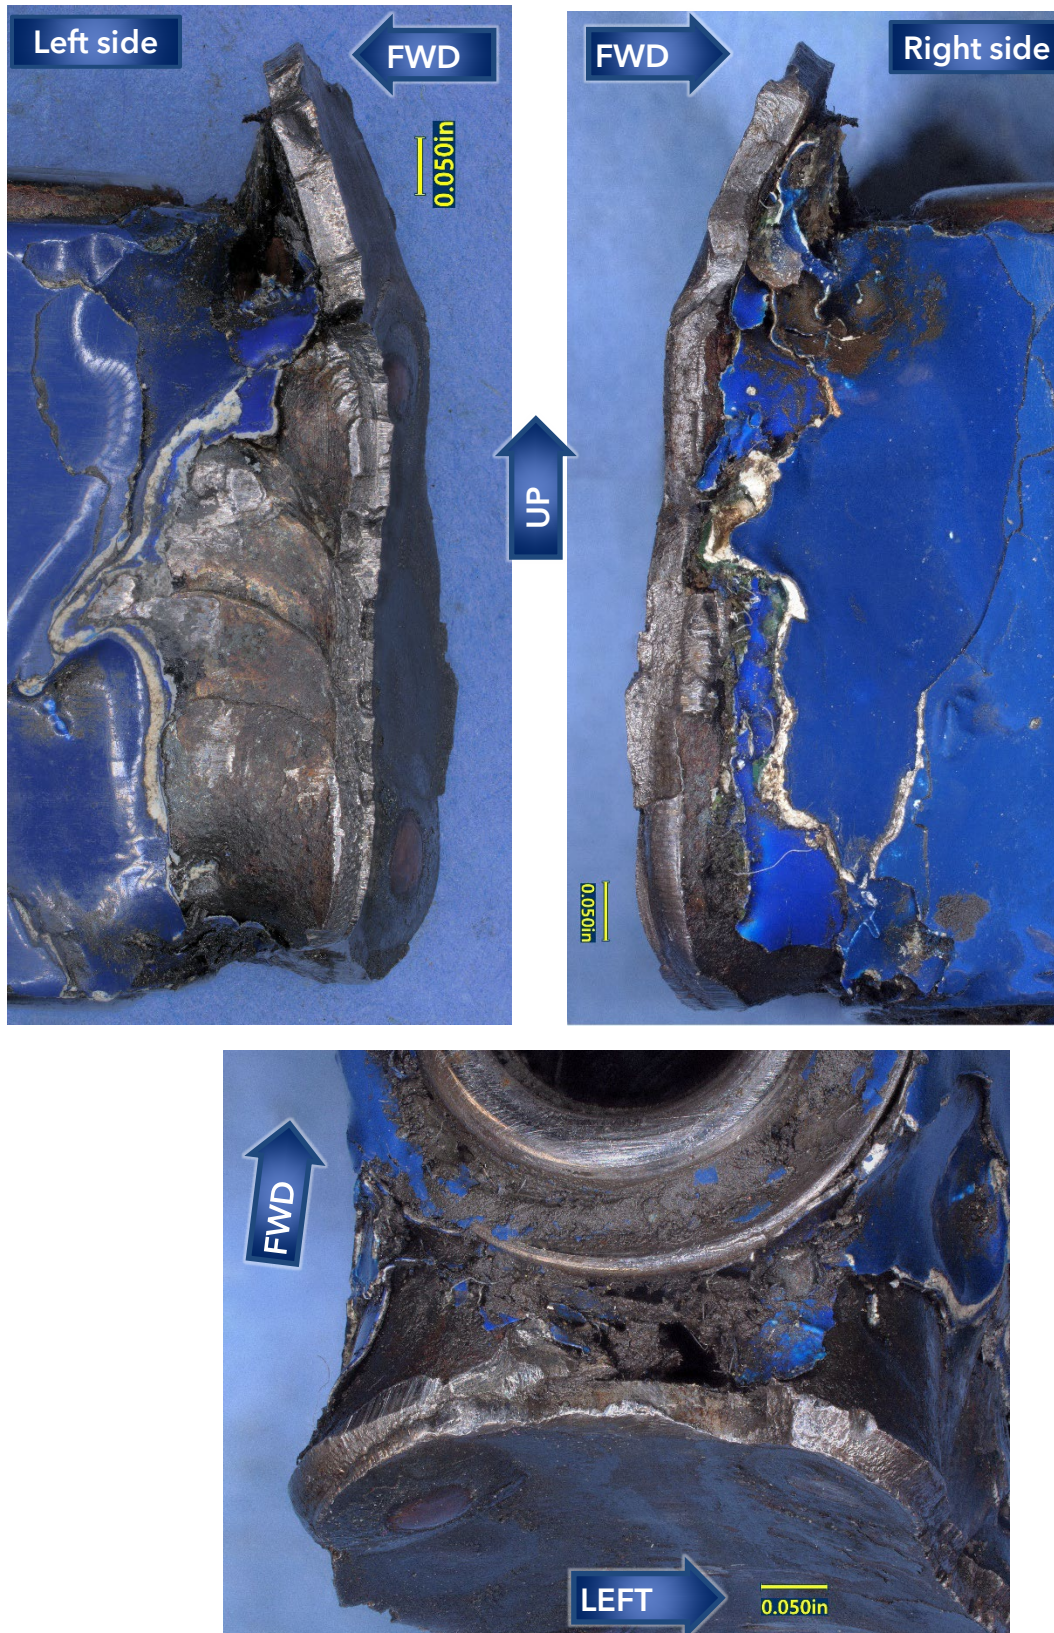
At the lower hinge location, the rudder post fractured at the toes of the welds attaching the middle knuckle to the post along the left and right sides of the knuckle and along the lower side as shown in close views of the fracture in figure 2. At the upper end of the fracture, the fracture path on each side extended upward beyond the welds before turning to intersect approximately 0.25 inch above the upper ends of the welds. At the upper end of the fracture, the rudder post wall piece that remained attached to the knuckle piece was deformed forward relative to the lower welded portion of the wall.

received, the worn area on the lower side of the middle knuckle, partially visible in the lower image in figure 2, was mostly covered with grease and blue paint.

**Figure 2.** Knuckle side of the rudder post fracture surfaces as received showing the left, right, and lower sides (upper left, upper right, and lower images, respectively).

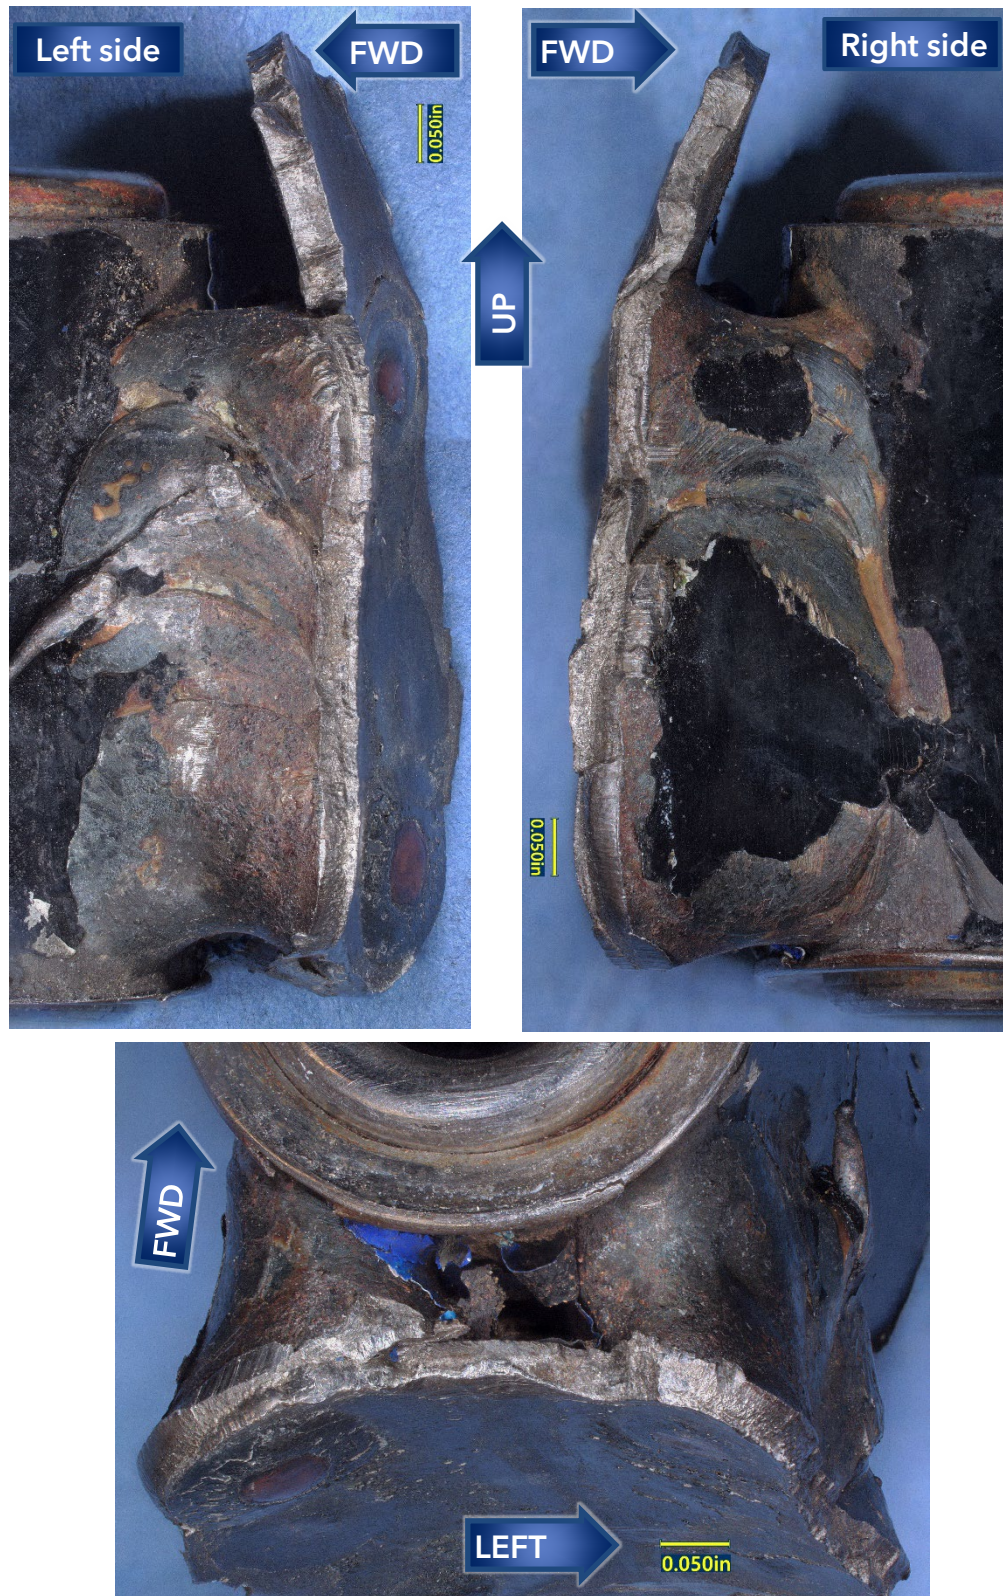
Views of the cleaned rudder post fracture surfaces on the knuckle side of the fracture are shown in figure 3. Relatively flat fracture features were observed around the lower side of the fracture and along the left side of the knuckle following the profile of the weld toes. Unlabeled arrows in figure 4 point to crack arrest lines near the upper end of the knuckle consistent with fatigue fracture initiating at the weld toe on the outside diameter surface of the post. However, flat features with curving boundaries and ratchet marks were observed on the opposite side of the fracture consistent with fatigue initiating at the interior surface of the weld post. Dashed lines in figure 4 indicate the extent of the fatigue regions initiating at the interior surface. The precise origin areas and extent of fatigue fracture were uncertain due to rubbing damage on the surfaces. However, the overall pattern was consistent with reverse bending fatigue with larger fatigue regions having originated at the toe of the weld on the outer surface of the post.

**Figure 3.** Knuckle side of the rudder post fracture surfaces after cleaning with acetone showing the left, right, and lower sides (upper left, upper right, and lower images, respectively).

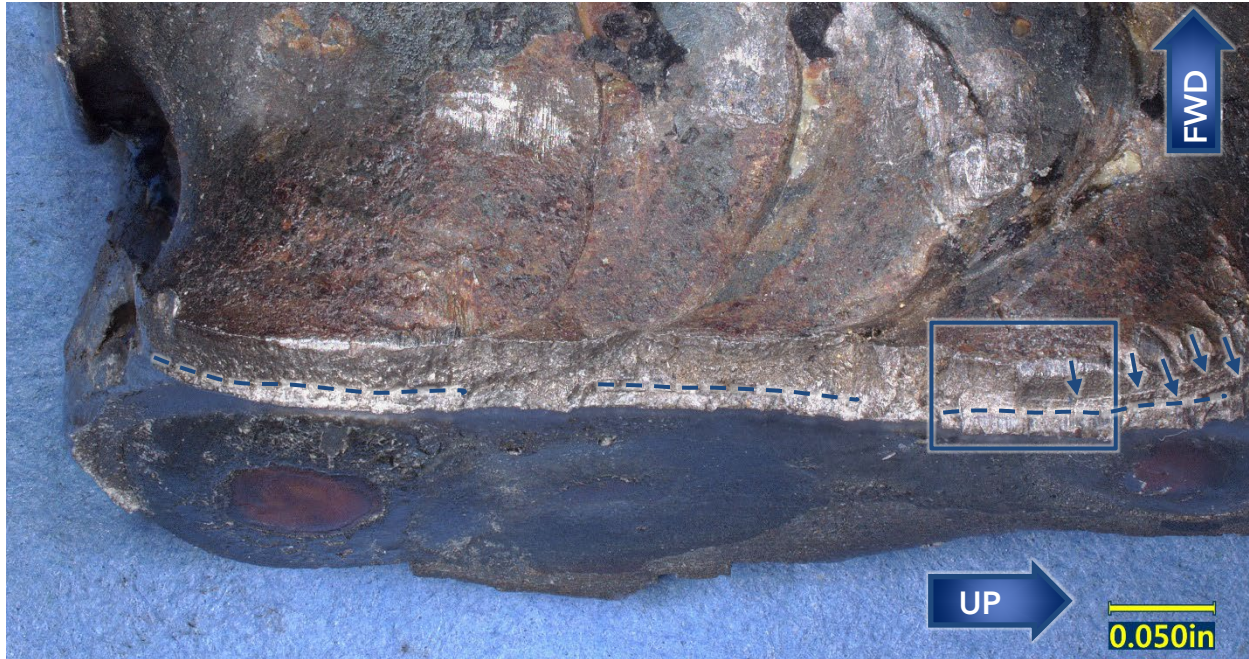
**Figure 4.** Lower portion of the middle knuckle showing fracture features on the left side. Dashed lines indicate fatigue regions originating at the interior surface, and unlabeled arrows indicate curving crack arrest lines for a fatigue region extending from the weld toe. An SEM image of the area within the rectangle is shown in figure 5.

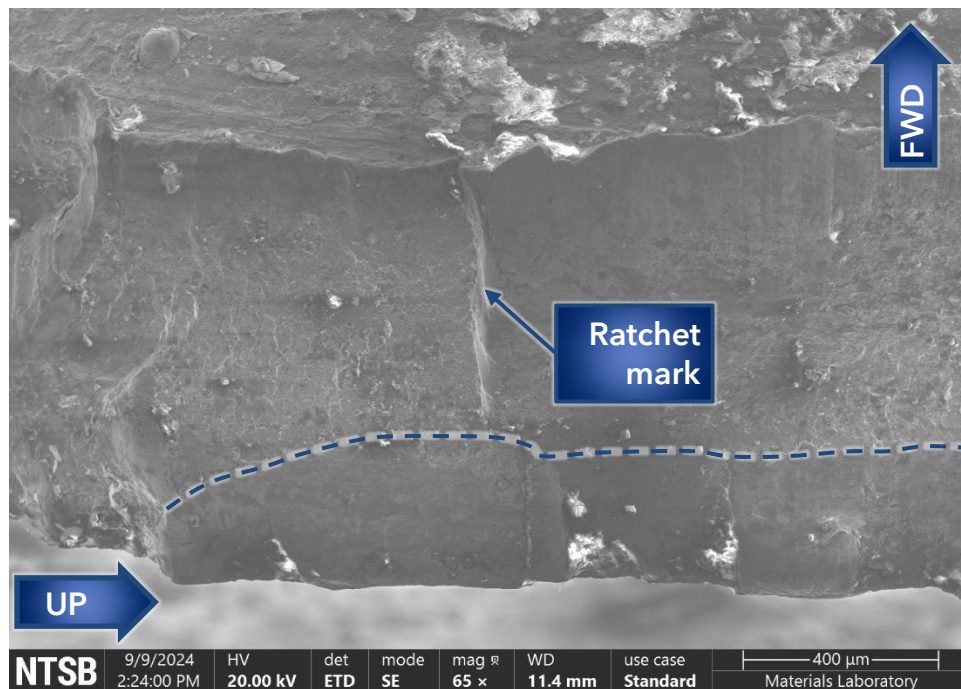
The post fracture surfaces on the knuckle side of the fracture were further examined using a scanning electron microscope (SEM). Fine fracture features were mostly obscured or obliterated by oxidation and fracture surface recontact damage. However, flat fracture features with ratchet marks<sup>1</sup> were observed such as the area shown in figure 5, features consistent with reverse bending fatigue. The origin area at the forward side of the fracture in this location was smeared by recontact damage, but a ratchet mark is noted consistent with multiple origins at the outside surface. At the lower end of the fracture, the intersection between the fatigue regions was associated with an abrupt change in fracture plane. Dimples consistent with ductile overstress fracture were observed at the upper right side of the fracture consistent with an area of final fracture.

**Figure 5.** SEM image of the fracture surface on the left side of the middle knuckle piece in the area indicated in figure 4. A dashed line indicates the boundary of the fatigue region extending forward from multiple origins at the inner surface of the rudder post.

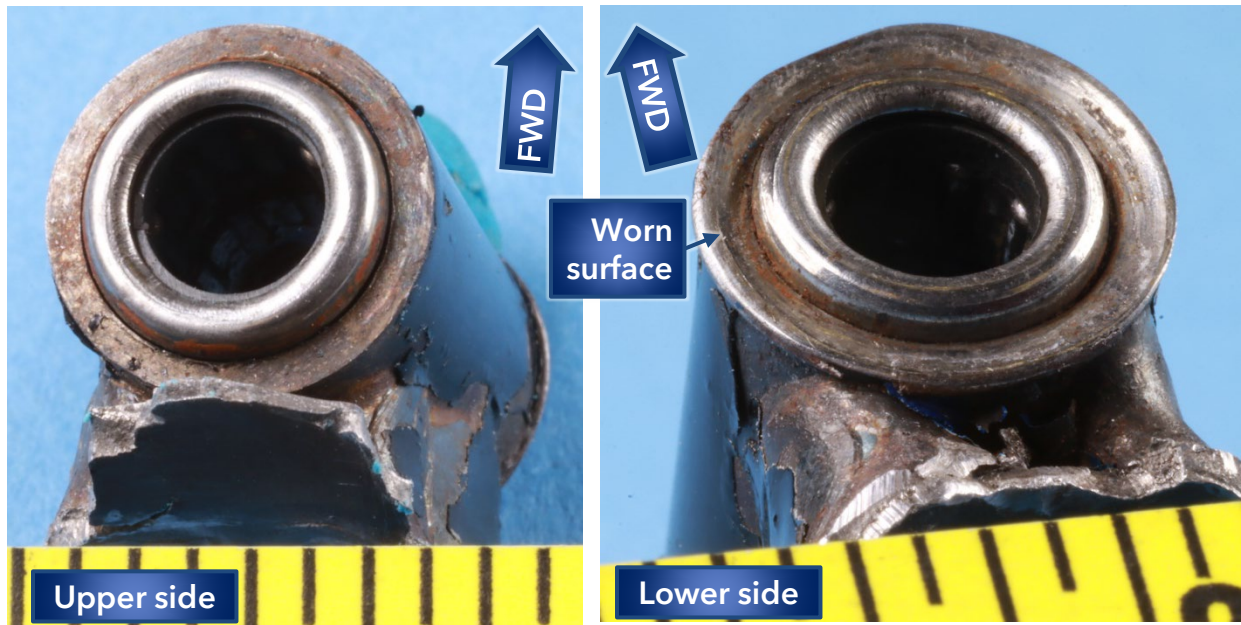
The upper and lower faces of the middle knuckle for the lower hinge are shown in figure 6. The lower face around the bearing was worn as indicated in the right image in figure 6, and the outer edge of the face had a deformation lip that extended radially outward around the outer circumference. The upper surface, shown at the left in figure 6, was free of deformation and wear. When initially

**Figure 6.** Upper (left image) and lower (right image) sides of the middle knuckle for the lower hinge. The lower face of the middle knuckle around the bearing was worn and deformed radially outward.

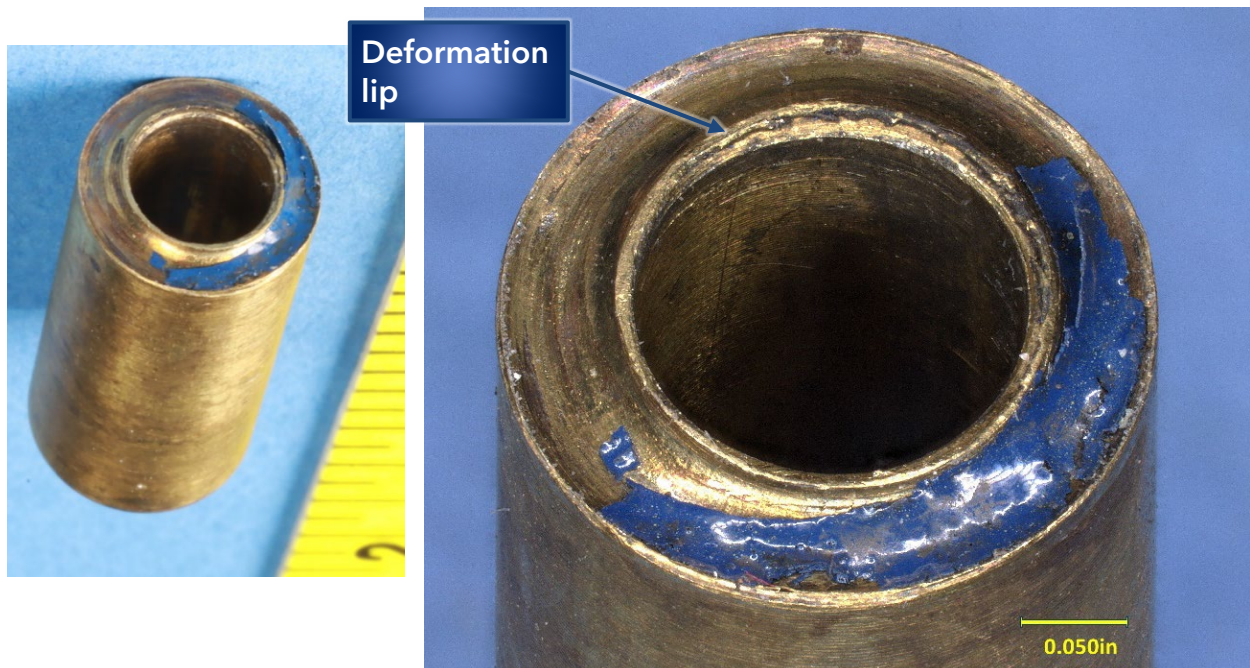
Lengths and outside diameters were measured on the two bushings. The upper bushing measured 0.690 inch long and 0.310 inch to 0.313 inch in diameter. The lower bushing measured 0.680 inch long at the outside diameter and 0.695 inch long near the inside diameter at the deformation lip. The outside diameter of the lower bushing measured 0.310 inch to 0.312 inch.

**Figure 7.** Bushing from the lower hinge with a wear pattern consistent with positioning in the lower knuckle attached to the vertical stabilizer. The lower image shows a closer view of deformation, wear, and paint deposits at one end of the bushing.

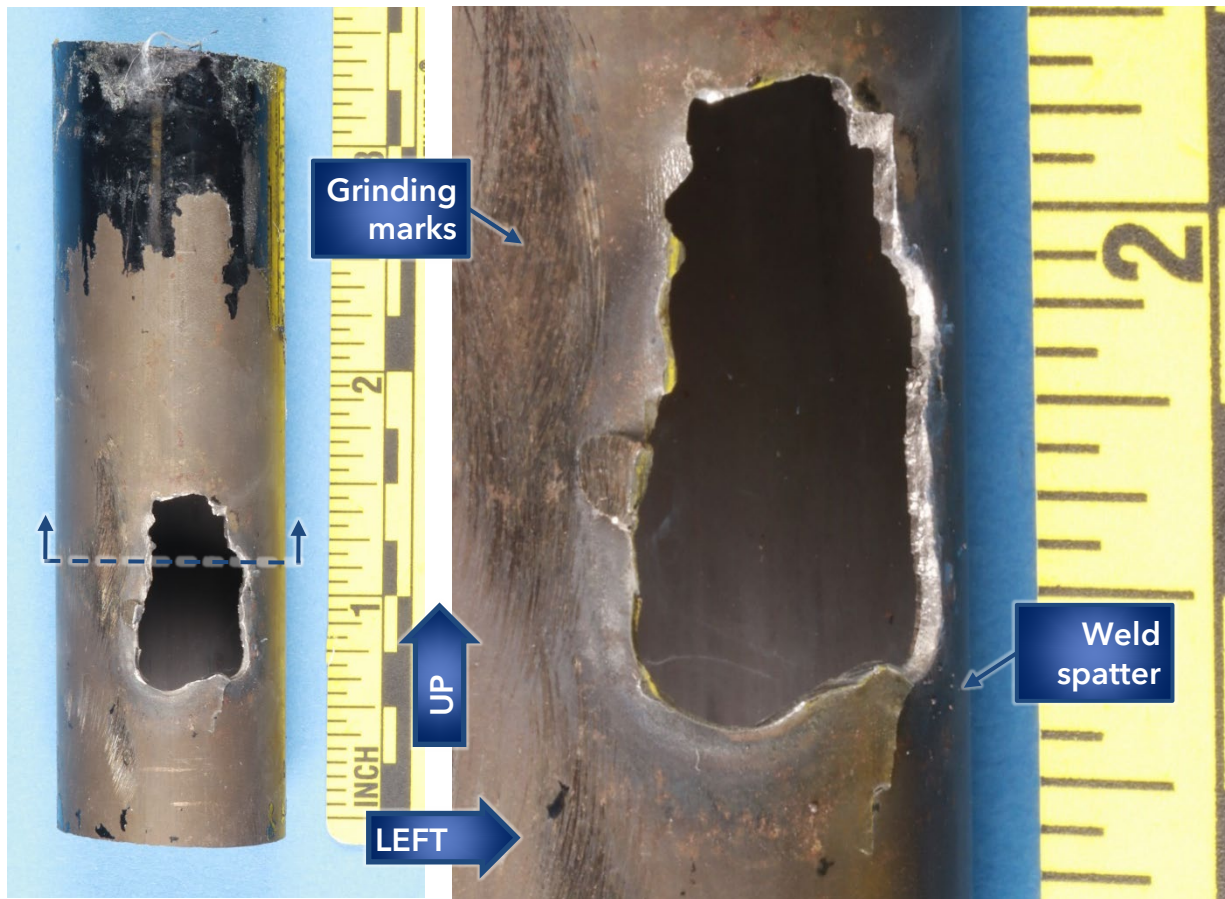
A view of the rudder post section after cleaning and a closer view of the fractured area around the lower hinge middle knuckle are shown in figure 8. Small scattered beads of molten metal were observed solidified on the surfaces around the weld consistent with weld spatter. Grinding marks were observed on the post and on a weld bead to the right of the fracture. At the upper right side of the fracture, the post wall was deformed inward adjacent to the fracture surface. At the lower side of the fracture, the right half of the post wall was bent outward adjacent to the fracture, and a vertical crack extended downward at the left edge of the deformed piece.

**Figure 8.** Sectioned piece of the rudder post at the lower hinge location after skin and paint removal and cleaning with acetone. A dashed line with arrows indicates the location of a cut to prepare a cross-section for metallography.

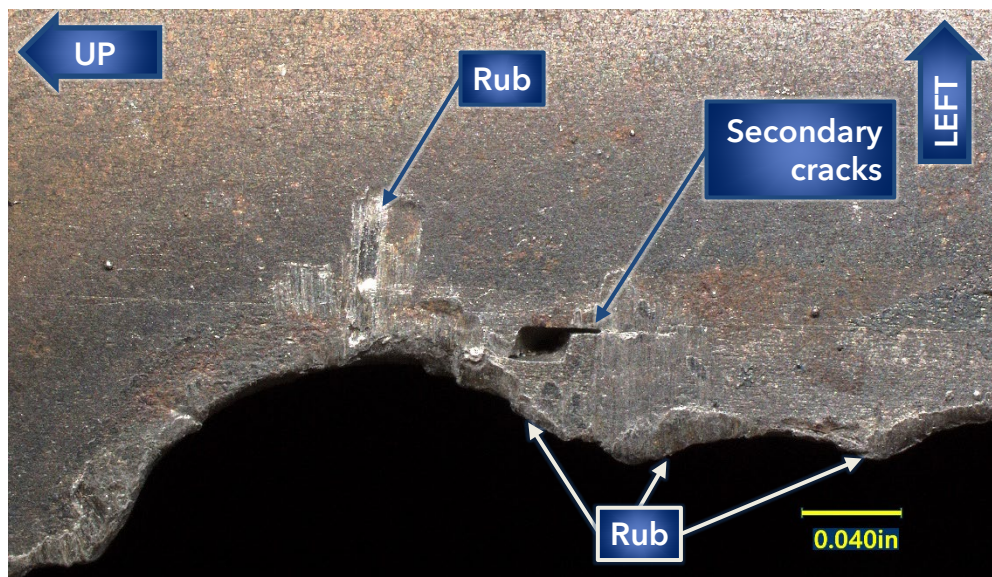
Secondary cracks located in the heat-affected zone were observed on the external surface on the left side of the fracture as shown in figure 9. Rub damage was also observed at the edge of the fracture surface along the left side of the fracture and on the adjacent external surface.

No secondary cracks were observed in the polished cross-section near the left side of the fracture. Although secondary cracks were observed during the fractographic examination on the outside surface near the left fracture surface, the polished cross-section for the metallurgical examination was located above the secondary cracks indicated in figure 9.

**Figure 9.** External surface adjacent to the left side of the fracture at the upper end of the middle knuckle weld.

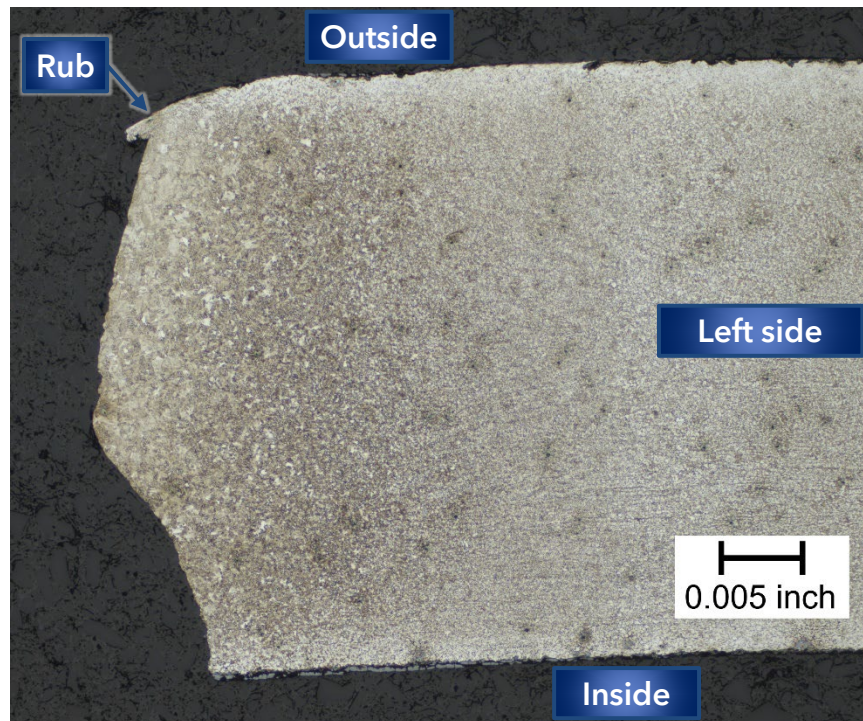
Overall views of the etched microstructure at the left and right fracture surfaces are shown in figures 10 and 11, respectively. Deformation associated with rub damage noted in figure 9 is indicated at the outside edge of the left fracture surface in figure 10. The outside surface of the rudder post generally etched lighter than the bulk of the thickness consistent with decarburization, and the heat affected zones showed a different microstructure relative to the rest of the circumference. The heat-affected zones had a lath microstructure consistent with tempered martensite as shown in the representative micrograph in figure 12. In contrast, the remainder of the circumference showed dispersed round particles (carbides) in a white background (ferrite) as shown in the representative image in figure 13, a microstructure consistent with spheroidization.

The cross-section adjacent to the left side fracture shown in figure 10 had a curvature that was consistent with the overall diameter of the post cross-section. The wall adjacent to the right side of the fracture shown in figure 11 had a local reverse bend in the polished cross-section. Traversing toward the fracture from the right side of the post, the wall first bent locally inward (outside the field of view in figure 11), then closer to the fracture, the wall bent locally outward. At the fracture surface, the inside edge of the fracture was bent inward.

**Figure 10.** Polished and etched cross-section of the rudder post intersecting the fracture at the left side of the hinge middle knuckle. (2% nital etch)

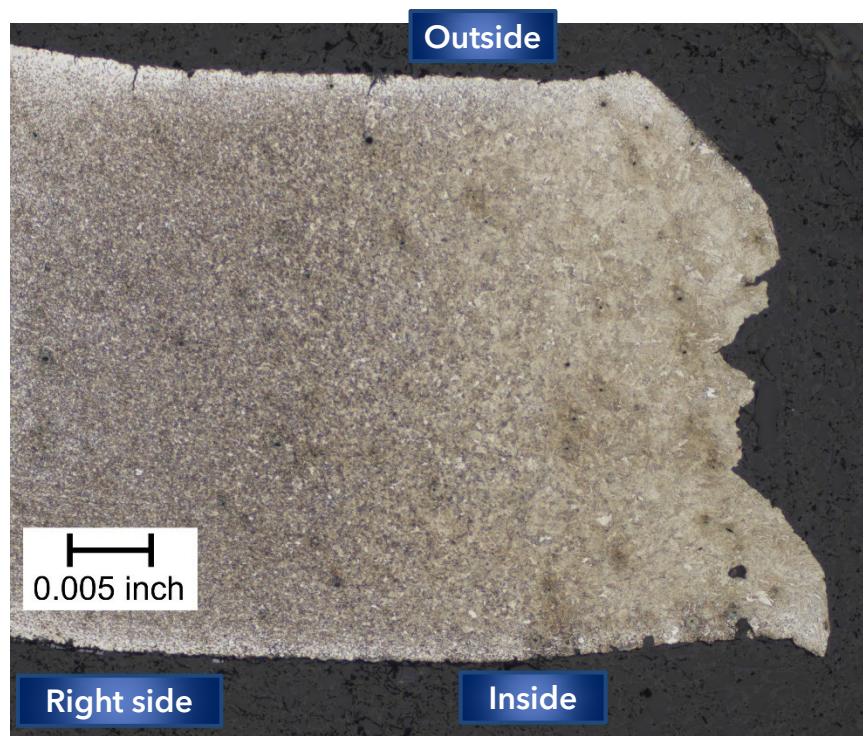
**Figure 11.** Polished and etched cross-section of the rudder post intersecting the fracture at the right side of the hinge middle knuckle. (2% nital etch)

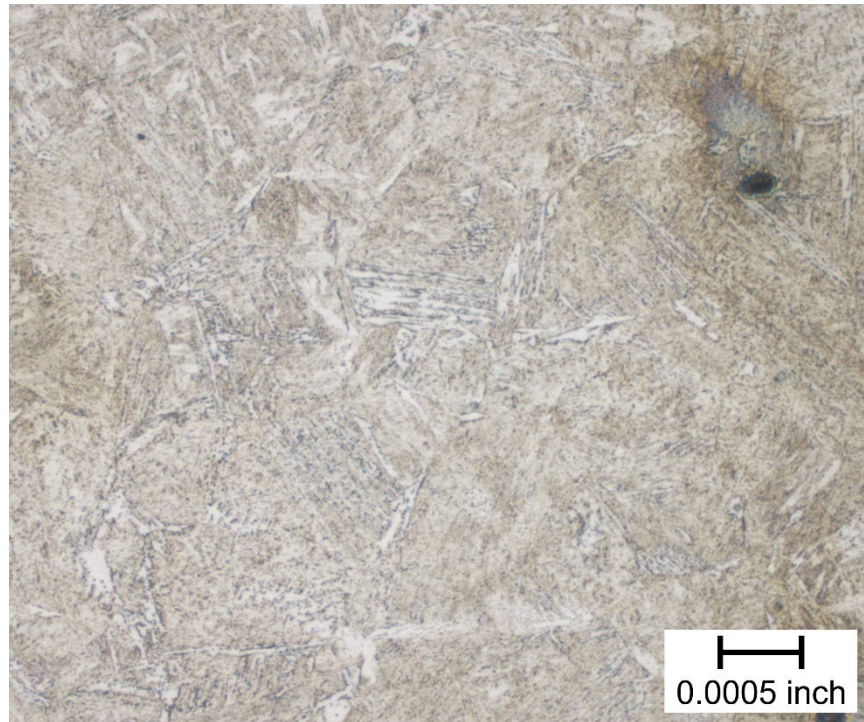
**Figure 12.** Polished and etched section of the rudder post showing the microstructure in the heat-affected zone near the fracture surface. (2% nital etch)

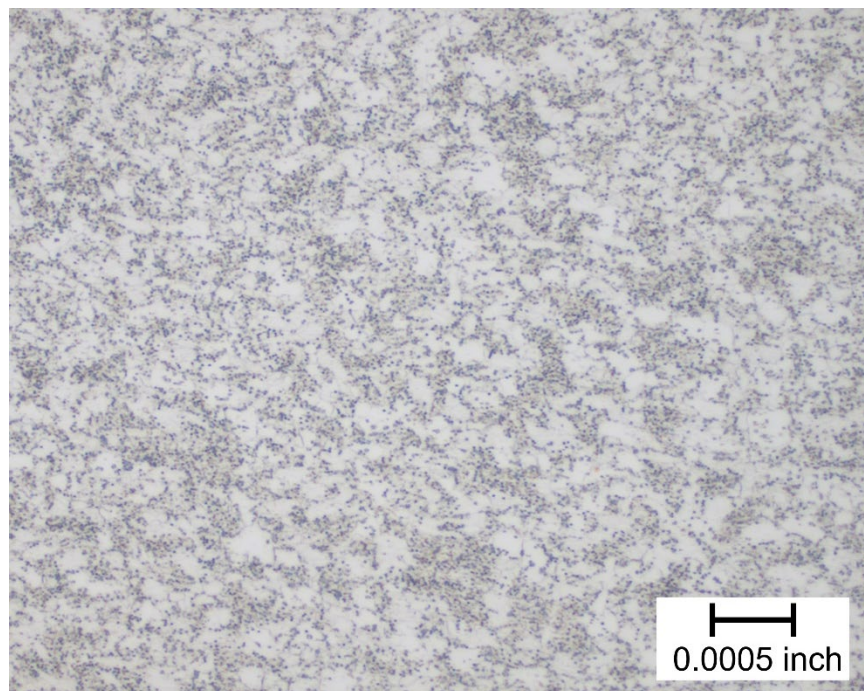
**Figure 13.** Polished and etched section of the rudder post showing the microstructure near the middle of the thickness away from the heat-affected zone. (2% nital etch)

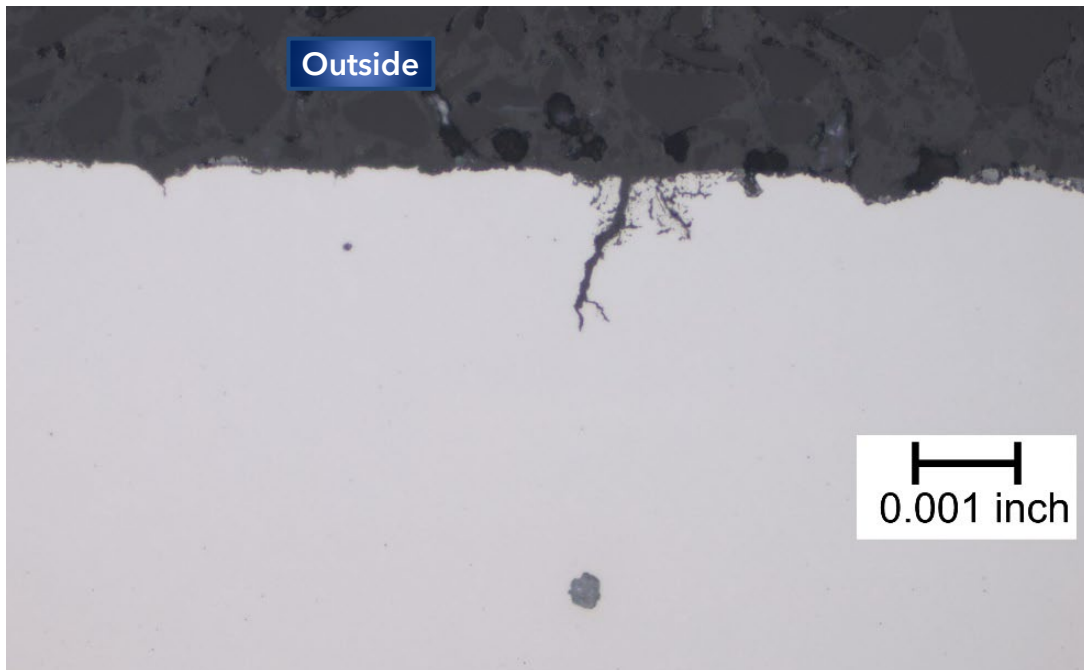
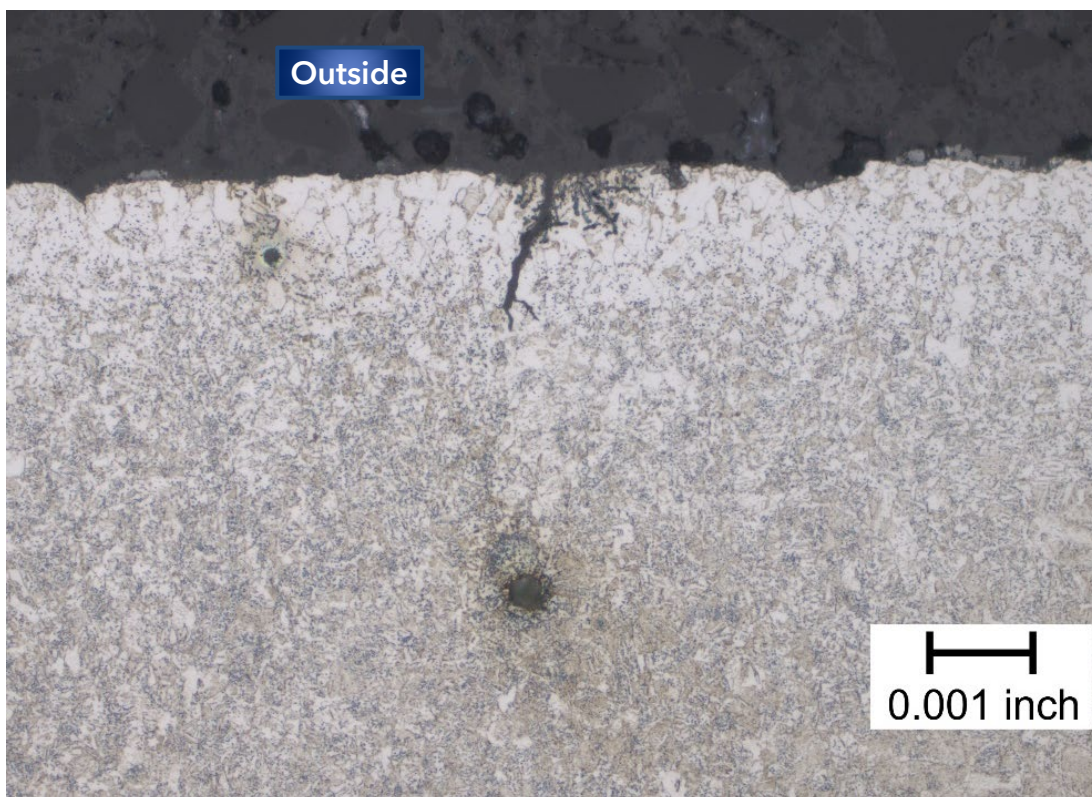
A series of secondary microcracks were observed in the polished cross-section in the heat-affected zone adjacent to the right fracture surface. Micrographs showing one of the microcracks in the as-polished and the etched conditions are shown in

figure 14. A dominant microcrack with limited crack branching was observed extending from a cluster of smaller branched crack-like features near the surface. Similar microcracks appeared to extend from small pits on the external surface.

**Figure 14.** Secondary crack at the external surface in the rudder post cross-section near the right fracture location shown in the as-polished condition (upper image) and after etching with 2% nital (lower image).

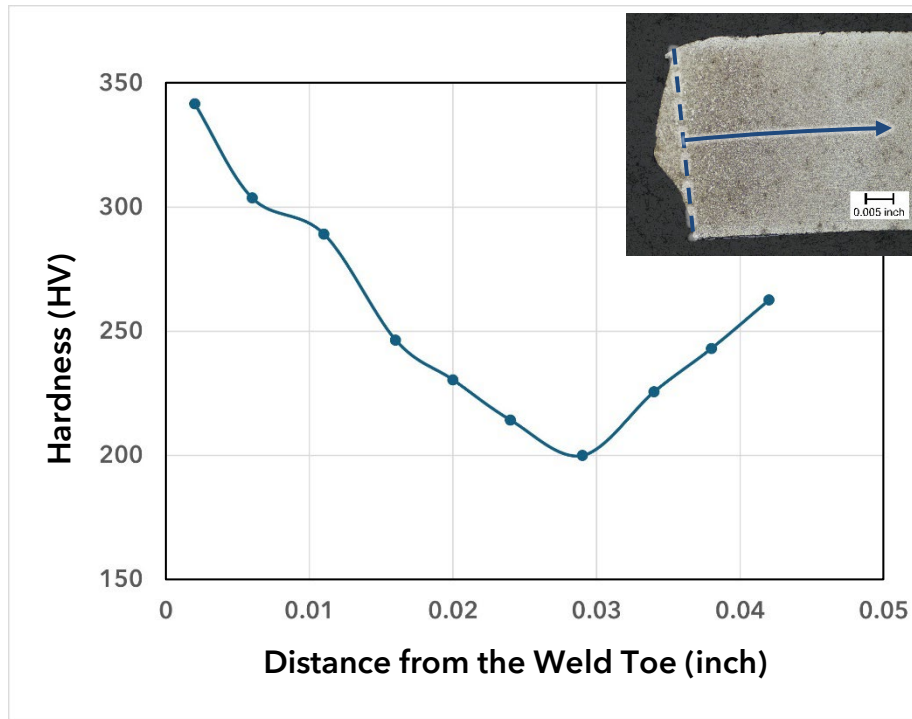
Next, a series of Vickers microhardness indents were made near the center of the post wall thickness at varying distance from the weld toe on the left side of the middle knuckle. Results from this series of microindents are shown plotted in figure 15. An inset image in figure 15 illustrates how distance from the weld toe was measured. Hardness values ranged from a maximum of 35 HRC (342 HV) at a location 0.002 inch from the weld toe to a minimum of 93 HRB (200 HV) at a location 0.029 inch from the weld toe.

**Figure 15.** Plot of Vickers microhardness as a function of circumferential distance from the weld toe to the left of the middle knuckle (see inset image for illustration of the distance measurement).

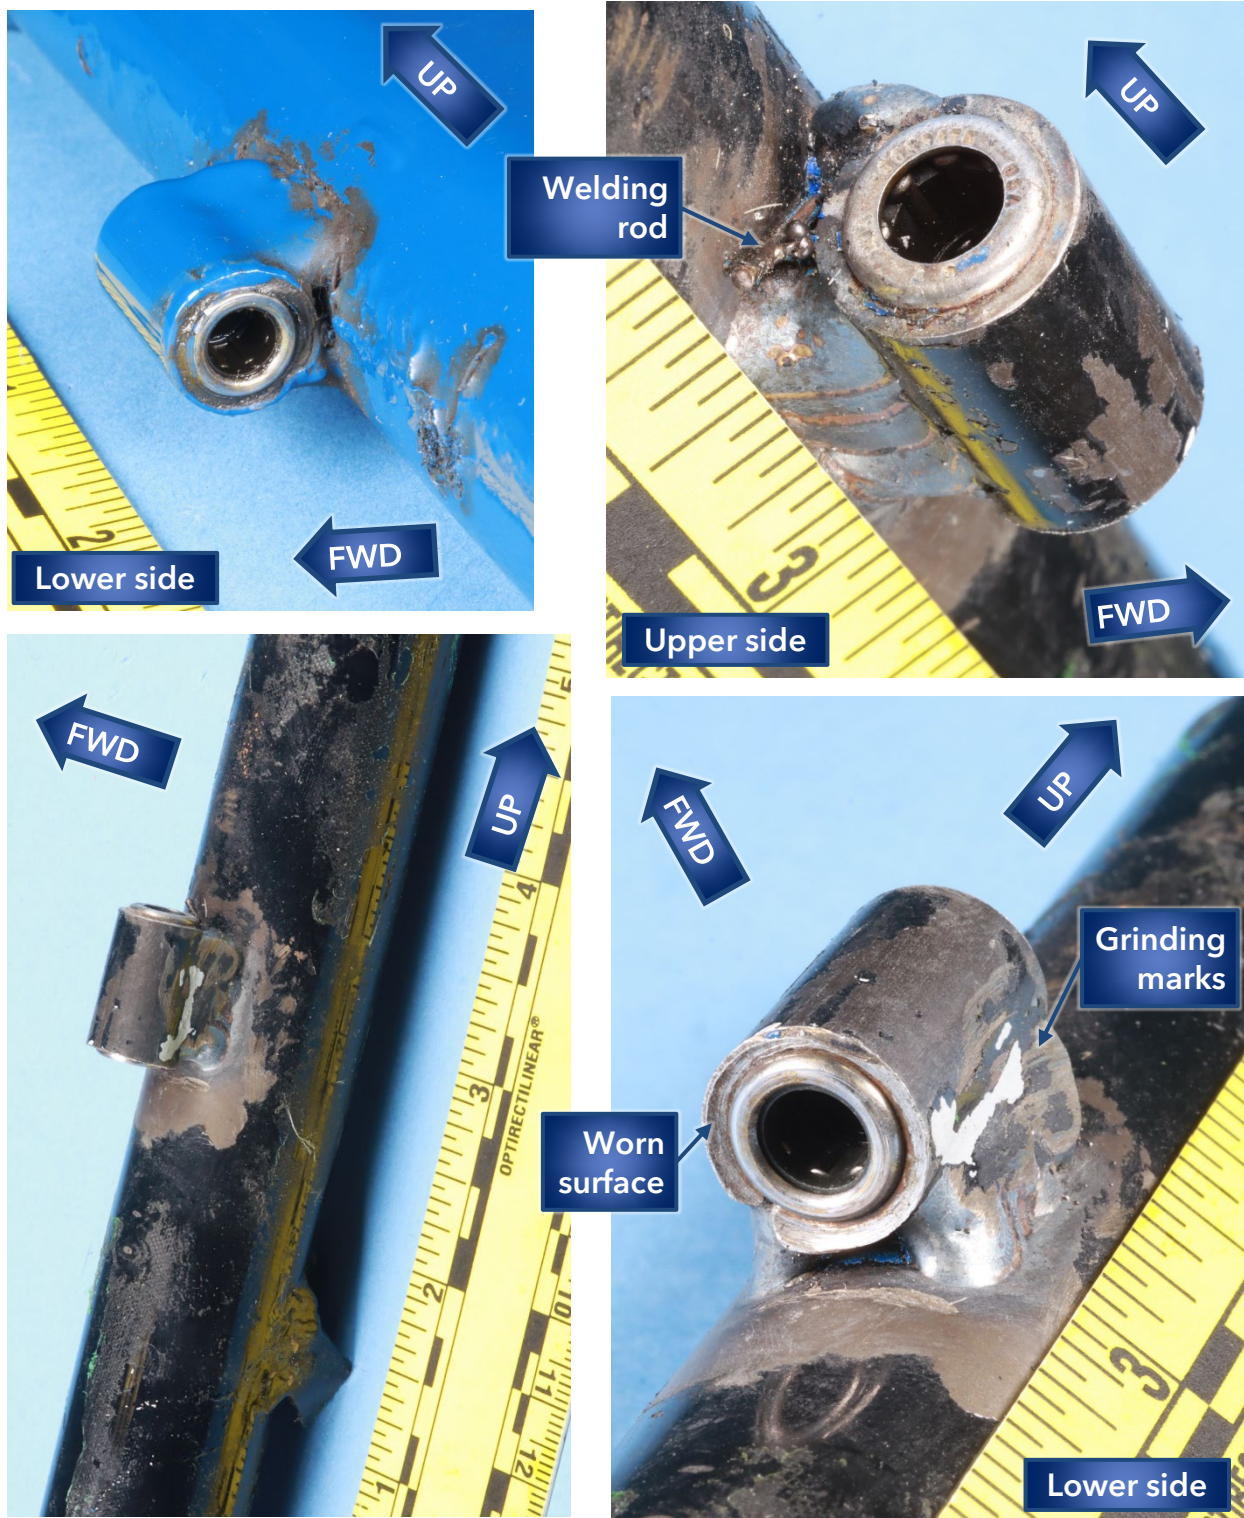
Views of the intact middle knuckle at the rudder's upper hinge location are shown in figure 16. As received, the surfaces of the middle knuckle were covered with blue paint, including upper and lower surfaces around the bearing as shown in the upper right image in figure 16. After an initial examination, the rudder skin was peeled away from the rudder post around the upper hinge location. Transverse cuts were then made through the rudder post above and below the upper hinge location, and a vertical cut was made through frame members attached to the aft side of the post, which separated a section of the post with the upper hinge middle knuckle from the remainder of the rudder. After an isolated scraping with a scalpel on the outside of the knuckle, the sectioned rudder post from the upper hinge location was then submerged in acetone and cleaned using an ultrasonic cleaner for approximately 10 minutes. Additional cleaning was completed with soft-bristle brushes dipped in acetone and a plastic scraper to remove coatings from the upper hinge middle knuckle and surrounding area on the post.

Views of the middle knuckle from the rudder's upper hinge location after cleaning are shown in the upper right, lower right, and lower left images in figure 16. The blue and white coating layers were mostly gone, and the black coating remained

partially intact. A worn contact surface (indicated in the lower right image in figure 16) was observed on the lower side of the middle knuckle around the bearing in areas that had previously been covered with blue paint. The upper surface (upper right image in figure 16) was free of deformation and wear. Weld spatter was observed on the surfaces around the weld, and a wire consistent with a welding filler rod was observed attached at the upper end of the middle knuckle as shown in figure 16. No visual crack indications were observed around the weld toes at the upper hinge middle knuckle when examined at optical magnifications of up to 300x.

**Figure 16.** Views of the middle knuckle for the rudder's upper hinge as received (upper left) and after skin removal, sectioning, and cleaning with acetone (remaining 3 images).

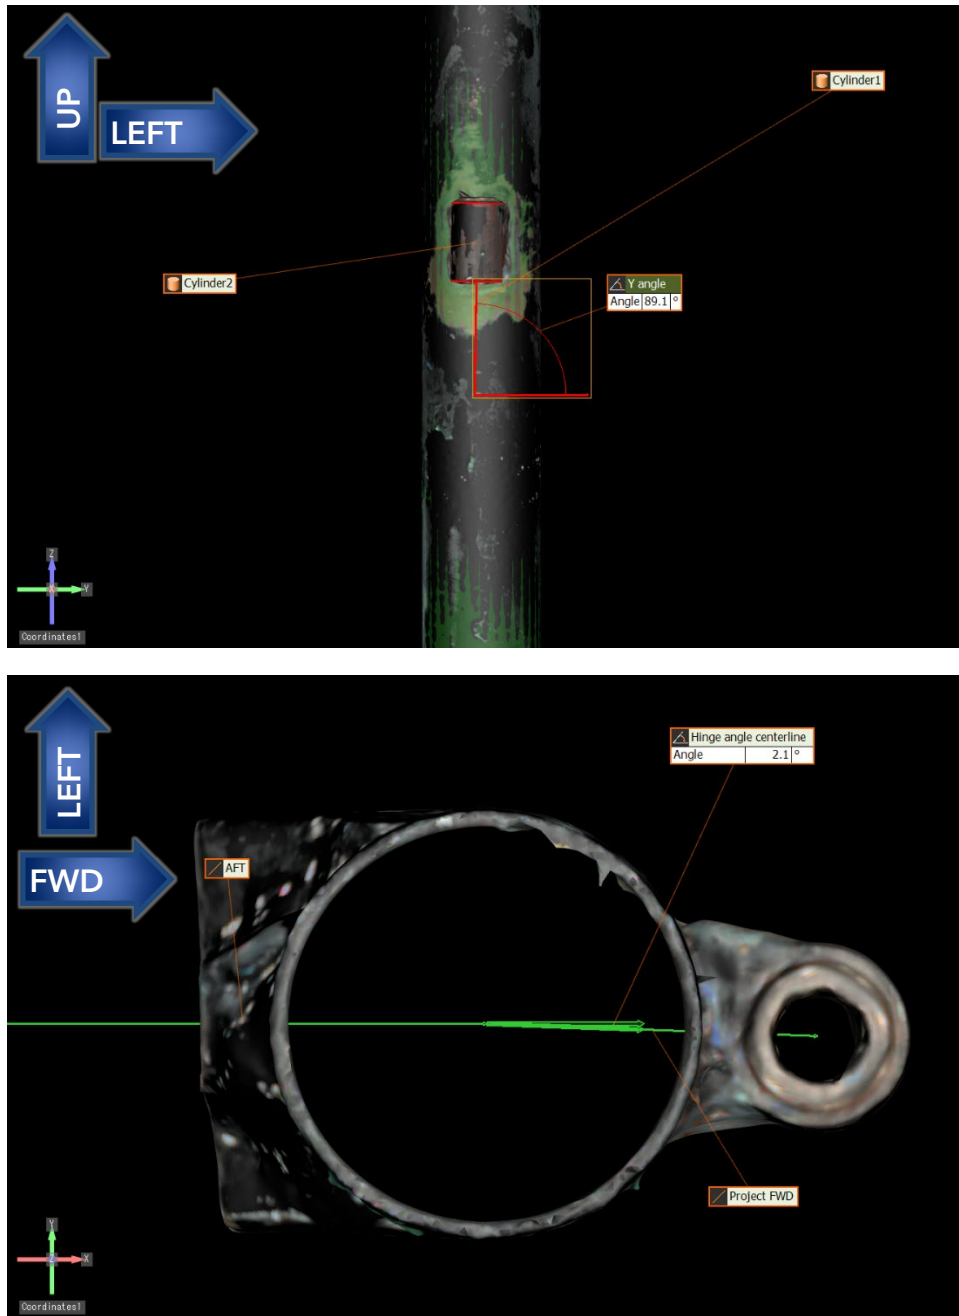
The sectioned rudder post from the upper hinge location was scanned using a Keyence VL-500 series 3-dimensional (3D) coordinate measurement machine (CMM). Three separate scans were stitched together to obtain a 3D representation of the piece shown in figure 17. Cylinders were fit to the post, the middle knuckle, and a tubular frame element cut from the aft side of the post. The rudder centerline was defined by the direction between the frame tube axis and the rudder post axis in the horizontal plane, where the horizontal plane normal was defined parallel to the rudder post axis. In figure 17, the Z axis points upward parallel to the rudder post axis, the X axis is the forward direction parallel to the rudder centerline in the horizontal plane, and the Y axis points to the left.

The upper hinge middle knuckle axis was rotated slightly relative to the rudder post axis and was located to the right of the rudder centerline as shown in the measurements in figure 17. In the view looking aft (upper image in figure 17), the hinge middle knuckle was rotated slightly clockwise relative to the rudder post axis. The resulting angle between the middle knuckle axis and the horizontal left direction was 89.1-degrees as measured in the Y-Z plane. Looking downward (lower image in figure 17), the centerline of the middle knuckle was observed to be to the right of the rudder centerline. At the upper and lower ends of the middle knuckle, the middle knuckle axis was located 0.029 inch and 0.039 inch, respectively, to the right of the centerline. The angular measurement of 2.1 degrees in the lower image in figure 17 represents the angle between the rudder centerline and the middle knuckle axis location at the upper end of the middle knuckle measured in the X-Y plane with the angle's vertex positioned at the rudder post centerline.

**Figure 17.** Three-dimensional representations of the sectioned and cleaned rudder post at the upper hinge location after scanning with a Keyence VL-500 series CMM. The upper image shows the angle between the post and middle knuckle axes as measured in the Y-Z plane, and the lower image shows the angular displacement of the hinge middle knuckle axis relative to the rudder centerline measured in the X-Y plane.
