Aaron Sauer  
Sr. Air Safety Investigator  
Office of Aviation Safety - Central Region

**Date:** 04/30/24

**Subject:** CEN24LA169

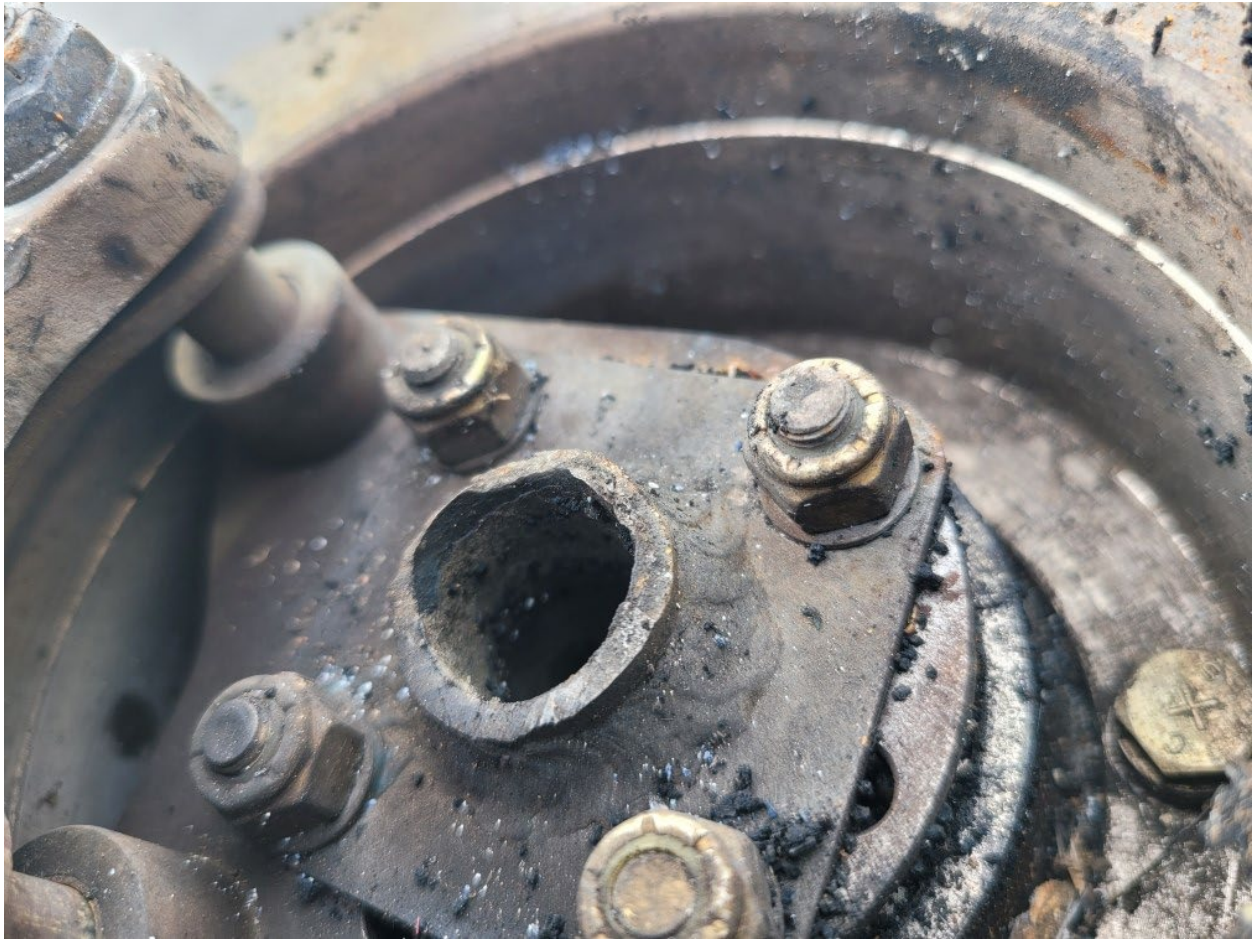
Pete and some airport personnel recovered the airplane at the direction of the NTSB investigator-in-charge (IIC) and moved the airplane to the pilot's hangar. The NTSB IIC asked Pete (who is a mechanic) to note during recovery anything that appeared unusual or a potential problem. Pete observed a fracture of the right main landing gear spindle near the wheel attachment (see photo 1.).

Photo 1. Right main landing gear spindle.

About 50% of the fracture surface appeared to be a fracture that had been there for quite some time due to the surface, grease, and other materials. Pete photo documented the fracture and waited for further instructions on his assistance.

Pete stated that when the airplane is resting on its landing gear, the lower wing sits about 14 inches off the ground. Based on the evidence, Pete said it appeared the right main wheel separated during the landing, and wheel assembly became trapped under the wing and fuselage. The airplane skidded on its lower right wing and rotated. A section of the main landing gear assembly appeared to have punctured the fiberglass fuel tank, which was located between the pilot's legs in the cockpit.
