## INSPECTOR STATEMENT

### Aircraft Accident

Location: Castroville Municipal Airport, TX (KCVB)

Aircraft: N822CH / Pratt William J, Baby Great Lakes

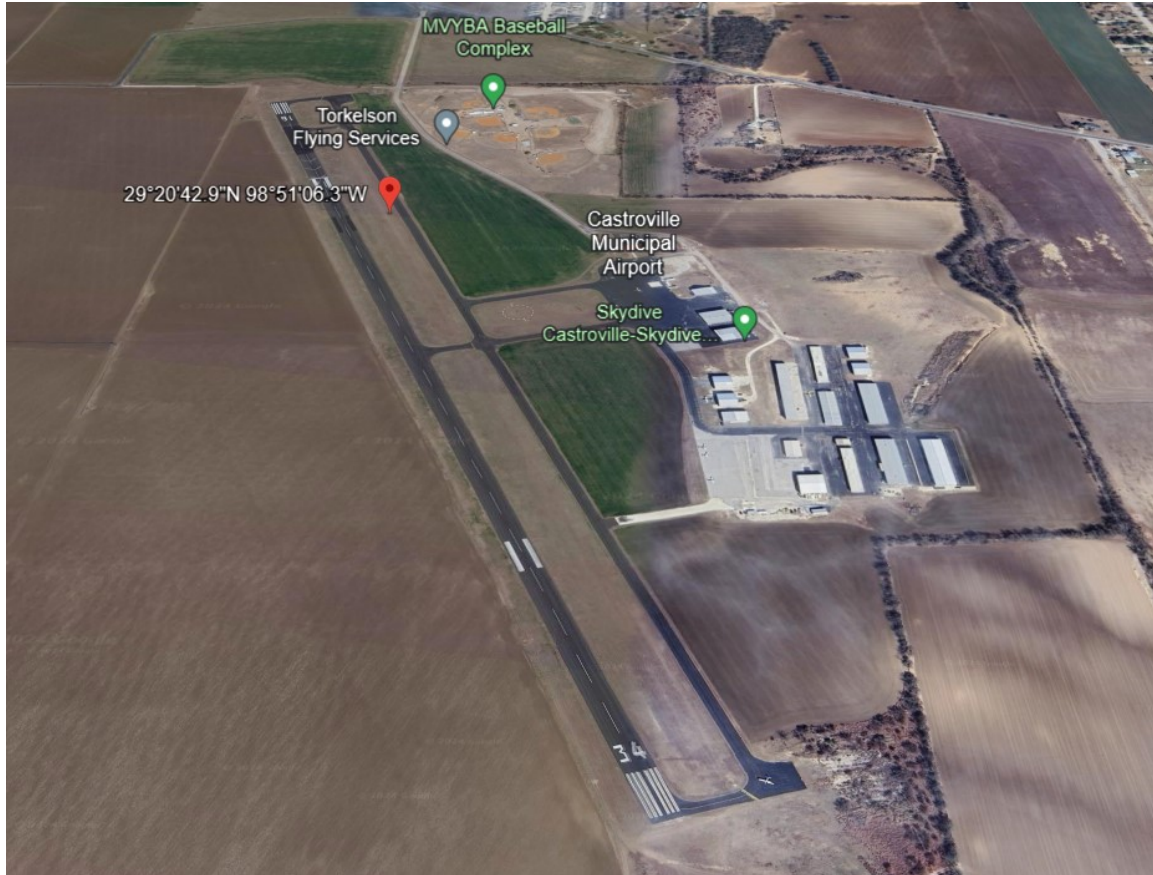
**Accident Area – Castroville Municipal Airport (KCVB):**

On April 29, 2024, at approximately 1600 local time, I, the FAA IIC, arrived on-site at Castroville Municipal Airport. Upon examining the accident area, I observed a single tire skid mark approximately 30 feet in length along with a few areas that appeared to be propeller strikes. The aircraft was located approximately 50 feet further south from the ground skid markings. The right wheel was lodged under the aircraft and could not be pictured. I performed an inspection of the grass runway area along with 6 volunteers and no separated aircraft equipment could be located nor any potholes observed. I took pictures of the accident scene and questioned the airport staff that was on-site. There were no eyewitnesses and no video picked up the accident. I left the scene at approximately 1730L.

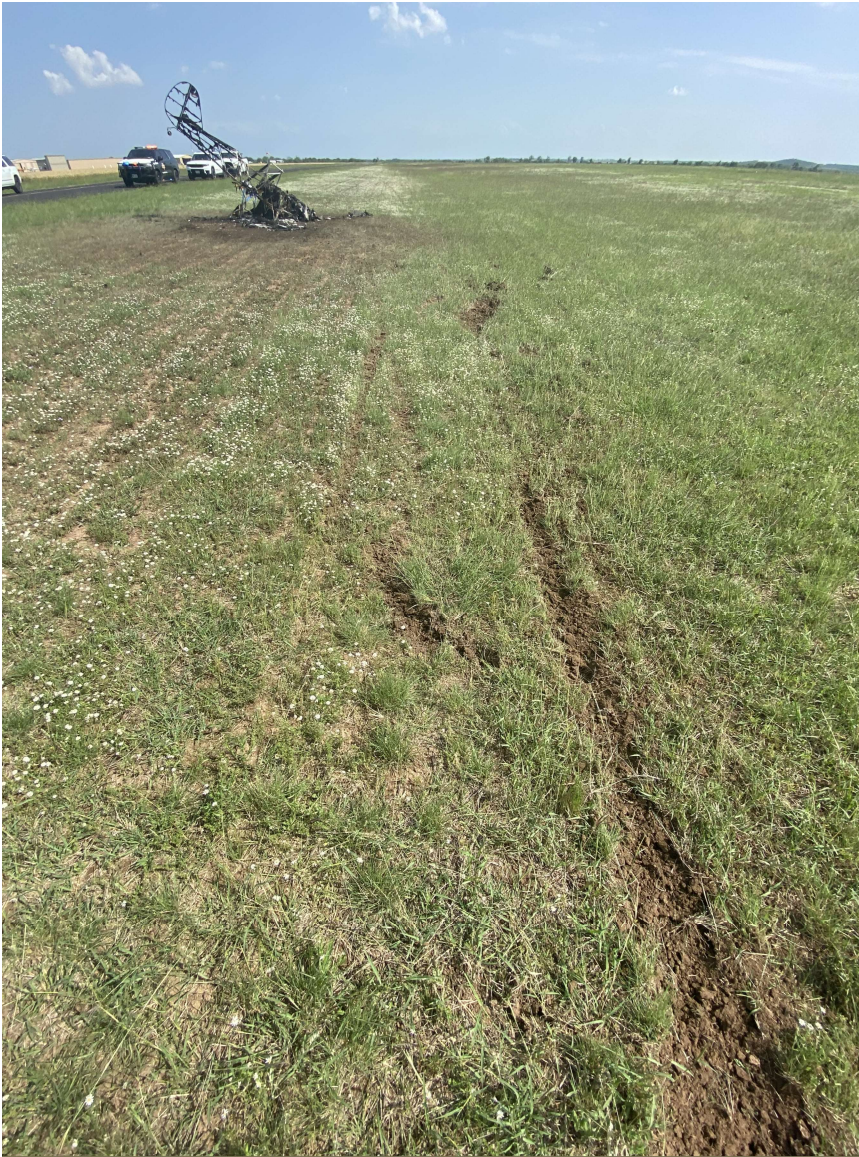
**Accident Scene looking south on undocumented grass runway 16:**

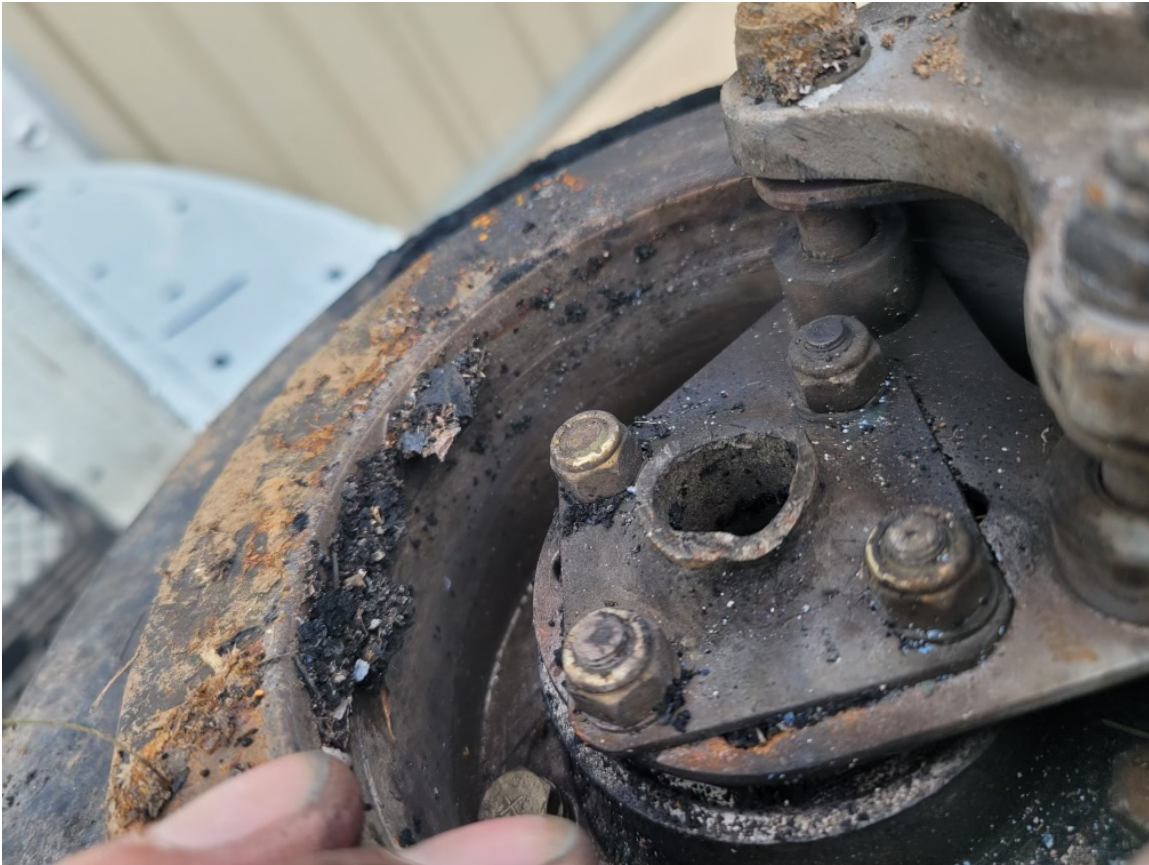
wheel detached the landing gear frame at the weld. The broken area showed evidence of rust on the forward section and would suggest it was broken prior to this flight. At the request of the NTSB IIC, I took the right wheel assembly and right gear attachment frame from the wreckage to be sent to the NTSB lab for testing. I was unable to recover the aircraft logbooks. I have asked the pilots wife to provide them.

On May 01, 2024, after review of the available data, it appears that the most likely cause of the aircraft accident was a previous break between the right wheel assembly and the right wheel gear/frame attachment point. The data suggests that on landing, the wheel started to break and was drug for approximately 30 feet before completely detaching from the frame and causing the accident, which would correspond to the pilot's statement that the aircraft felt like it hit a pothole. When the wheel separated from the aircraft, the right frame dug into the ground approximately 10 inches and broke the gear/frame support for the left and right wheels. The broken left frame/gear assembly pushed up into the non-metal fuel tank, rupturing it and dowsing the aircraft pilot and engine with fuel. The engine heat ignited the fuel and engulfed the plane and pilot.

**Right Wheel break point showing evidence of prior rust (Part sent to NTSB):**

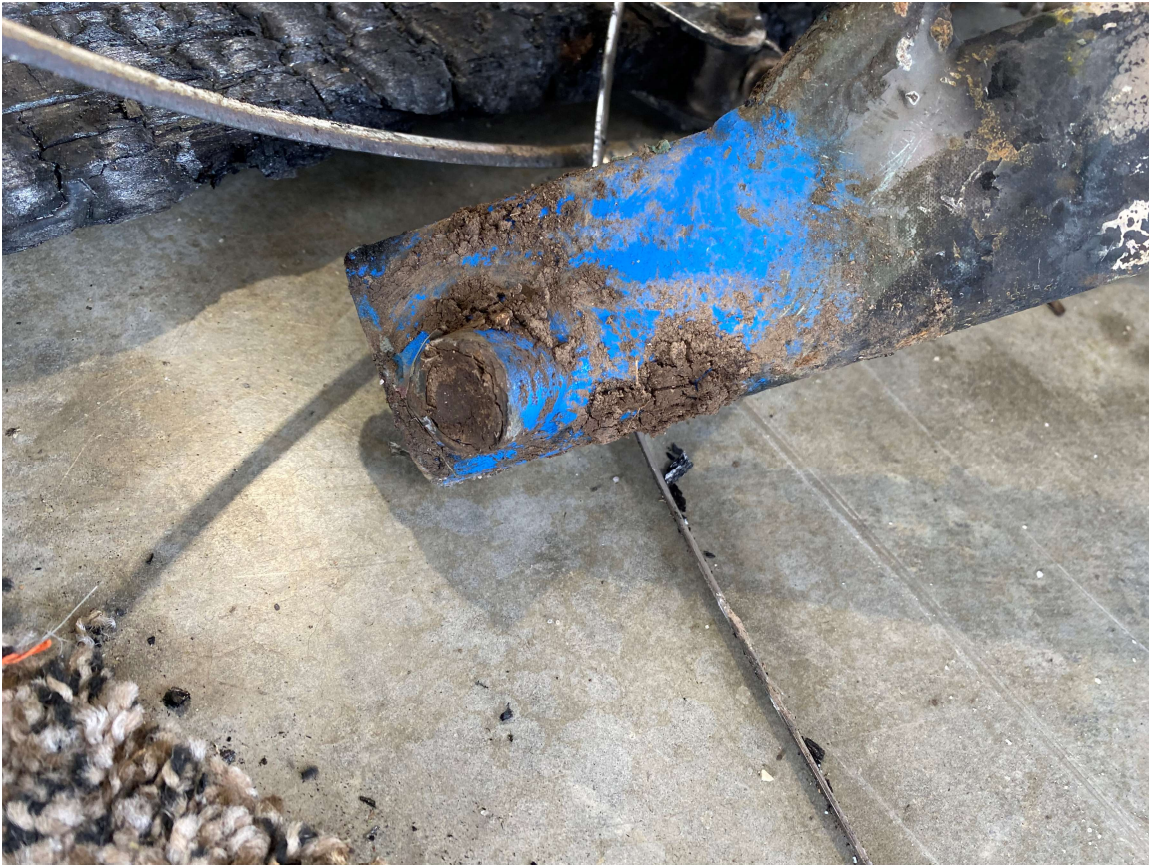
**Right gear/frame attachment break point (Part sent to NTSB):**
