**From:** [REDACTED]  
**To:** [REDACTED]  
**Cc:** [REDACTED]  
**Subject:** Email Report (CEN24LA169 - Landing Gear)  
**Date:** Friday, July 12, 2024 8:06:46 AM  
**Attachments:** [Figure 1.png](#)  
[Figure 2.jpg](#)

On April 29<sup>th</sup>, 2024, a Baby Great Lakes (N822CH) crashed upon landing on a grass strip in Castroville, Texas and subsequently caught fire. A fractured landing gear assembly was submitted to the Materials Laboratory for further inspection. The tubular welded assembly arrived at the lab in two pieces, consisting of a Y-shaped portion of the landing gear leg and a flanged fitting which remained bolted to the wheel.

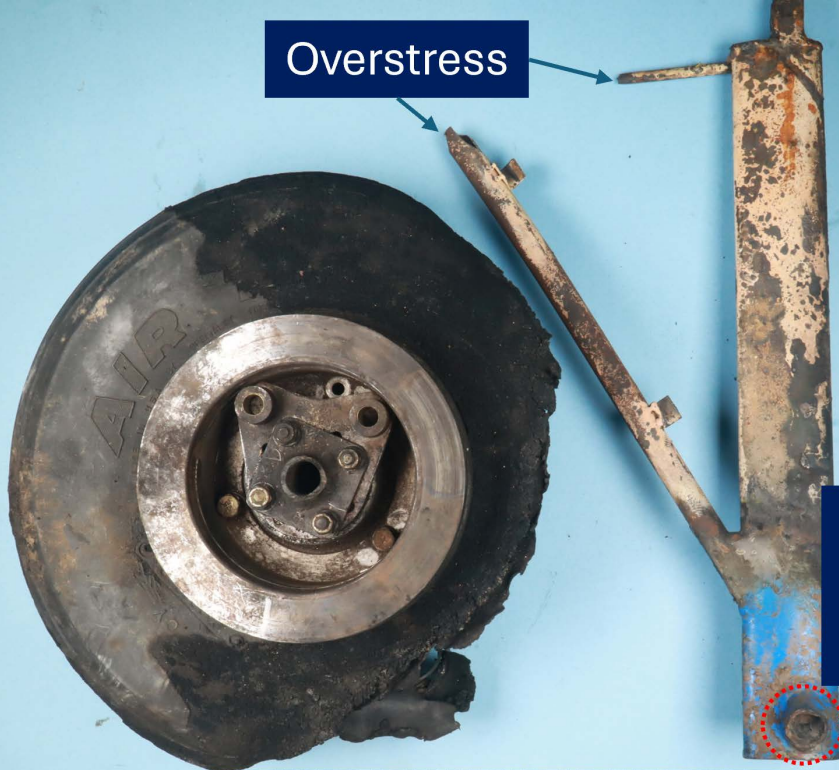
Three fracture surfaces were identified on the landing gear leg. Two of these surfaces were at the upper end, and one towards the lower. The two fracture surfaces on the upper end of the leg were matte gray and rough in nature, consistent with overstress fracture.

Overstress

Subjected to  
cleaning and  
further  
inspection

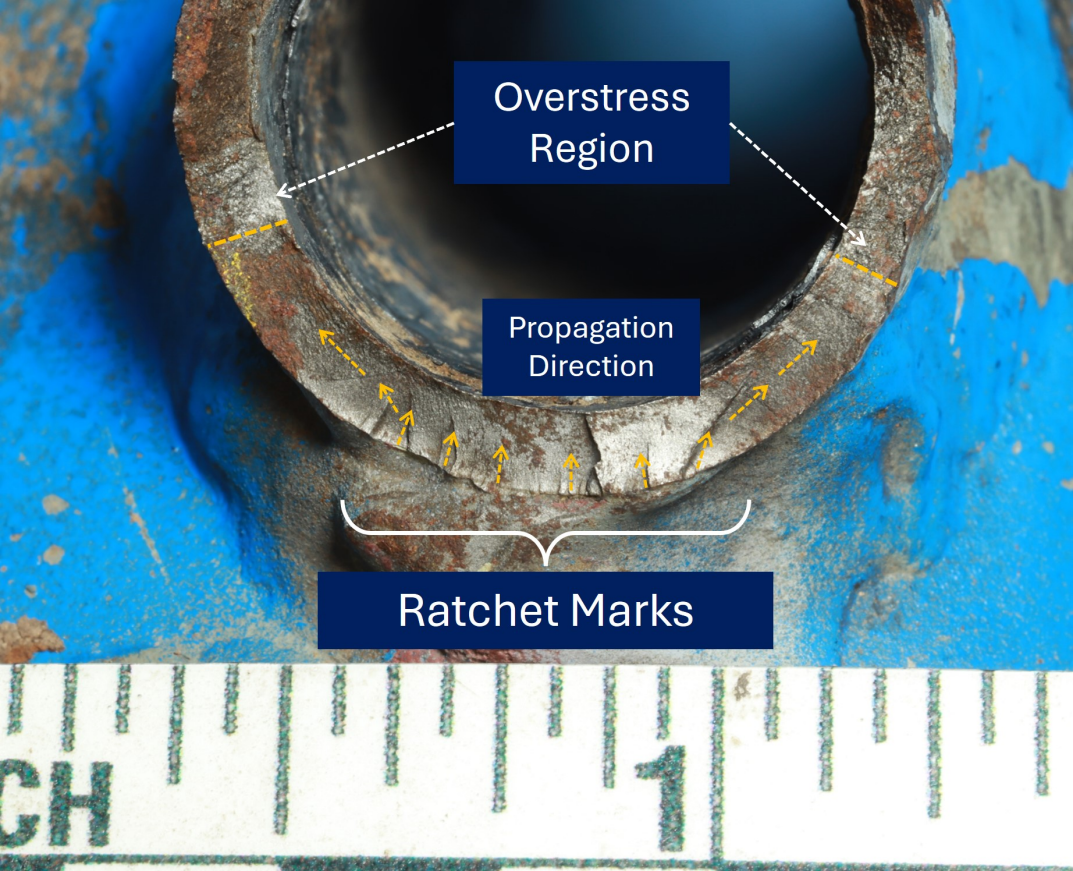
The fracture surface on the lower end of the leg was located on a tube (OD 0.8 in, thickness 0.1 in) that passed through the body of the landing gear leg and was welded in place. The fracture surface mirrored the fracture surface seen on the flanged fitting on the wheel. It was cleaned with soap, water, and a soft brush to remove soil. Examination of the cleaned surface under an optical stereoscope revealed a series of ratchet marks extending from the weld toe at the outside lower edge of the fracture surface which coalesced through the tube wall, consistent with multiple fatigue crack initiation points joining into a single larger crack. In this region, the surfaces between the ratchet marks were primarily oriented perpendicular to the axis of the tube. The fatigue crack extended across approximately 30% of the cross section of the tube before transitioning into a rougher, slanted appearance towards the upper side of the tube, consistent with final failure due to overstress. The locations of the fatigue initiation points were consistent with the cyclic bending forces that would have been applied to this section of the landing gear under normal landing and takeoff conditions.

Overstress  
Region

Propagation  
Direction

Ratchet Marks
