Bradley Miller  
Aviation Accident Investigator  
AS-CEN

**Date:** June 21, 2023

**Subject:** Flap Switch Examination / Information

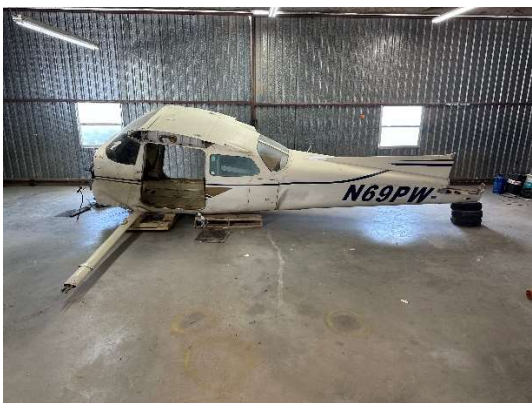
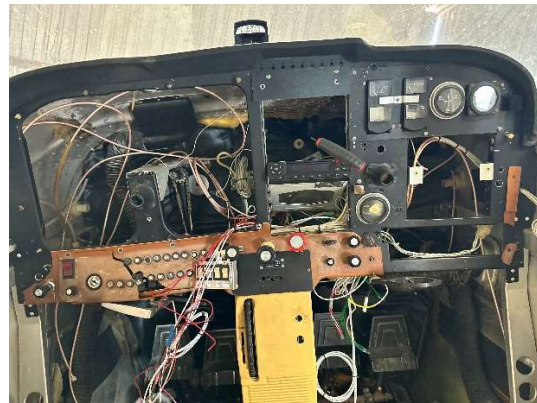
Upon receipt of the new information an attempt to examine the airplane was made. During the follow up, the FAA reported that the airplane had already been stripped down and salvaged. The condition of the airplane precluded examination of the stall horn but did allow the flap switch to be removed and retained for further examination.

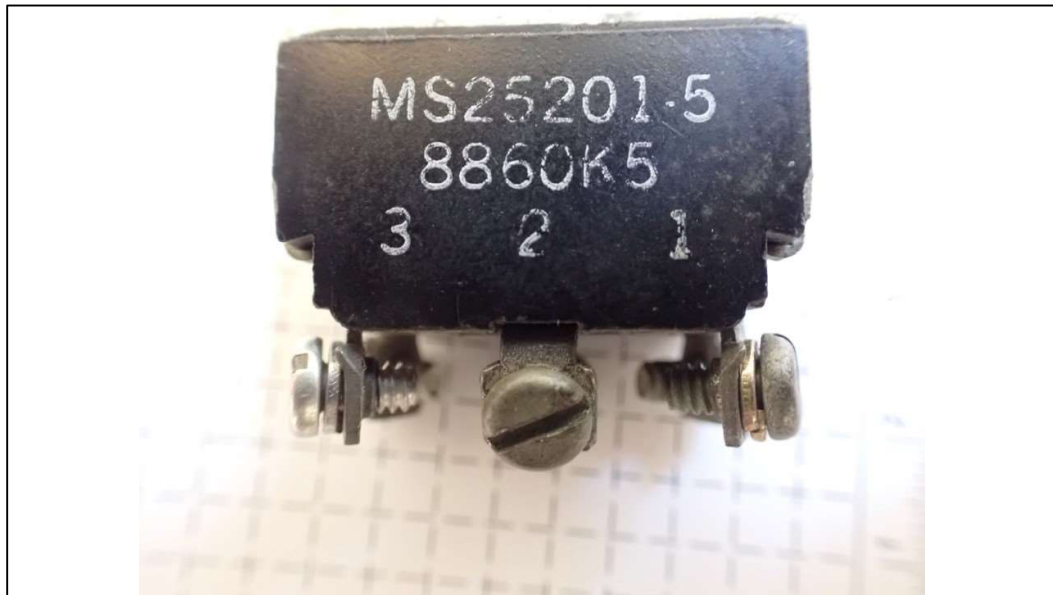
The flap switch was marked "MS25201-5." This military specification (mil spec) was used to determine the normal operation of the switch. According to publicly available information, the switch has three positions: Up, Center, and Down.

The accident airplane switch was examined, and function checked in all three switch positions - it worked correctly and no anomalies were noted.

Accident airplane flap switch

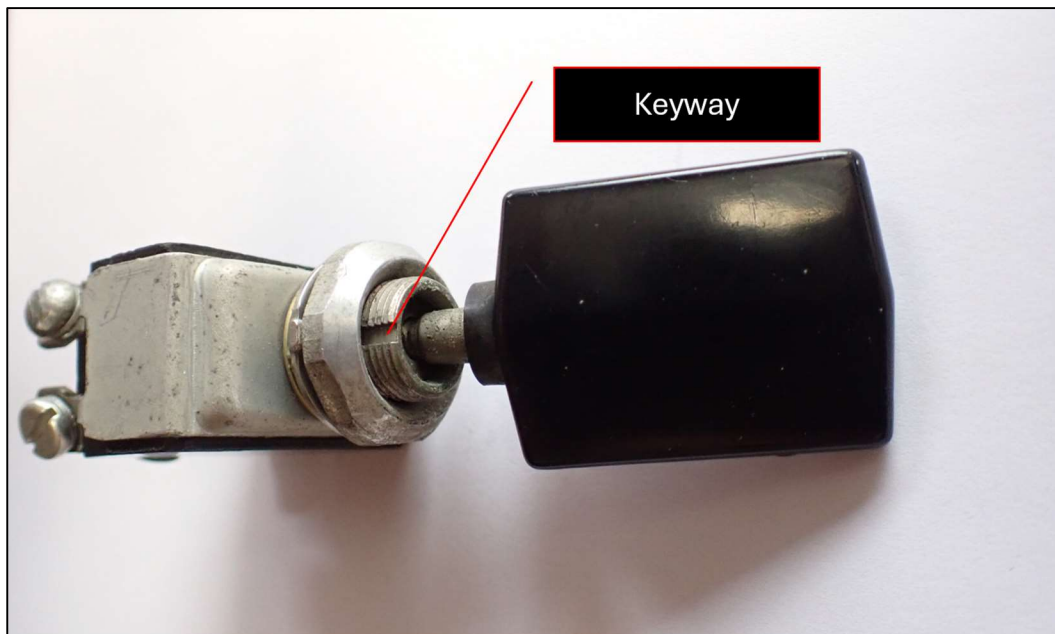
If the switch is activated to the **Down position**, the switch is spring loaded and will return to the Center position once physical pressure is removed from the switch. The down position is in alignment with a keyway in the barrel of the assembly.

Accident airplane flap switch keyway. Denotes down position when switch is activated in the direction of the keyway.
