CEN24LA180

## INVESTIGATION PHOTOGRAPHS

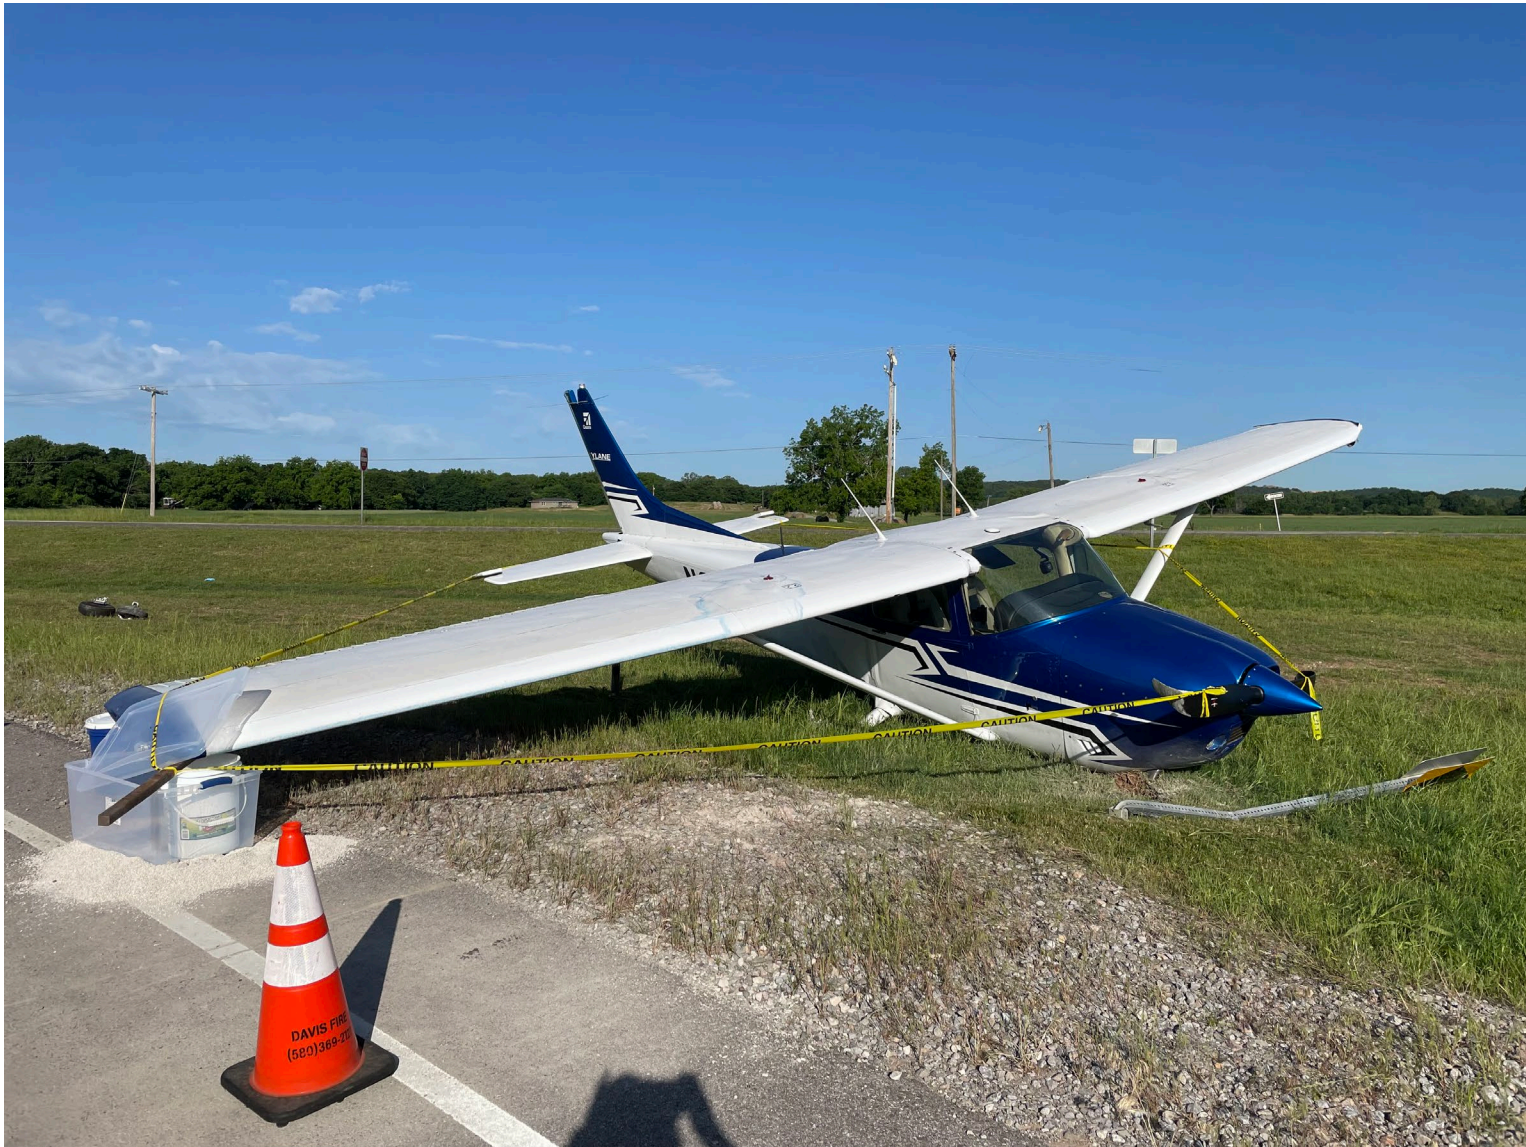
**Photograph 1 -Accident Site (Courtesy of FAA)**

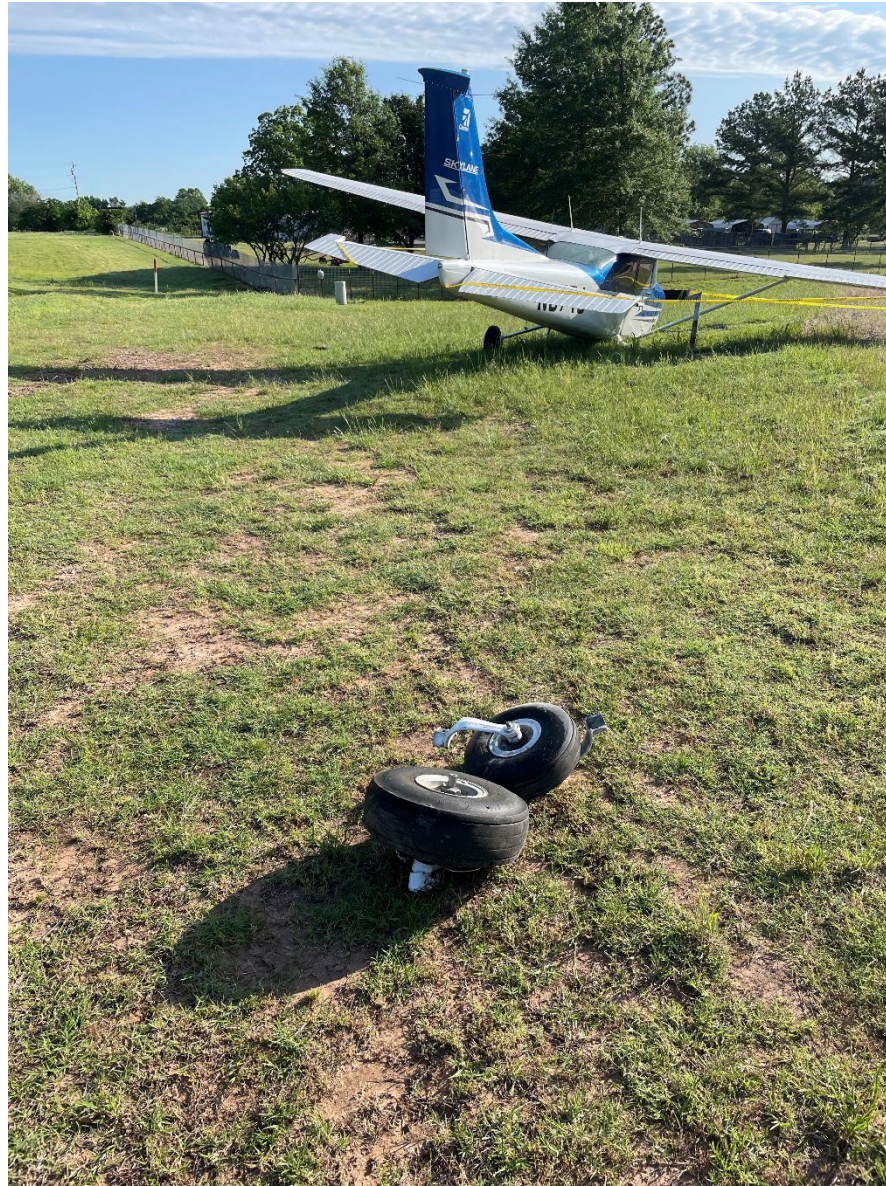
**Photograph 2 - Accident Site (Courtesy of FAA)**

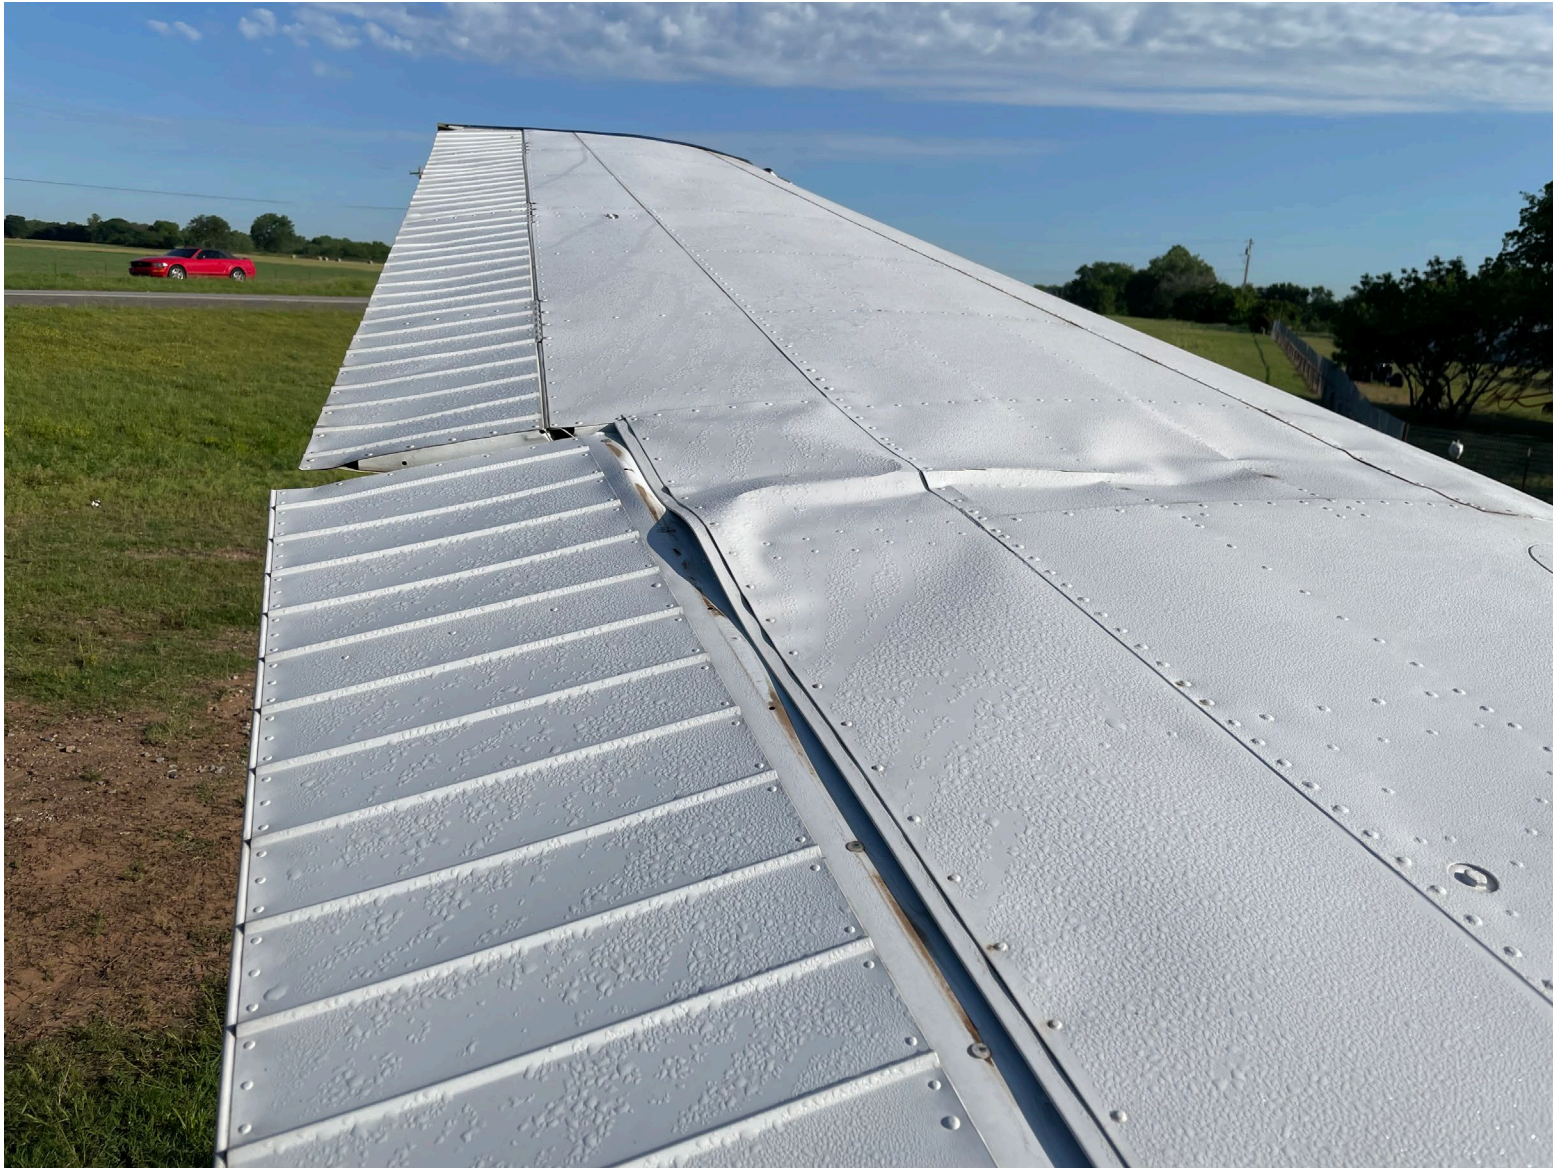
**Photograph 3 - Damaged Left Wing (Courtesy of FAA)**

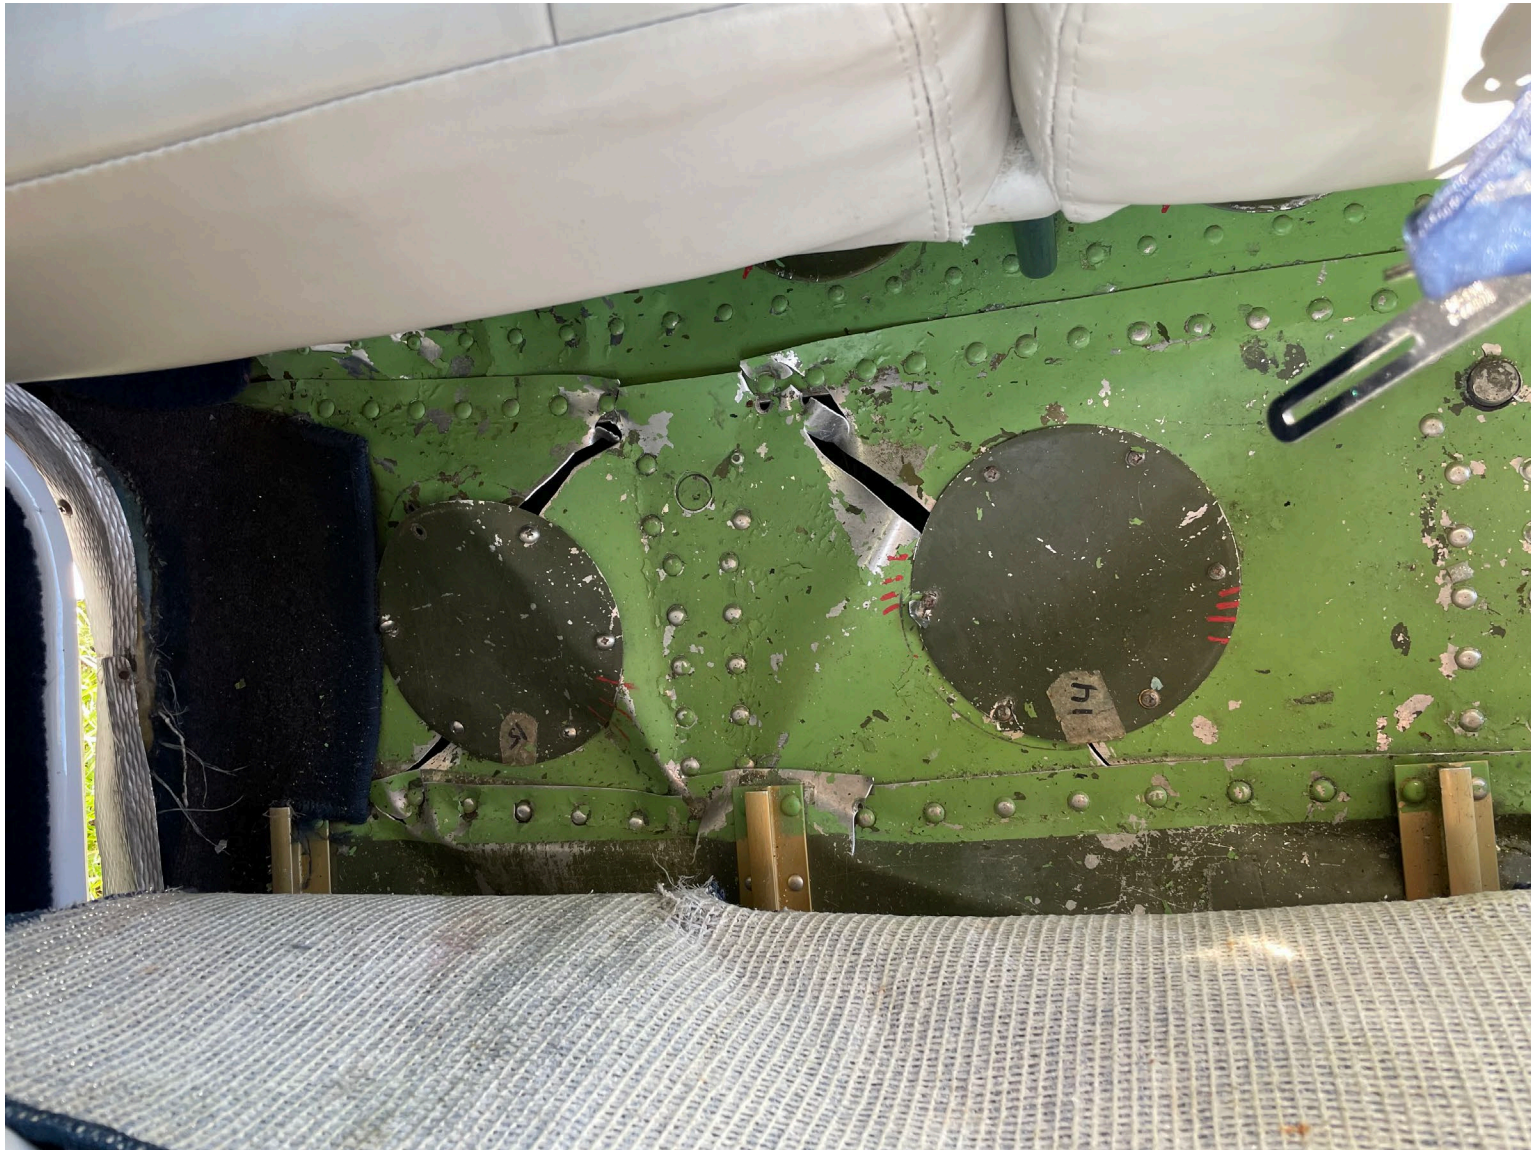
**Photograph 4 - Interior Fuselage Damage (Courtesy of FAA)**
