# National Transportation Safety Board

CEN24LA193

## **POWERPLANTS**

Group Chair's Factual Report

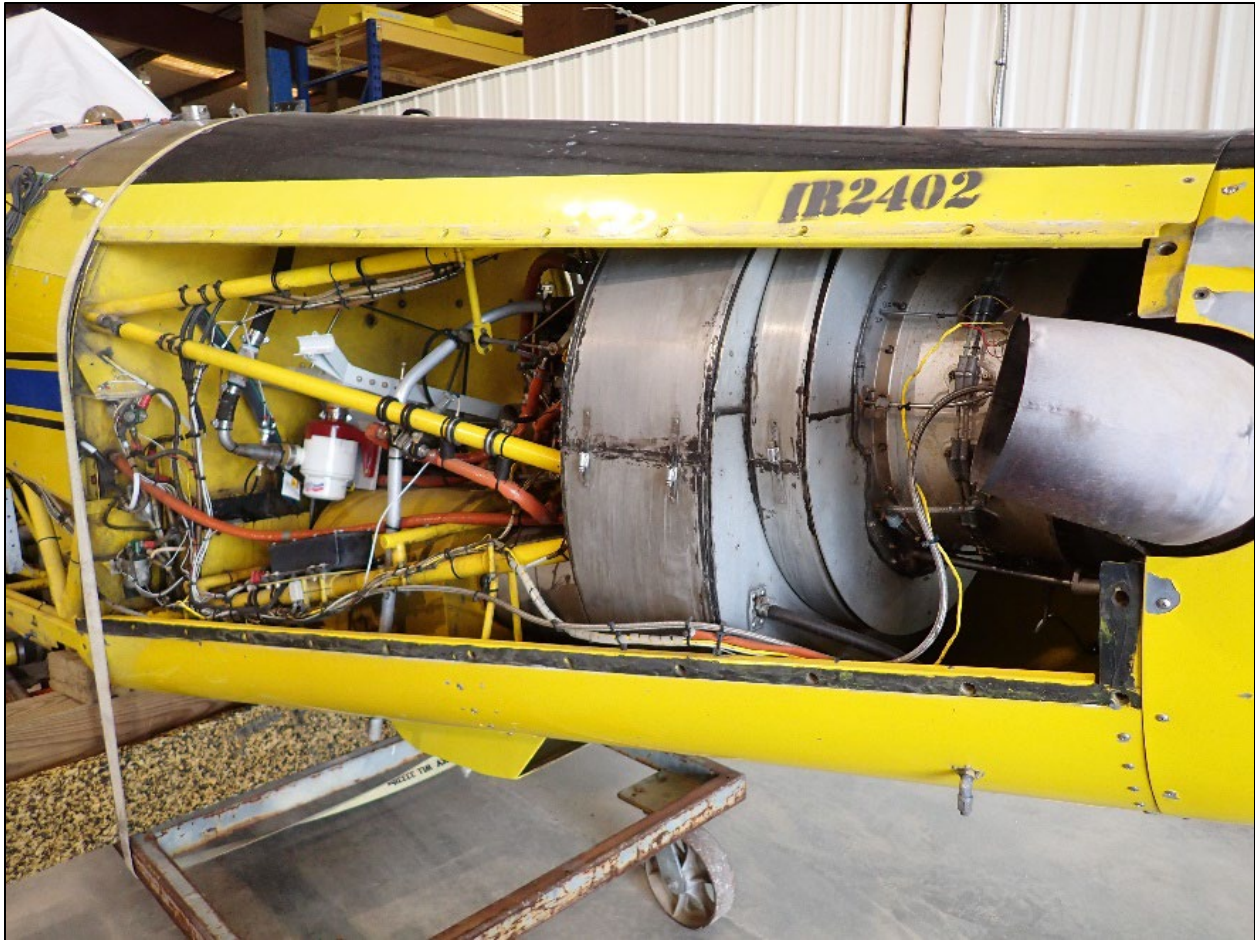
**Figure 15:** Left side view of the accident engine

The engine had no evidence of external fire or uncontainment. The exhaust case was distorted and buckled. The accessory gearbox attached to the air inlet housing appeared undamaged (Figure 15).

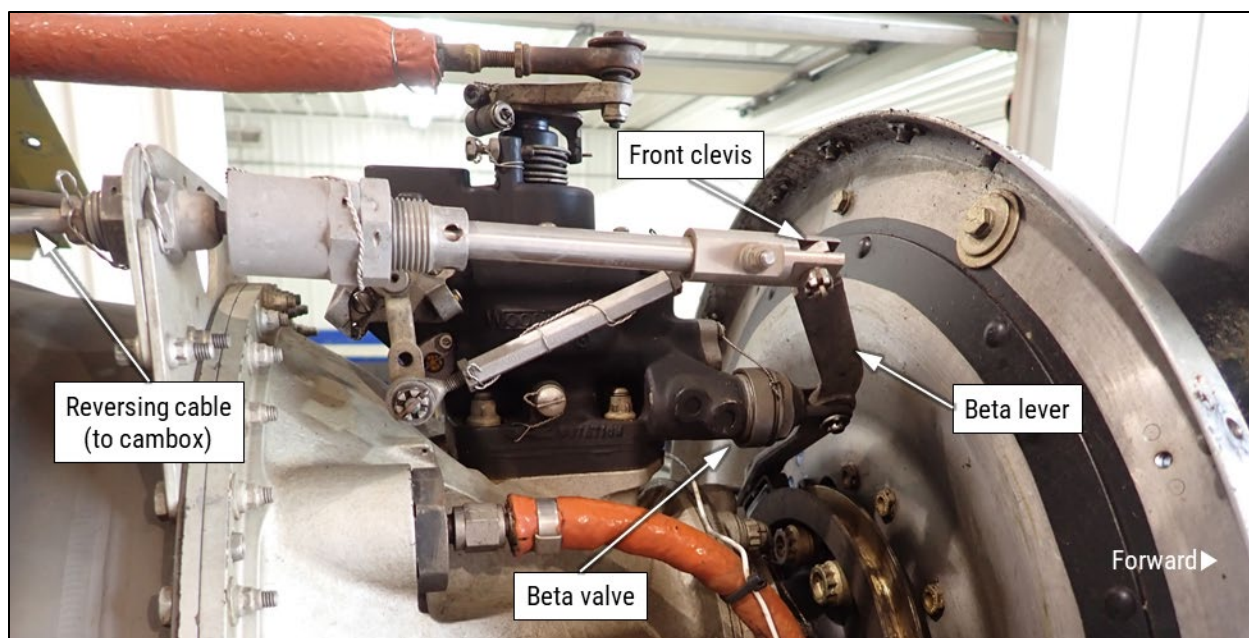
**Figure 16:** Front linkage rigging

The cockpit condition lever movement had some resistance when cycled between shut-off and high idle positions. Lever resistance persisted even after disconnecting the lever's control cable from the engine's starting flow control. The power lever inside the cockpit was difficult to move. The reversing cable was disconnected from the beta lever at the front clevis (Figure 16) and the power lever cable was disconnected from the cambox's input lever (Figure 17). With both cables detached, all cambox and FCU actuation movements felt smooth and appeared to have full range of motion.

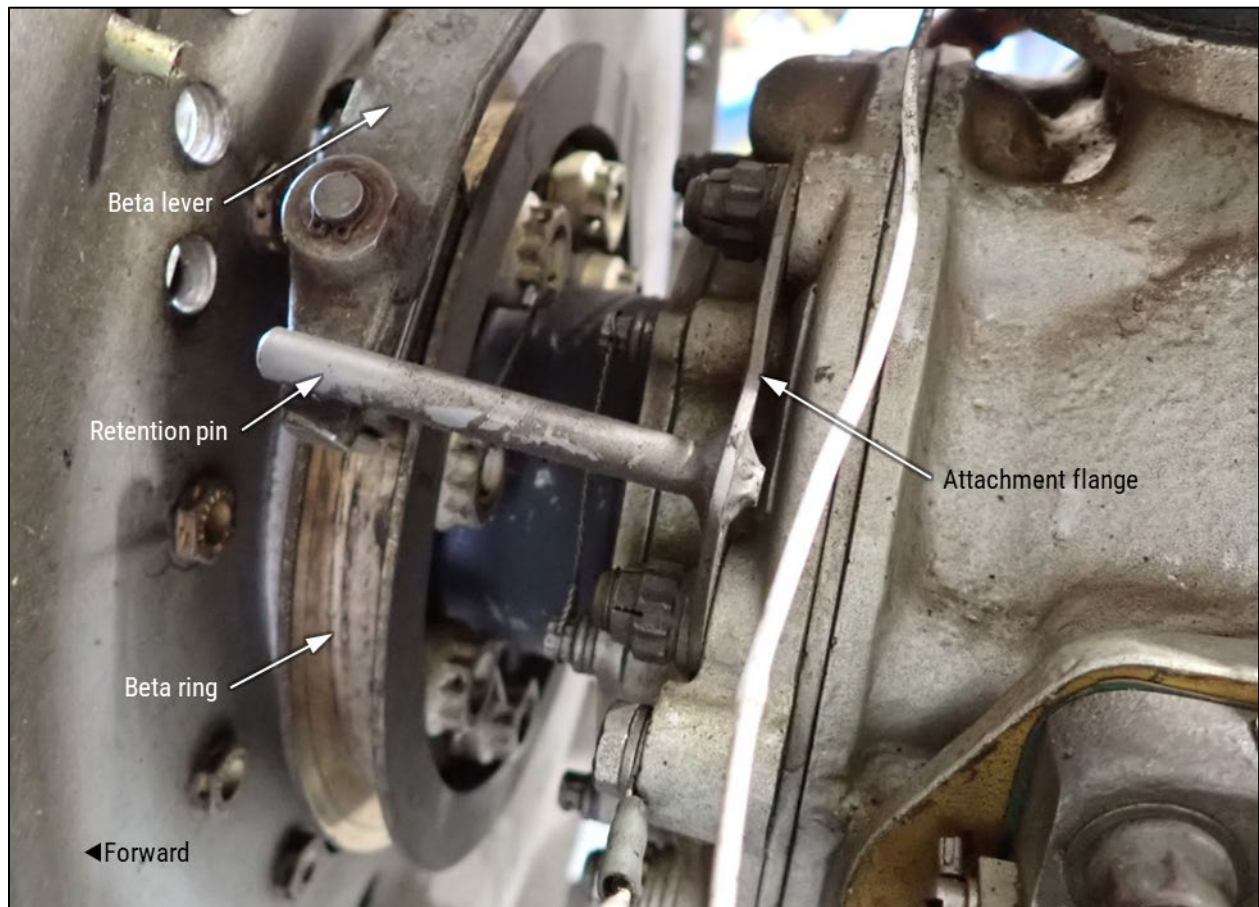
**Figure 18:** Beta ring in full-forward position

The beta ring appeared undamaged and was positioned full-forward because the propeller's hydraulic unit (piston, cylinder, and feathering spring assembly) had

separated from the propeller hub assembly during the impact sequence. The beta arm was properly positioned under the retention pin and the carbon block was correctly positioned in the beta ring. The pin's attachment flange was bent aft (Figure 18). The beta valve moved smoothly and appeared to achieve full travel. The propeller flange appeared undamaged and its dowel pins were securely in place with no evidence of movement (Figure 19).

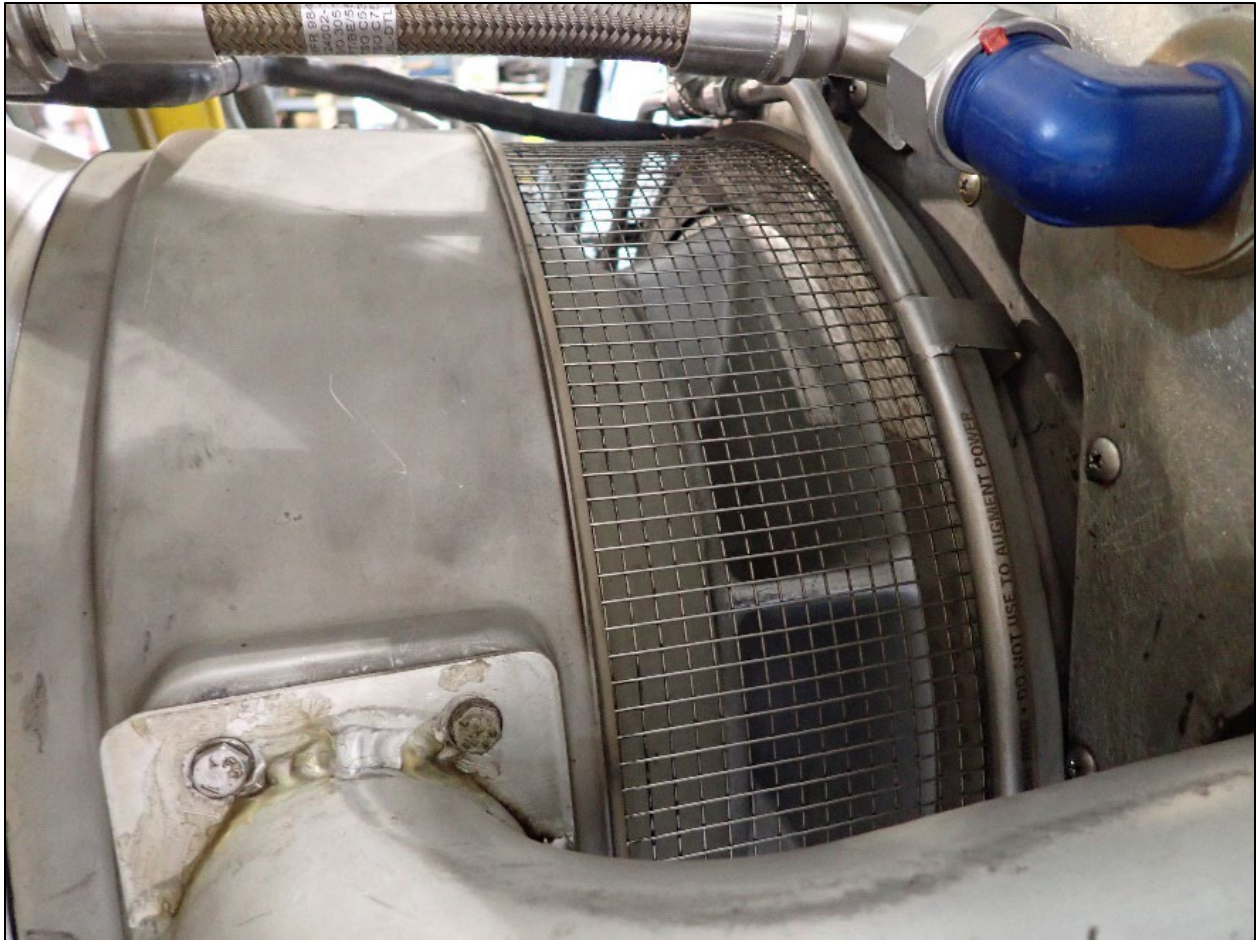
**Figure 20:** Air inlet screen

The airbox surrounding the gas generator section was in good condition and removed from the engine. The air inlet screen was removed to access the stage 1 compressor which rotated smoothly (Figure 20). No cracks were found on the inlet struts. Borescope inspection of the stage 1 compressor found some blades had previous leading edge blend repairs, but all blades appeared typical of normal operational condition. Visible portions of the stage 1 stator vanes appeared undamaged (Figure 21). The compressor turbine blades appeared full length and undamaged when inspected by borescope through the 9 o'clock fuel nozzle port. The compressor was not disassembled further.

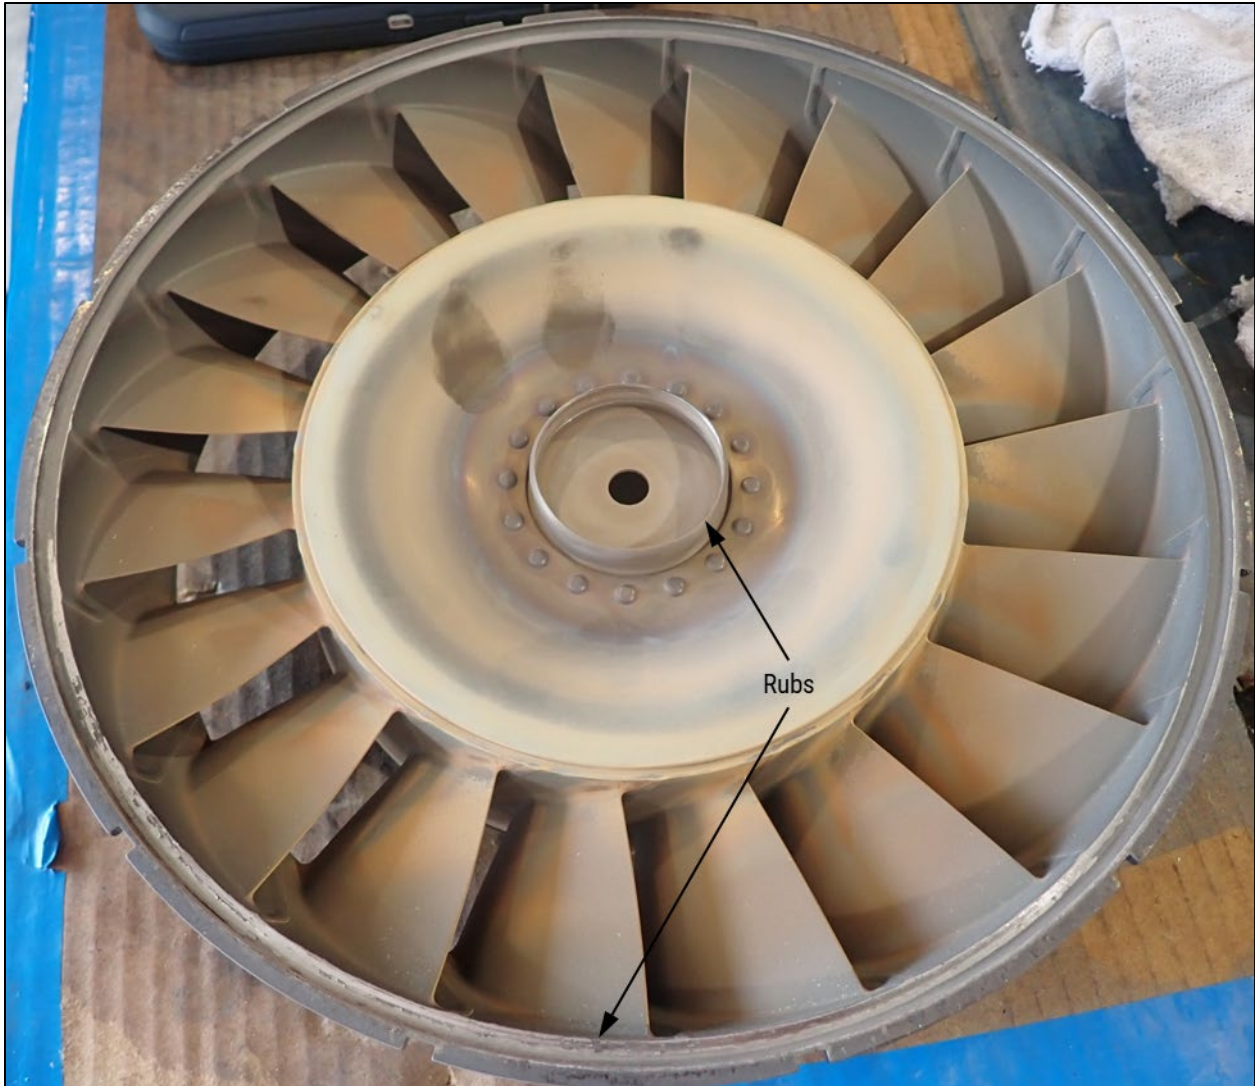
The PT rotated when the propeller flange was rotated by hand. Light metal scraping was heard coming from inside the power section. The PT stator housing and PT vane ring assembly appeared in good condition. The upstream and downstream sides of the vane ring's inner bore baffle had light circumferential rubs. The vane ring's outer diameter step near the airfoil trailing edge had circumferential rubs from 7 to 11 o'clock (Figure 22).

**Figure 22:** Downstream side PT vane ring

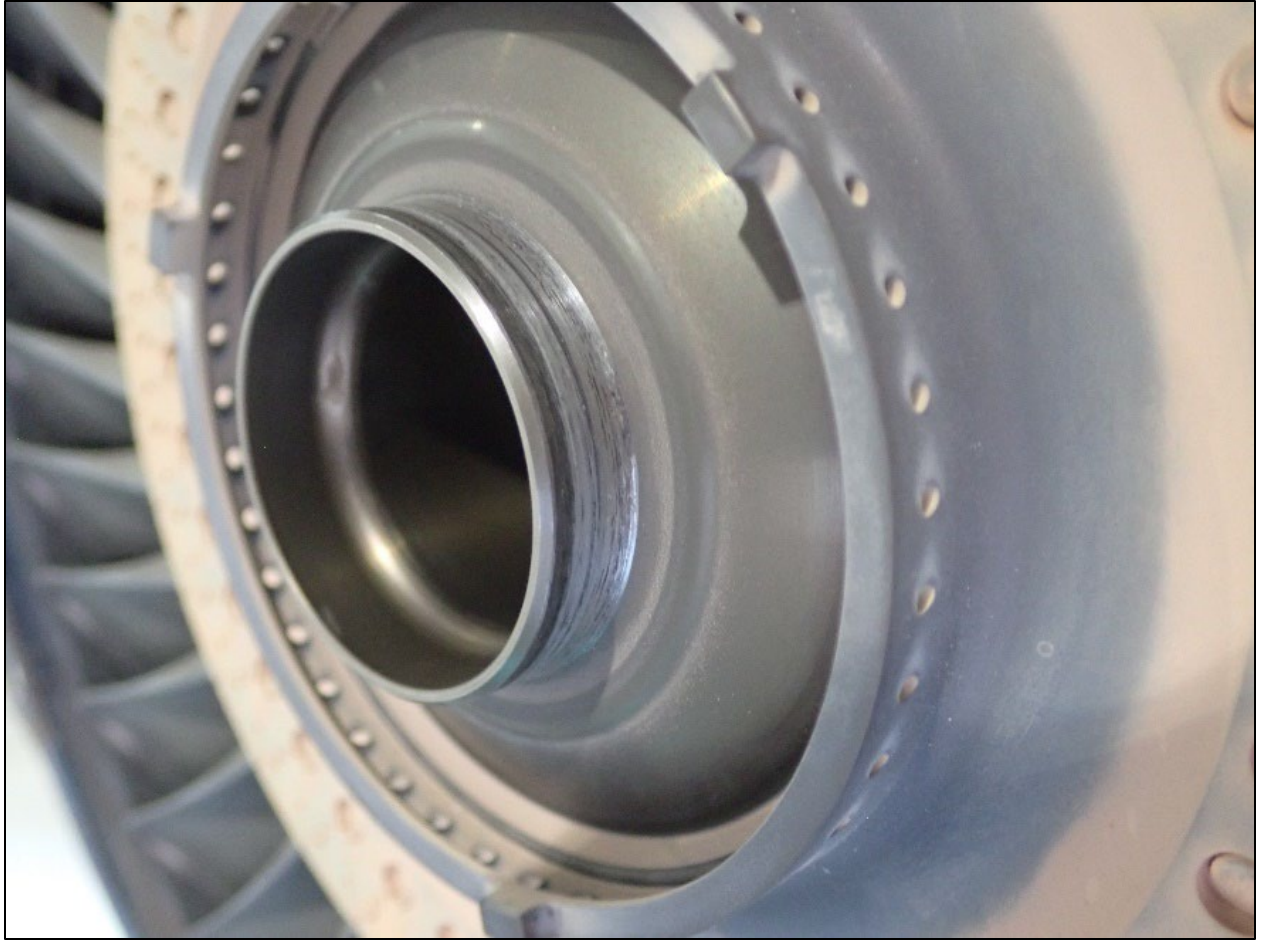
The PT disk spigot bore had circumferential rubs that corresponded to rubs on the PT vane ring assembly's inner bore baffle (Figure 23). The PT blades were full length. The front faces and outer diameters of the blade tip shrouds were rubbed (Figure 24). Corresponding circumferential rubs were found on the PT shroud (Figure 25).

**Figure 23:** Upstream side of PT disk spigot bore rubs

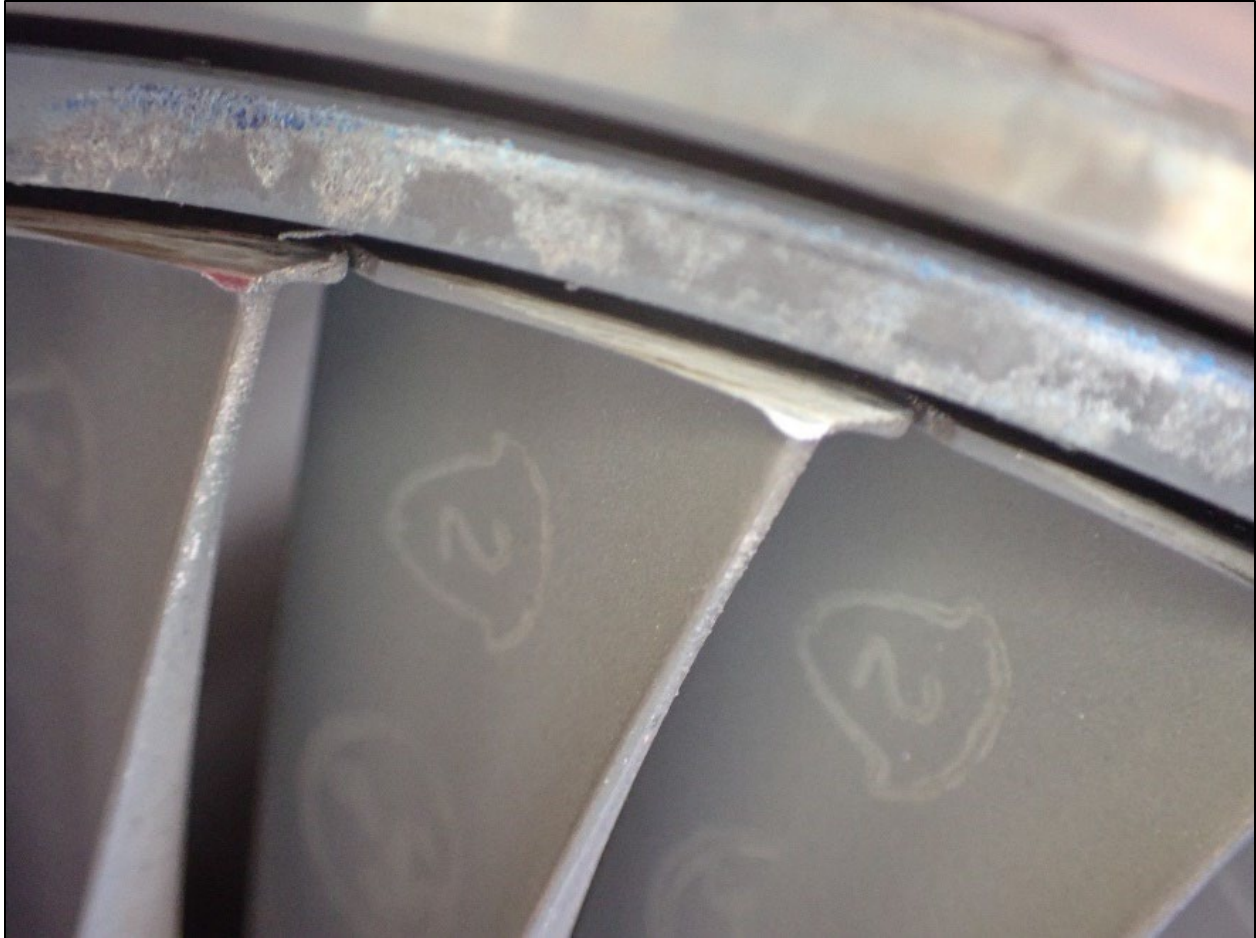
**Figure 24:** Rubs on the front faces of the blade tip shrouds

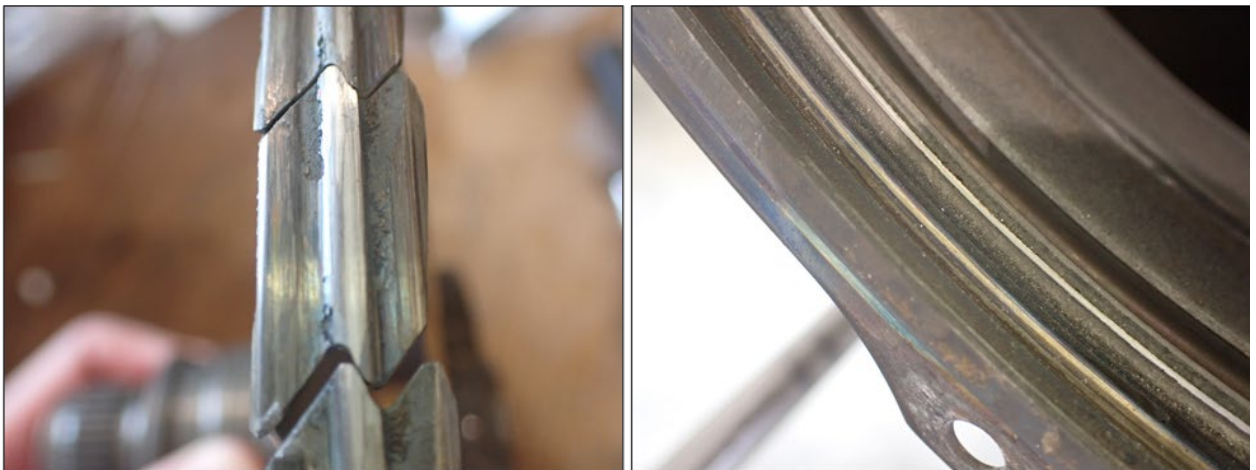
**Figure 25:** Rubs on PT blade tip shrouds (left) and on the PT shroud (right)

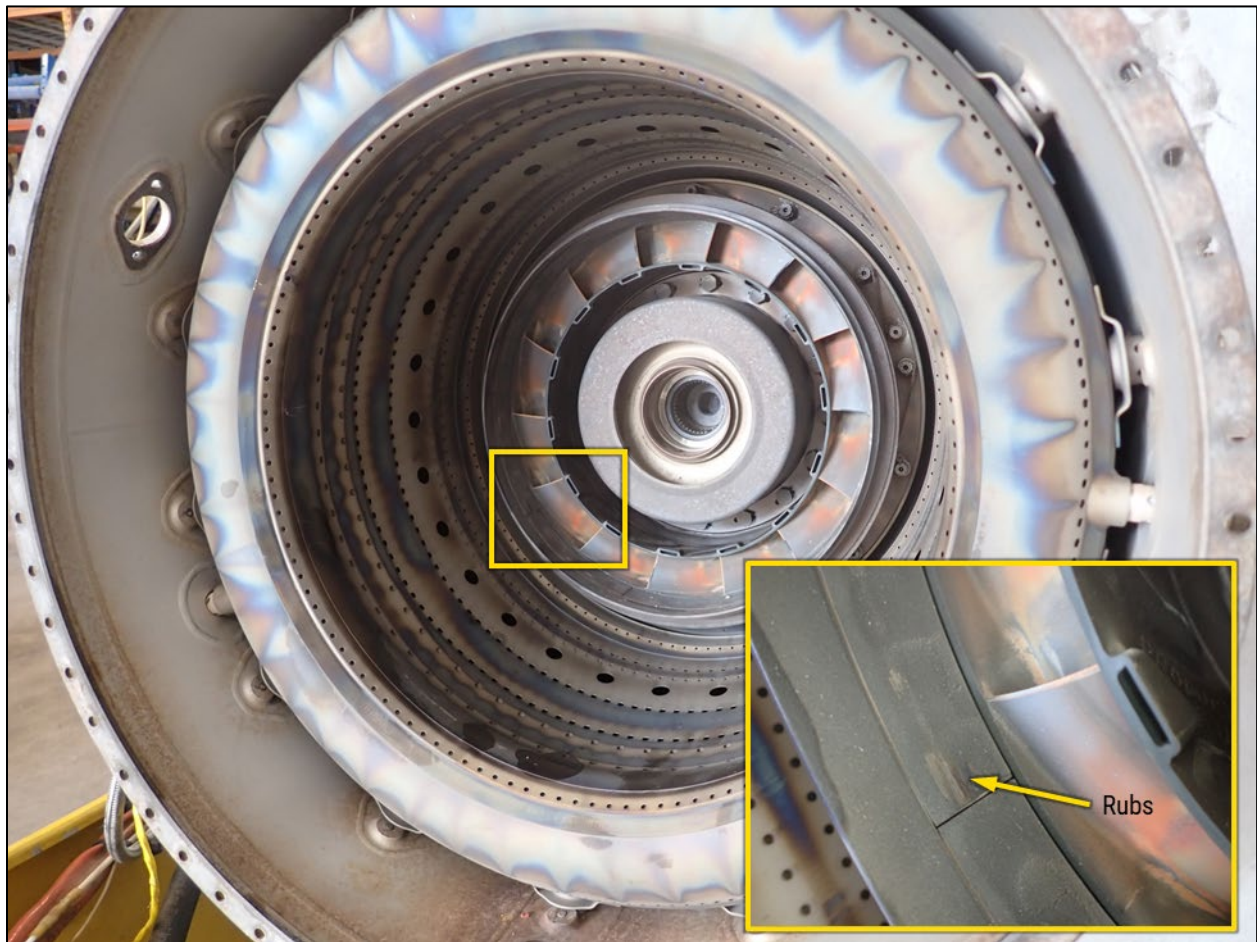
The downstream side of the combustor assembly and CT vane appeared undamaged and typical of normal engine operation. Light circumferential rubs were found on the CT outer shroud (Figure 26). The combustor liner appeared in good

condition and had no hot spots, burnthroughs, or fuel streaks. The combustor assembly and CT were not disassembled further.

**Figure 26:** Downstream side of combustor and CT vane and rubbing on the CT outer shroud (inset)

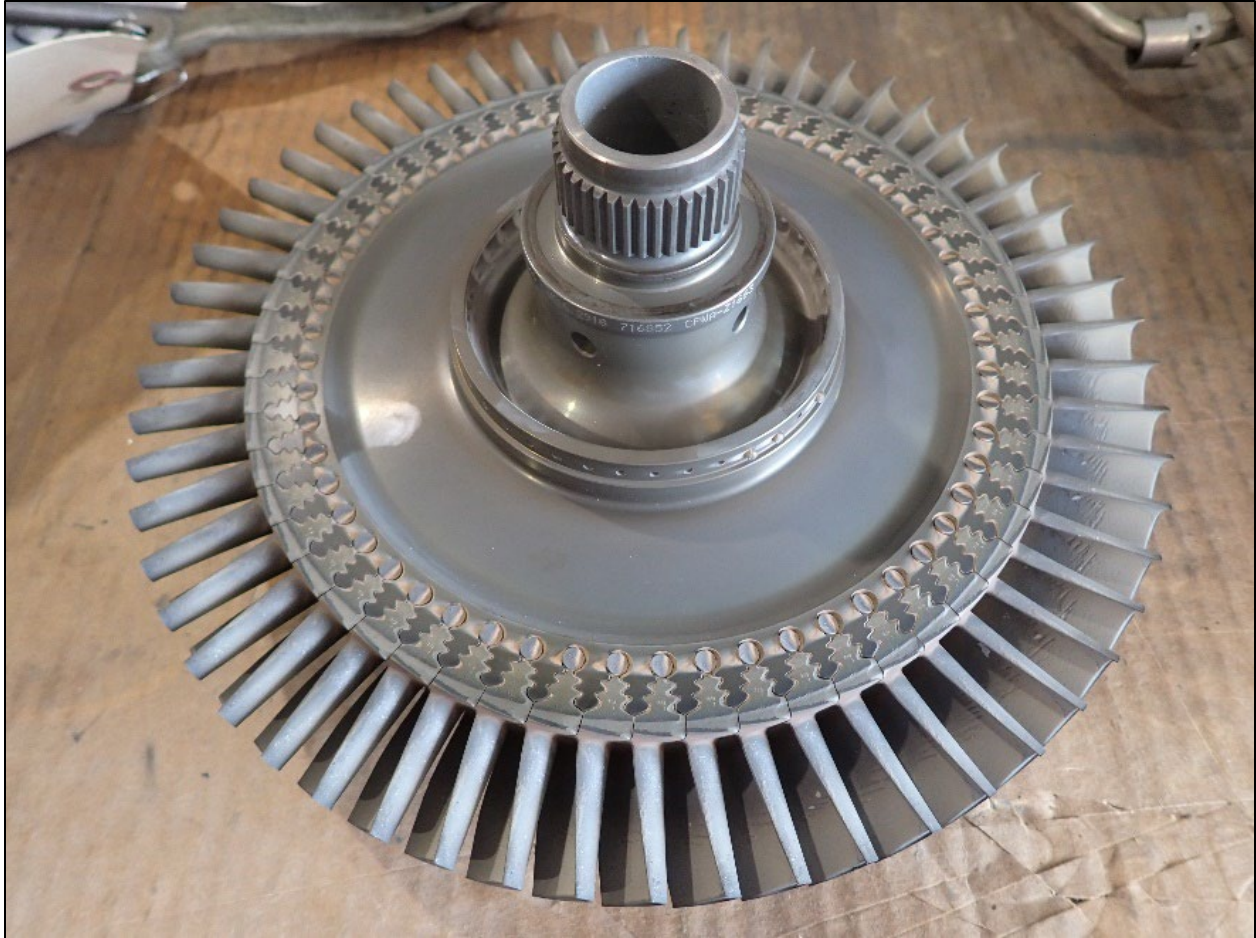
**Figure 27:** Upstream side of CT disk

The CT disk was in good condition. The upstream side of the CT disk face had rub marks on the attachment posts that corresponded with rubs on the CT vane ring inner platform. The splines on the disk forward coupling appeared undamaged. Circumferential rubs were found on the downstream spigot bore. CT blade airfoil tips had light circumferential rubs from contact with the CT shroud segments (Figure 27).

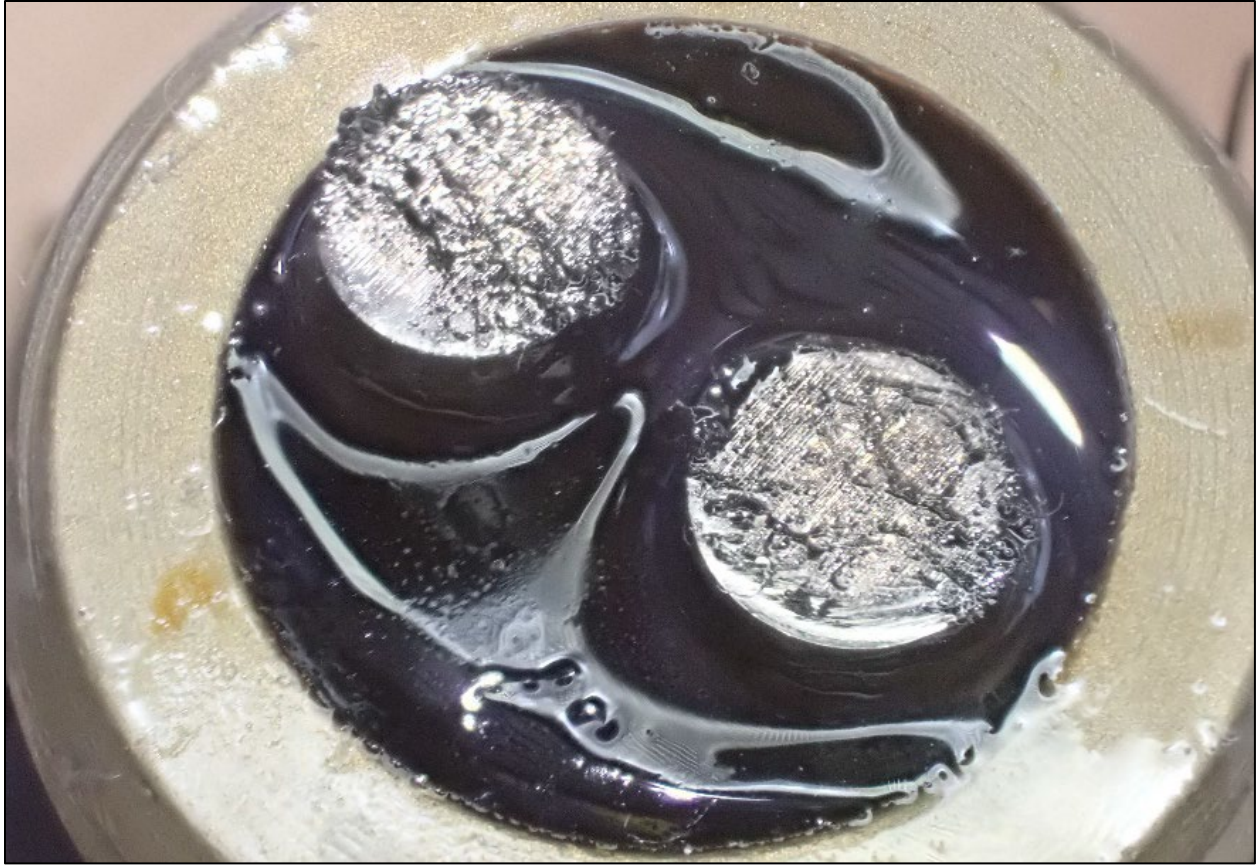
The reduction gearbox chip detector was mostly clean with small metal particles adhered to the magnetic elements. Engine oil appeared normal with no acrid smell (Figure 28).

**Figure 28:** Small metal shavings on chip detector

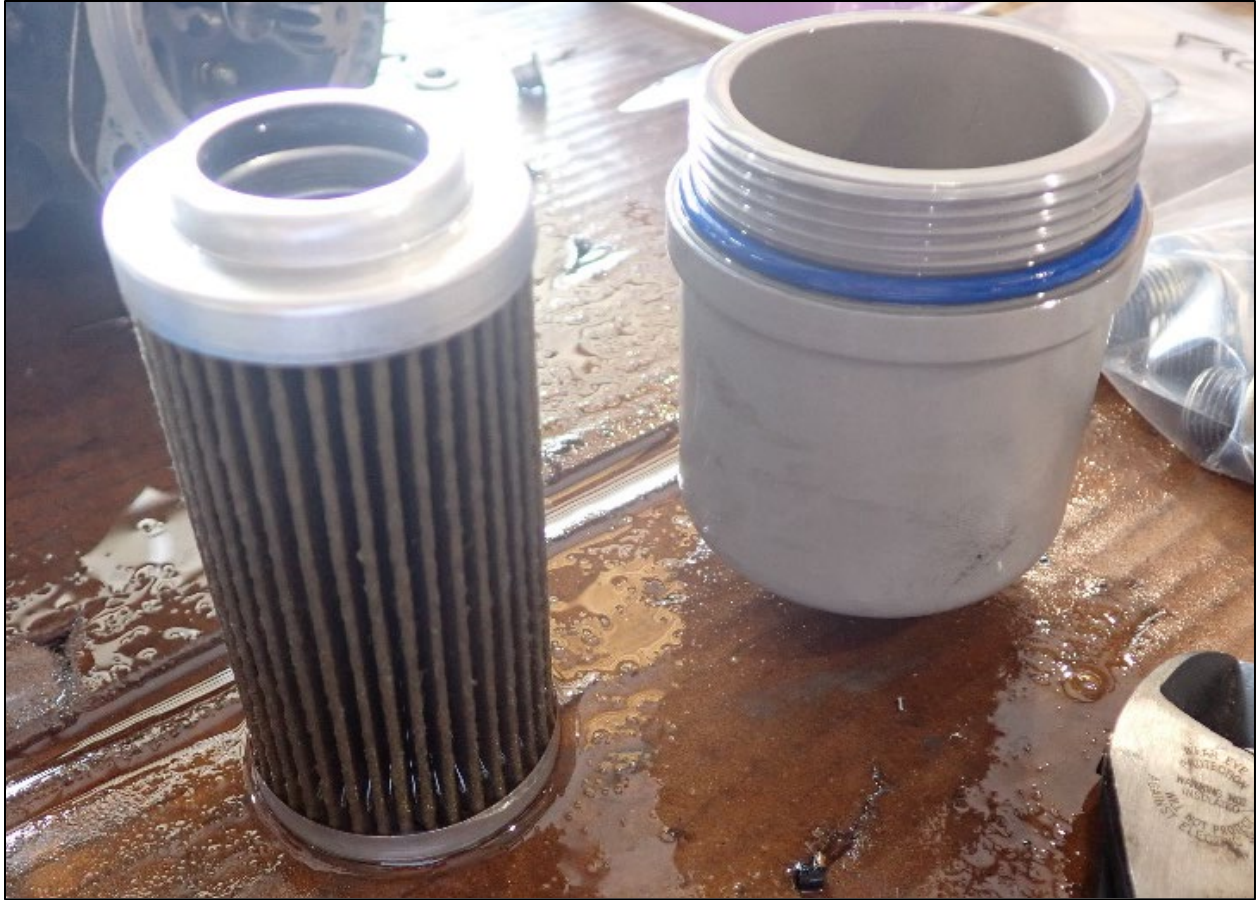
**Figure 29:** Fuel filter and bowl

The fuel filter appeared dirty but typical of normal operation. The fuel within the filter bowl was clear and free of debris (Figure 29).

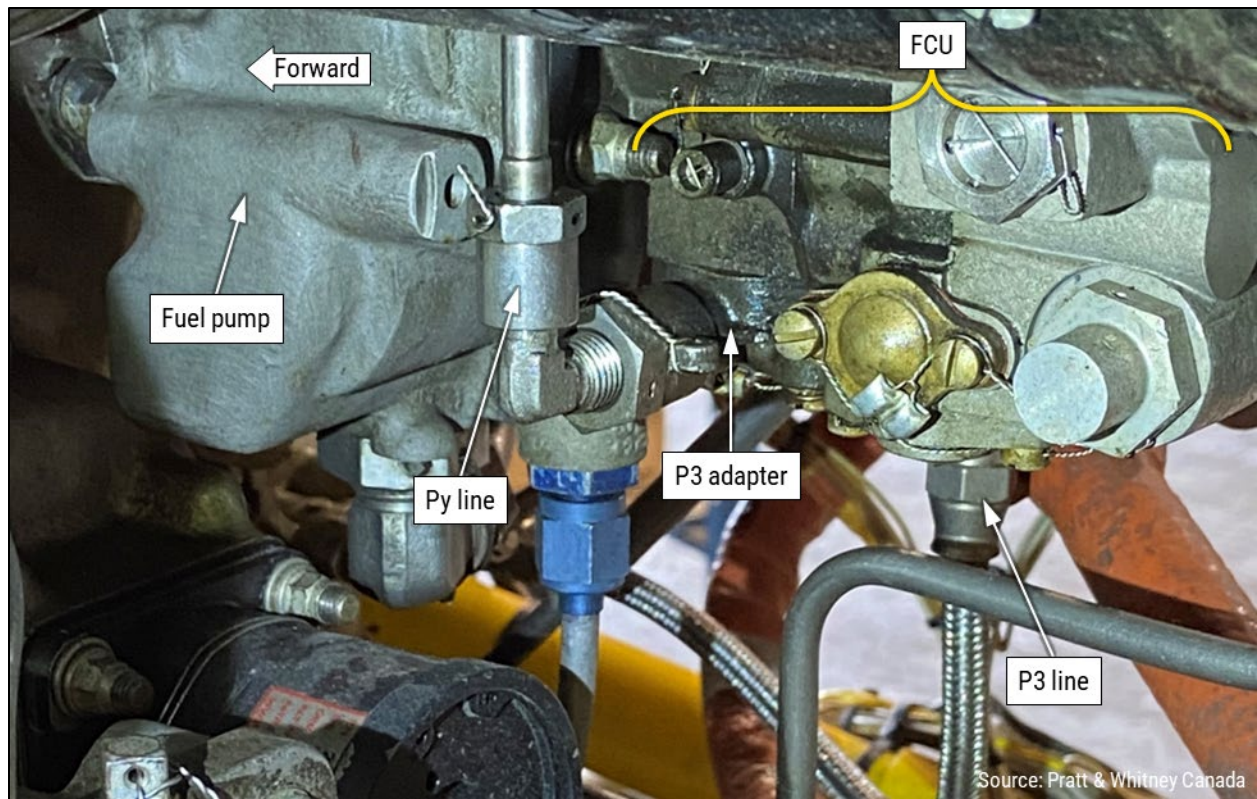
**Figure 30:** P3 and Py connections to FCU as-installed on the engine

The flexible P3<sup>5</sup> line from the compressor case to the FCU and the rigid Py<sup>6</sup> line from the FCU to the propeller governor (also called constant speed unit) both appeared undamaged with all connections tightly secured in place (Figure 30). The P3 filter was dry, free of debris, and undamaged (Figure 31).

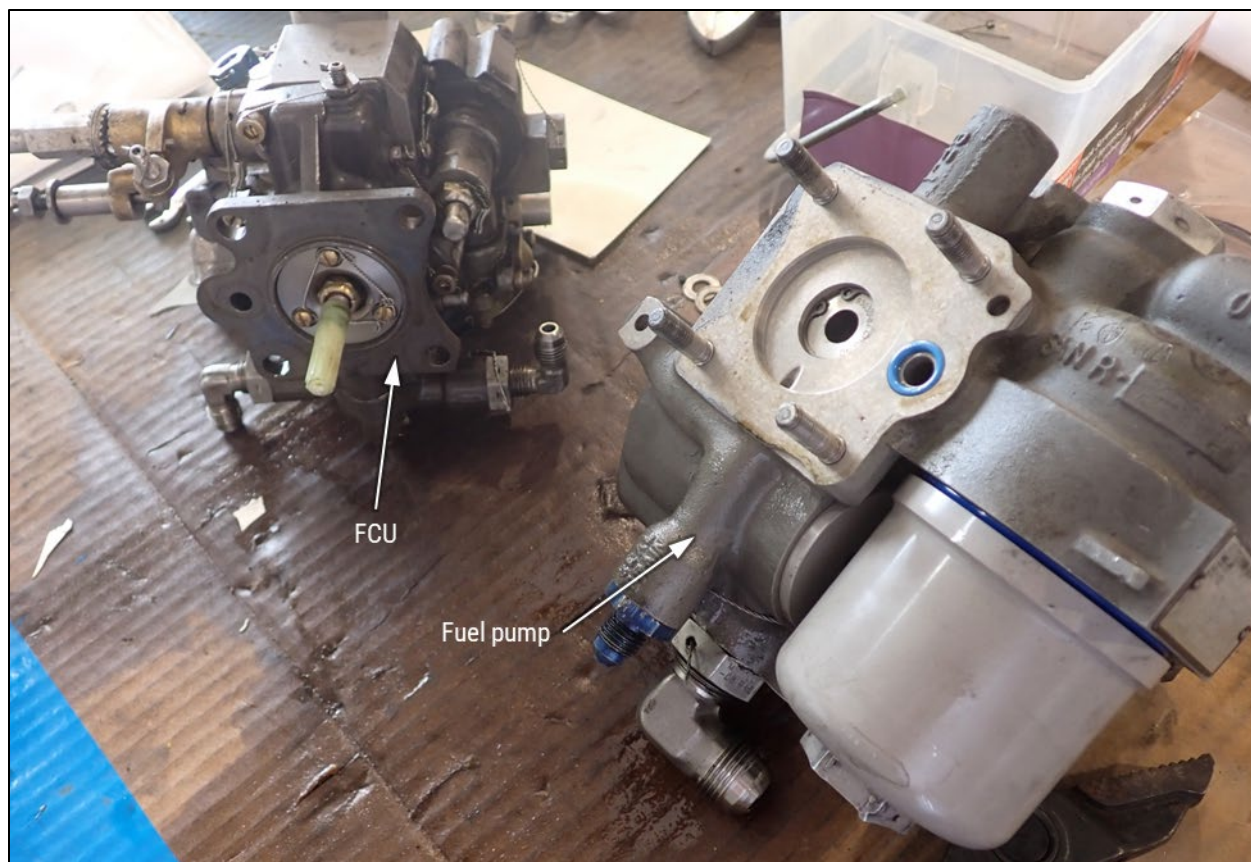
**Figure 32:** FCU and fuel pump

The fuel pump and FCU were removed from the accessory gearbox. The nylon protective sleeve connecting the FCU to the fuel pump appeared undamaged and was in place on the drive shaft which spun freely. All fasteners were tight and secured with lockwire. The power control lever moved freely. According to the FCU data plate, the unit was a Honeywell p/n 3244777-6-5, s/n A85159. The FCU was held for further examination (Figure 32).

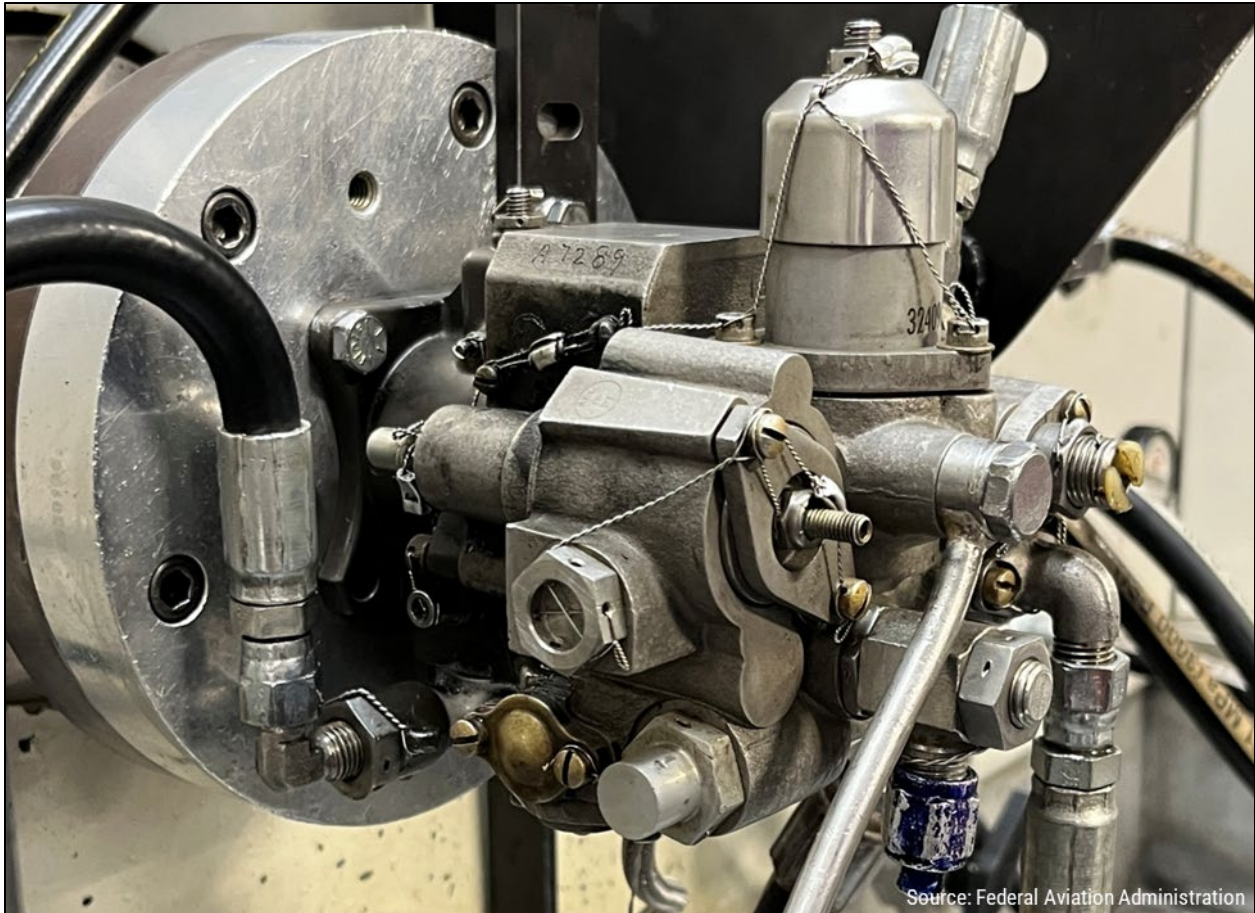
**Figure 35:** FCU test setup

The FCU (with flexible P3 air supply line) was tested in accordance with Honeywell Test Specification AETS 48182 (Figure 35). Test point K which checks for external air leakage specifies only "slow bubbling" is allowed from specific FCU locations, including the joint between the drive body and P3 air adapter. If excessive leakage is found, measured Px minus Py must be within  $\pm 1.2$  inches of mercury. This measurement was performed twice and found to be 15 and 36 inches of mercury, both outside of limits. The FCU was removed from the test stand and disassembled.

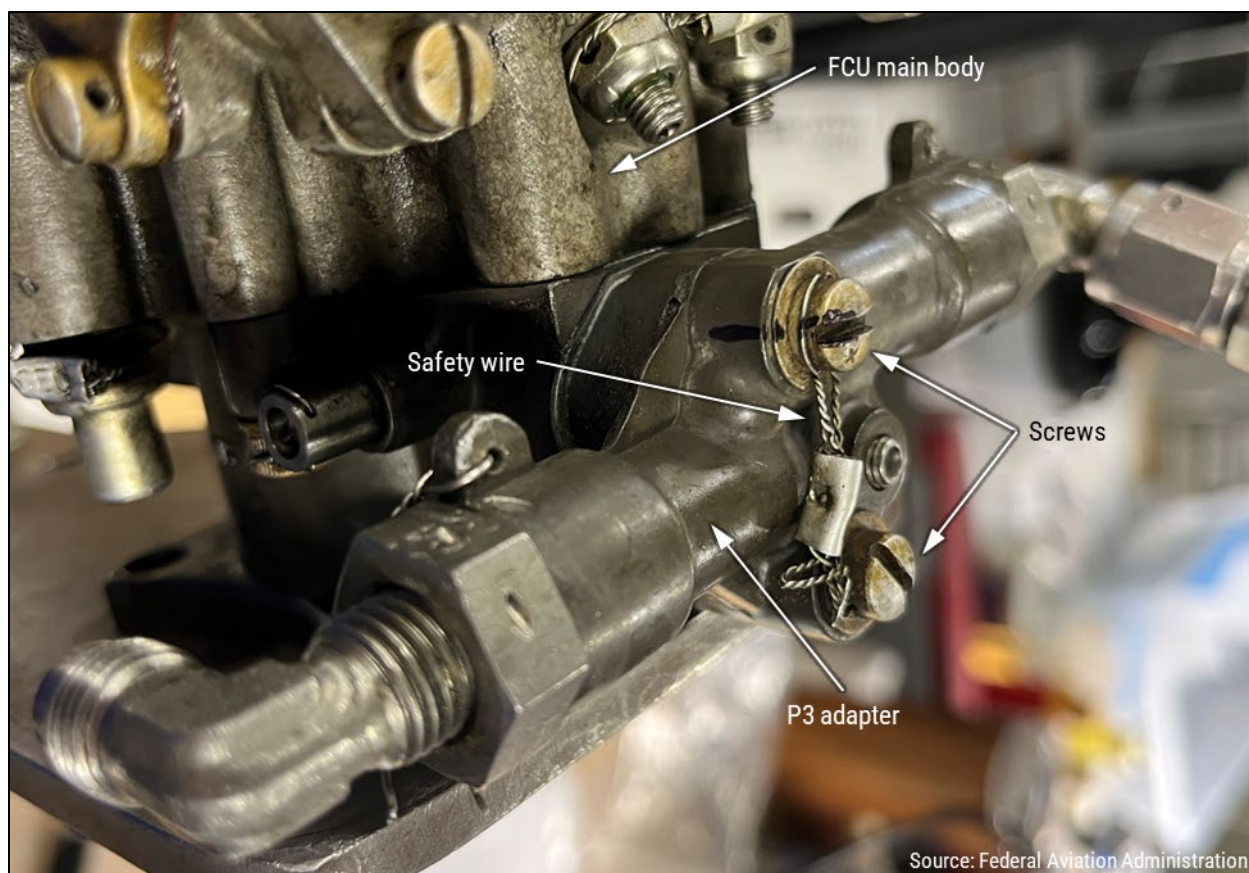
**Figure 36:** P3 adapter

The P3 adapter attached to the FCU's main body was loose and appeared to move with light finger pressure. Two screws securing the P3 adapter to the FCU's main body were safety wired; however, the wire on both screws appeared to be in a neutral configuration<sup>7</sup> (Figure 36).

<sup>7</sup> Properly installed safety wire (also called positive wire locking) should always tend to tighten a screw, bolt, nut, or fastener. Neutral configuration refers to safety wire installation that exerts no tightening or loosening force and is considered improper safety wiring practice.

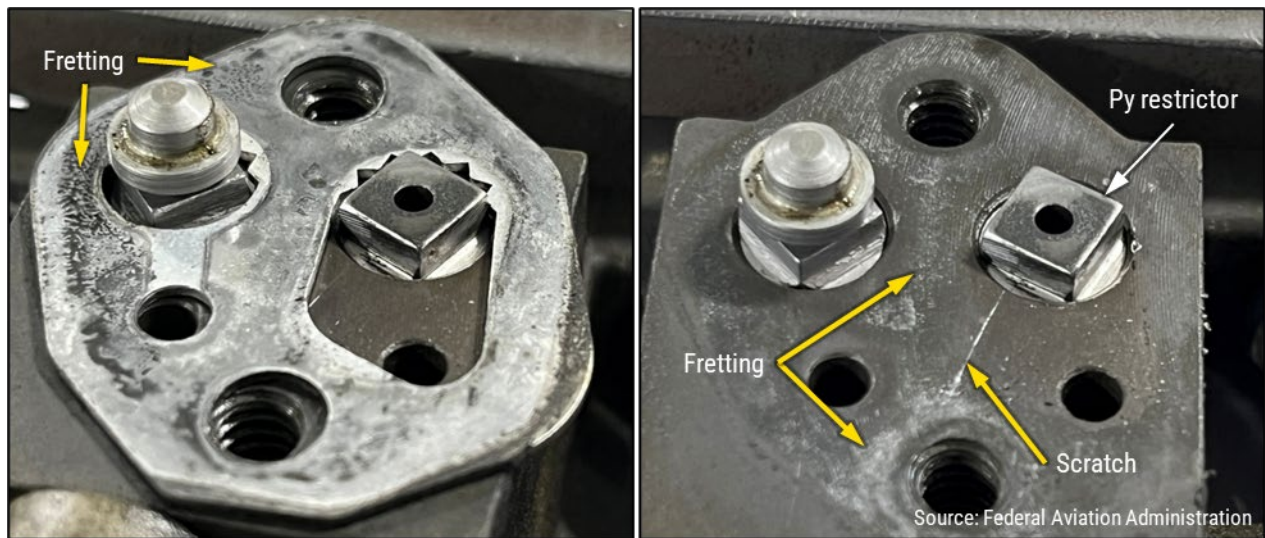
The P3 adapter was removed from the FCU by cutting its safety wire and removing its two screws. A digital screwdriver registered zero torque to unscrew one screw while the other was removed by hand without the screwdriver. Both screws and their threaded holes appeared in good condition. Contact surfaces on the P3 adapter, aluminum gasket, and FCU main body appeared fretted. A light scratch was found between the Py restrictor and aft screw hole on the FCU main body (Figure 37). The P3 air adapter had small, metallic particles inside the Px air cavity (Figure 38).

**Figure 37:** Fretted aluminum gasket (left) and FCU main body (right)

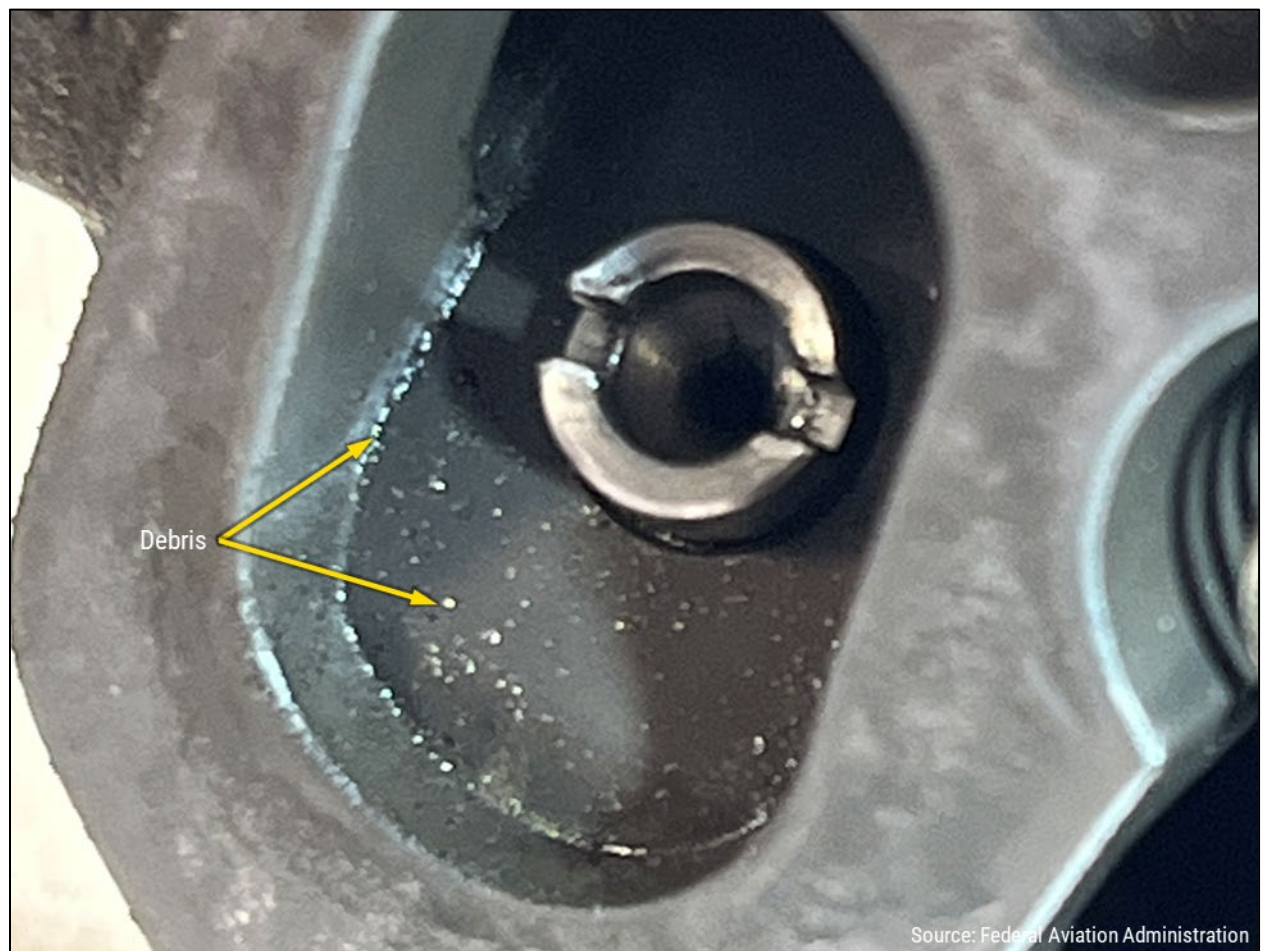
**Figure 38:** Metallic particles inside P3 adapter cavity

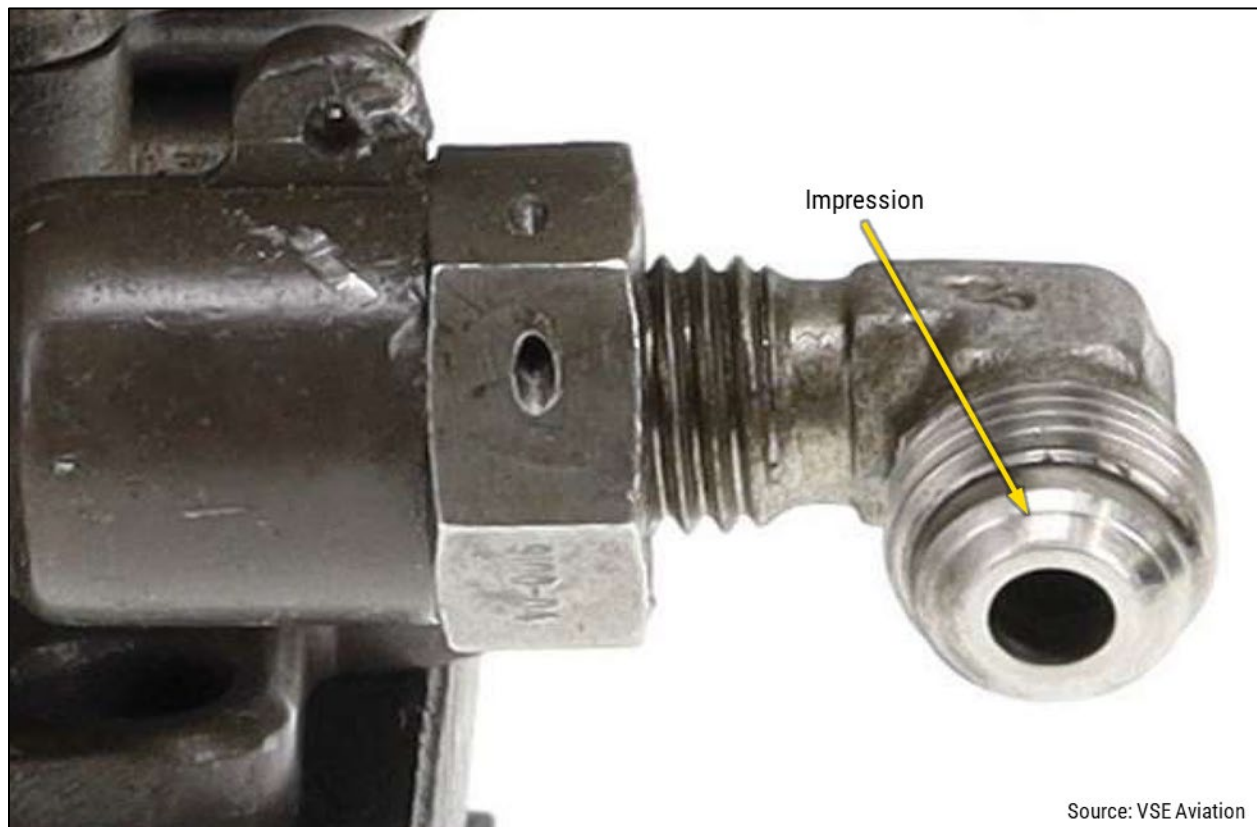
The flexible P3 supply line appeared undamaged and clear of internal obstructions. The P3 line connects to a pressure port fitting on the P3 adapter and has a

conical metering orifice to convert incoming P3 air into Px air. This orifice had a concentric impression around the cone portion of the fitting (Figure 39).

**Figure 39:** Impression on Px pressure port fitting
