## Investigation Report

VSE MFG010

| Unit Type | Fuel Control Unit |

| Location: | Covert, KS | Accident Number: | CEN24LA193 |

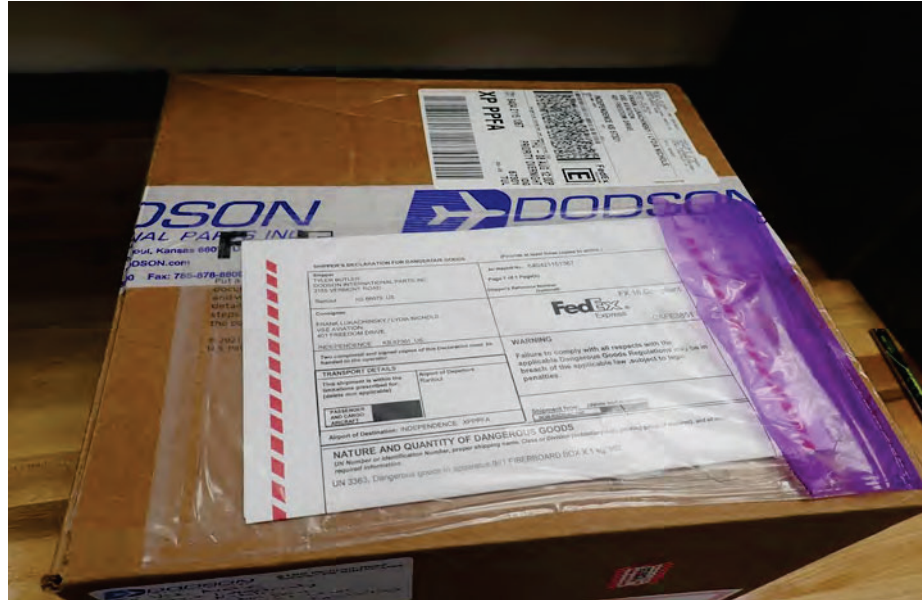
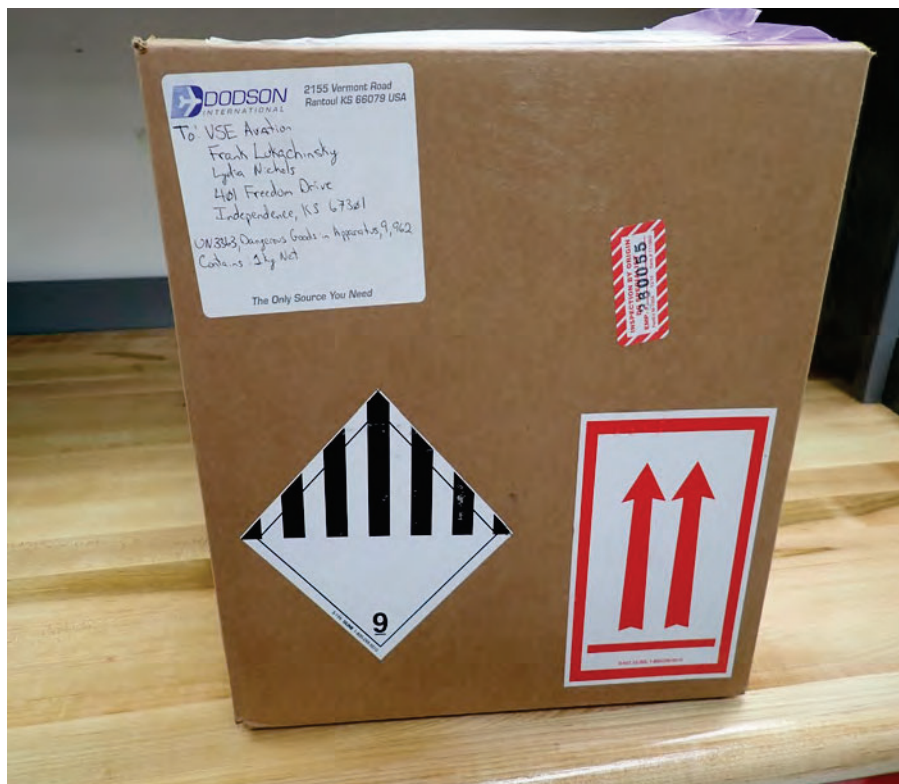
1. Boxed unit was removed from secure cabinet and visually inspected for damage to box prior to opening. No damage noted. Reference Photos 1A, 1B.
2. Box was opened, packaging material removed. Unit was observed to be in a plastic bag with an absorbent cloth partially wrapped around the unit. Unit was removed from the bag and photographed. Reference Photos 2A, 2B, 2C, 2D.

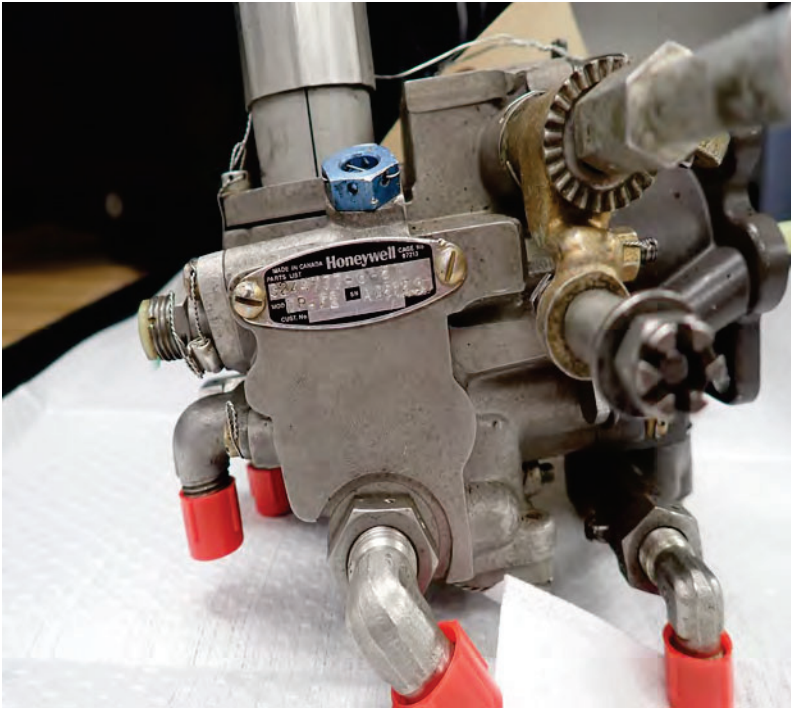
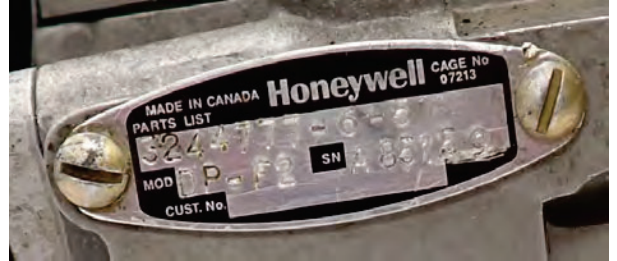
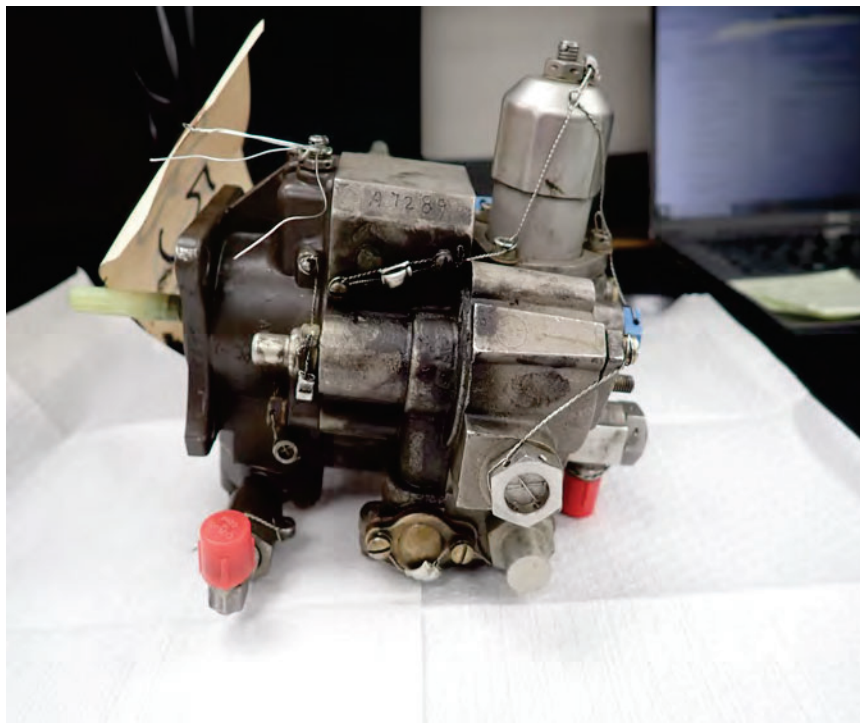
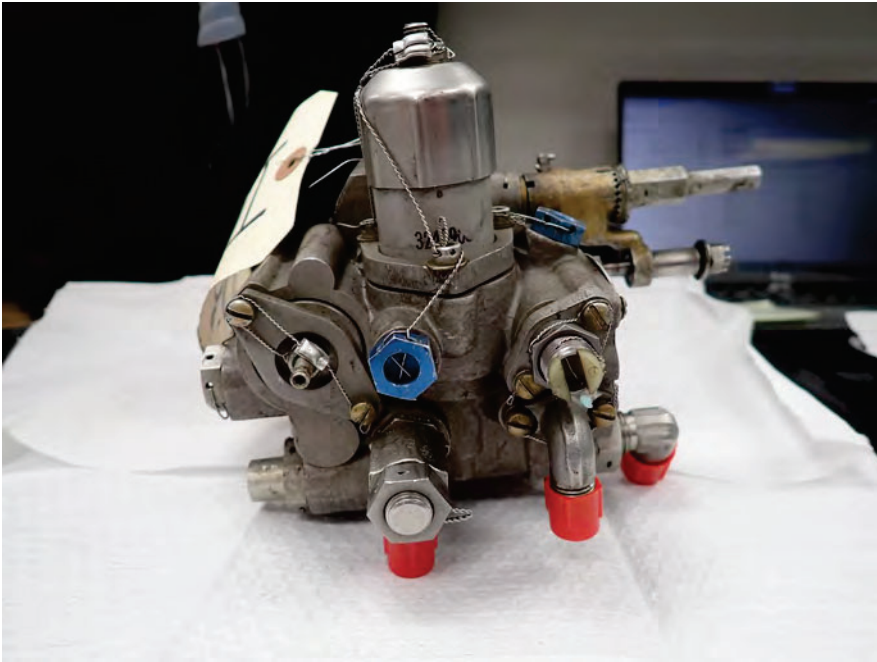
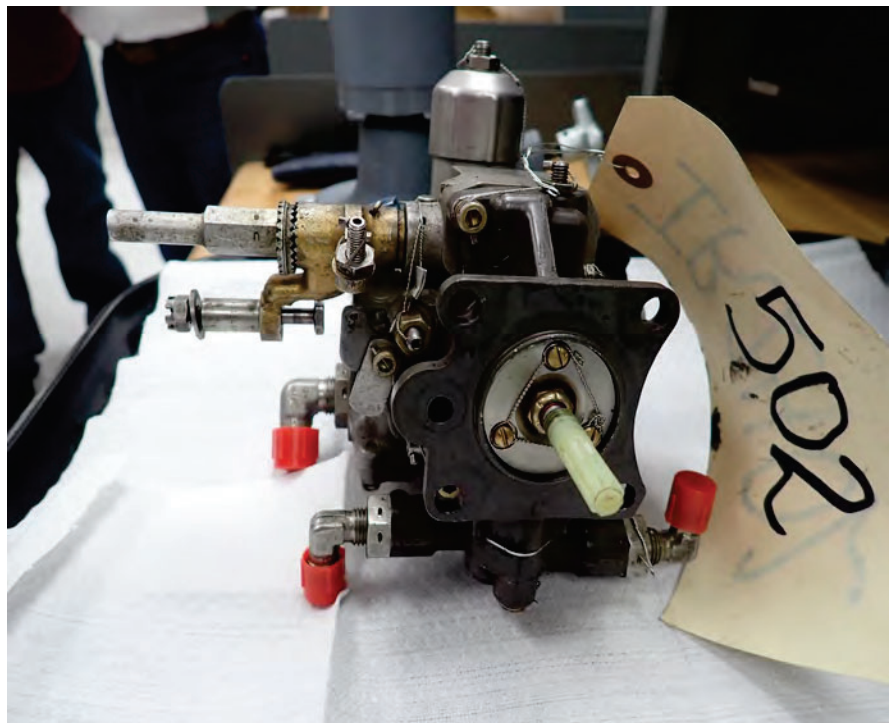
3. A manila tag was wired to the idle speed screw safety cable (IR2402 written on one side, 502 on the back side of the tag). Data Plate present, all fittings capped, protective sleeve was present on the drive shaft. Reference Photos 3A, 3B, 3C, 3D, 3E.

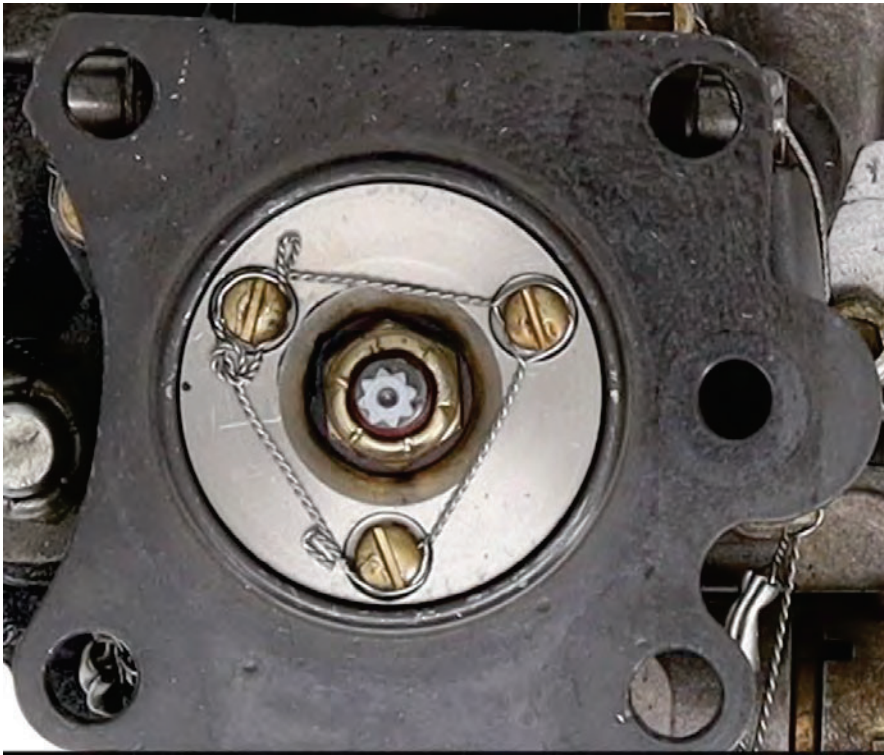
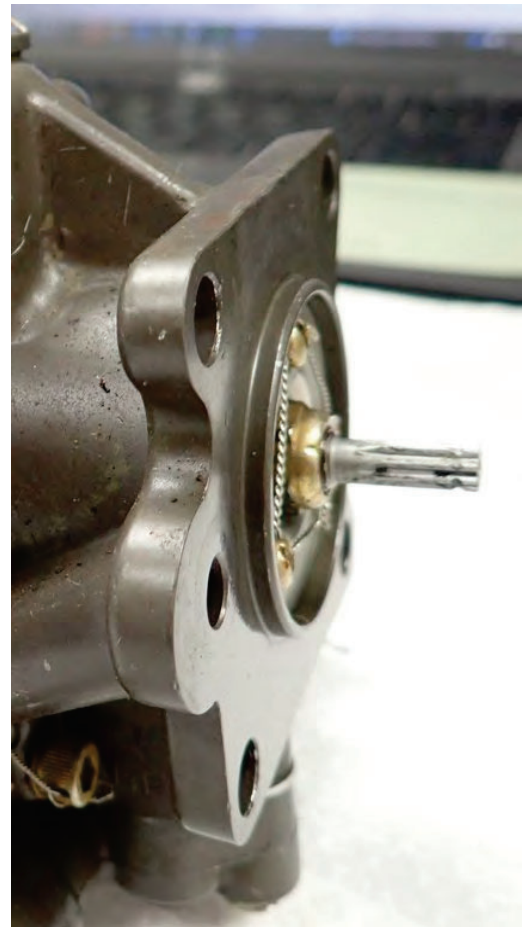
4. Unit was processed and photographed.
5. The following were observed prior to unit tested.
  - A. The drive shaft moved freely (no binding) with no visible damage. Reference Photos 4A, 4B.

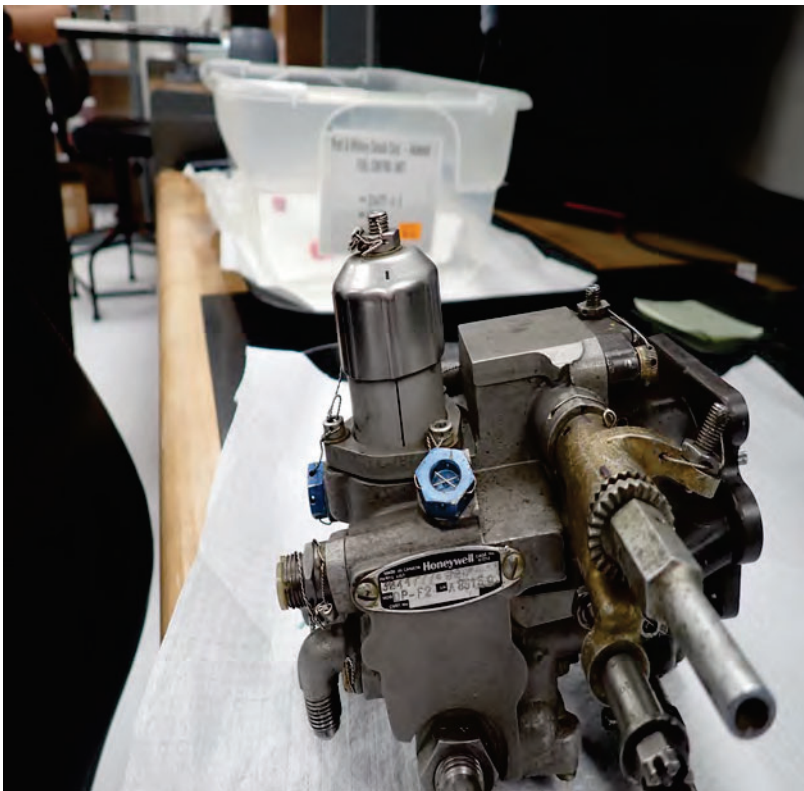
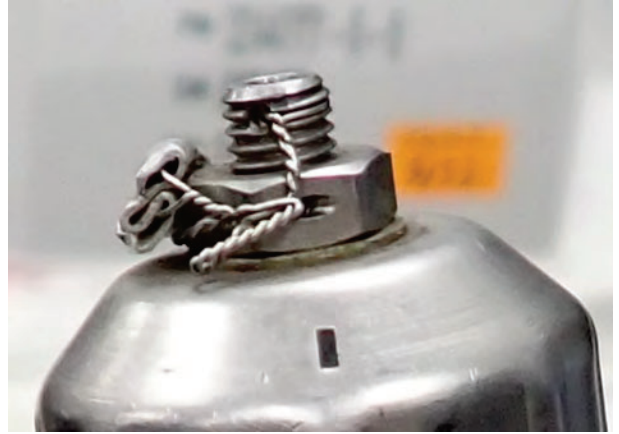
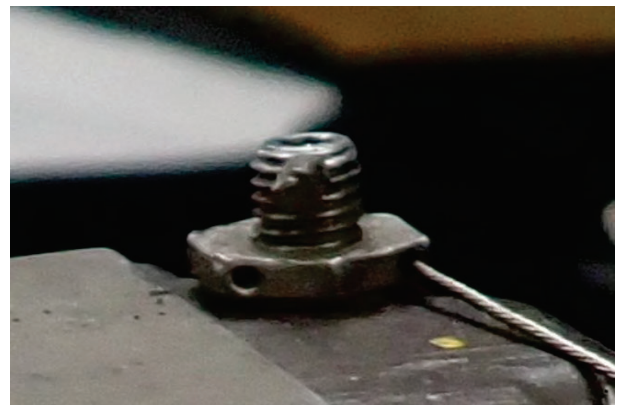
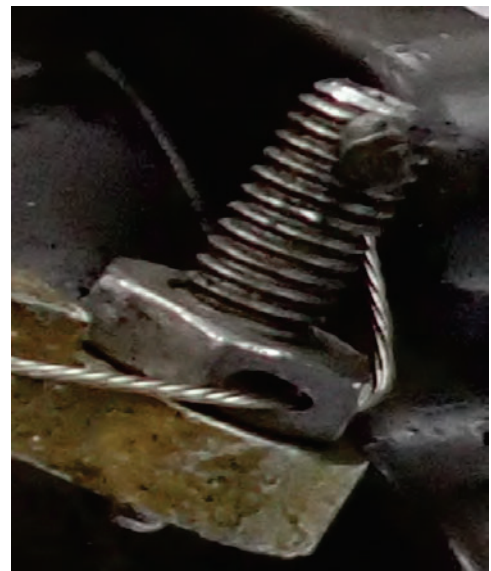
- B. Fuel by pass adjustment screw, idle adjustment screw, maximum throttle stop screw photographed. Reference Photos 5A, 5B, 5C, 5D.
  - C. Idle adjustment screw and maximum throttle stop screw are cable wired. Both are field adjustable. Reference Photos 6A, 6B.

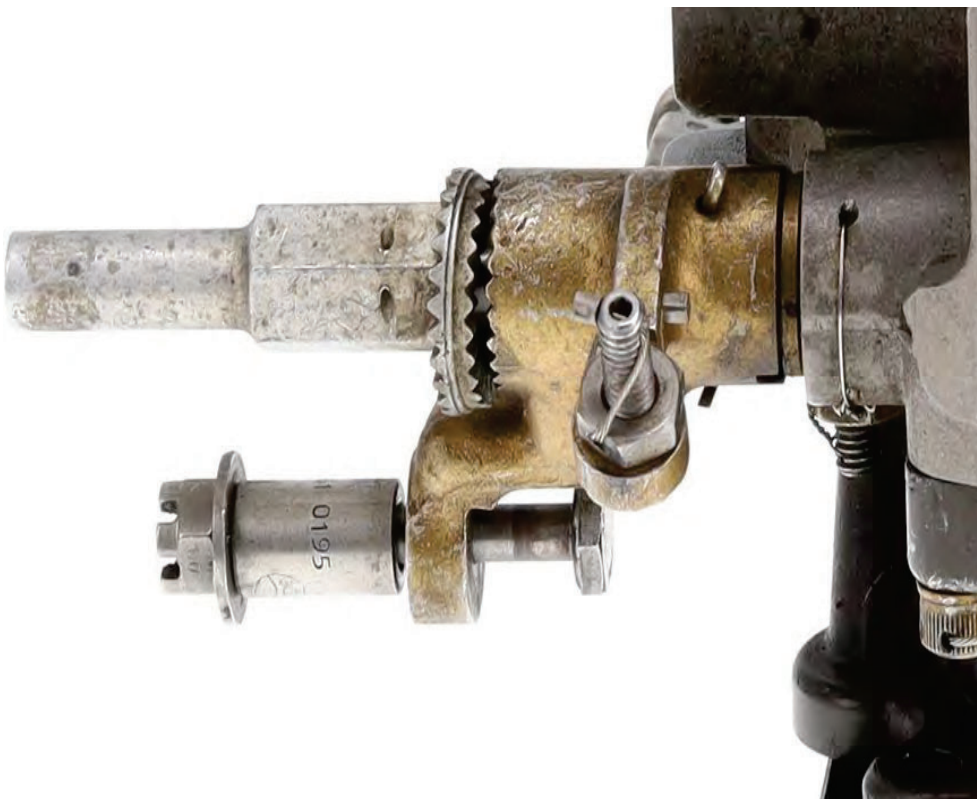
Photo 6B

- D. Throttle linkage attachment hardware was present and removed to facilitate flow bench testing. Reference Photo 6B.
  - E. The PC adapter loose. No visible gap noted. Technician was able to move the adapter with light finger pressure.

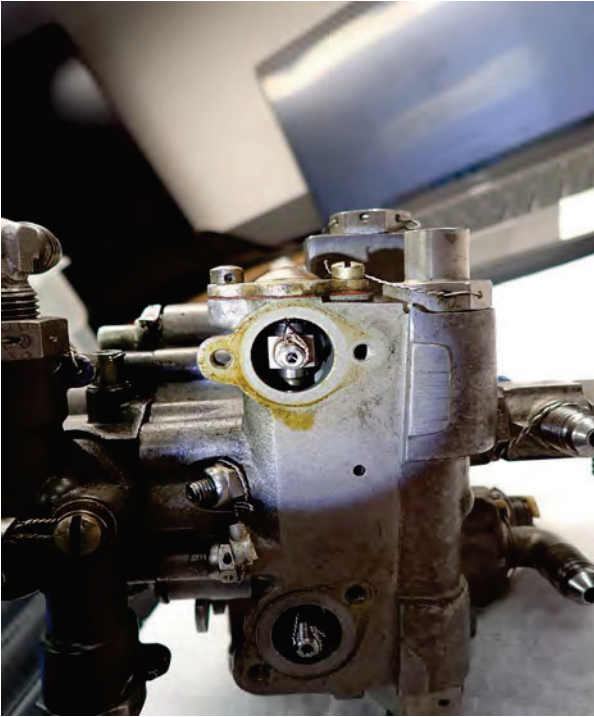
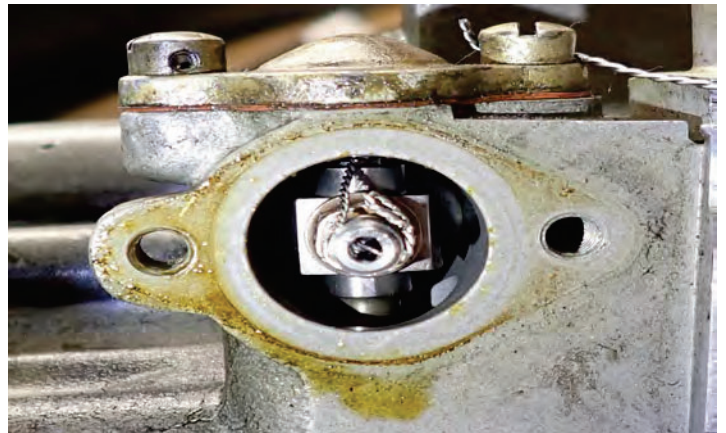
- H. Removed Lever Assembly (Bellows) cover, visually checked for debris, none present. Reference Photos 8A, 8B.
  - I. Removed Lever Assembly (Metering Valve) cover, visually checked for debris, none present. Reference Photos 8C, 8D.

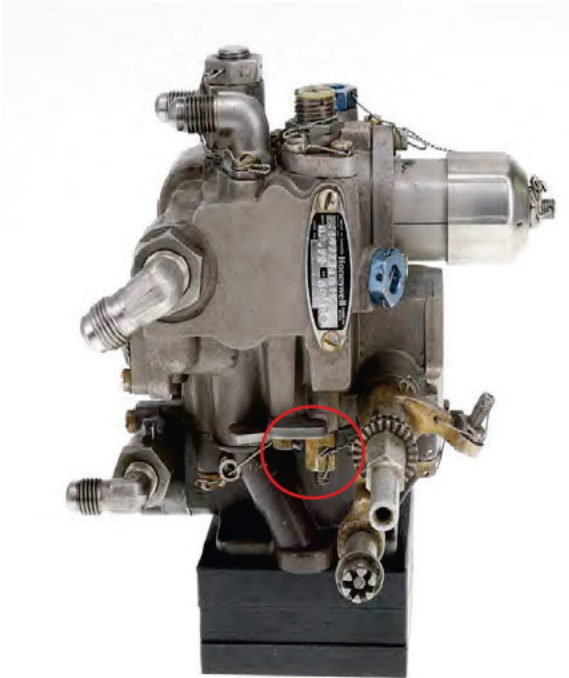
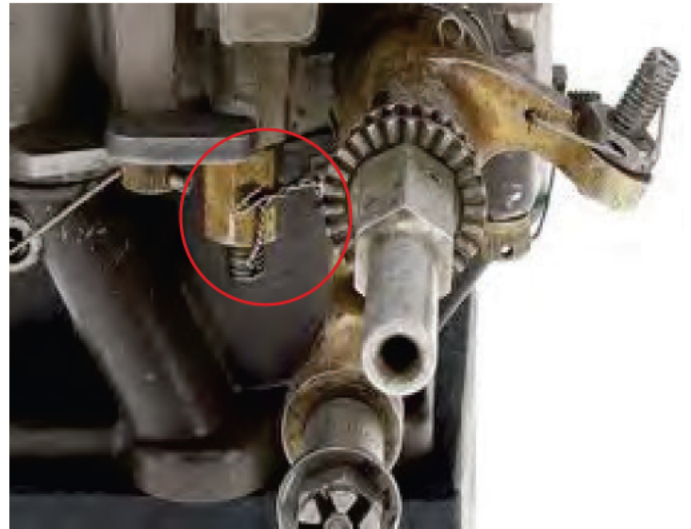
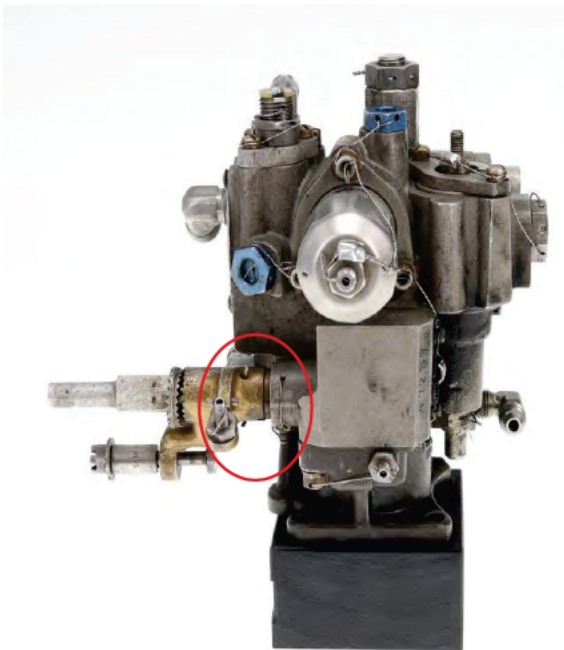
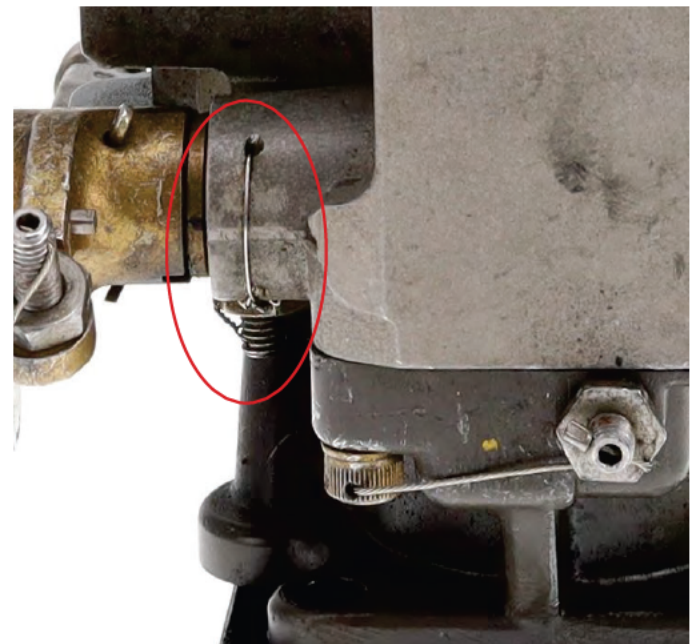
- A. Screw Adjustment (Maximum Flow) Nut does not appear to be safety wired IAW CMM Reference Figure 1006. Reference Photos 9A, 9B, 9C, 9D.
- B. Stop, Throttle and Stop, Trim appears to be safety cabled. Reference Photos 10A, 10B.
- C. Px pressure port fitting appears to have a concentric ring around the cone portion of the fitting. Reference Photos 11A, 11B.
