**Investigation Report**

**VSE MFG010****DETAILS OF INVESTIGATION**

| <b>Unit Type</b> | Fuel Control Unit |

**VSE MFG010****ATTACHMENT 1****CEN24LA193 FCU PWCRF24-093 ESN PH0869 VSE RESULTS DISCUSSION**

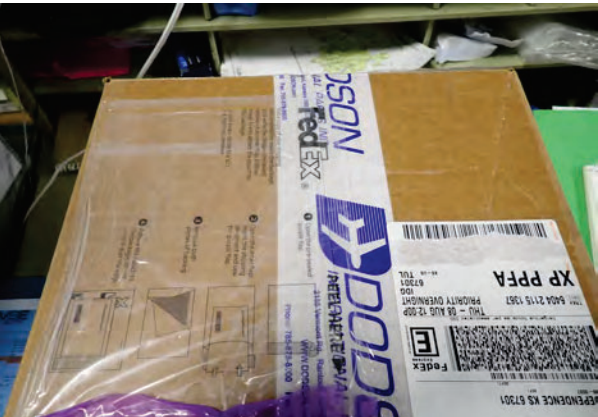
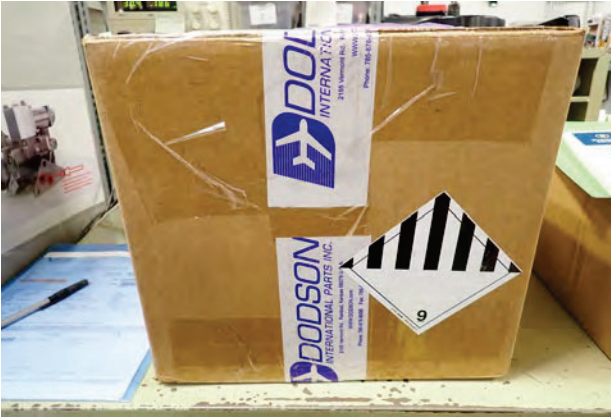
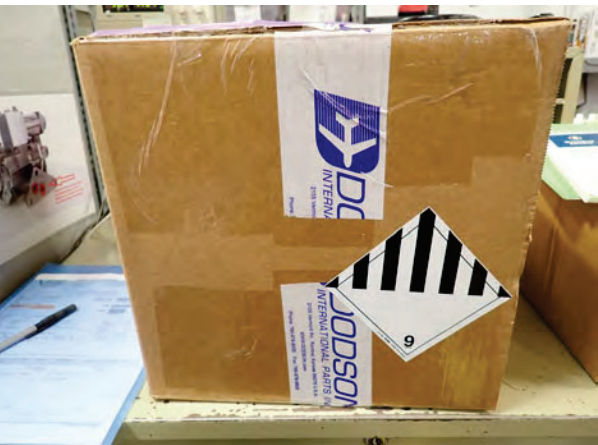
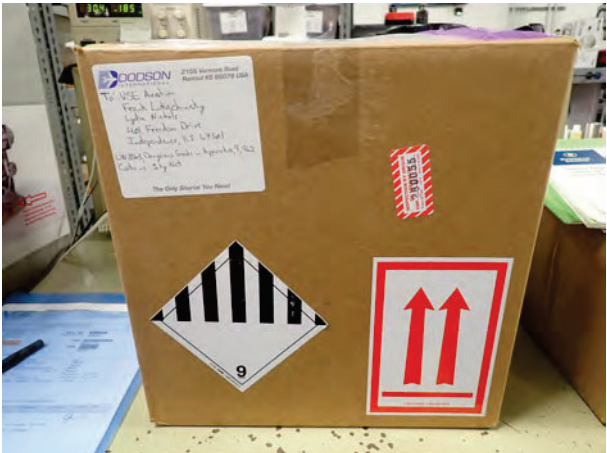
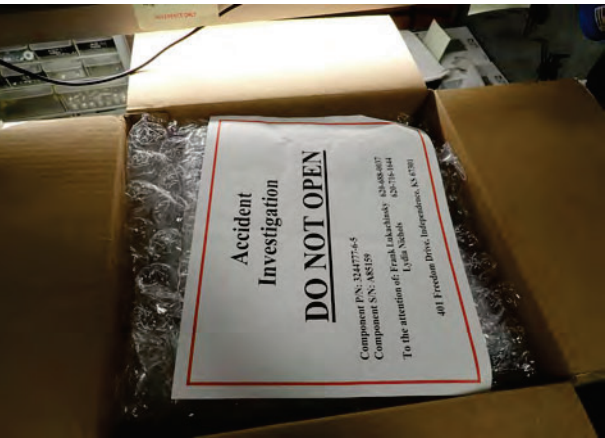
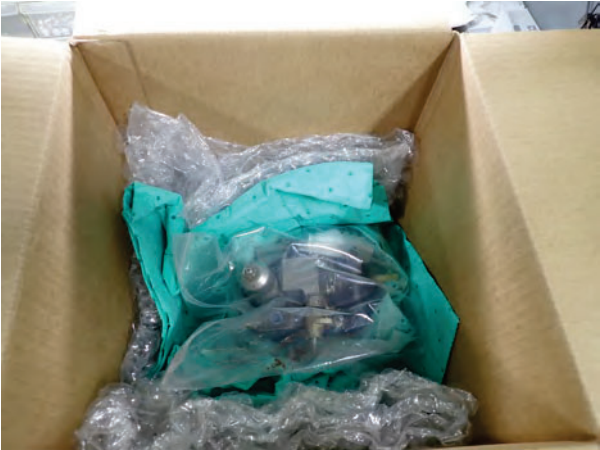
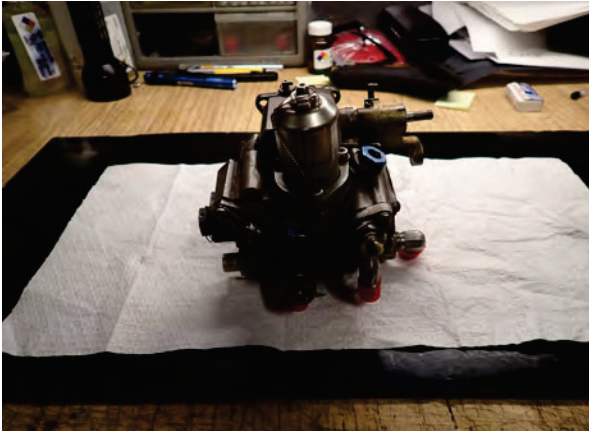
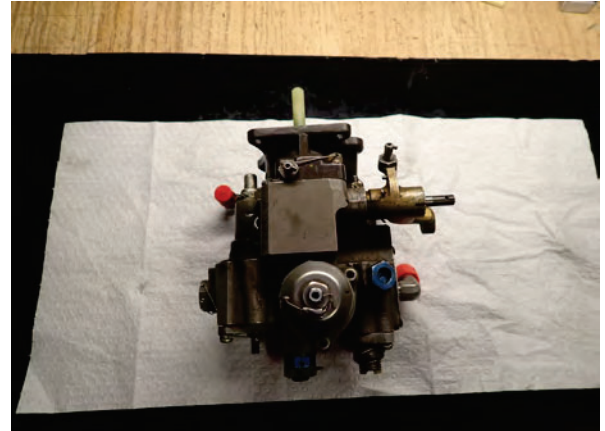
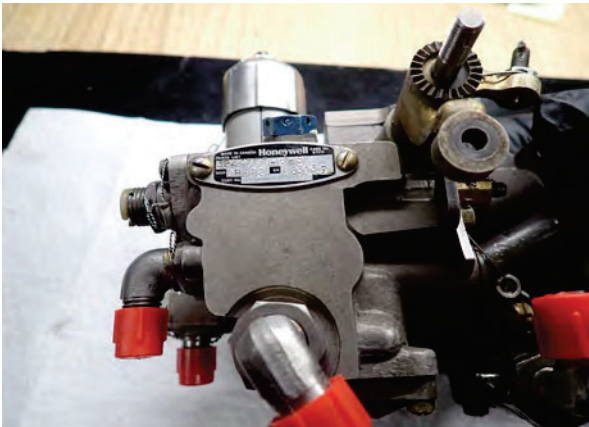
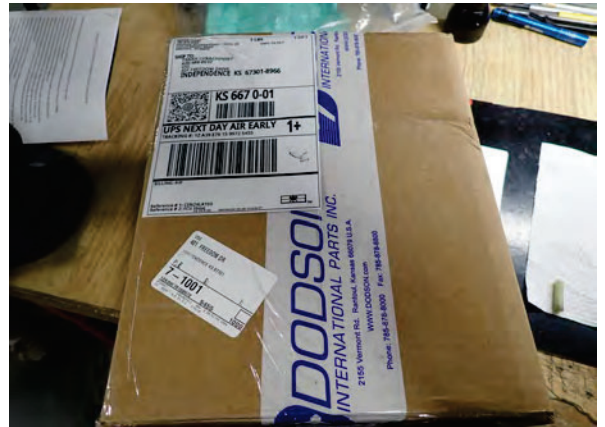
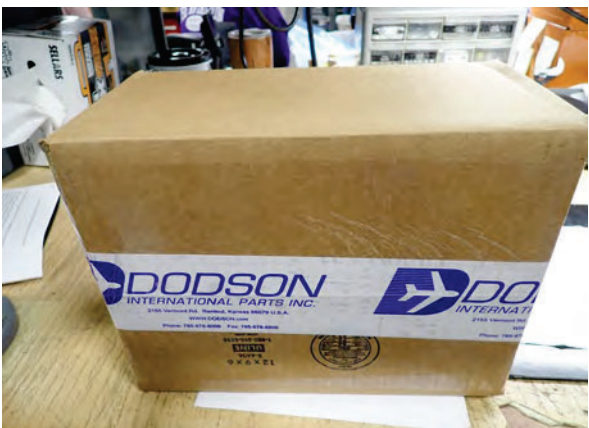
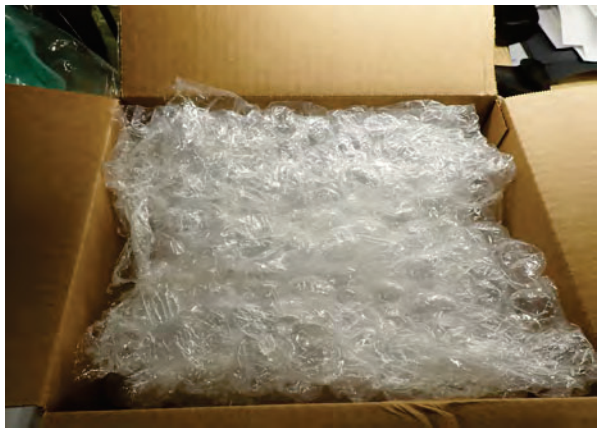
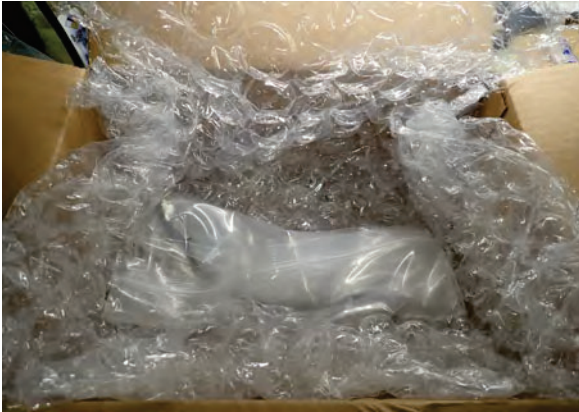
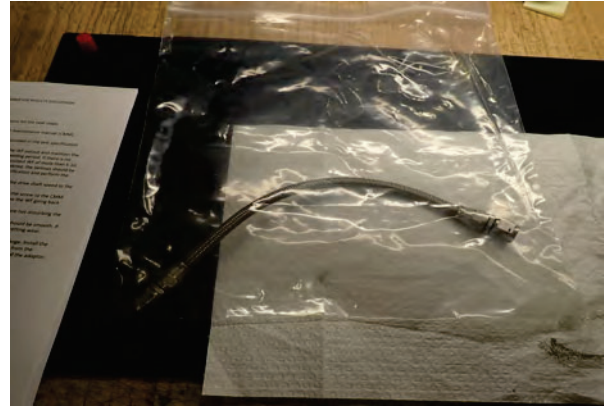
1. Unit and Line assembly removed from box. Reference photos: 1A through 1N.
2. Reviewed Line.

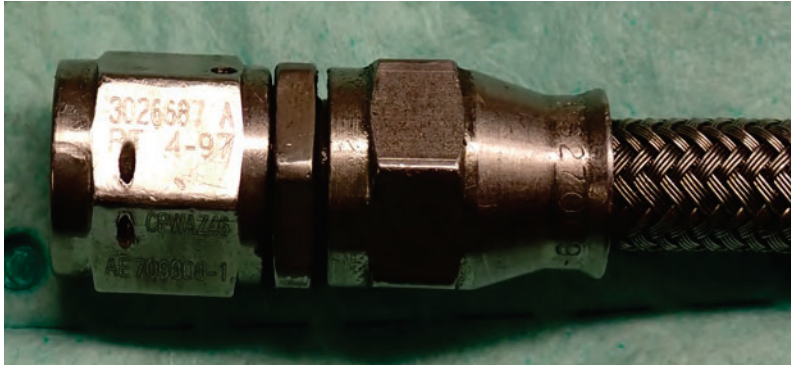
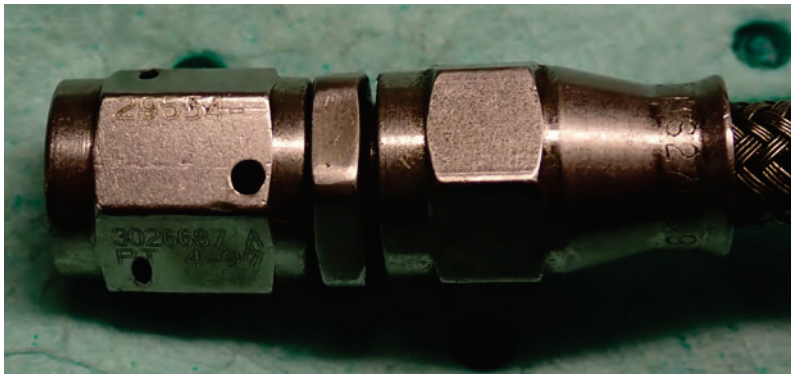
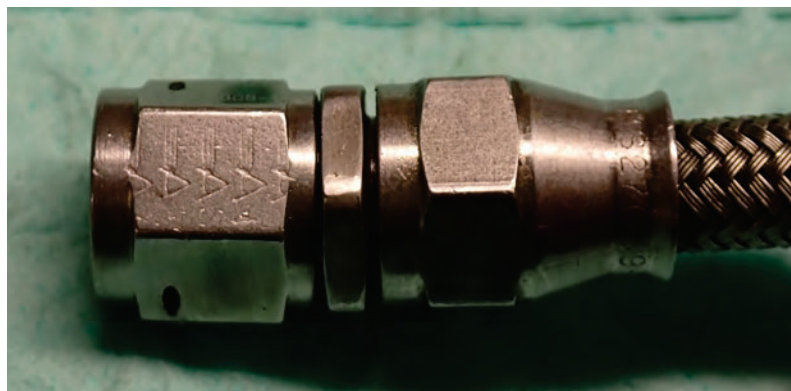
Part numbers are present on the "B" nut flats. Reference photos: 2A, 2B, 2C.  
P/N MS27069-4C AF506-4C on the ferrule.
3. Line was checked for obstructions, was found to be clear.
4. Unit and line were installed on the test stand. Line was torqued to 80 in lbs.
5. Performed Test Specification paragraph K (Reference Attachment).

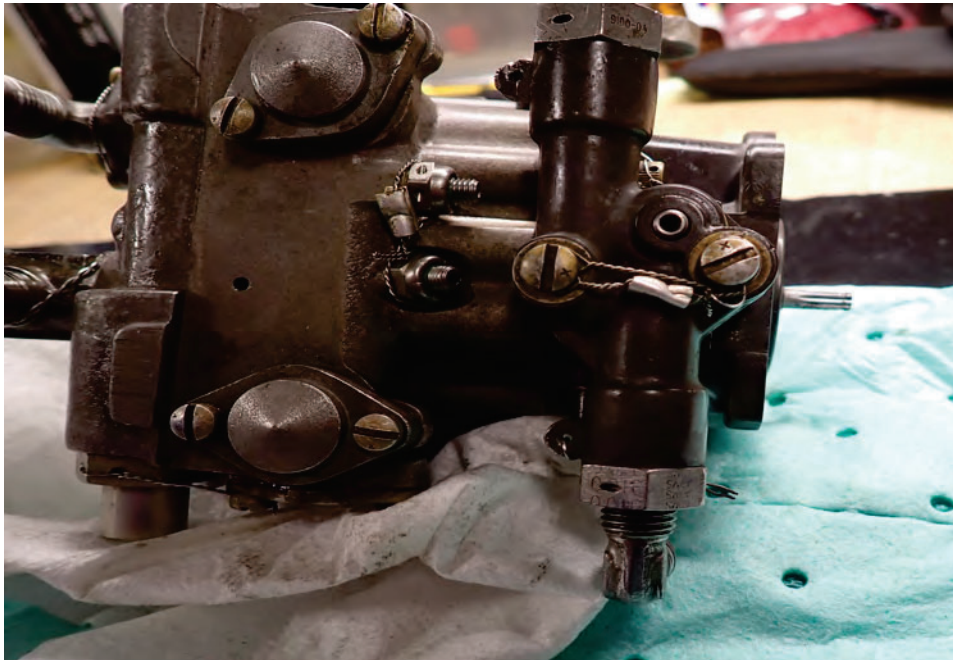
Photo 3A

Ran test point 5.01, results:  
Nozzle Flow, PPH = 155, Px - Py = 36 "Hg.
10. PC adaptor lockwire wire appears to be in a neutral configuration. Reference Photo: 3A.

Witness marked screws. Reference Photos: 3A, 3B. Removed adaptor screw lockwire, No "undo" torque registered on the torque wrench.
11. Removed adaptor, visually inspected adaptor screw holes. Holes do not appear to be smooth. Screws appear to have marks on the threads. Adaptor appears to have metallic looking particles in the housing. Fretting was observed on the gasket, housing and the body. Reference Photos: 4A through 4G.

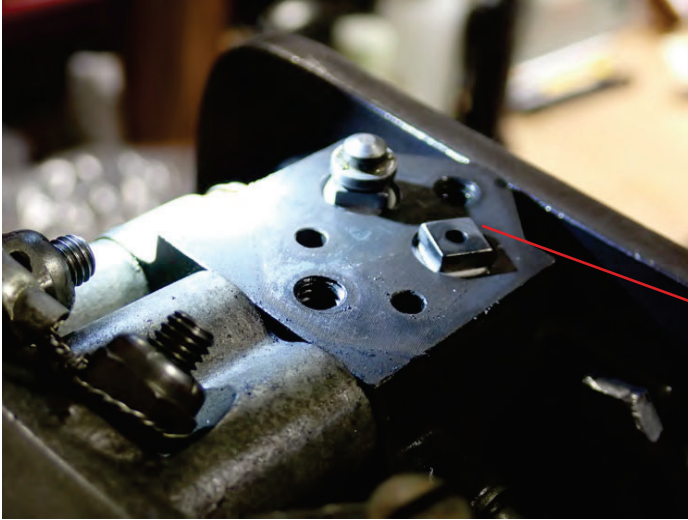
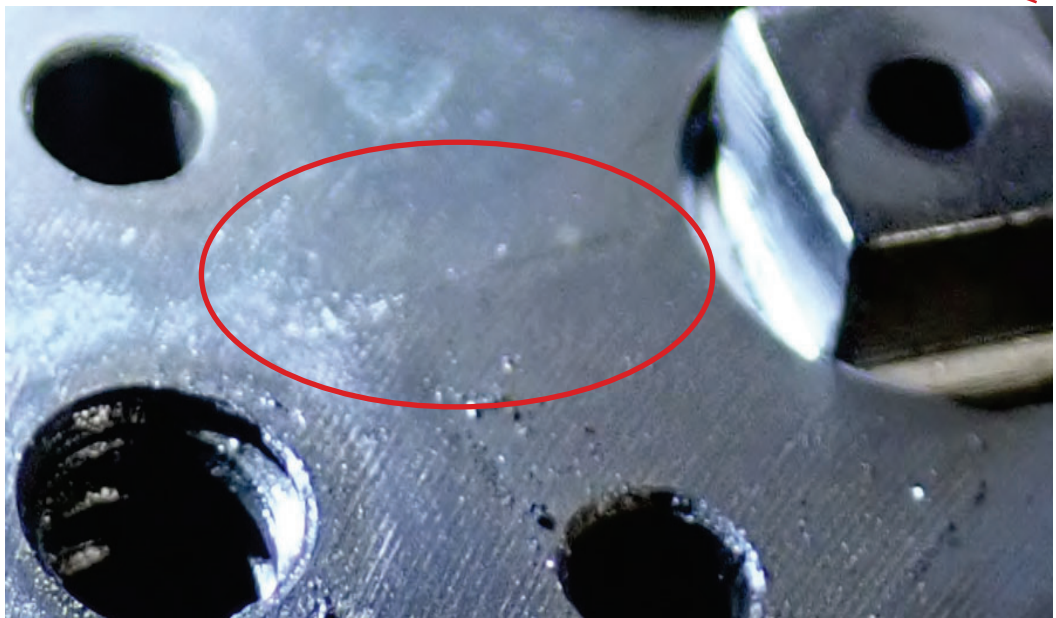
Photo 4H

12. Appears to be a mark on the mounting pad extending from mounting hole to Py restrictor.  
Photo 4H.
13. Adaptor/Gasket was re-installed on unit and torqued IAW the CMM.
