# National Transportation Safety Board

CEN24LA200

## **ENGINE EXAM SUMMARY**

Location: Taylor, TX  
Date: July 19, 2024  
Time: 1145 CDT  
1645 UTC  
Airplane: Piper PA-28-140 (Cherokee)

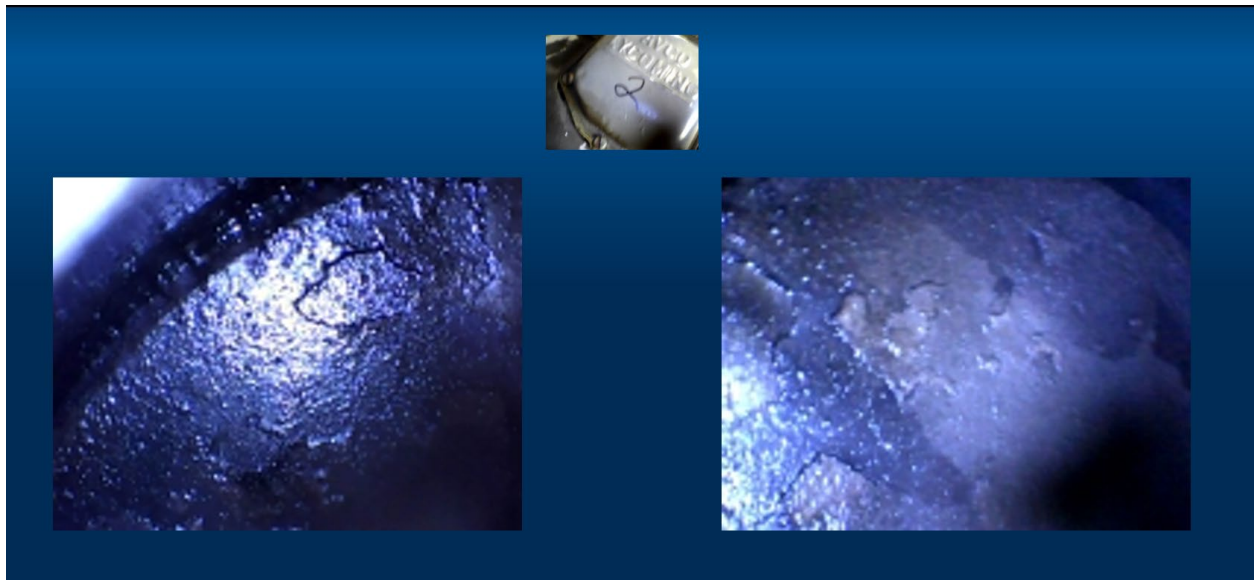
**Figure 1 - #2 Cylinder - Top of Piston**

The sparkplugs were removed and the cylinders borescoped. The cylinder domes and tops of some pistons were discolored black consistent with a rich fuel - air mixture (see Figure 1). The number three exhaust valve had non-uniform heat signatures (see Figure 2). Visually the cylinders did not have any anomalies that would contribute to a loss of engine power.

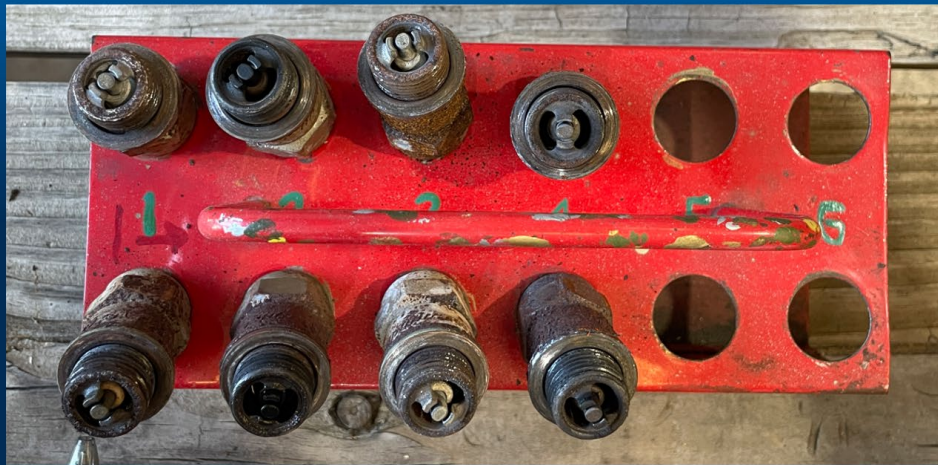
**Figure 3 - Spark Plugs Before Engine Runs Conducted**

The corrosion present on the sparkplugs made removal difficult. Some of the sparkplugs had oval shaped center electrodes and overall were dark in color compared to later when they were removed after the fourth engine run (see Figures 3&4).

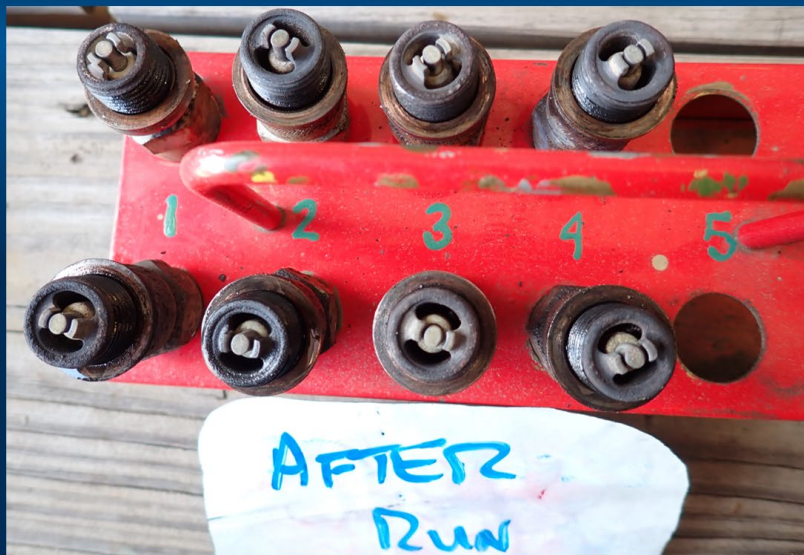
**Figure 4 - Spark Plugs After Engine Runs Conducted**

The air intake tubing was removed, and the engine was run again. The engine started normally and was run at full power for several minutes. The engine was shut off and allowed to cool, then the spark plugs were removed for comparison to their condition prior to the engine runs. The spark plugs overall were lighter in color and the center and ground electrodes were more uniformly light tan in color.

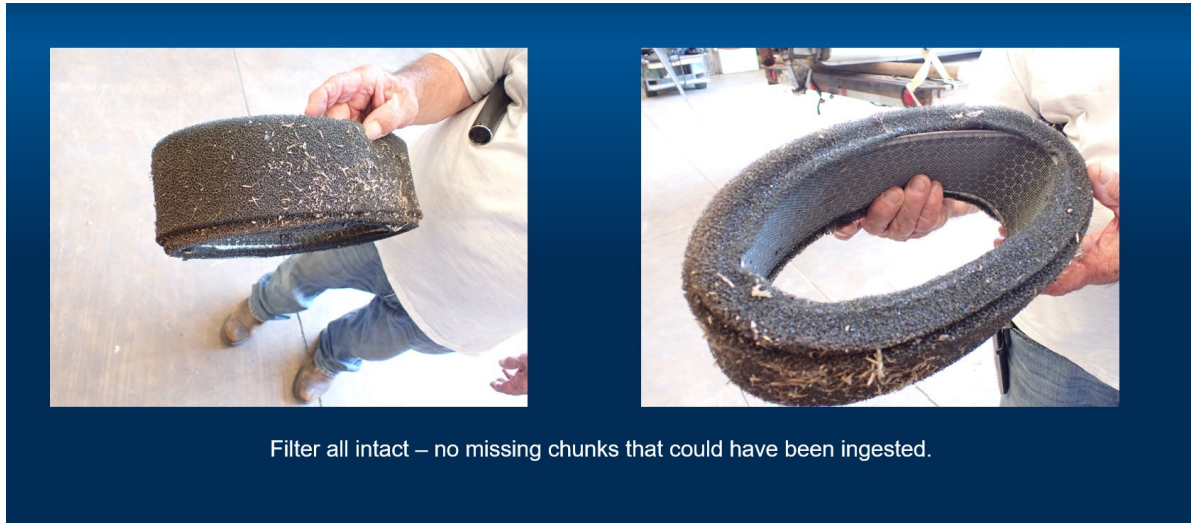
**Figure 5 - Air Intake Filter**

The air intake filter was examined. The foam prefilter was intact and no anomalies were noted (see Figure 5).

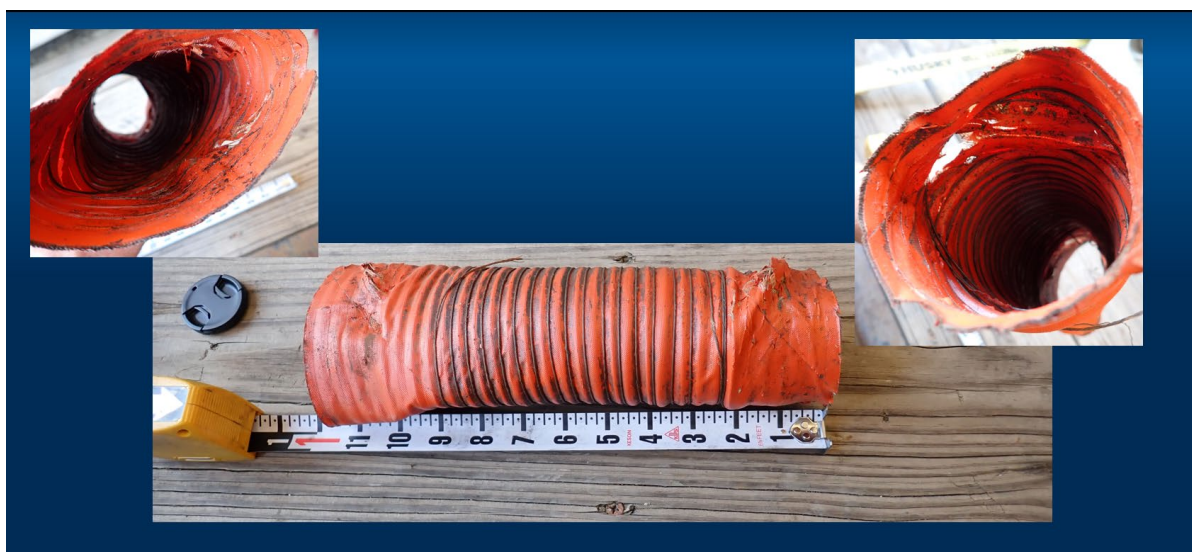
**Figure 6 - Carburetor Air Inlet Hose**

The carburetor air inlet hose that runs from the engine cowling to the inlet side of the carburetor exhibited impact damage. FAA Service Alert Information Bulletin (SAIB) CE-14-23 warns aircraft owners that use of tubing other than the manufacturer specifies may result in collapse of the tubing and could result in a rough running engine or a loss of power. Considering this bulletin, the carburetor air inlet hose was sent to the manufacturer to determine if it was the correct part (see Figure 6).

hooked to the engine cowling. The engine started normally. The cuffed end of the intake tubing folded inward causing a restriction in the airflow to the engine. The engine ran 100-200 rpm lower than the previous run. The loss in rpm could be restored through use of the mixture lever, but the lever was near the idle cut-off position to accomplish it.

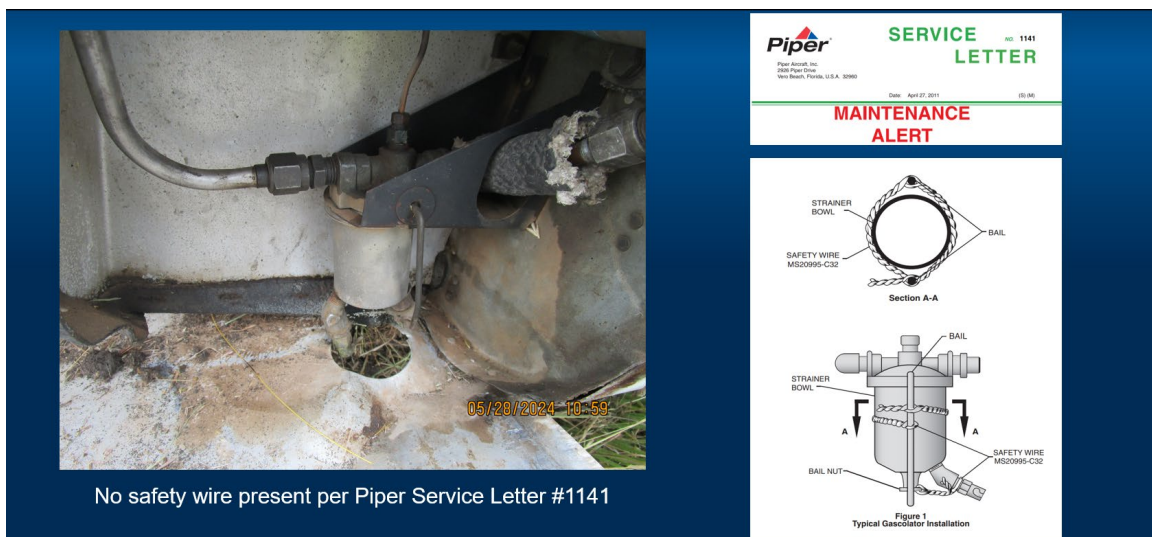
**Figure 7 - Gascolator at Accident Site Prior to Removal by FAA**

The fuel bowl on the gascolator was not present. The FAA inspector who was on the accident site was consulted by phone. He stated that he took a picture of the gascolator prior to him removing and inspecting it at the accident site (see Figure 7). The FAA inspector stated that the bowl had fuel in it and no anomalies were noted. The photo prior to disassembly taken by the FAA inspector showed there wasn't any safety wire present per Piper Service Letter #1141. The photos he provided also indicated that the wire bail had been displaced to one side with the fuel bowl remaining in its installed position to the top assembly. The displacement of the bail was consistent with being impact related. The FAA inspector bagged the components he disassembled and were located in the aft portion of the airplane's cockpit.

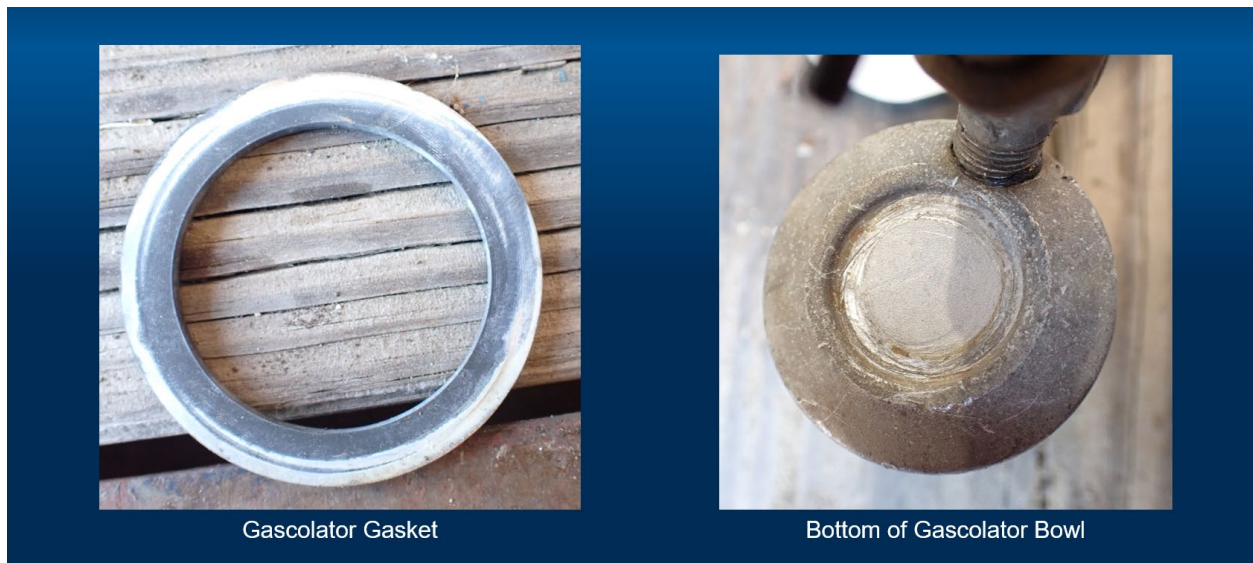
**Figure 8 - Gascolator Gasket & Fuel Bowl**

The top of the bail was wider, and the prongs still engaged the top of the gascolator assembly but not as fully as a new bail. The prongs that mate to the top assembly no longer had a definitive 90° angle. It was inconclusive whether this was from overtightening of the bail or impact damage.

The bottom of the fuel bowl had circular scoring the same size and shape as the bail nut (see Figure 8).

The gasket for the gascolator had black marks in a circle with one side of the circle protruding more than the rest of the circumference (see Figure 8).

At the completion of the engine runs the top assembly was removed from the airplane and the bowl was mated to it without the gasket. The top assembly was not square and the bowl rocked on its mating surface.

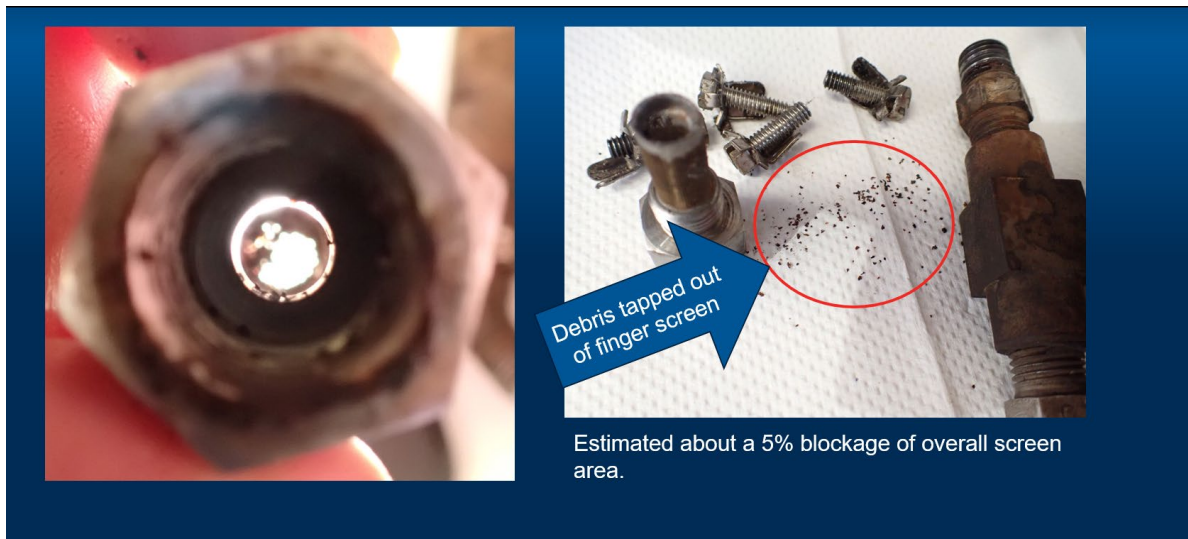
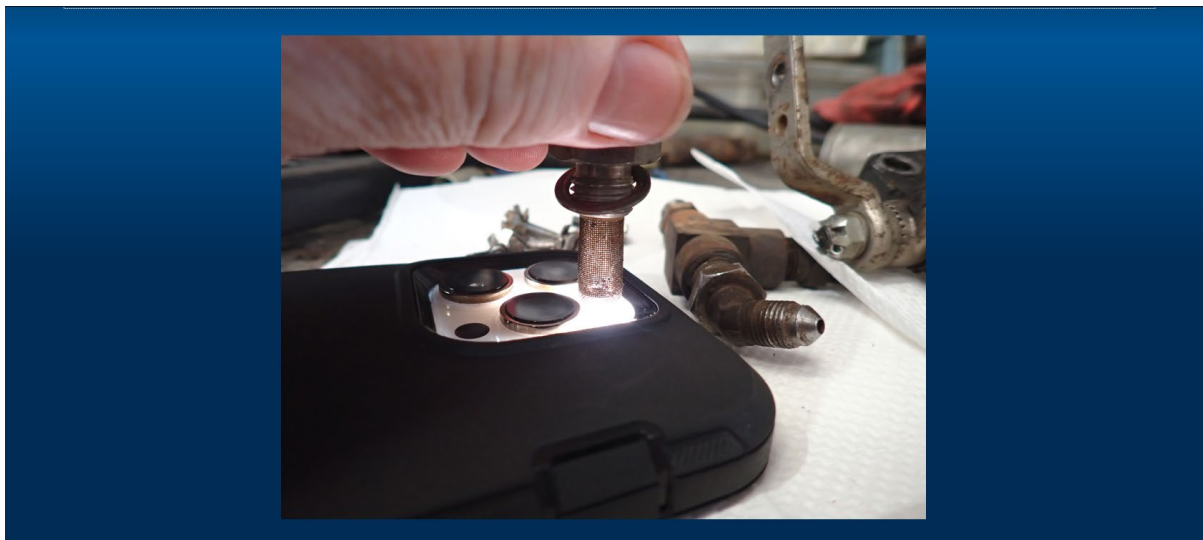
Upon completion of the engine runs the carburetor was removed and the case halves disassembled. The finger screen had a small amount of debris present covering an estimated 5% of the screen (see Figures 9&10). Based on the engine runs the amount of restriction to the finger screen was thought to be insignificant. The fuel bowl contained brown rust colored sediment (see Figure 11). Some of the sediment appeared as globules with up to about an eighth inch diameter. When poked with a pen the globules were found to have a flour like consistency and were not solid.

**Figure 9 - Carburetor Finger Screen (disassembled after engine runs)**

**Figure 10 - Carburetor Finger Screen (disassembled after engine run)**

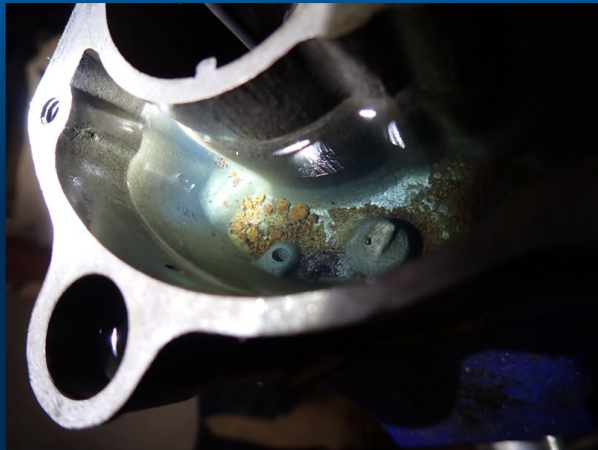
**Figure 11 - Carburetor Bowl (disassembled after engine runs)**

Sediment present in left side of fuel bowl on carburetor.

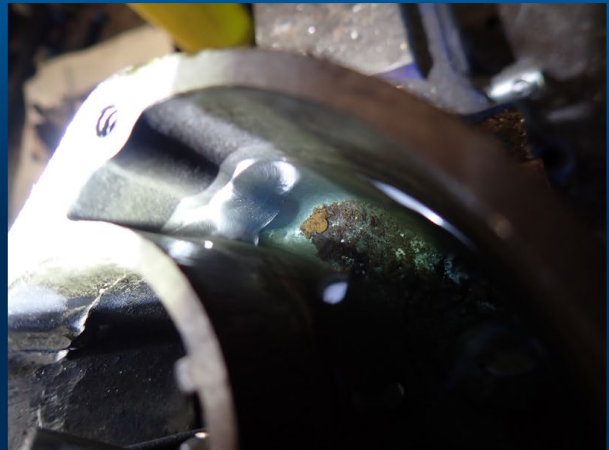
Sediment present in right side of fuel bowl on carburetor.
