Bradley Miller  
Aviation Accident Investigator  
AS-CEN

**Date:** October 8, 2024

**Subject:** Carburetor Air Inlet Hose Test & Research Summary

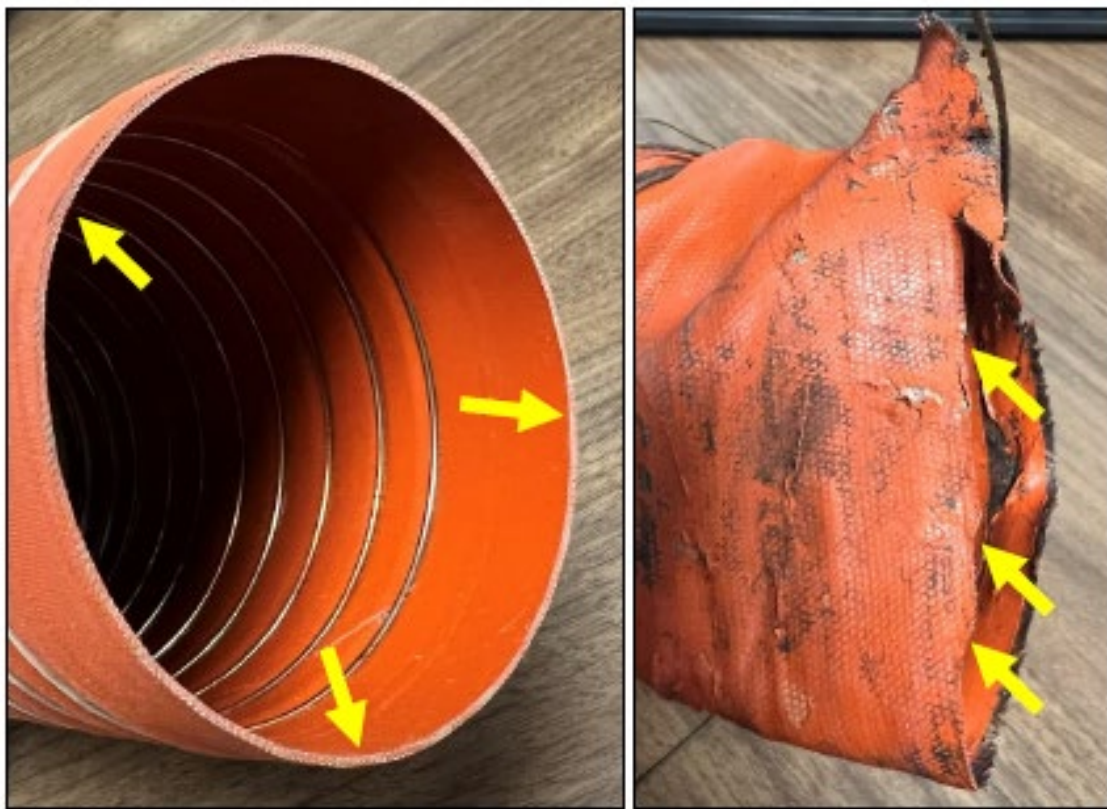
The carburetor air inlet hose on the accident airplane was removed and sent to Piper Aircraft for examination to determine if it was the correct part. The results of the examination showed that it was not the correct part, and that the accident airplane air inlet hose was fashioned from a longer section of tubing that was not made to the same specifications as the one offered in the Piper parts catalog.

The airplane manufacturer compared a carburetor air inlet hose from their stock to the one that was installed on the accident airplane and performed other checks to compare both against the drawing specifications. The stock part had a cuffed end on the hose and the wound wire stiffener in the hose ended where the cuff began. The end of the stock hose was uniformly cut. The accident airplane's hose had indications that the wire originally went all the way to the end of the hose. The end of the accident airplane hose was uneven indicating it was likely cut by hand from a larger section of hose. See Figure 1.

The wall thickness of the hose on the accident airplane measured 53% thinner than the correct part. This was noted as a likely indication that the hose was single ply instead of double ply material. This was important as the correct part is rated for a negative pressure of -24 inches of mercury (in. Hg).

*Figure 1 - comparison of stock hose (right photo) to accident airplane's installed hose (left photo). Photo courtesy of Piper Aircraft.*
