National Transportation Safety Board

CEN24LA200

## **INVESTIGATION PHOTOGRAPHS**

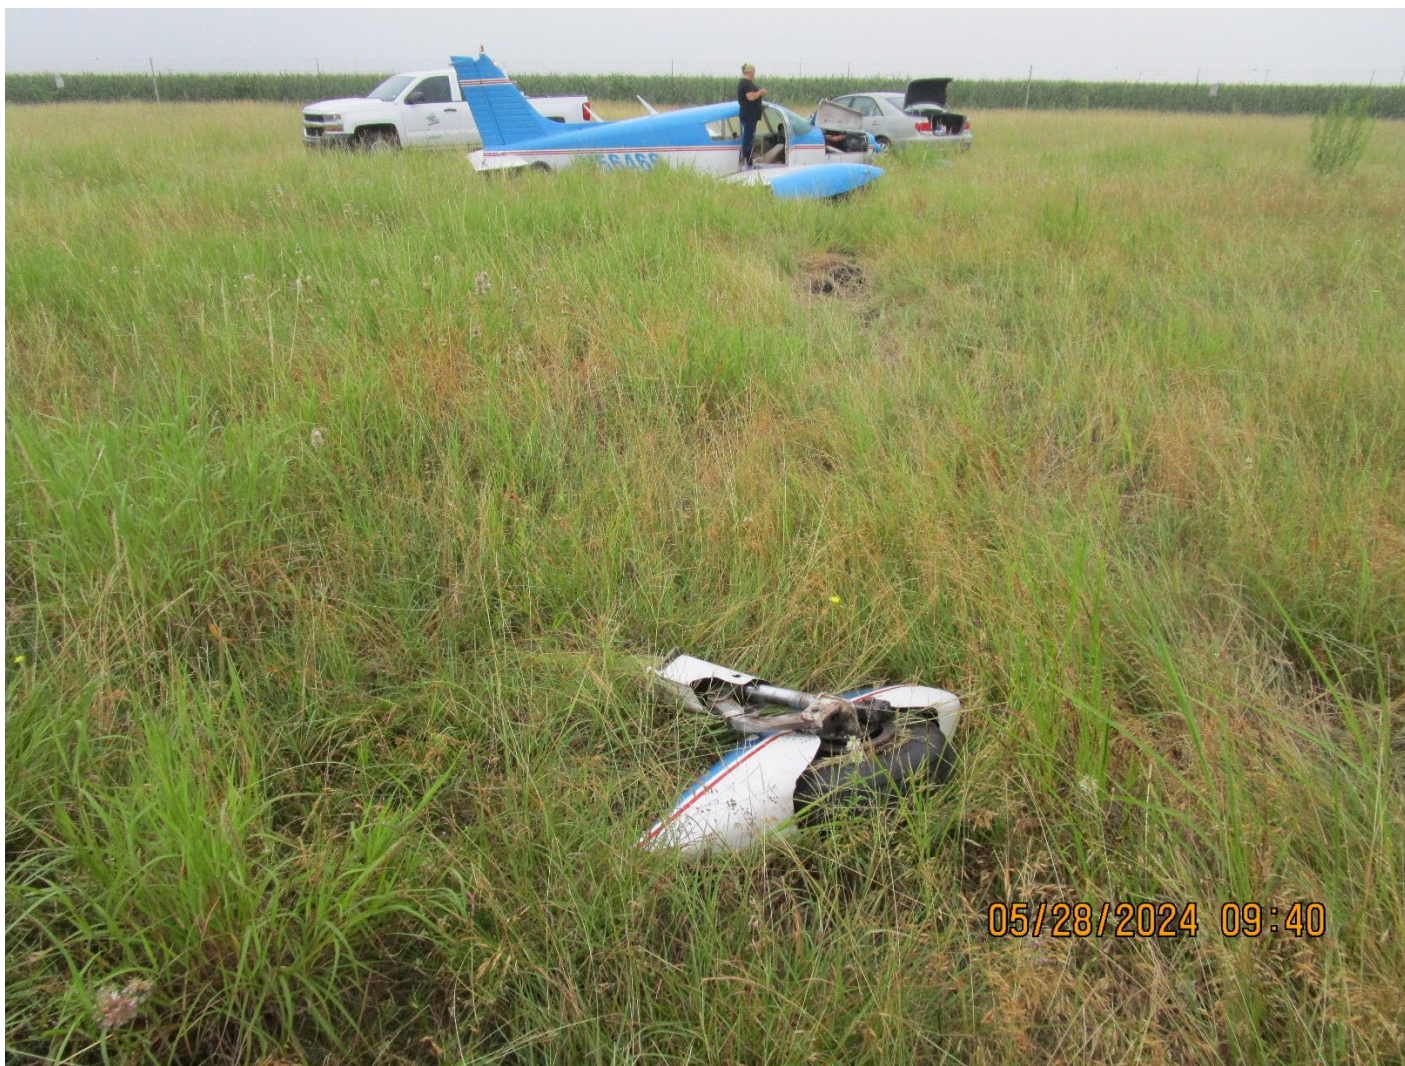
**Photograph 1 - Accident Site (Courtesy of FAA)**

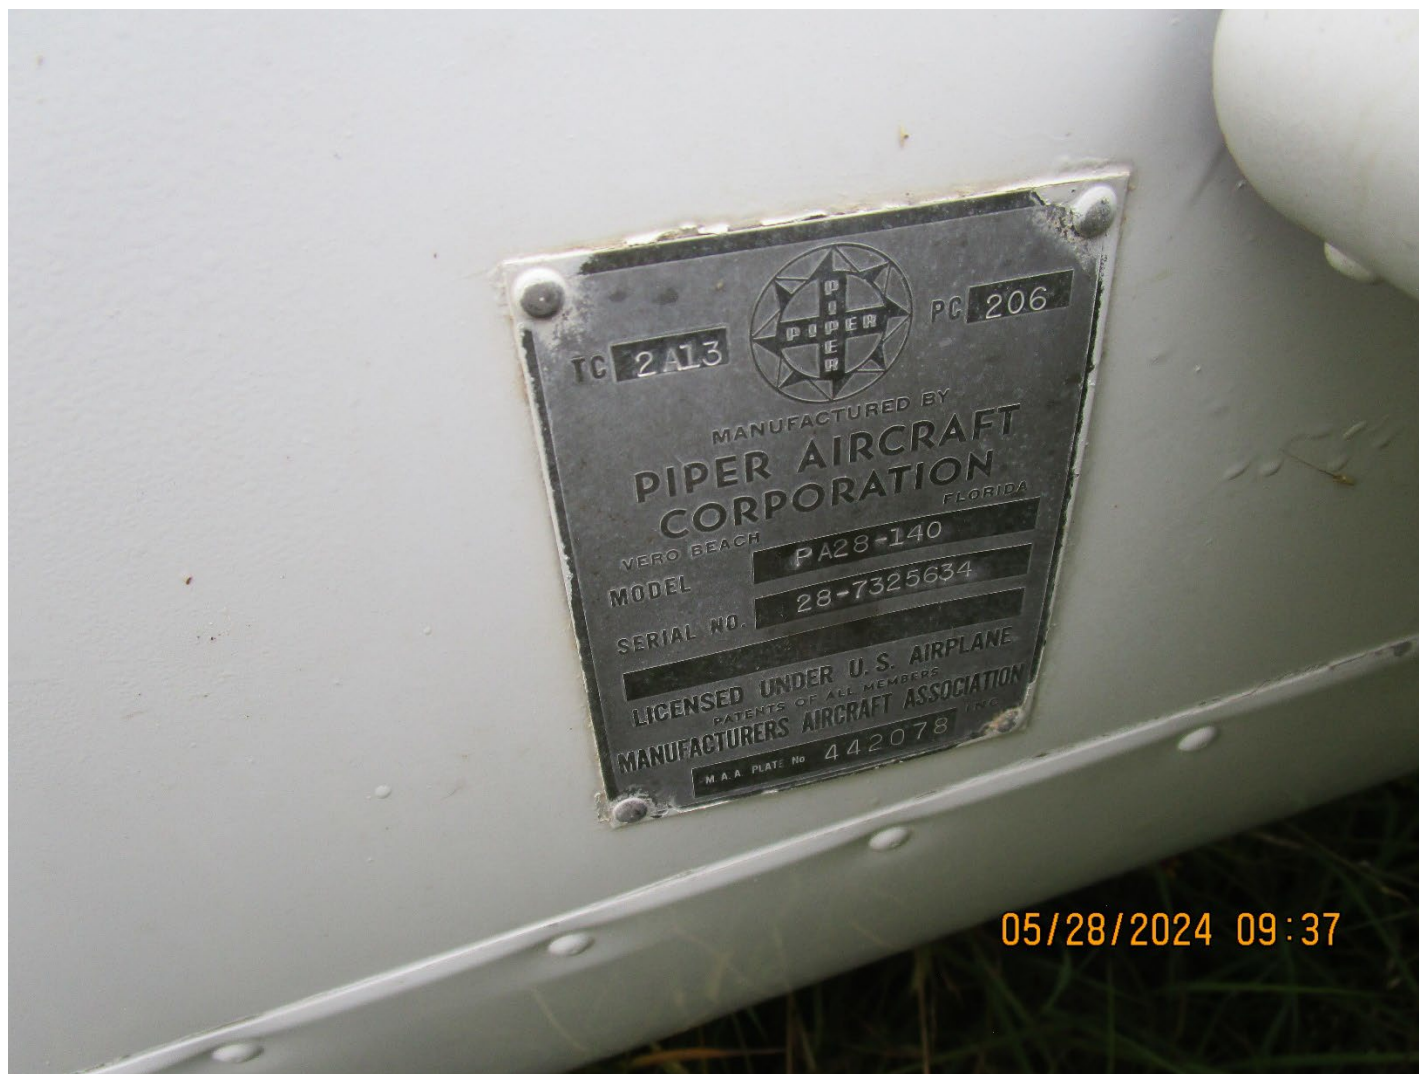
**Photograph 2 - Airplane dataplate (Courtesy of FAA)**

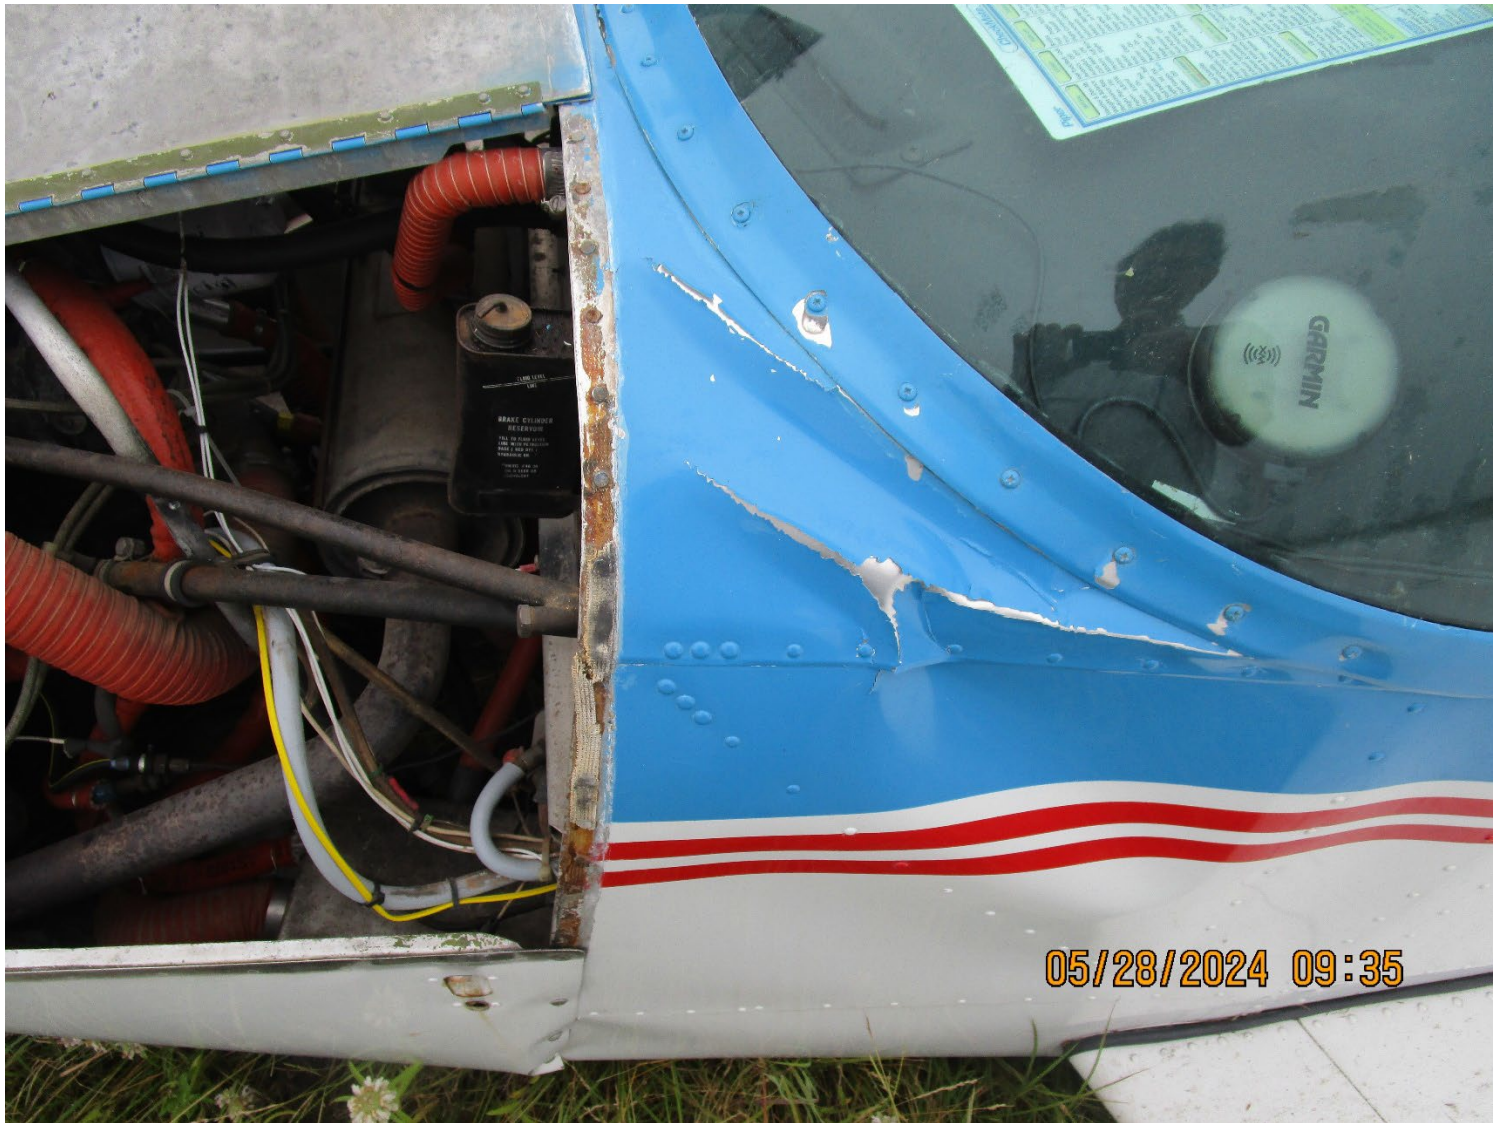
**Photograph 3 - Fuselage damage (Courtesy of FAA)**

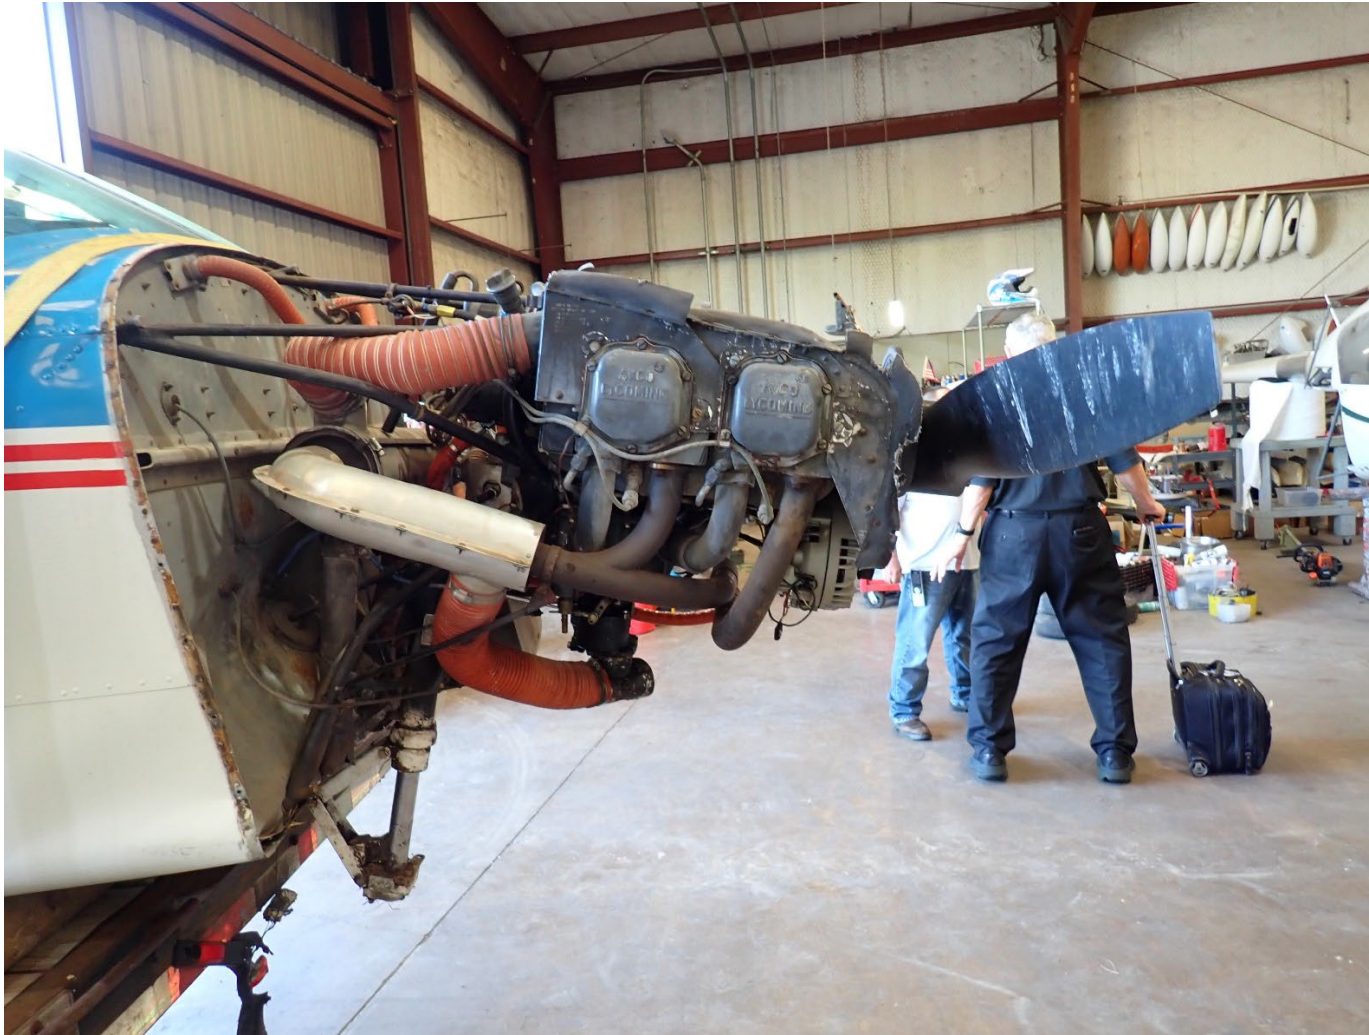
**Photograph 4 - Engine - right side**

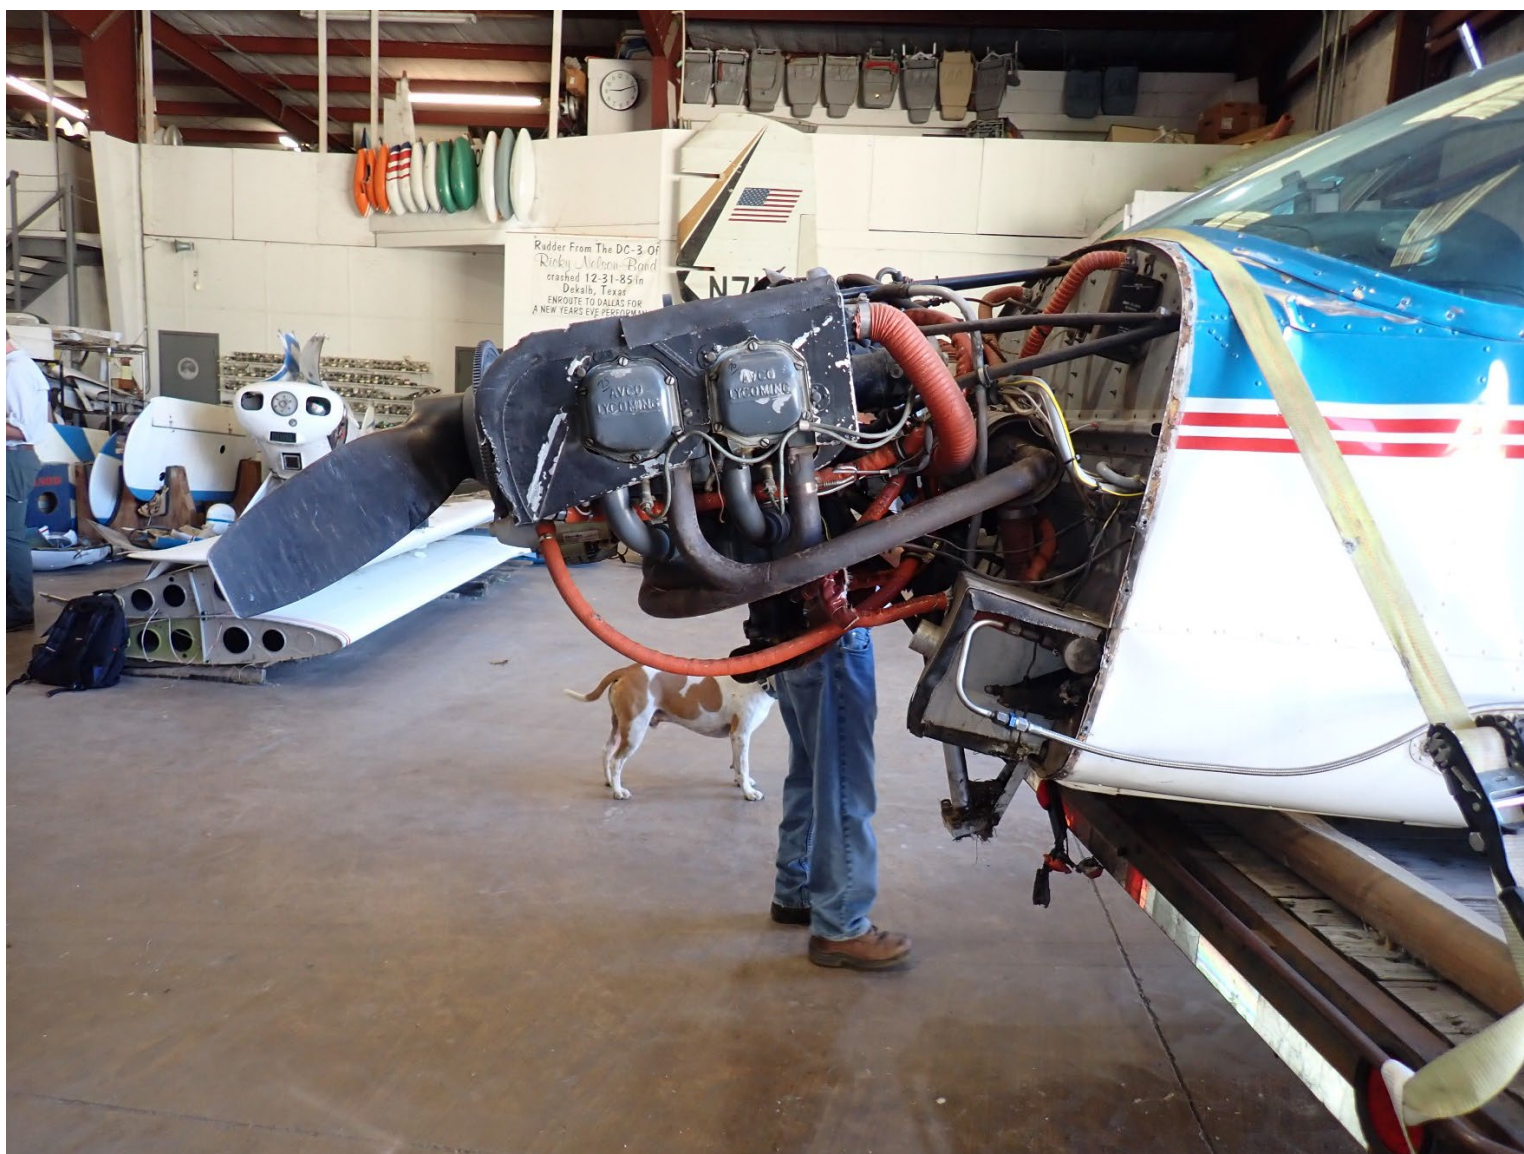
**Photograph 5 - Engine - left side**
