**From:** [REDACTED]  
**Subject:** RE: Engine Data - Plot via SAVVY Aviation Program  
**Date:** Tuesday, June 18, 2024 5:20:30 PM  
**Attachments:** [image001.png](#)  
[image002.png](#)  
[image003.png](#)

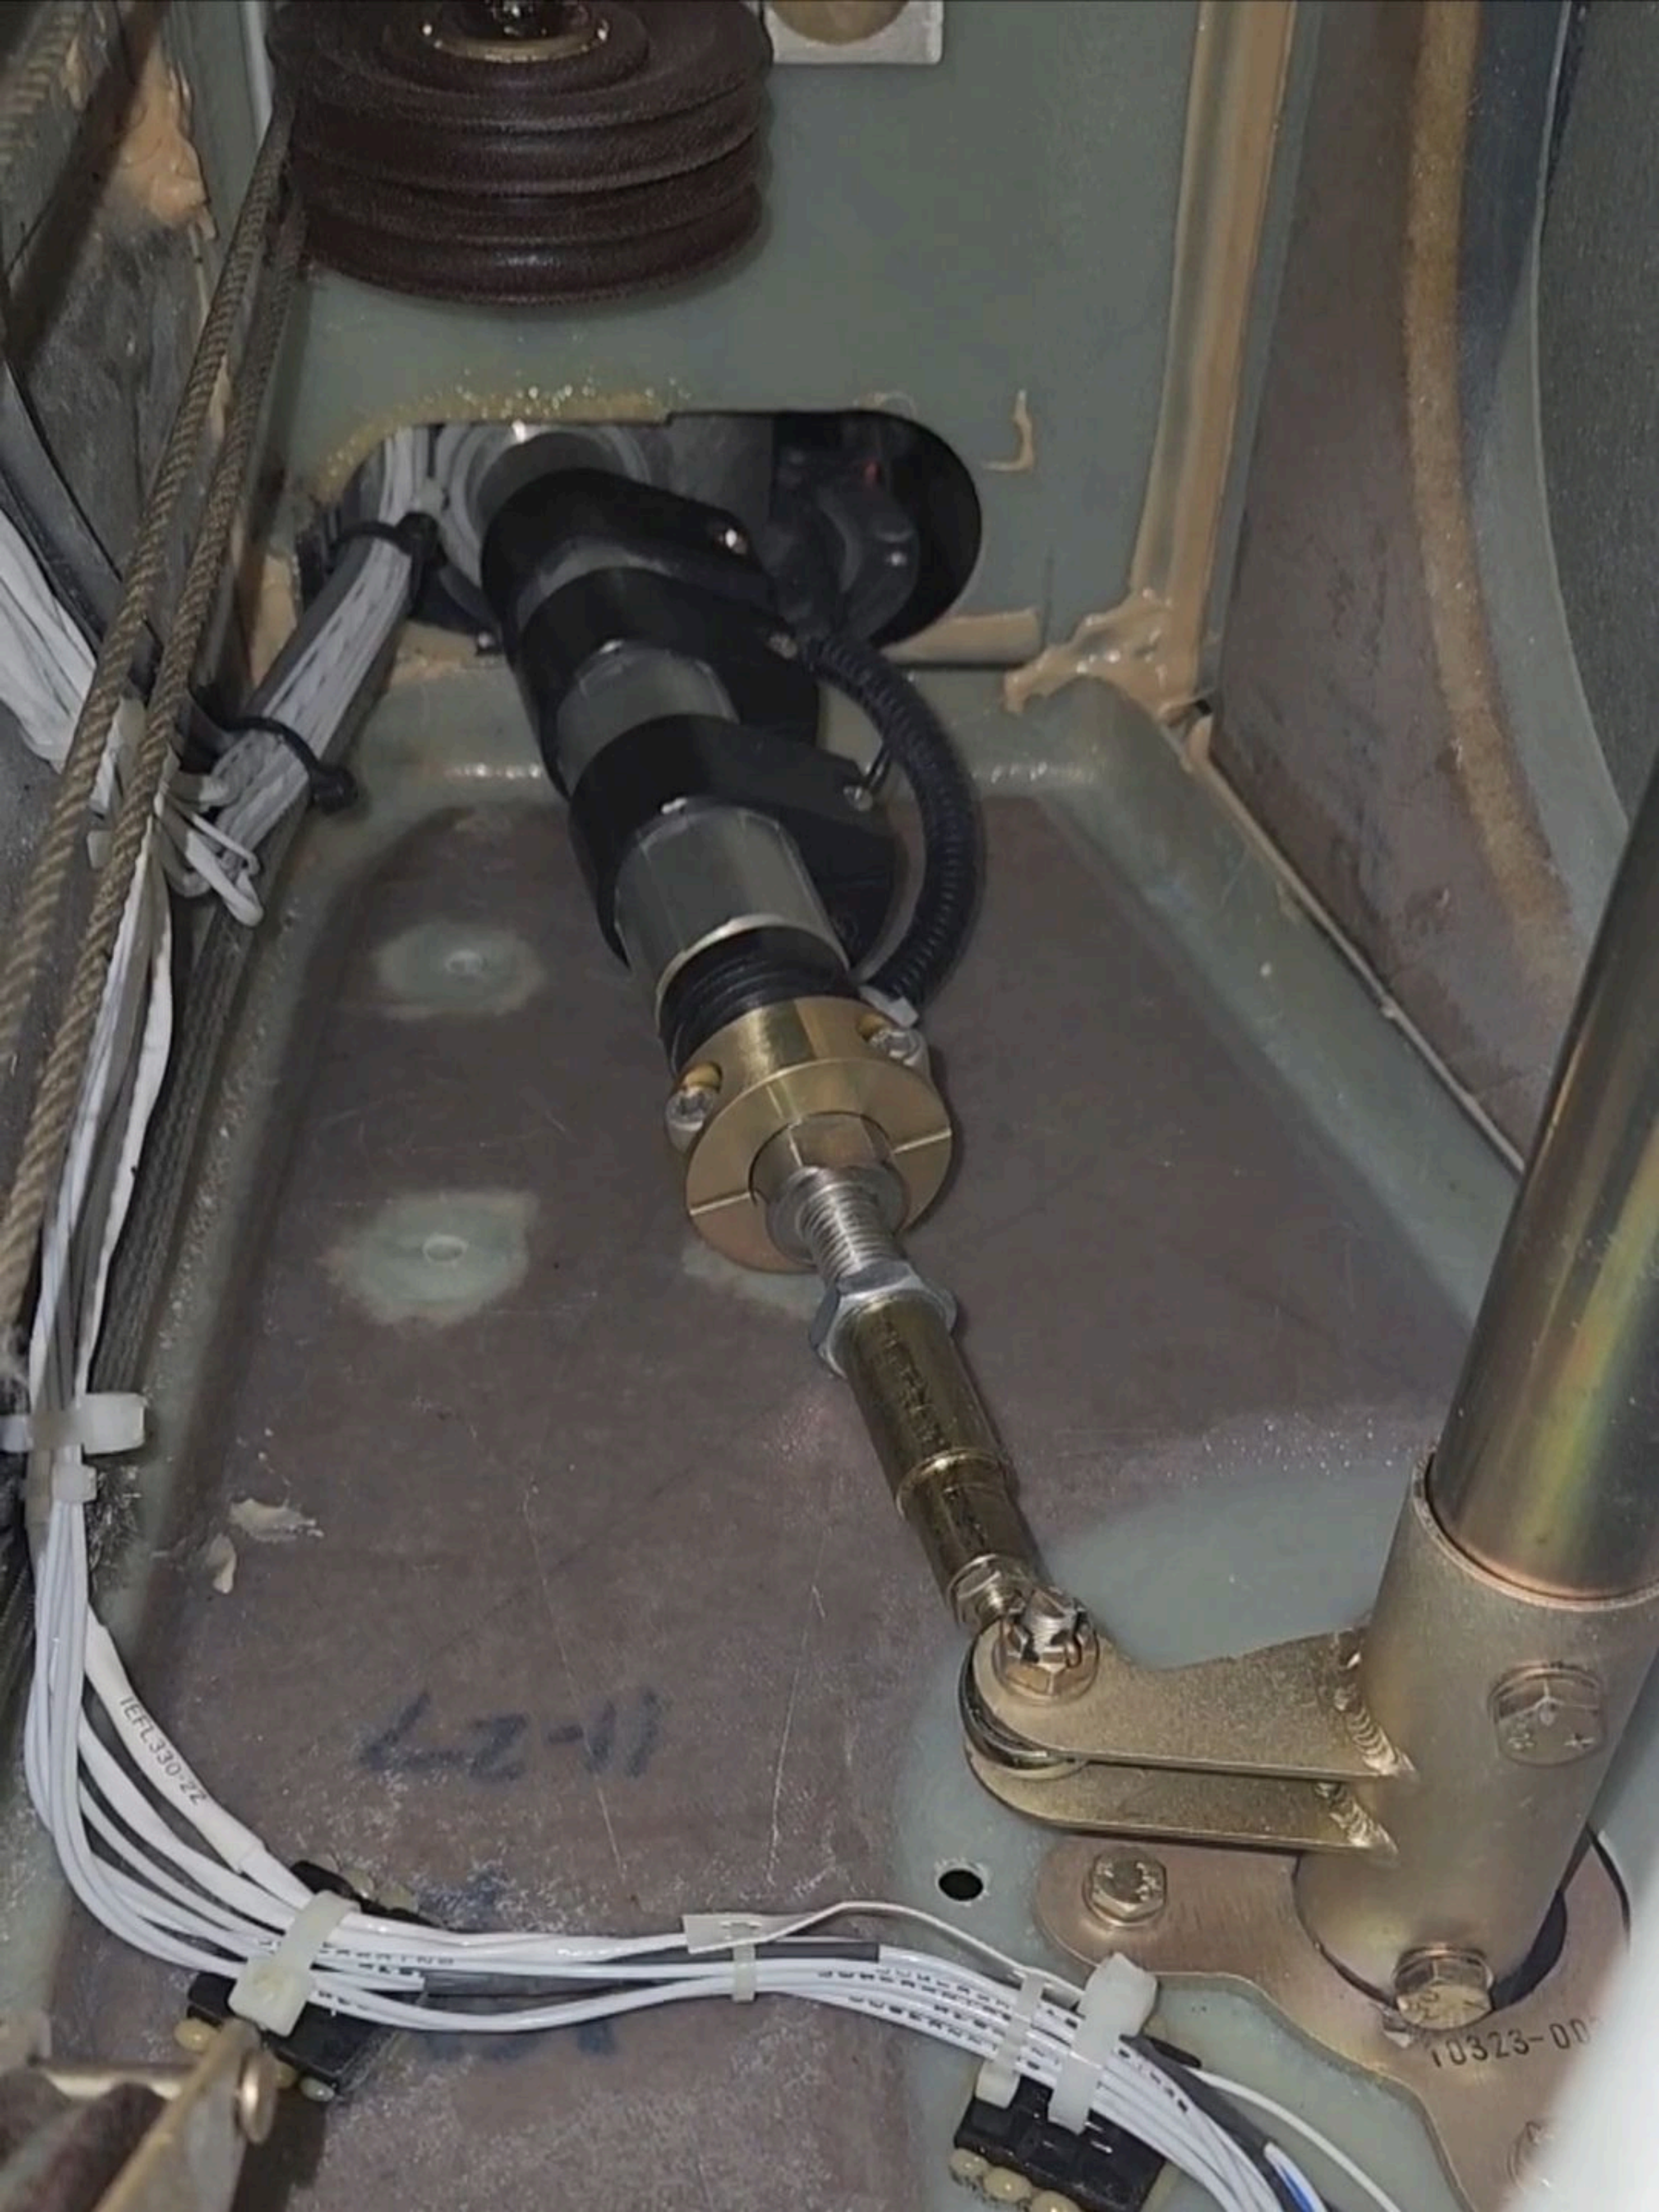
Thanks Aaron, yes, you are correct...the flap actuator is in the Flaps 100% position.

See attached photo of flap actuator position. 100% extended is what I observe. Correct?
