CEN24LA207

## INVESTIGATION PHOTOGRAPHS

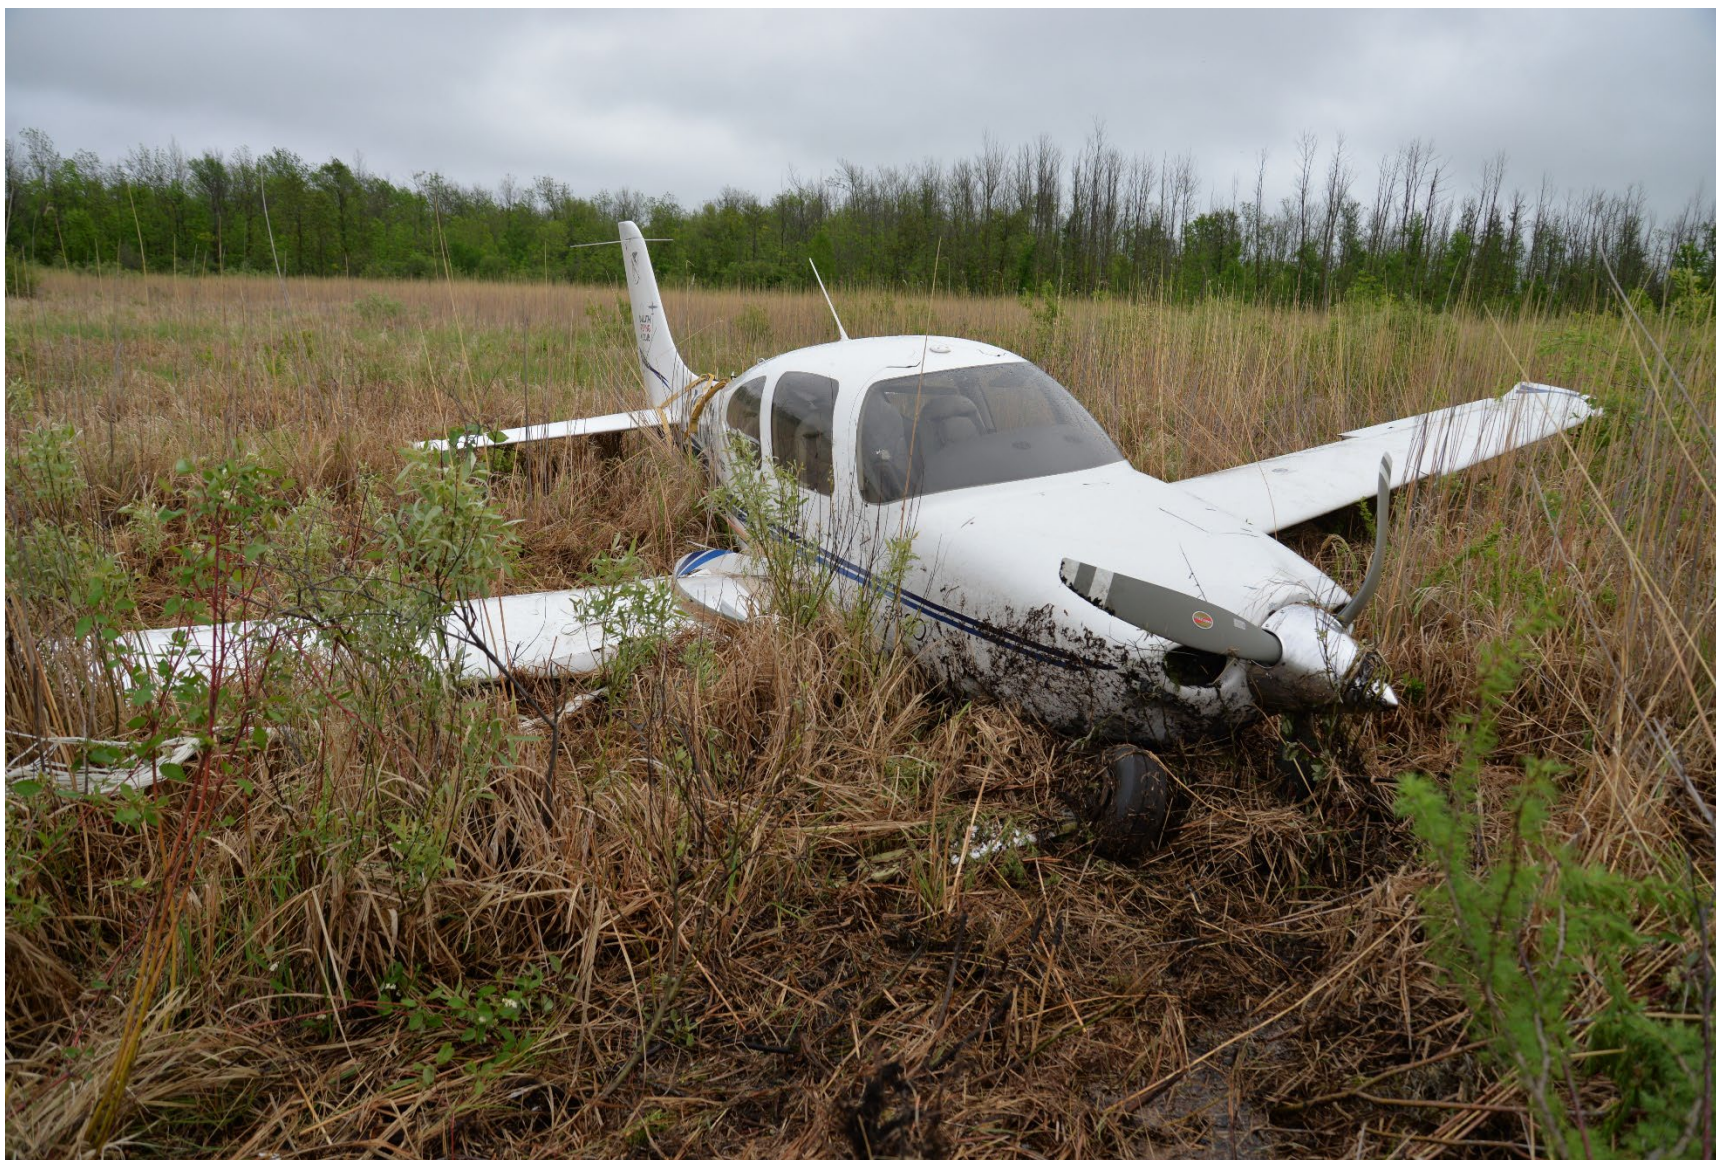
**Photograph 1 - Accident site and main wreckage (Source: Cirrus Aircraft)**

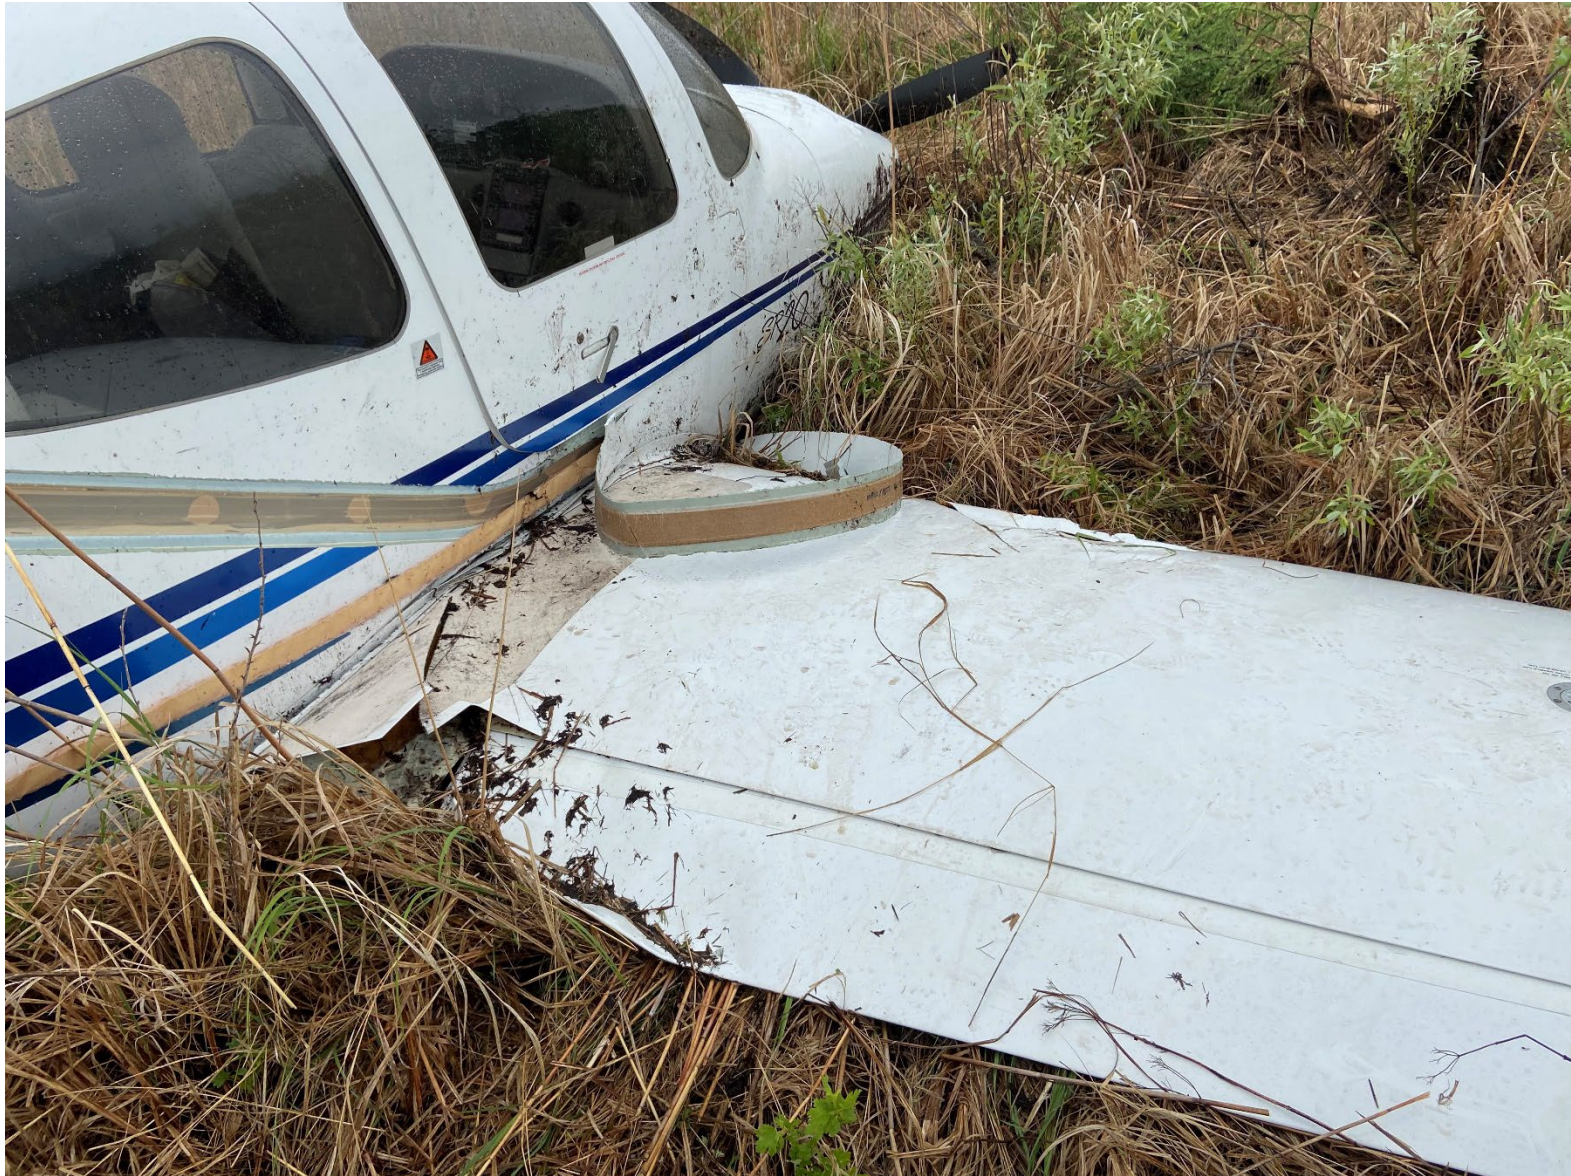
**Photograph 2 - Right wing damage (Source: Cirrus Aircraft)**

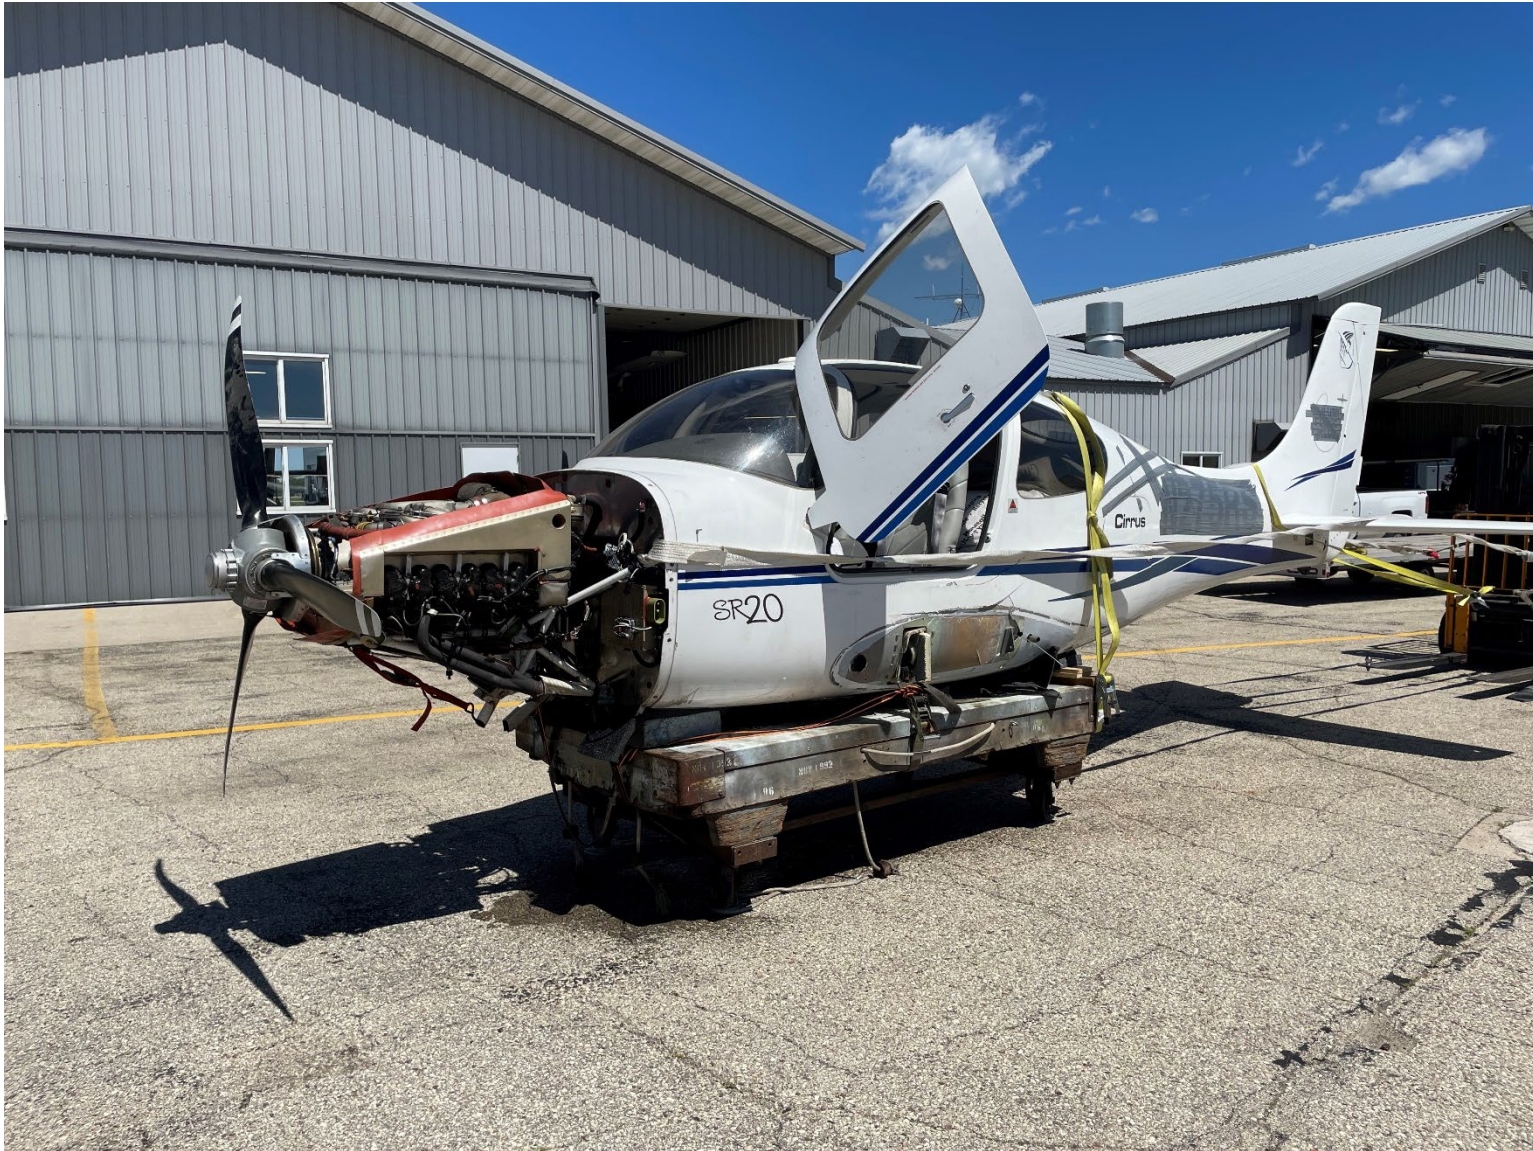
**Photograph 3 - Engine functional test setup**
