National Transportation Safety Board

CEN24LA208

## **INVESTIGATION PHOTOGRAPHS**

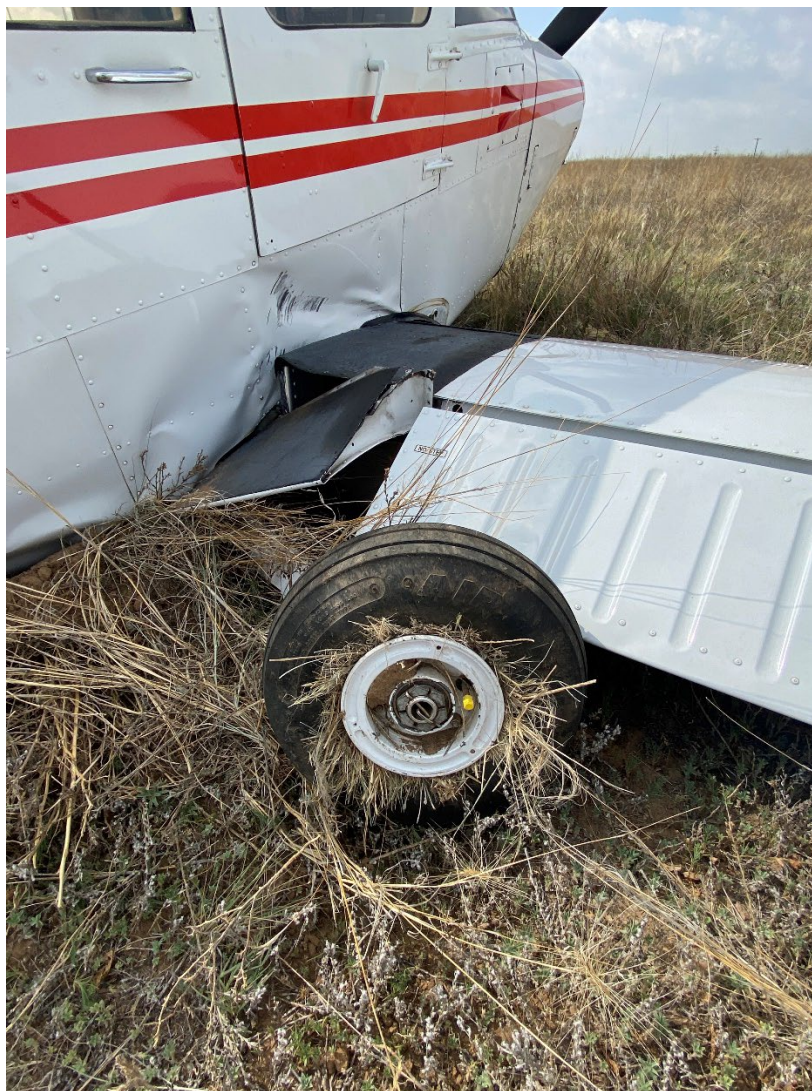
**Photograph 2 - Impact damage to right wing & fuselage (courtesy of FAA)**

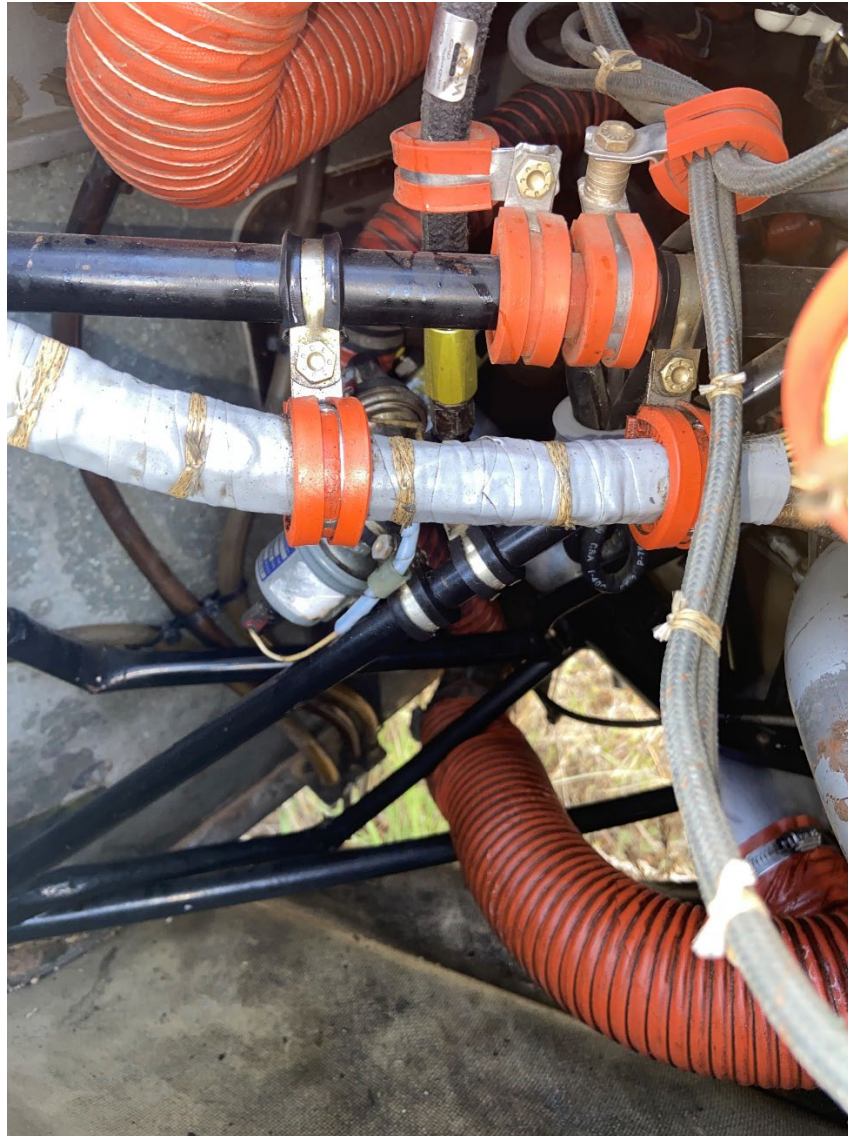
**Photograph 4 - Impact damage to engine mount (Courtesy of FAA)**
