CEN24LA209

## INVESTIGATION PHOTOGRAPHS

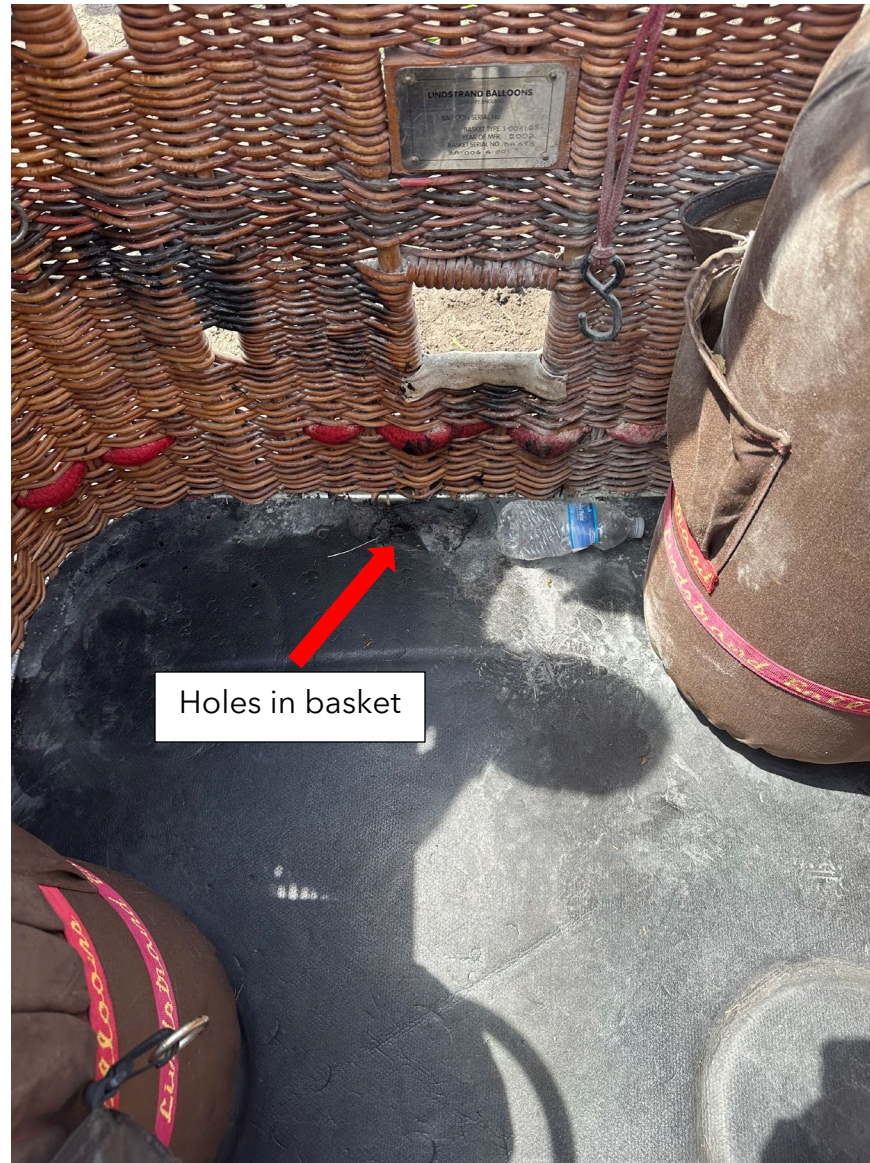
**Photograph 1 - Holes burned in the bottom of the basket (Courtesy of FAA)**

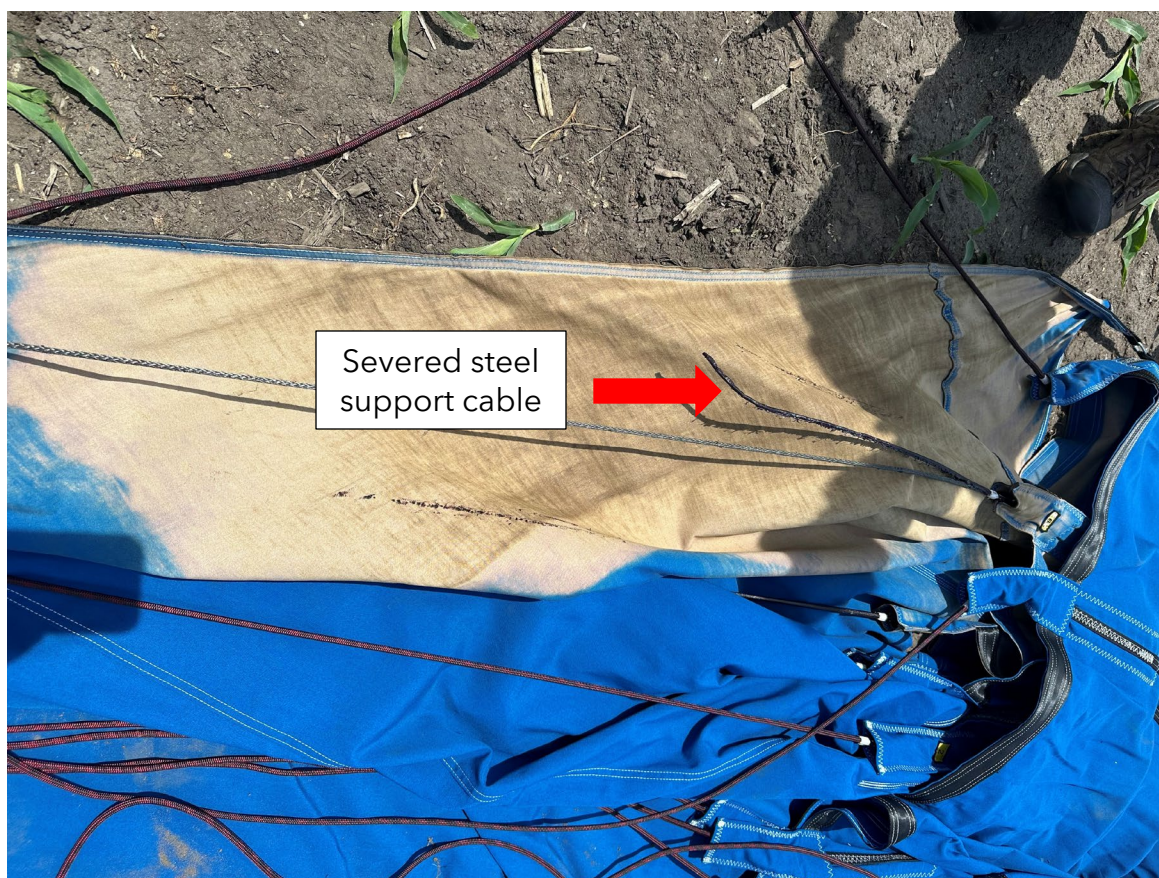
Severed steel  
support cable

**Photograph 2 - Severed steel support cable (Courtesy of FAA)**
