# National Transportation Safety Board

CEN24LA211

## **MATERIALS LABORATORY**

Factual Report 24-046

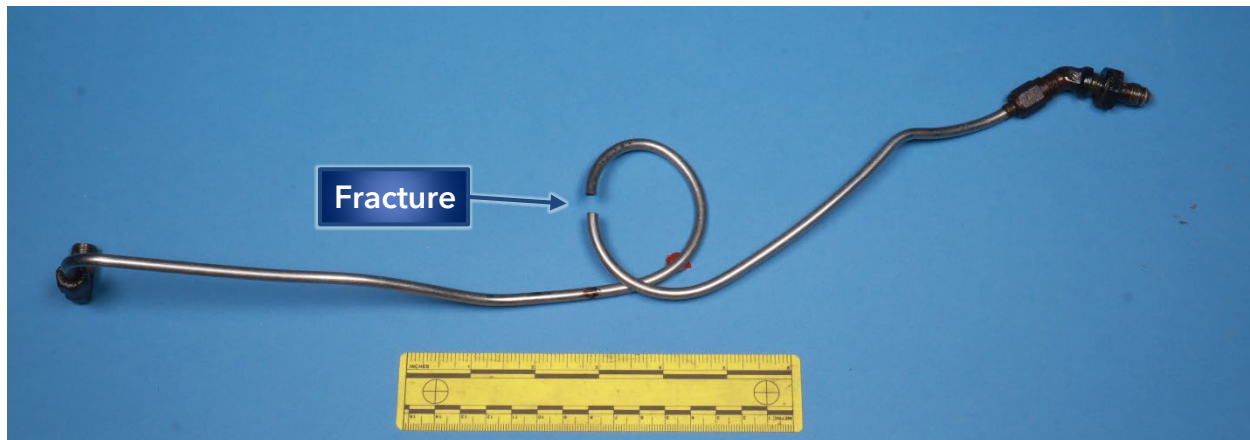
An overall view of the submitted oil pressure line is shown in figure 1. The oil line was bent approximately 360 degrees near the middle of the line, and the line was fractured within the bent segment.

**Figure 1.** Overall view of the bent and fractured oil pressure line as received. The mating fracture surfaces are positioned in their approximate relative positions.

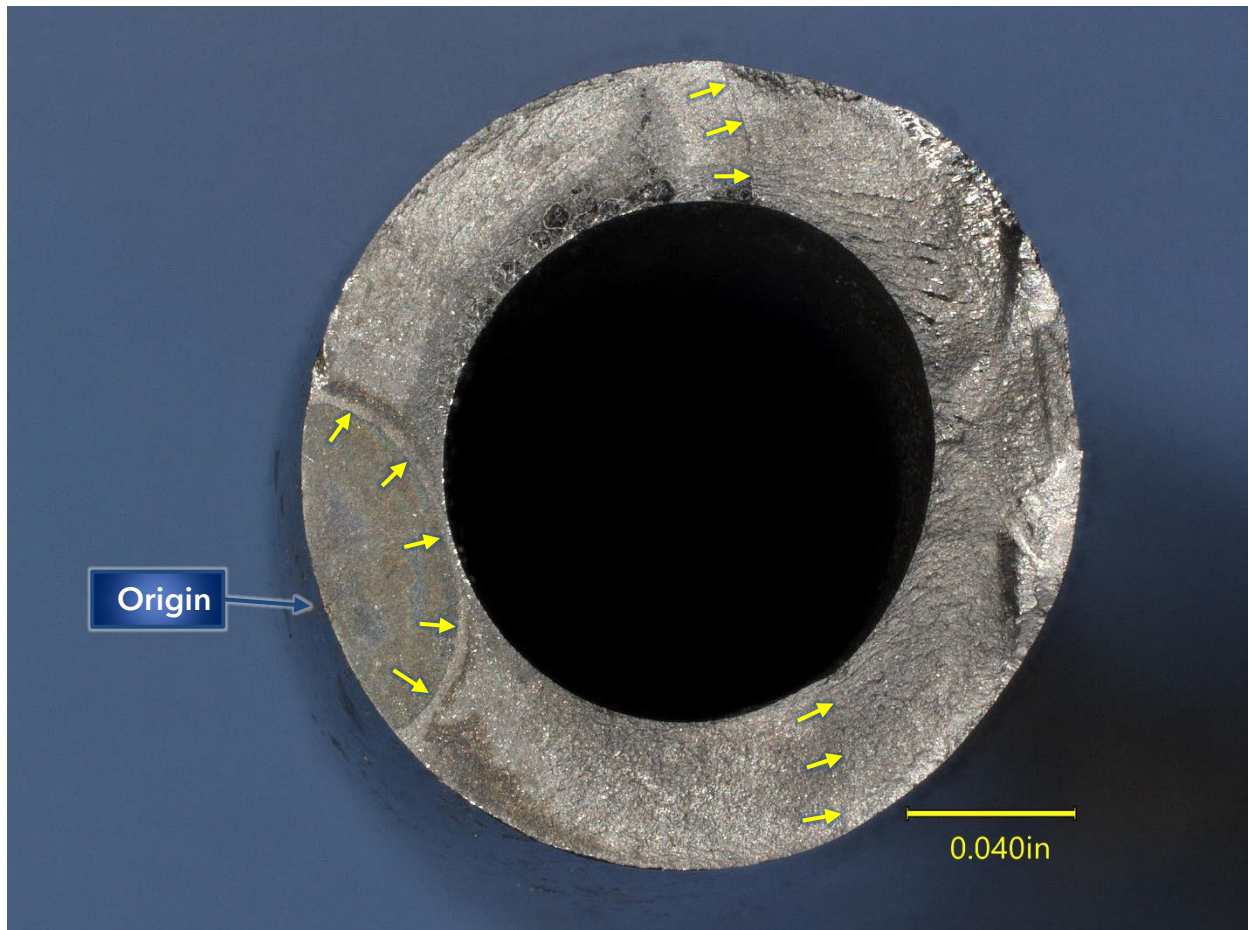
An overall view of the fracture surface is shown in figure 2. The fracture surface had a relatively smooth surface with curving crack arrest lines emanating from an origin area on one side, features consistent with fatigue. The origin was located at the exterior surface of the tube at the outside of the 360-degree bend. Unlabeled arrows in figure 2 indicate fracture arrest lines as the crack progressed initially through the thickness of the tube wall and then circumferentially to final fracture at the opposite side of the tube.

**Figure 2.** Fracture surface on the oil line piece shown at the right in figure 1. Unlabeled arrows point to several crack arrest lines.
