CEN24LA211

## INVESTIGATION PHOTOGRAPHS

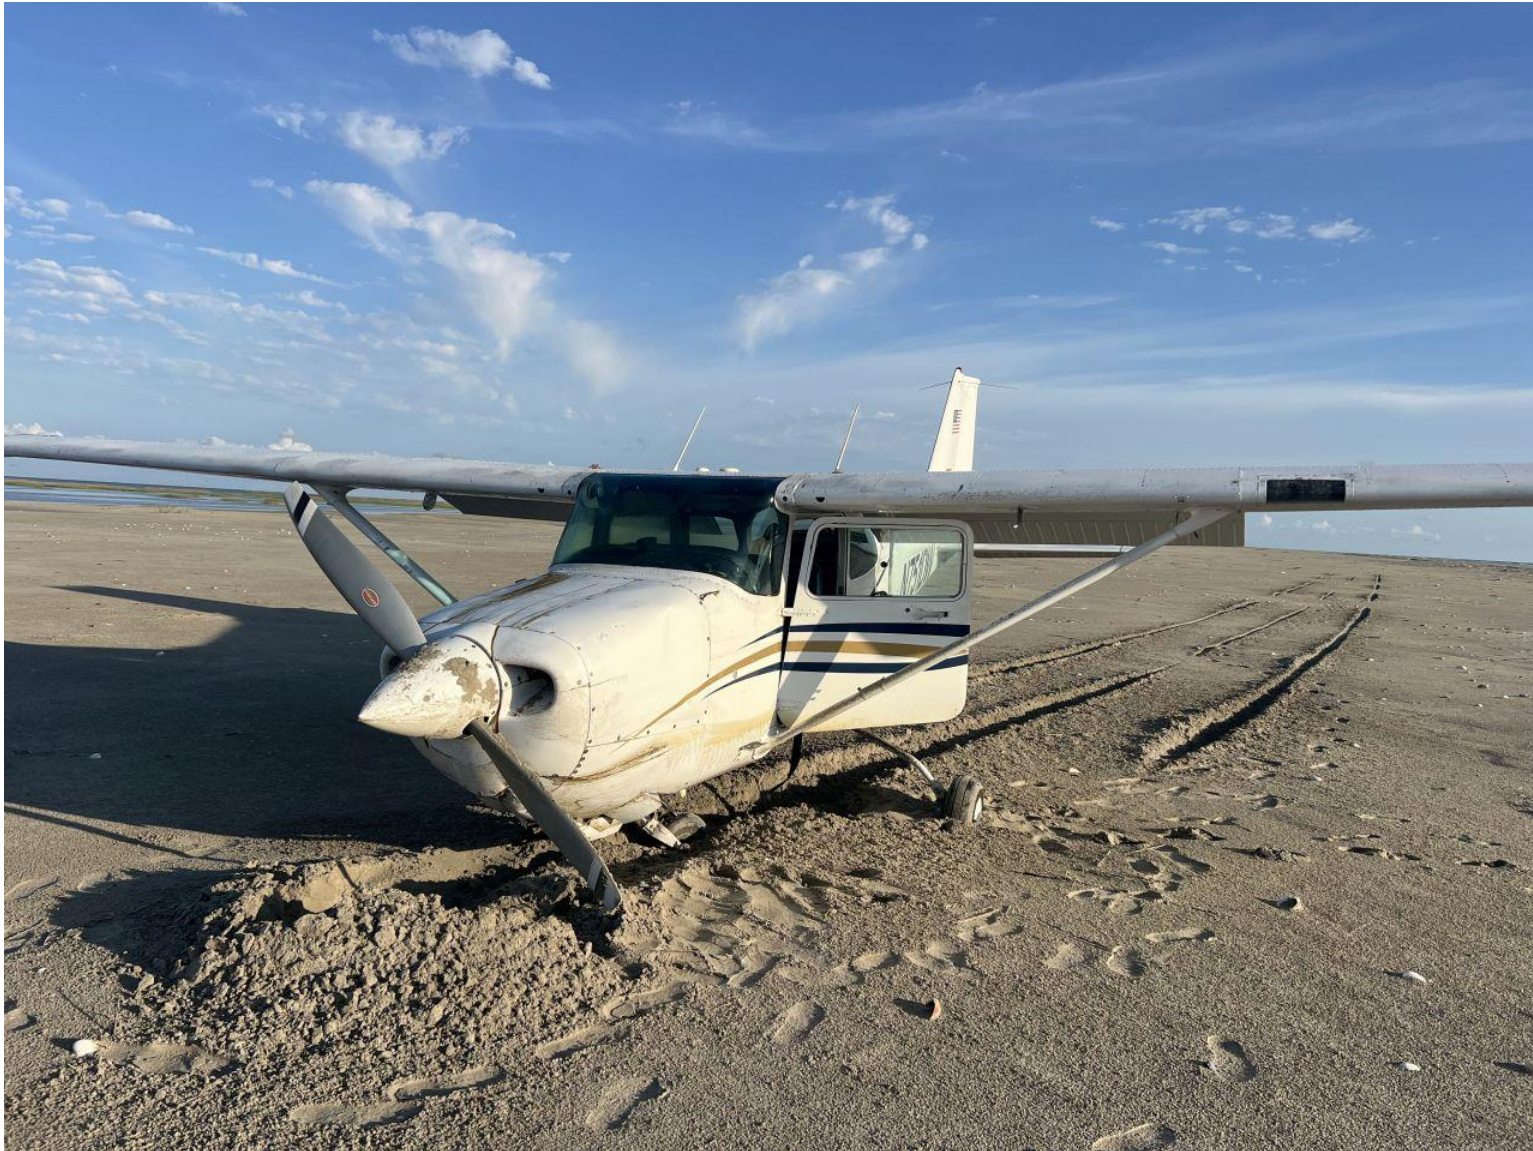
**Photograph 1 - Accident Site (Pilot Photo)**

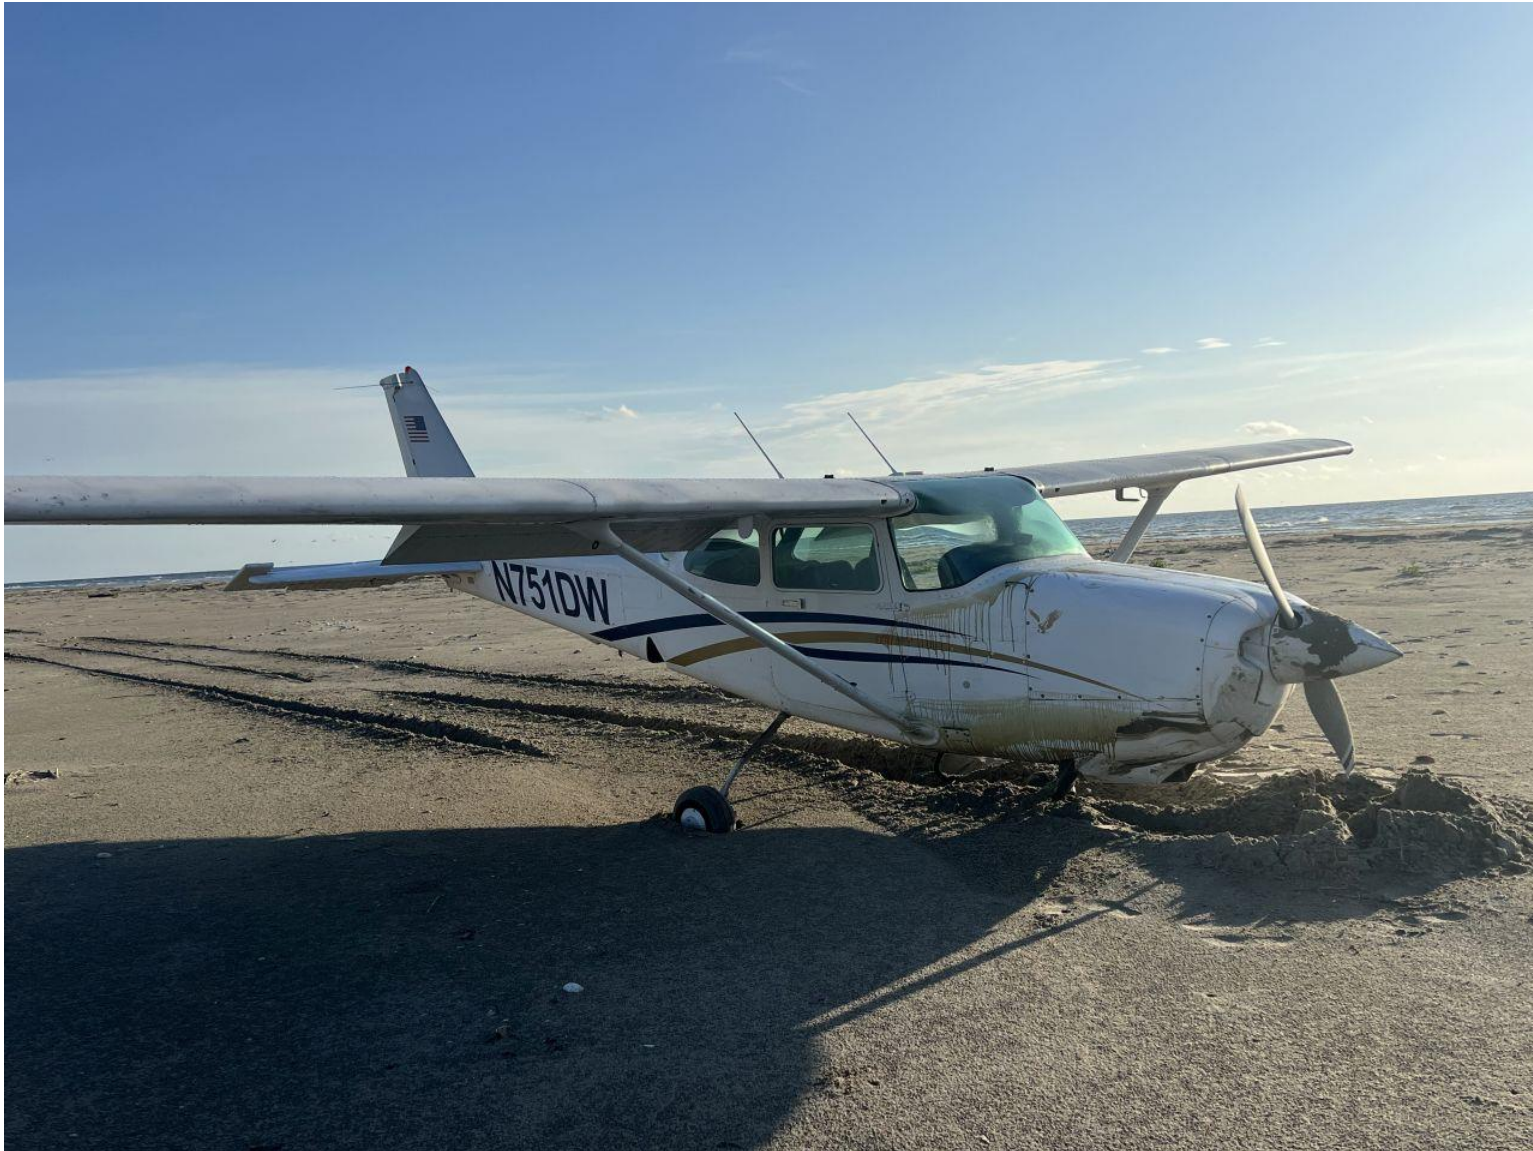
**Photograph 2 - Accident Site (Pilot Photo)**

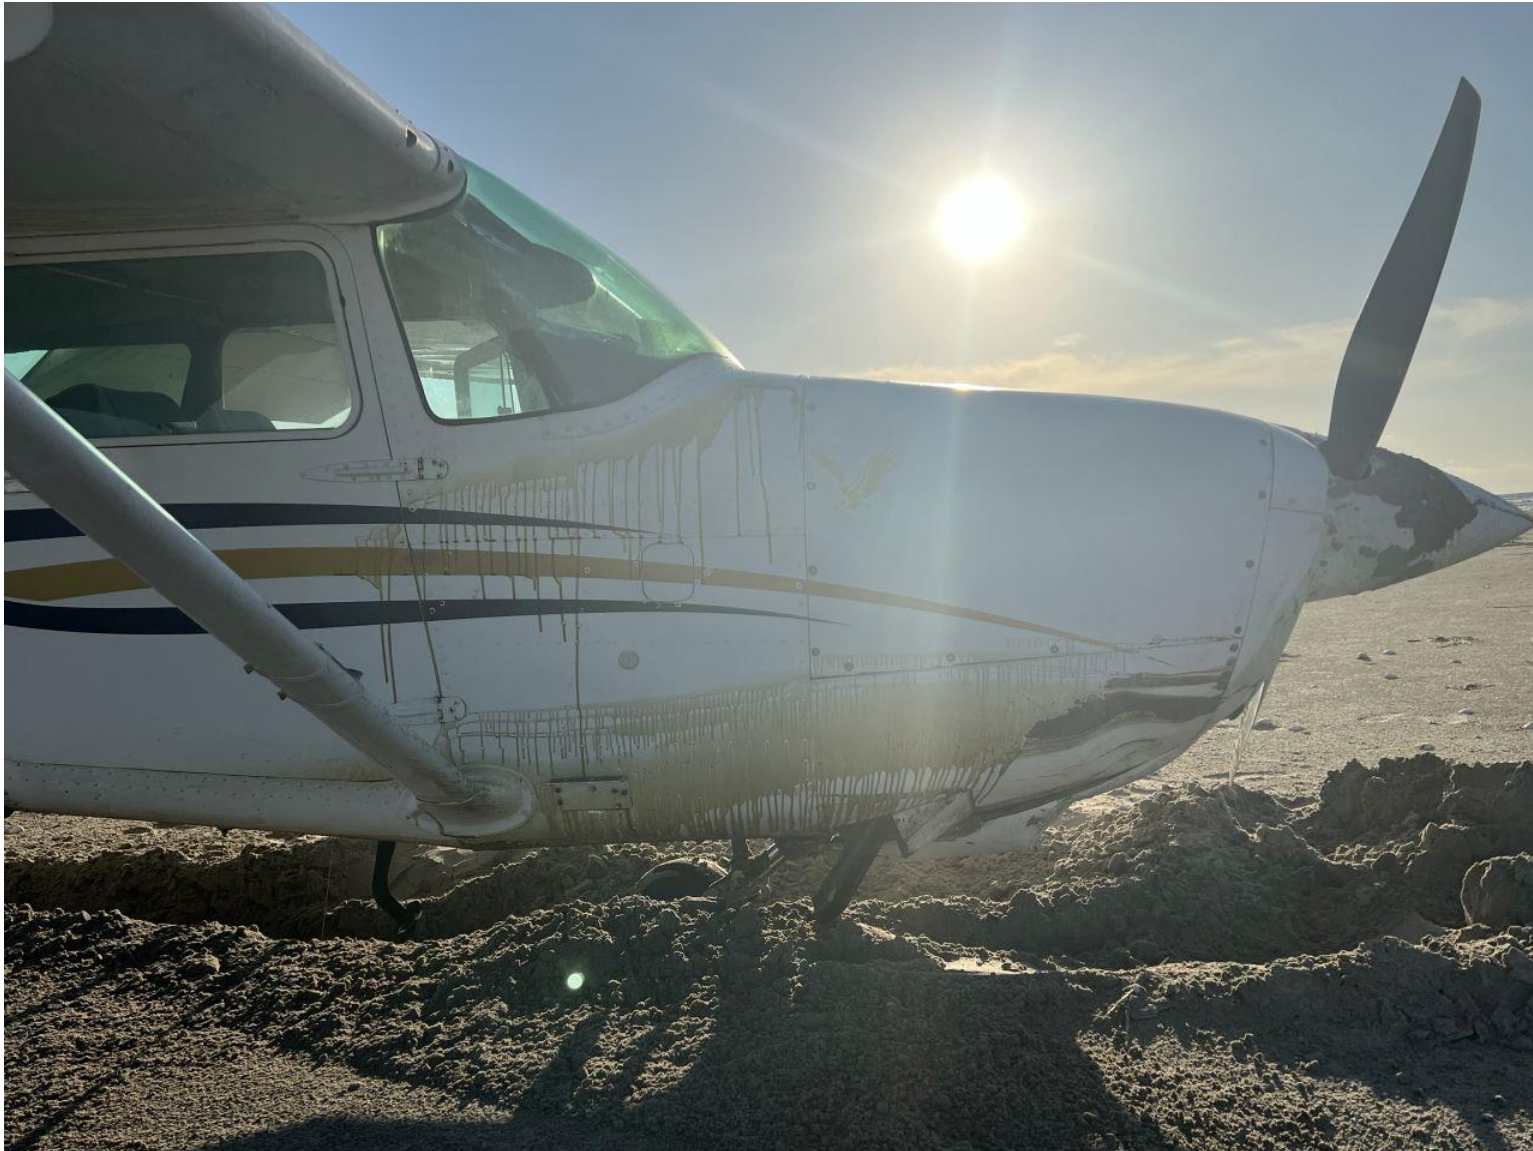
**Photograph 3 - Engine Cowling (Pilot Photo)**

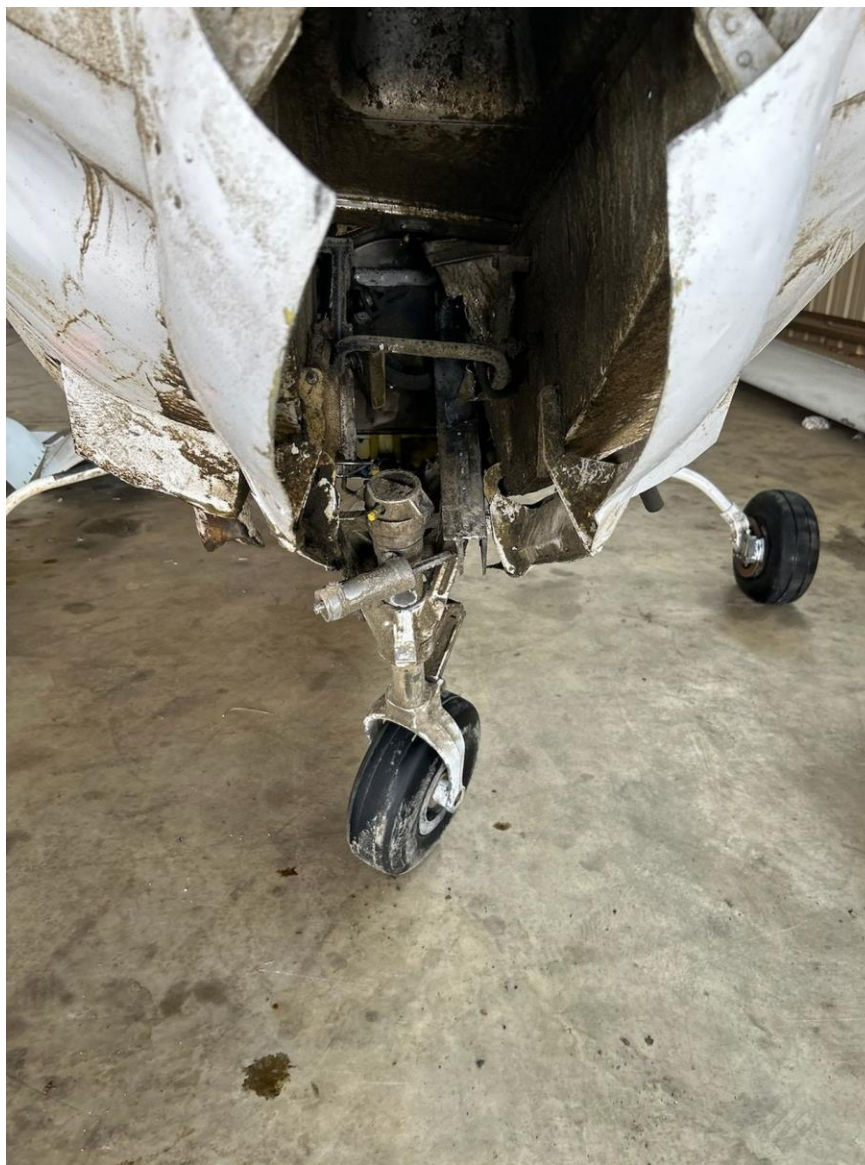
**Photograph 4 - Nose Landing Gear Well (FAA Photo)**

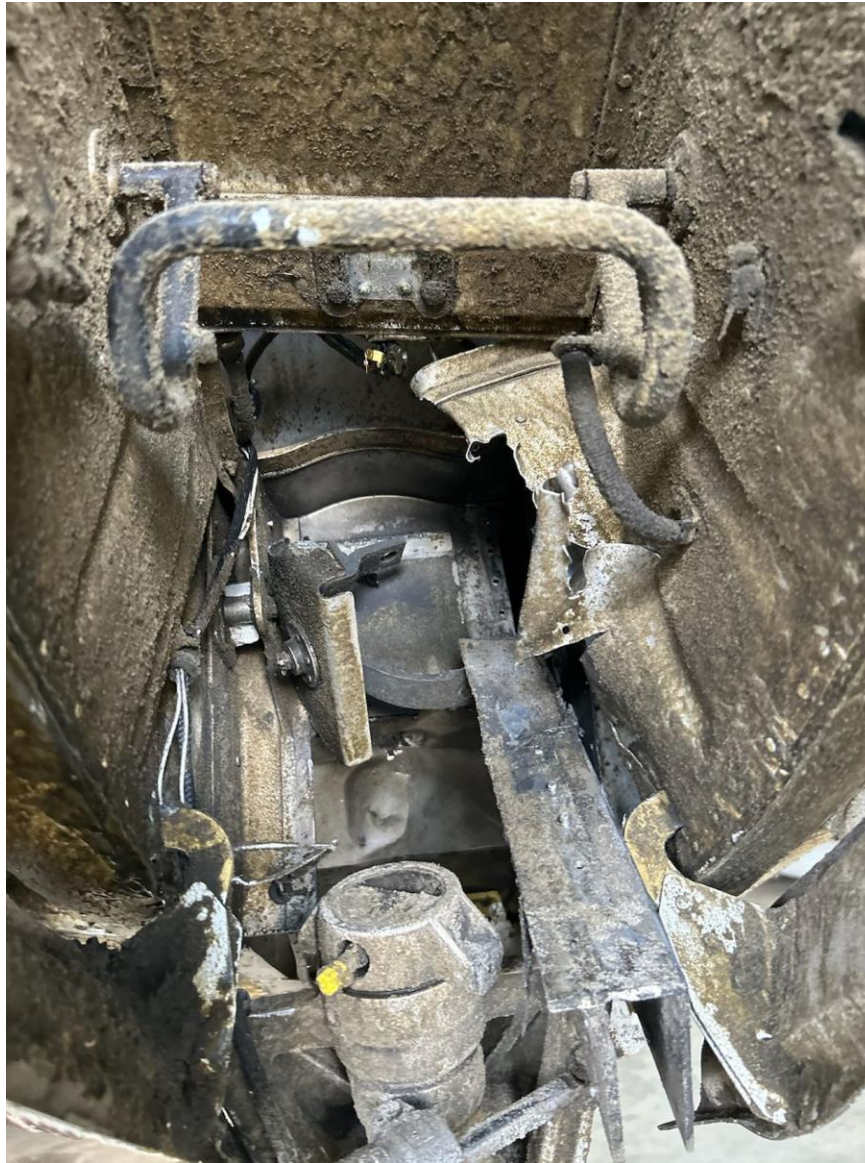
**Photograph 5 - Nose Landing Gear Well (FAA Photo)**

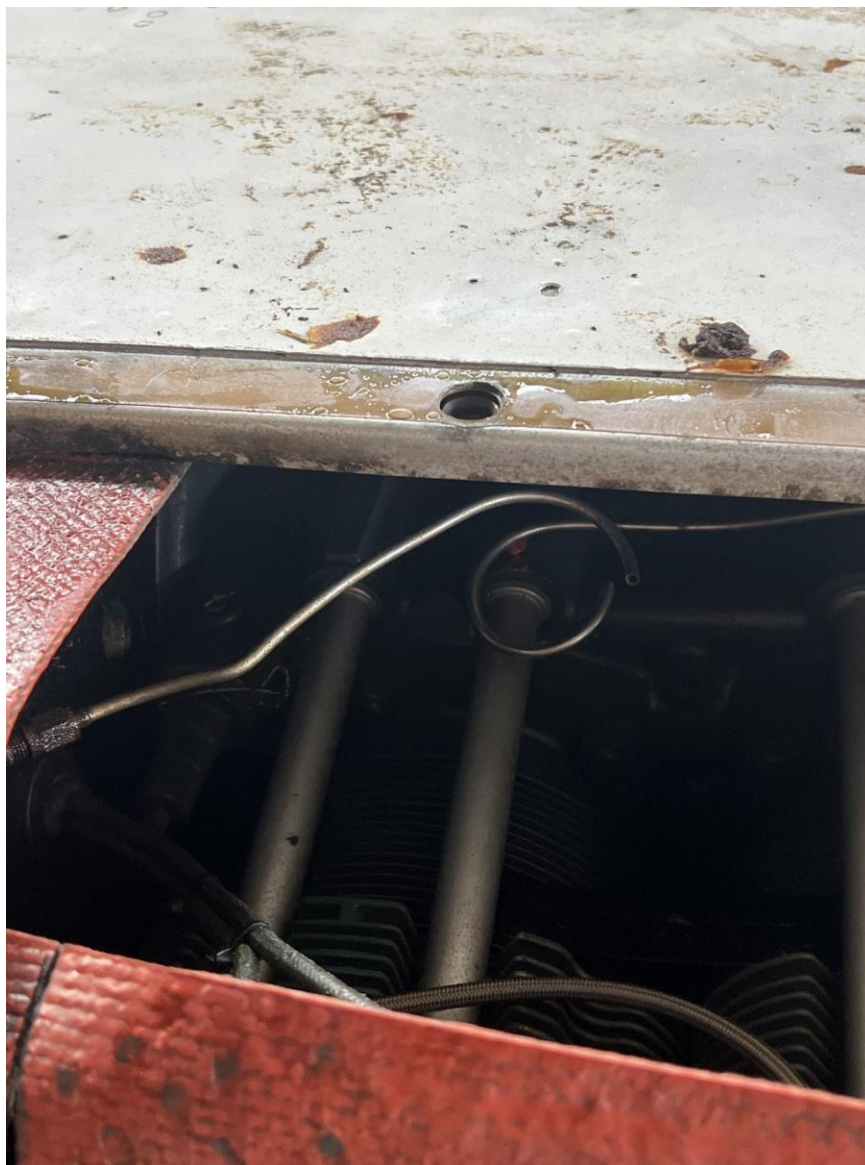
**Photograph 6 - Engine Oil Pressure Line (Pilot Photo)**

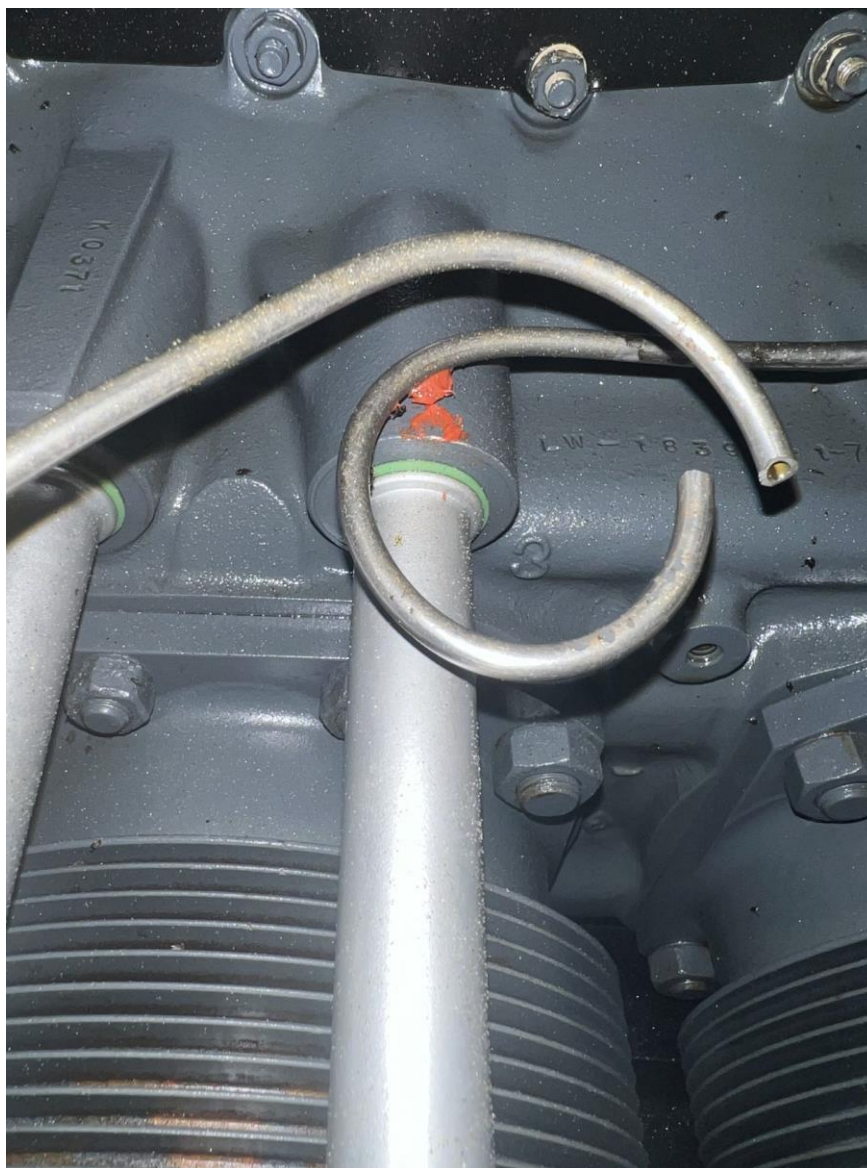
**Photograph 7 - Engine Oil Pressure Line (Pilot Photo)**

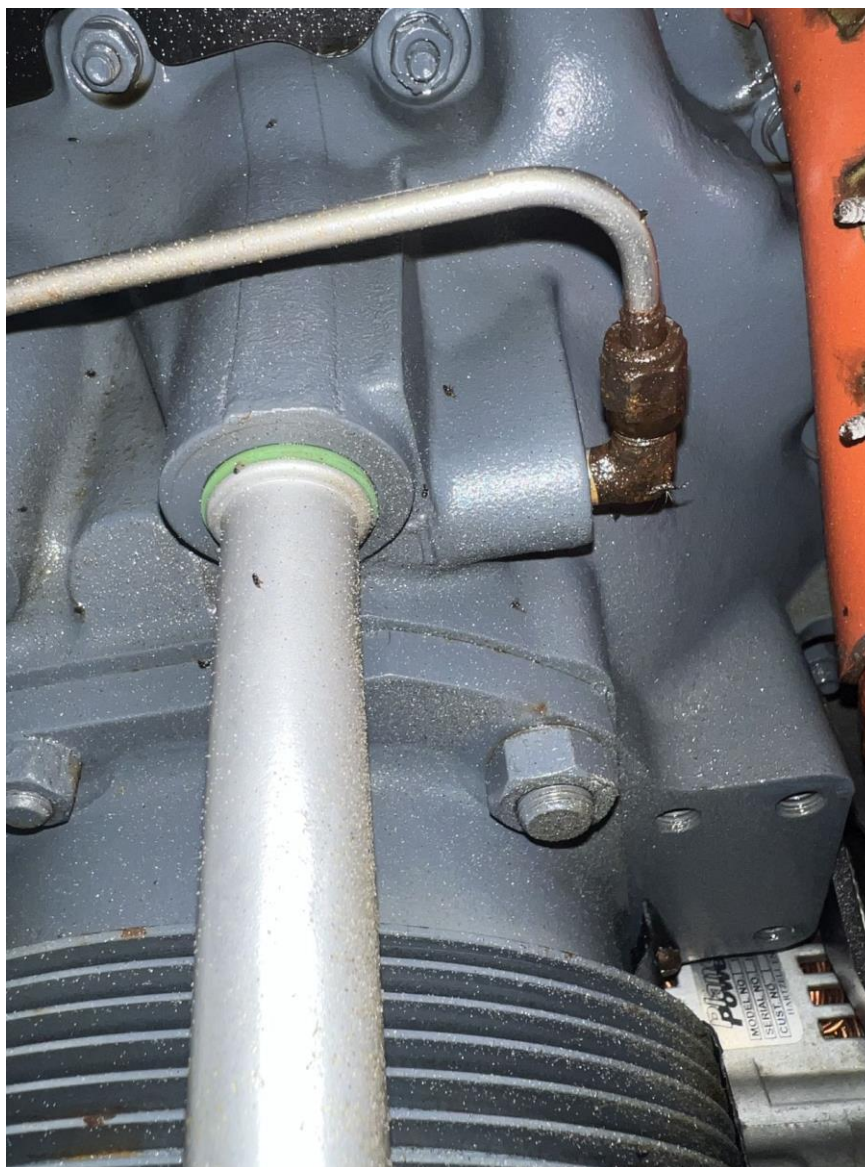
**Photograph 8 - Engine Oil Pressure Line (Pilot Photo)**
