CEN24LA229

## INVESTIGATION PHOTOGRAPHS

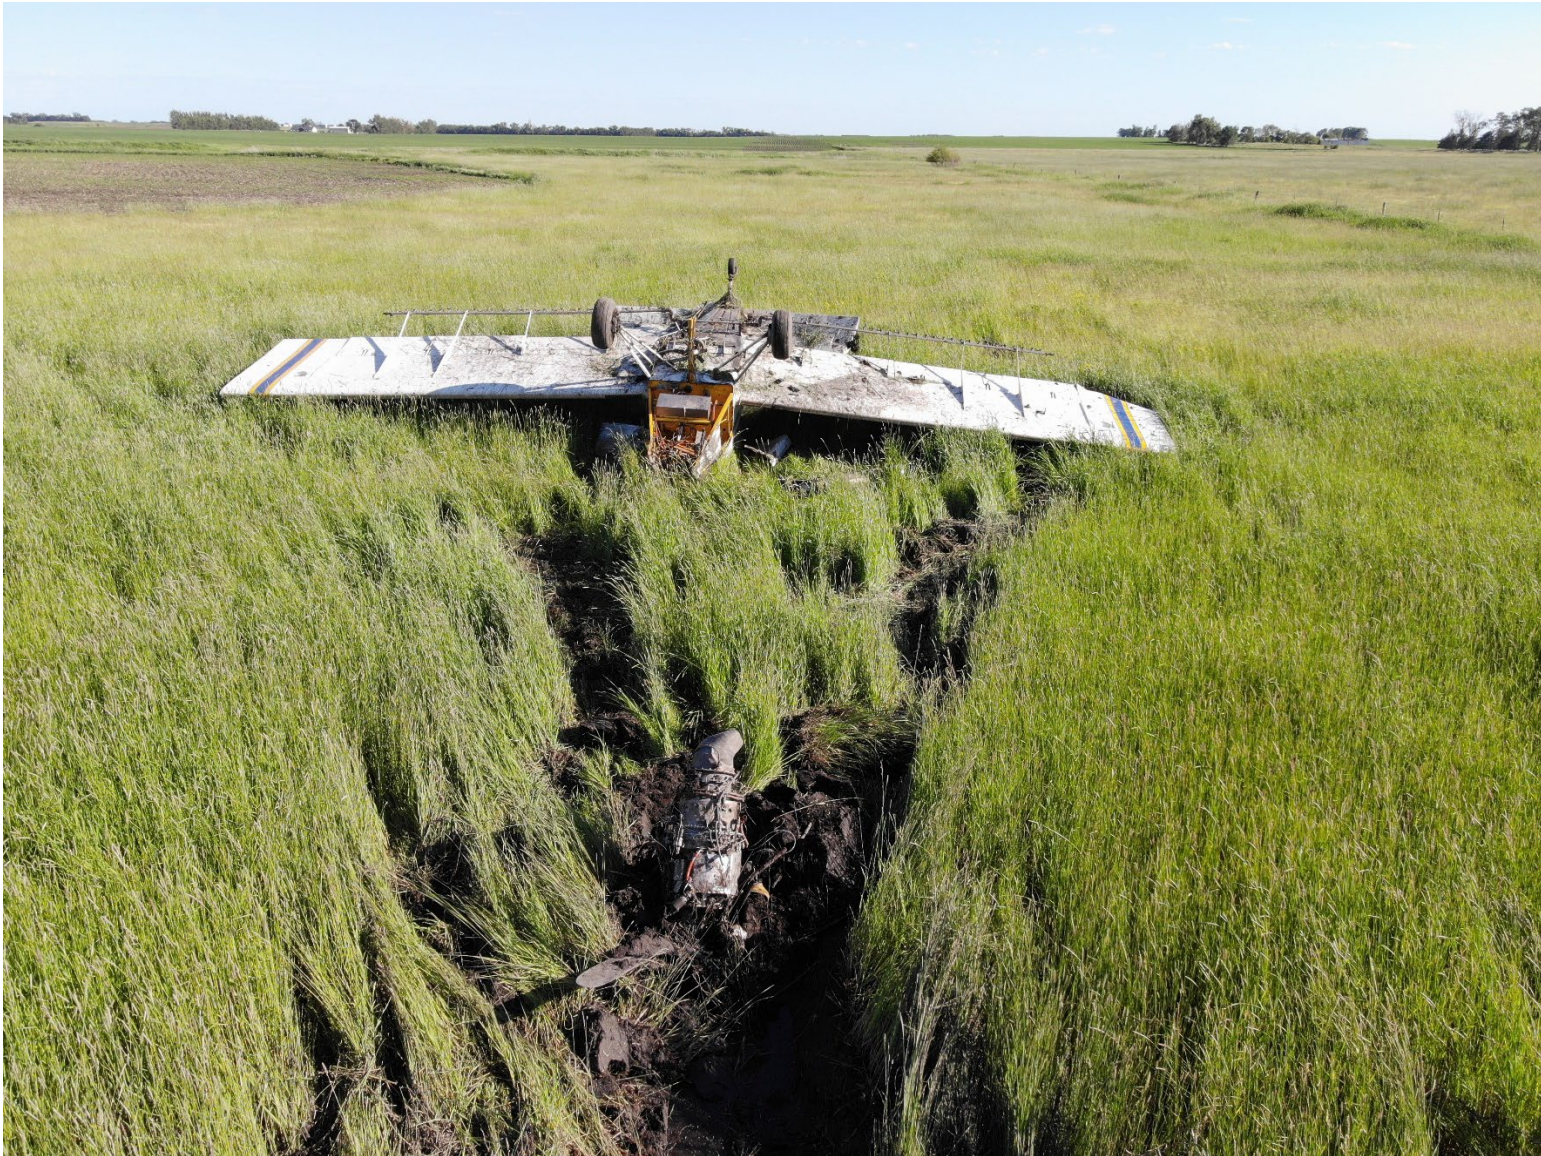
**Photograph 1 - Aerial view of the front of the airplane at the accident site (courtesy of the Brookings County Sheriff's Office)**

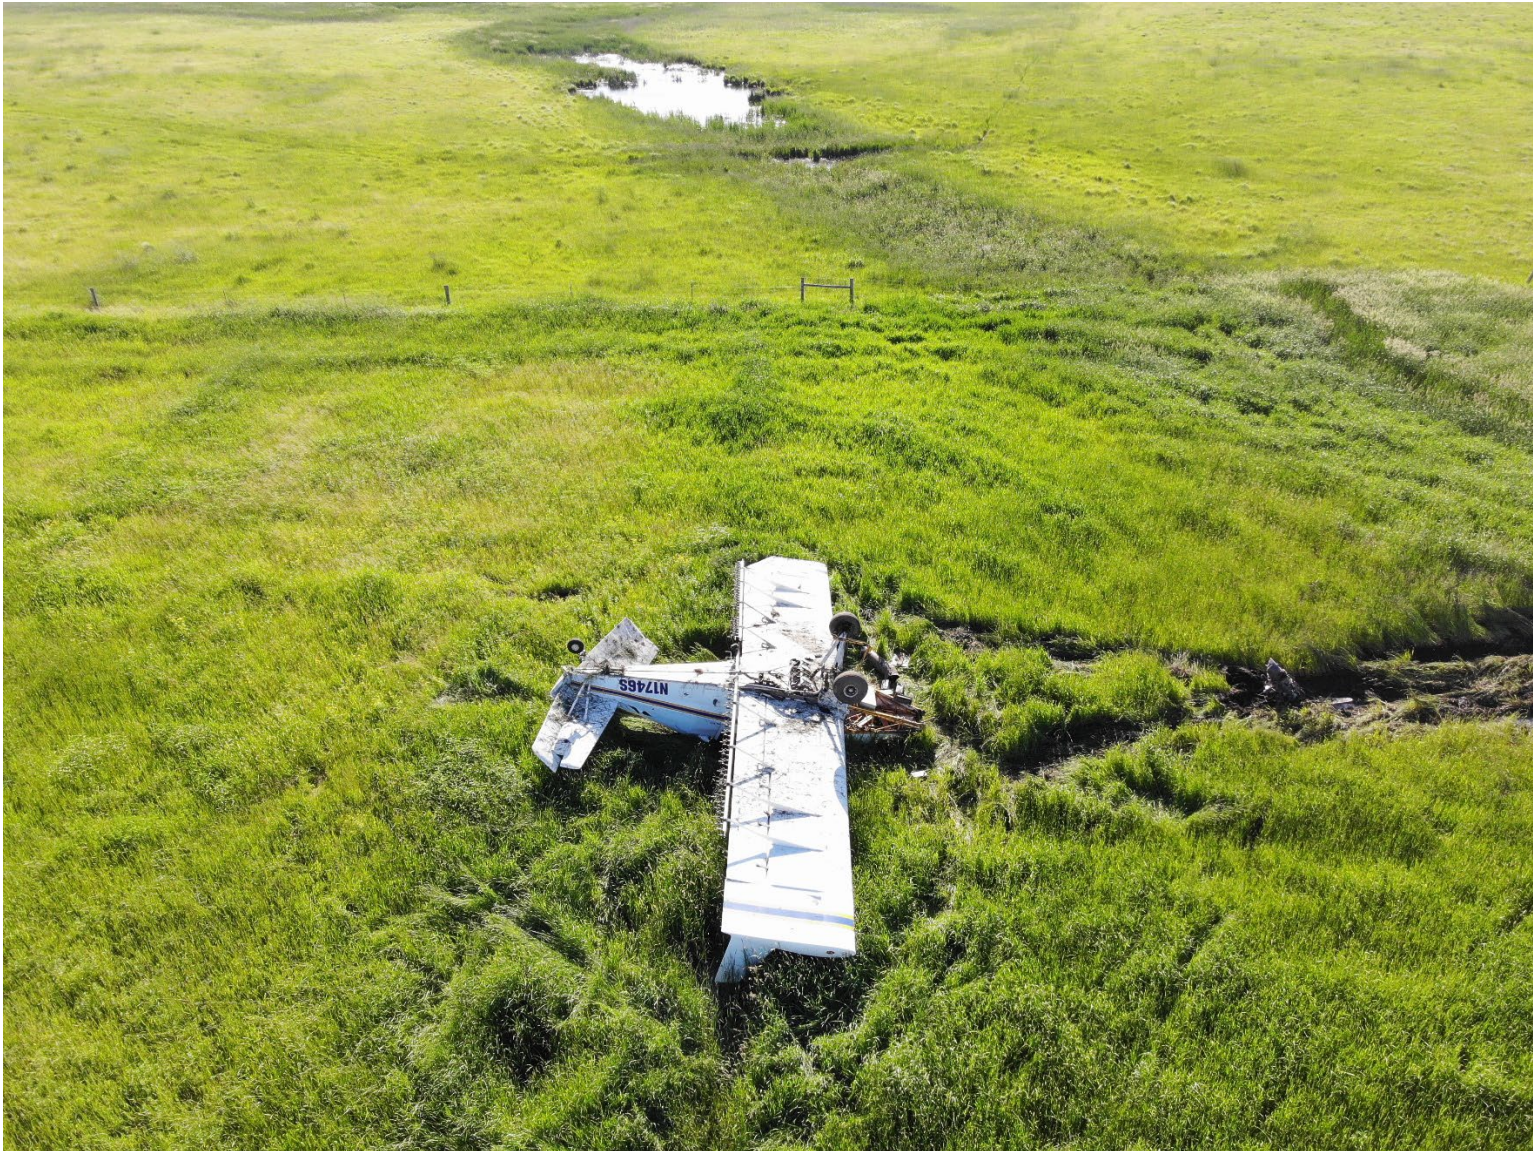
**Photograph 2 - Aerial view of the left side of the airplane at the accident site (courtesy of the Brookings County Sheriff's Office)**

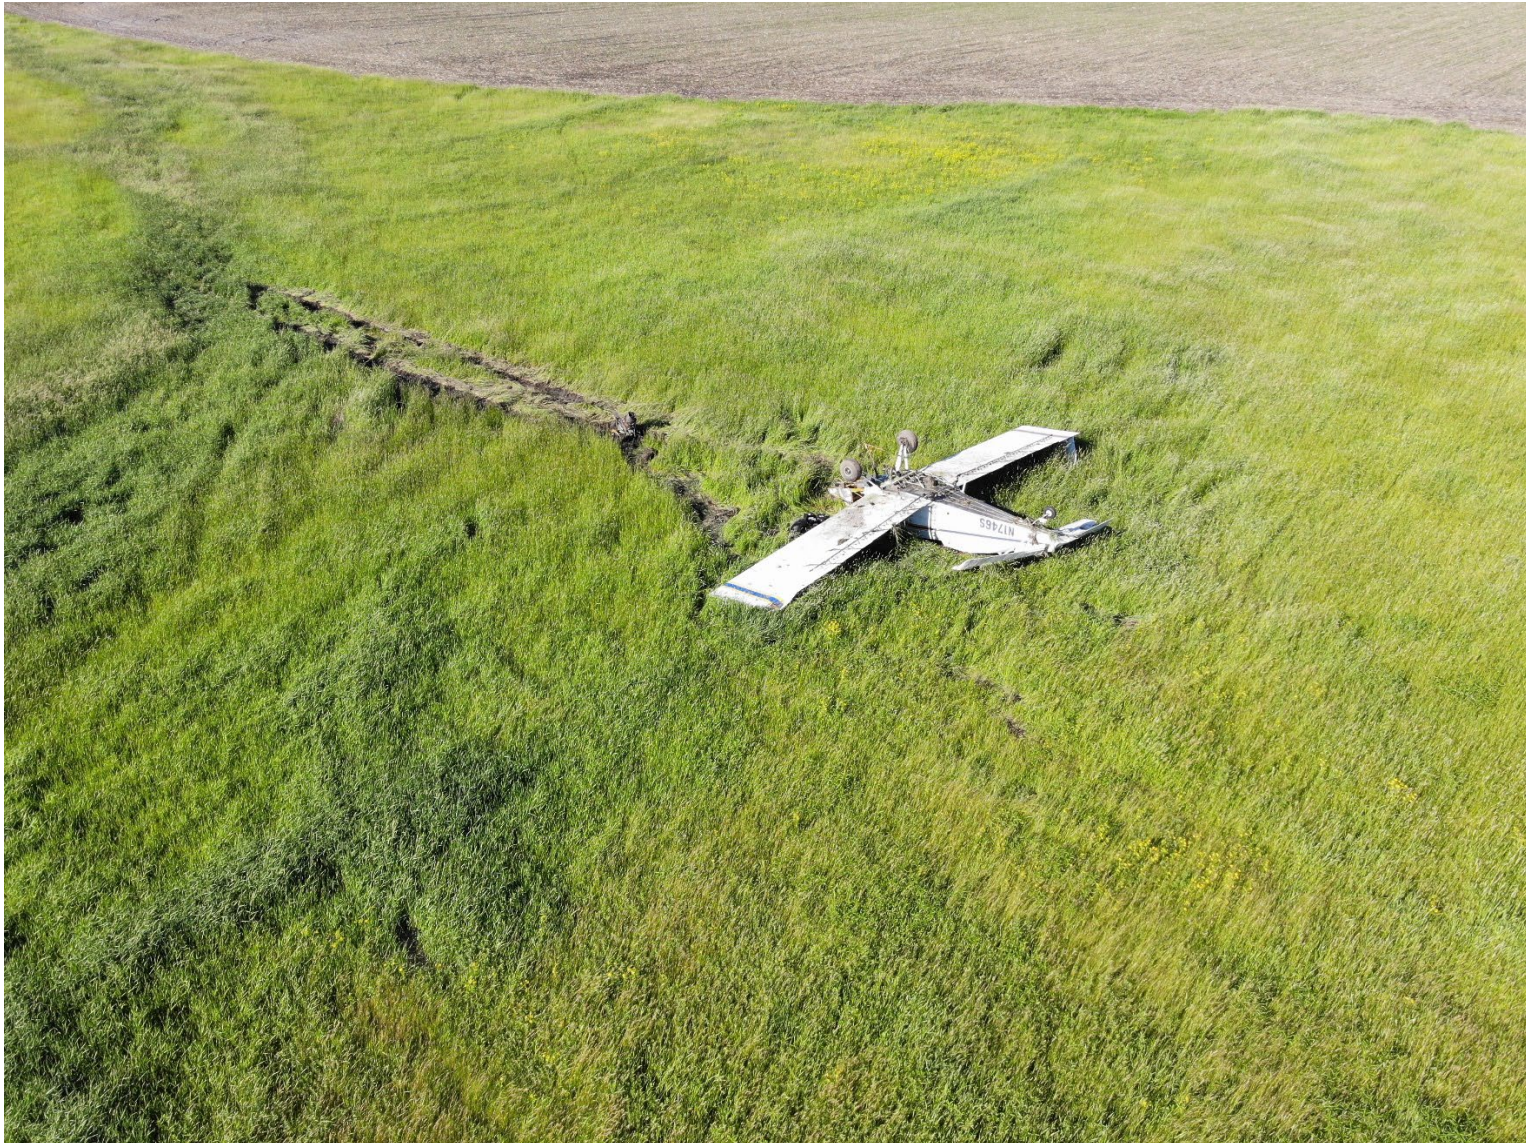
**Photograph 3 - Aerial view of the right side of the airplane at the accident site (courtesy of the Brookings County Sheriff's Office)**

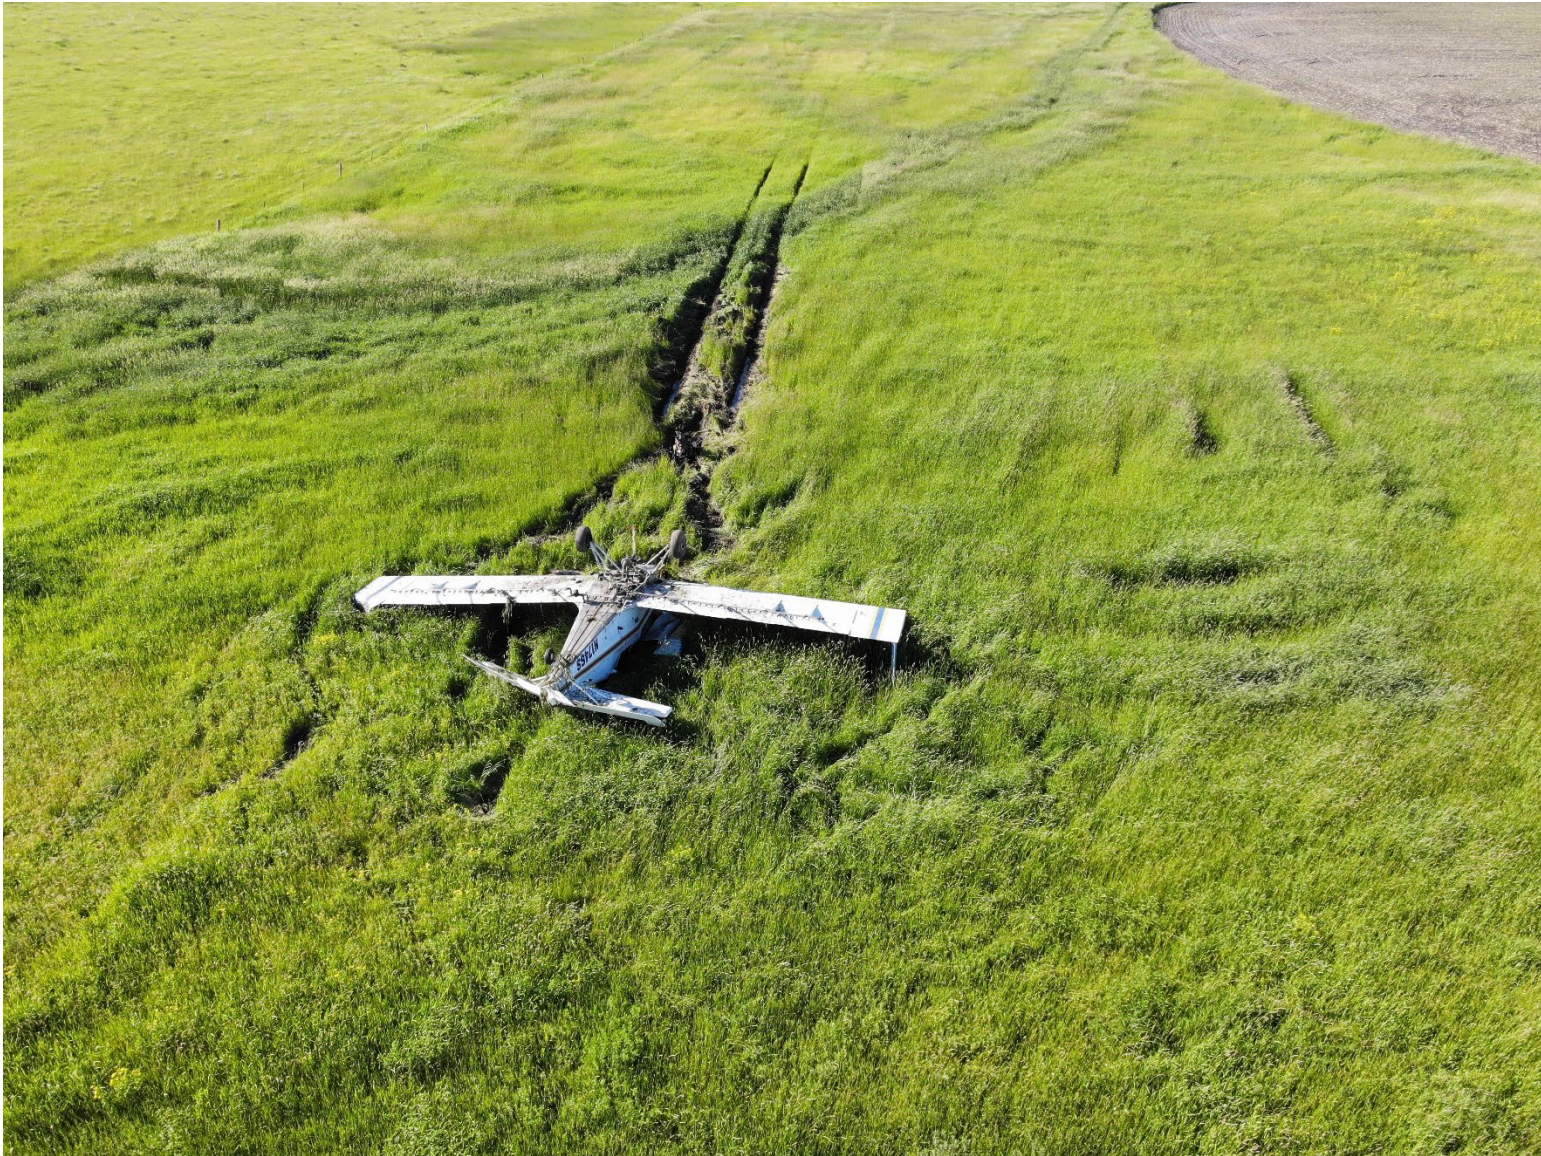
**Photograph 4 - Aerial view of the rear of the airplane at the accident site (courtesy of the Brookings County Sheriff's Office)**

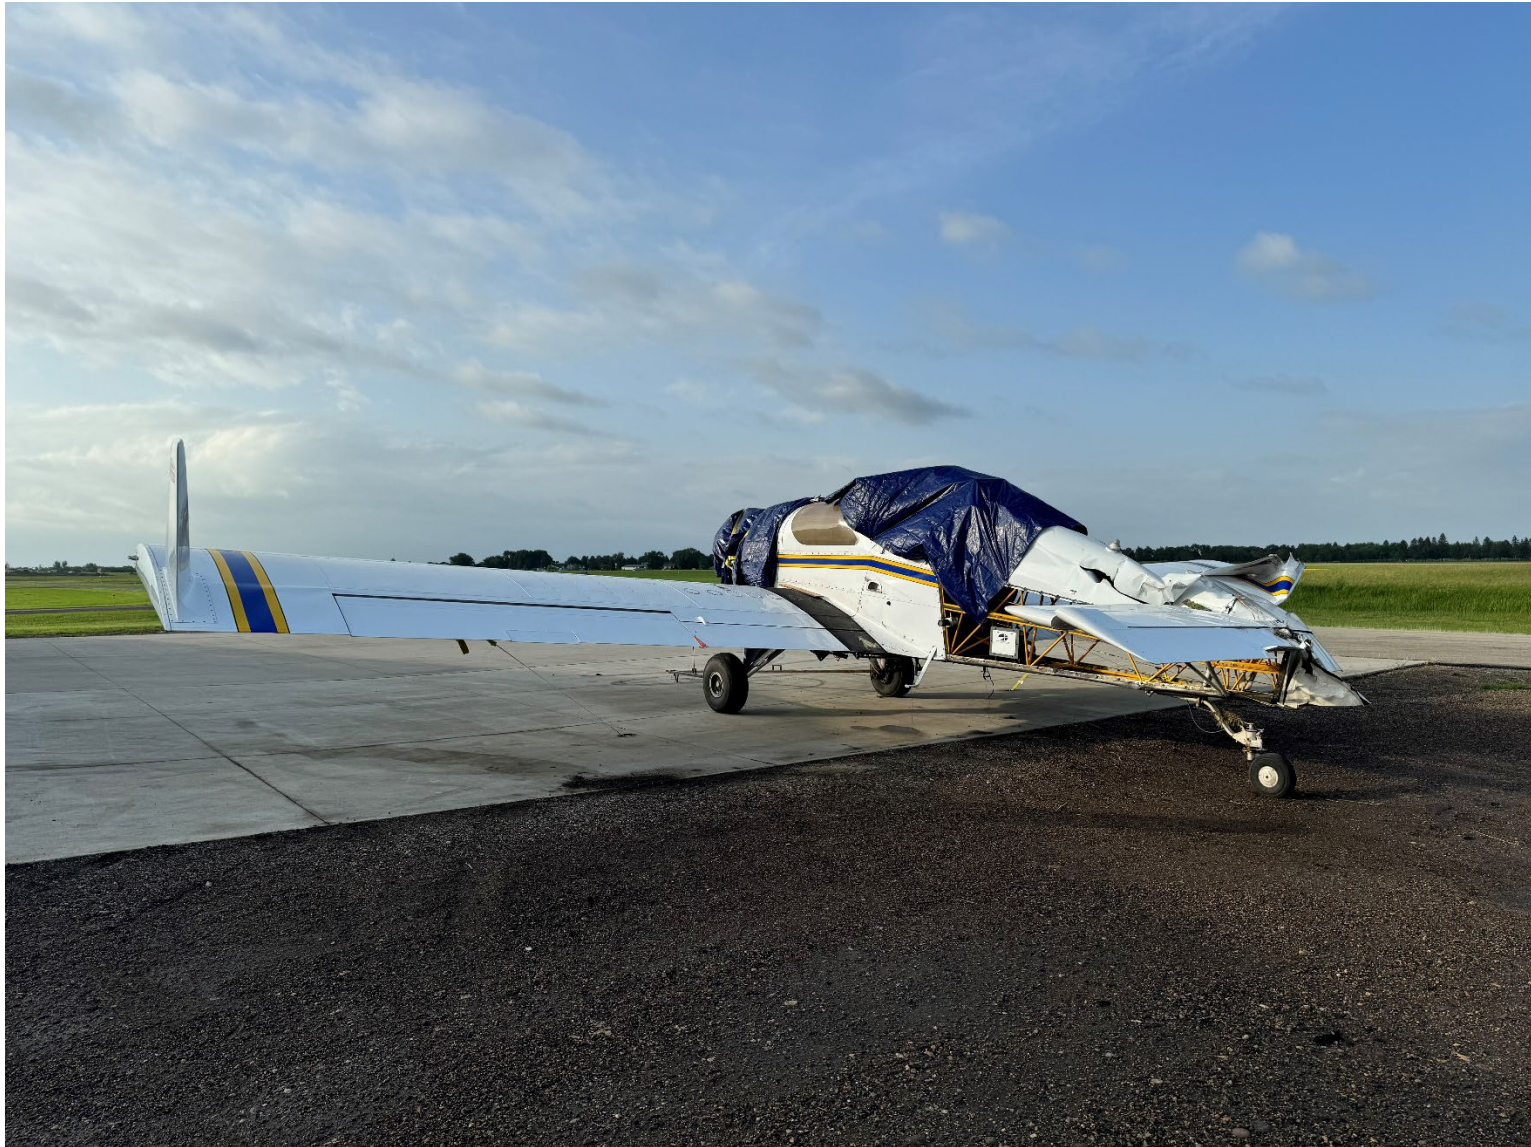
**Photograph 5 - View of the rear left side of the airplane after it was recovered from the accident site (courtesy of Wilde Air Service LLC)**

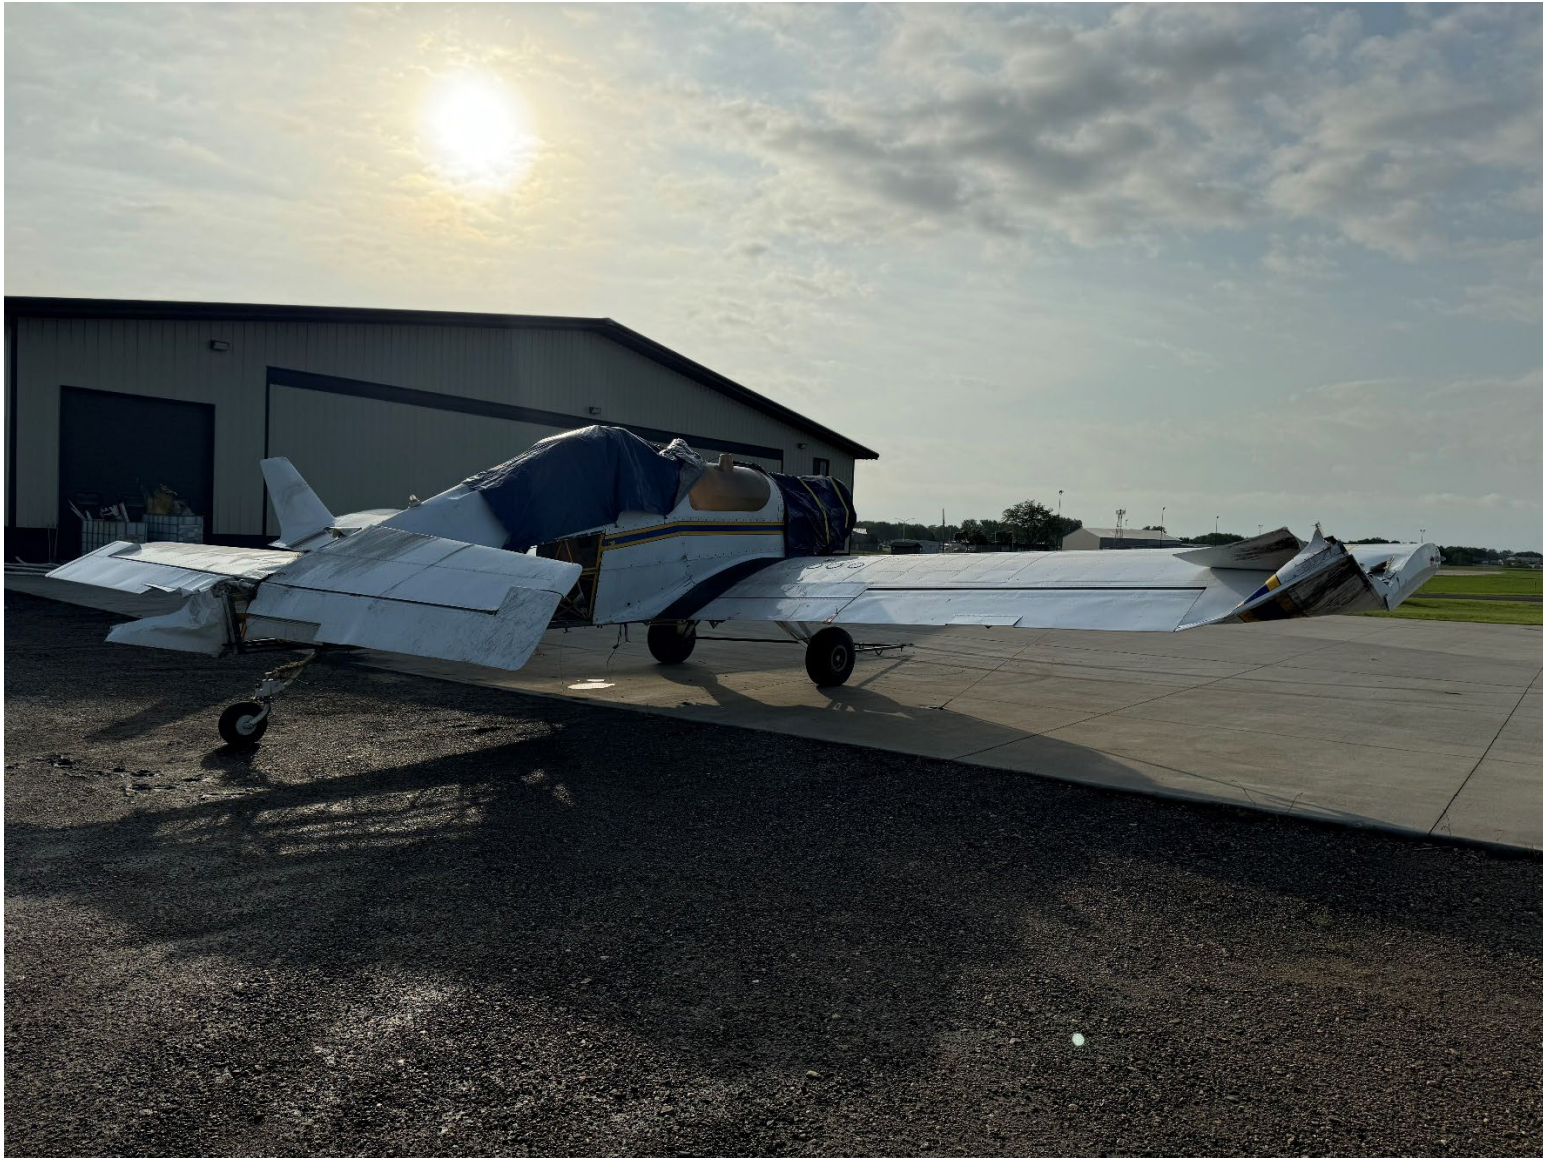
**Photograph 6 - View of the rear right side of the airplane after it was recovered from the accident site (courtesy of Wilde Air Service LLC)**

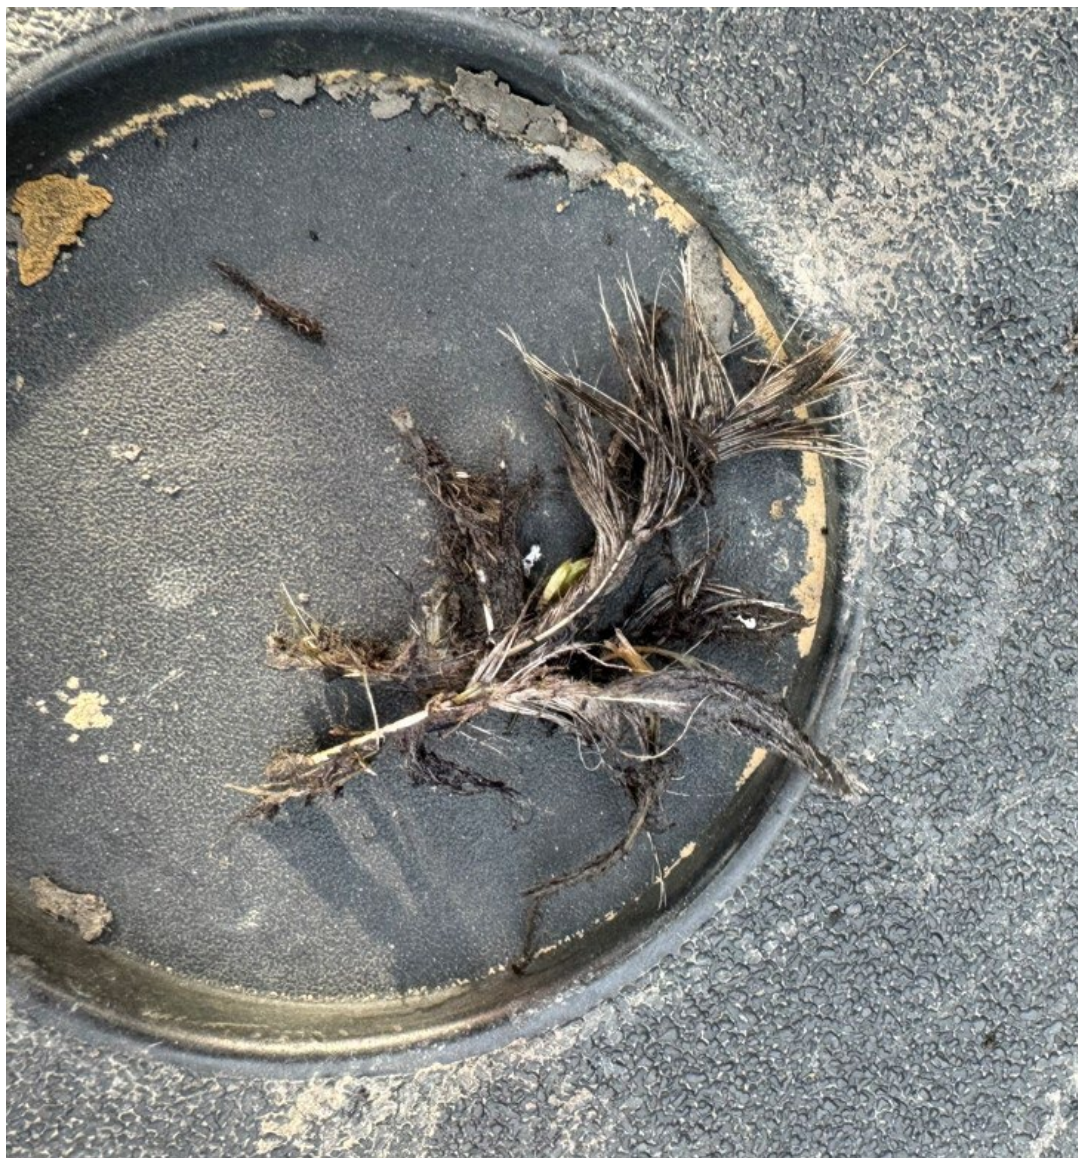
**Photograph 7 - View of a feather recovered from the airplane (courtesy of Wilde Air Service LLC)**
