## Aircraft Damage Report

**Model:** SR20    **Serial:**1638    **Registration:** N154WF    **Flight Meter:** 7508.6

**Aircraft Location:** Battle Creek, MI    **Aircraft Operator:** WMU College of Aviation

**Damage Description:** This aircraft sustained the following damage due to a CAPS deployment.

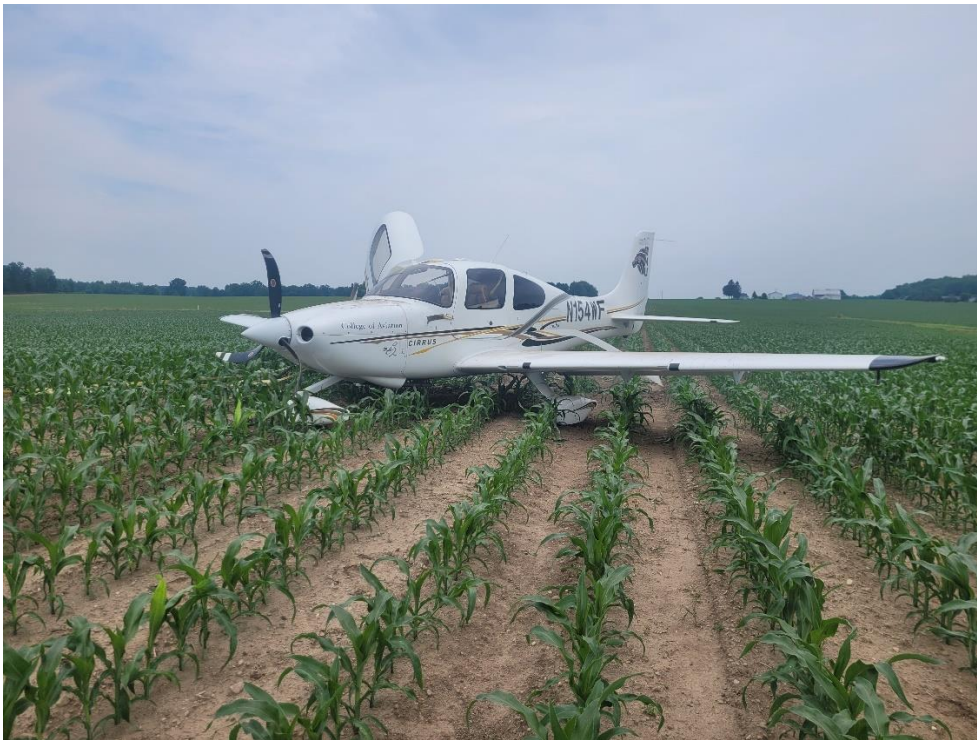
**Pic 1:**  
CAPS  
Straps

1. CAPS deployment fuselage damage (see pics 1-3)
  - A. Fuselage composite skin from firewall aft to CAPS rocket/parachute exit area is damaged due to embedded parachute straps being deployed.

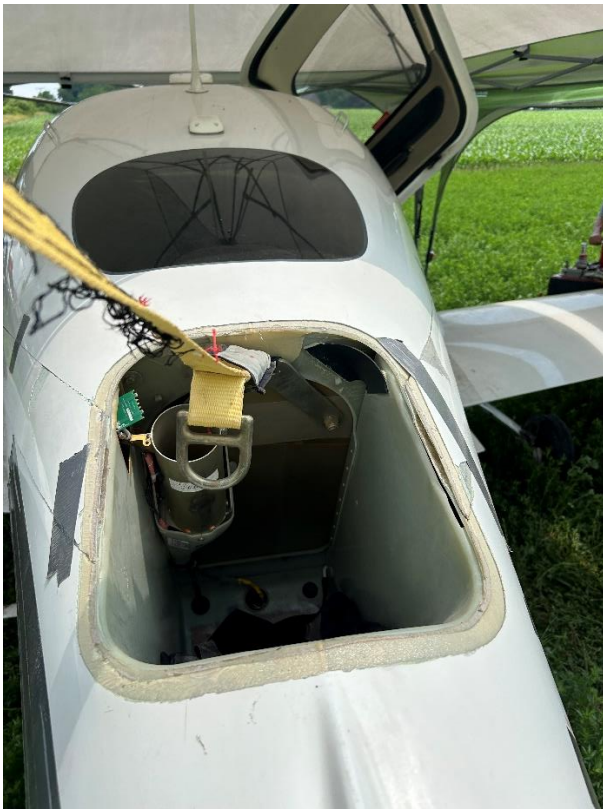
**Pic 3:** CAPS  
Rocket/Parachute  
Exit Cover Area

- B. CAPS rocket and parachute exit area has been damage due to deployment.
2. Rudder damage
  - A. Upper rudder hinge bracket and skin has damage near base of rudder horn (see pic 4 and 5).

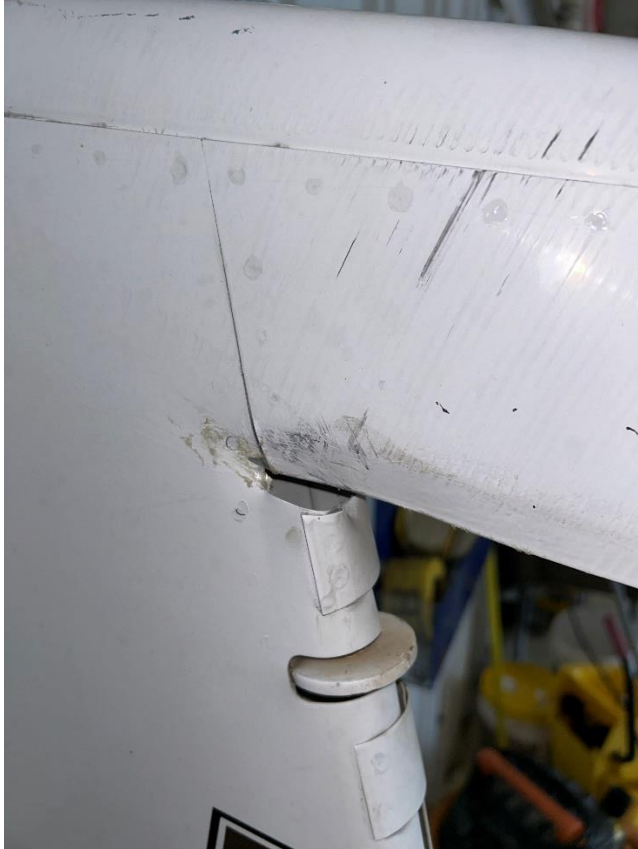
**Pic 5:**

Rudder Horn Skin

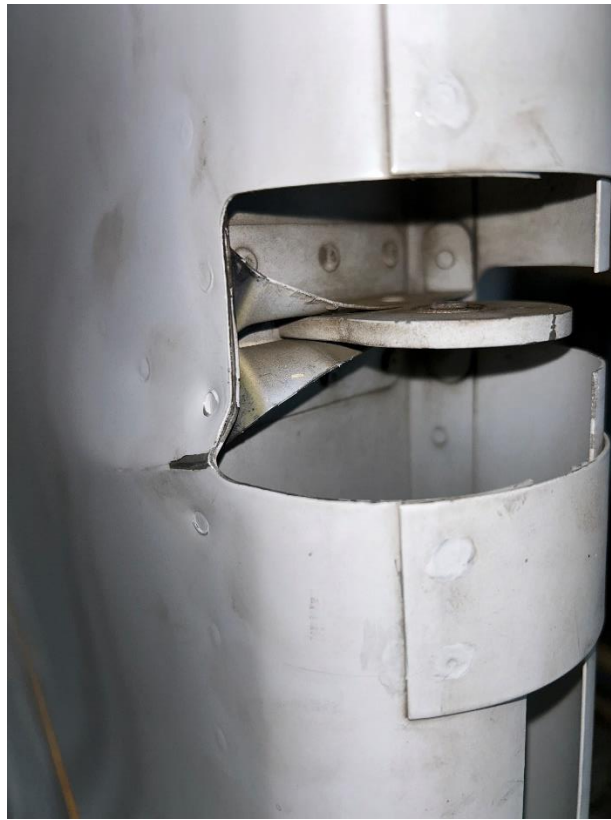
**Pic 6:**

- B. Middle rudder hinge bracket and skin damage (See Pic 6).
  - C. Rudder spar bent and twisted (see pic 7)
3. Vertical Stabilizer damage
  - A. Upper rudder attach bracket ripped and torn away from stabilizer mount area (see pic 8).

Middle  
Rudder  
Hinge  
Bracket

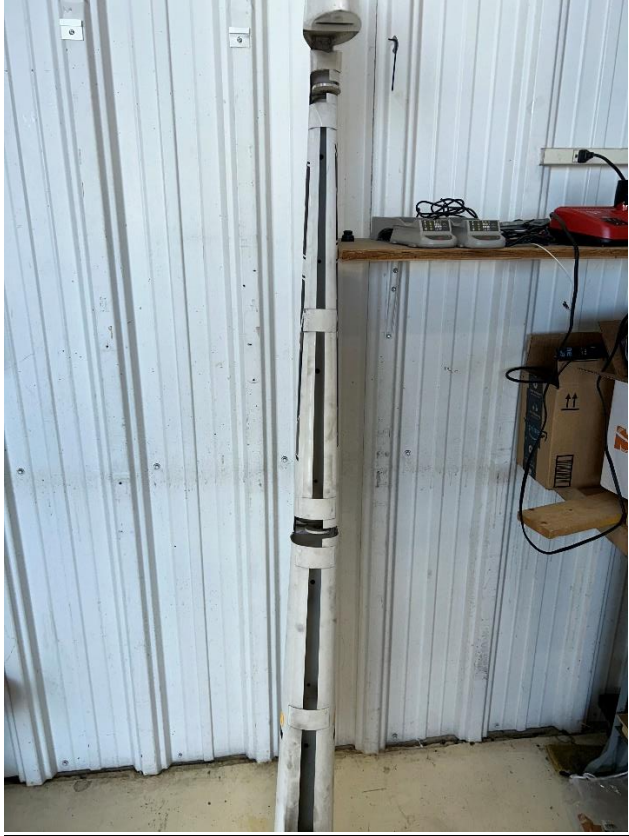
Pic 7:

Rudder  
Spar

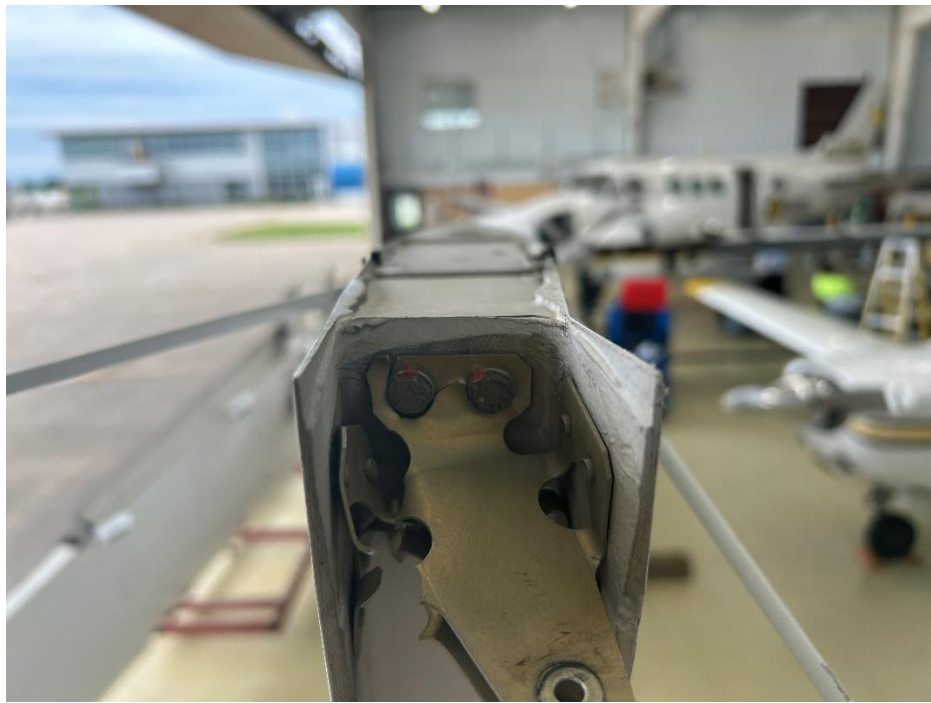
Pic 8:

Vertical  
Stabilizer

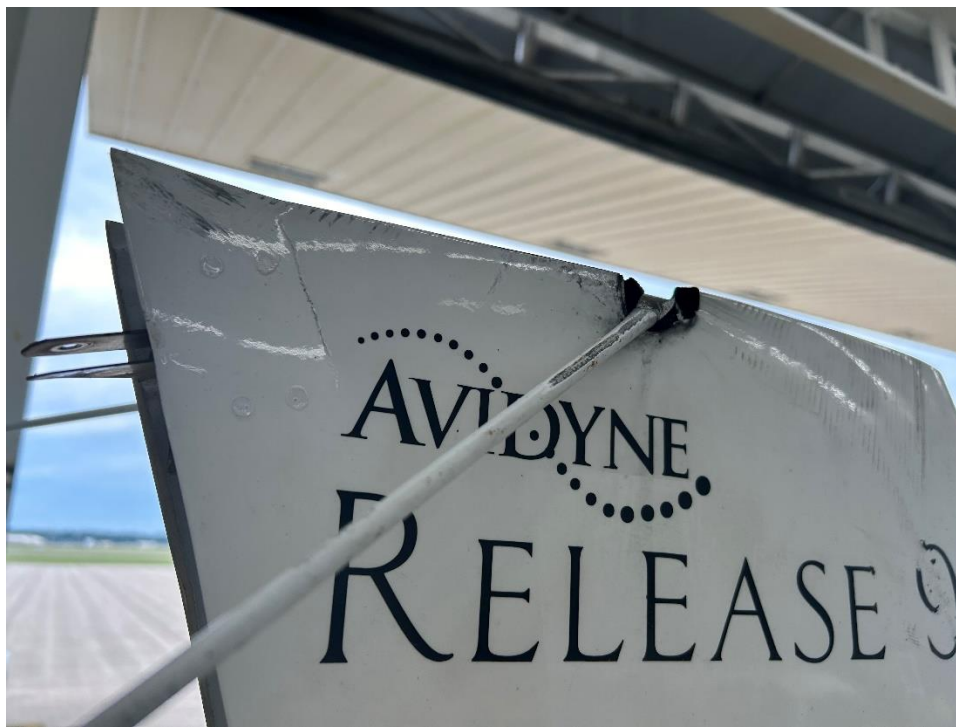
Pic 9:  
Vertical  
Stabilizer

- B. Composite delamination present @ bracket area (see pic 9).
4. LH side cabin door sustained damage due to CAPS strap deployment.
  - A. Bottom door latch has damage along with bottom door hinge/skin area (see pic 10).

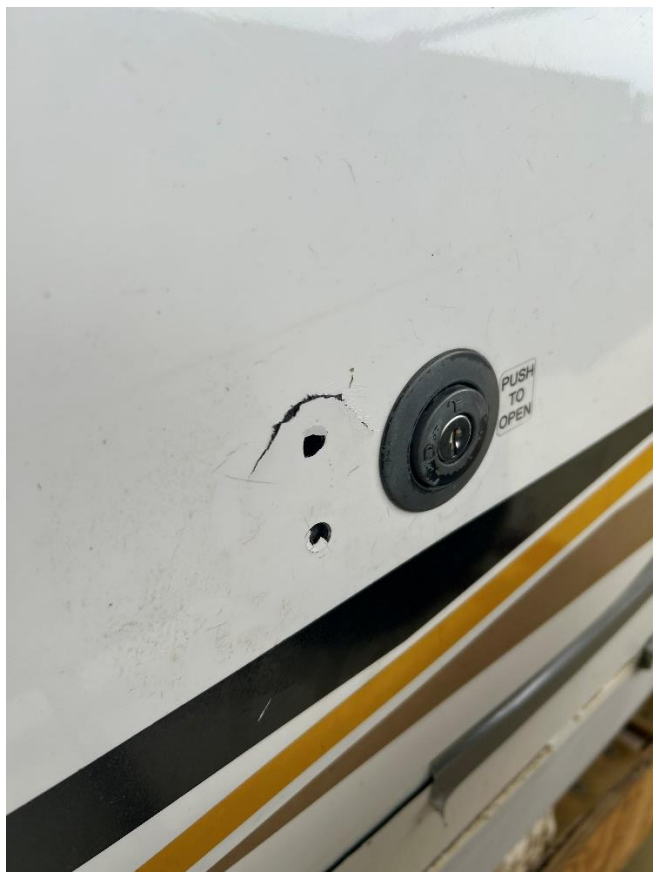
Pic 11:

- B. Door skin near latch entry button has crack with delamination (see pic 11).
5. RH landing gear leg has minor delamination present (see pic 12).
6. Propeller blades damaged due to strike on ground upon touchdown

LH Cabin  
Door

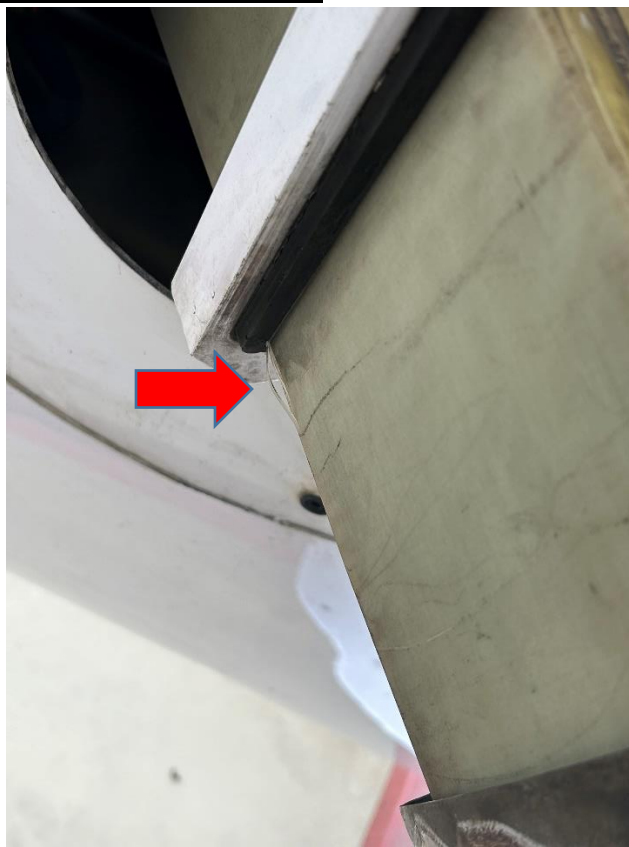
Pic 12:

RH MLG  
Strut

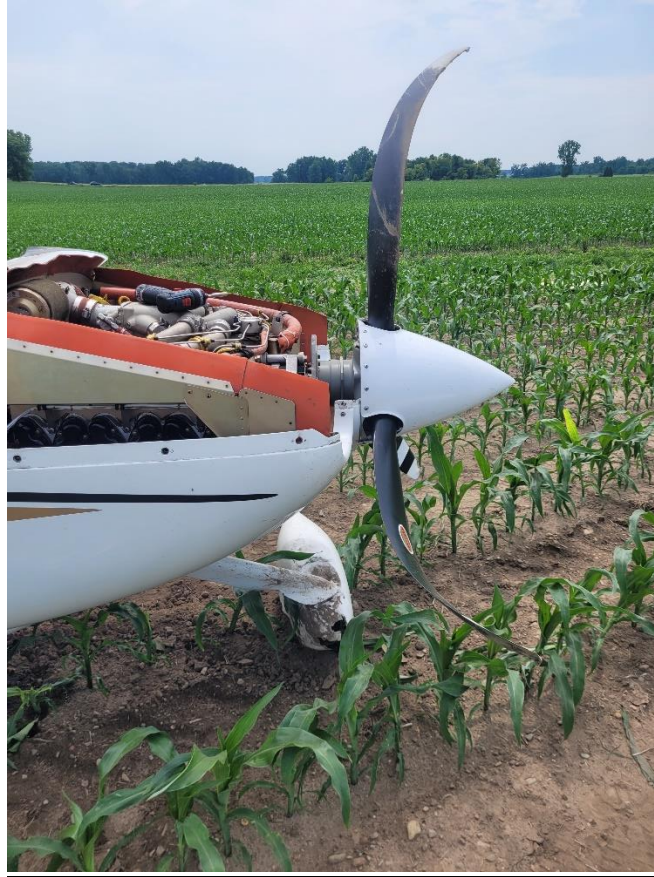
Pic 13:  
Engine/Prop

- A. All 3 propeller blades damaged beyond repair (see pic 13).
7. Engine requires tear-down inspection due to propeller strike (see pic 13).
8. Wheel pant fairing damage.

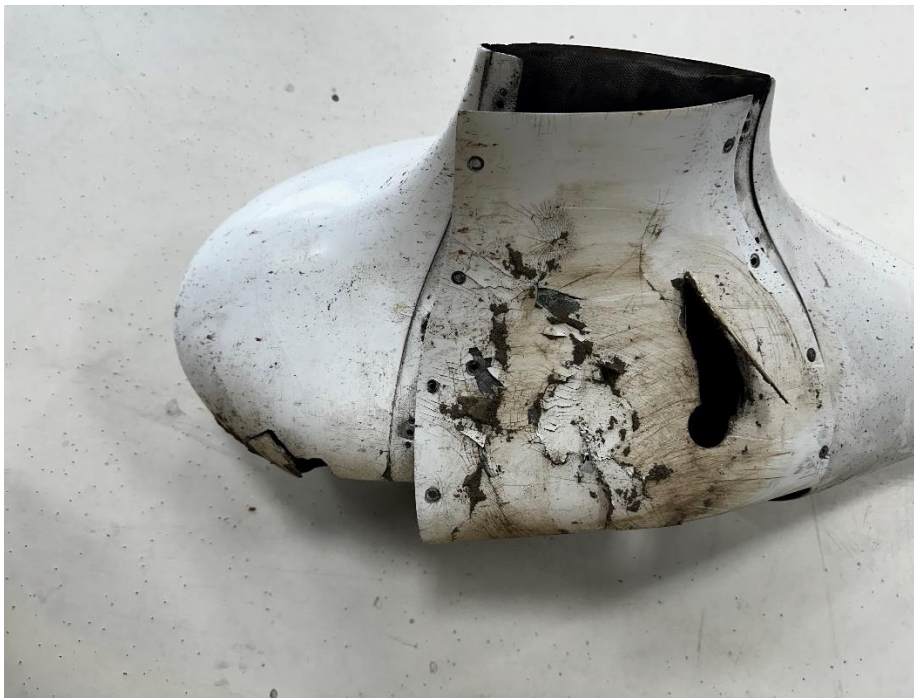
Pic 14:  
RH MLG  
Wheel Pant  
Fairing

- A. RH MLG fairing: Large dent on top with delamination. Inboard fairing panel damaged, ripped apart and delaminated (see pic 14).
  - B. LH MLG fairing: Delamination with large crack on inboard side of wheel pant. Inboard wheel pant panel totally destroyed (see pic 15).

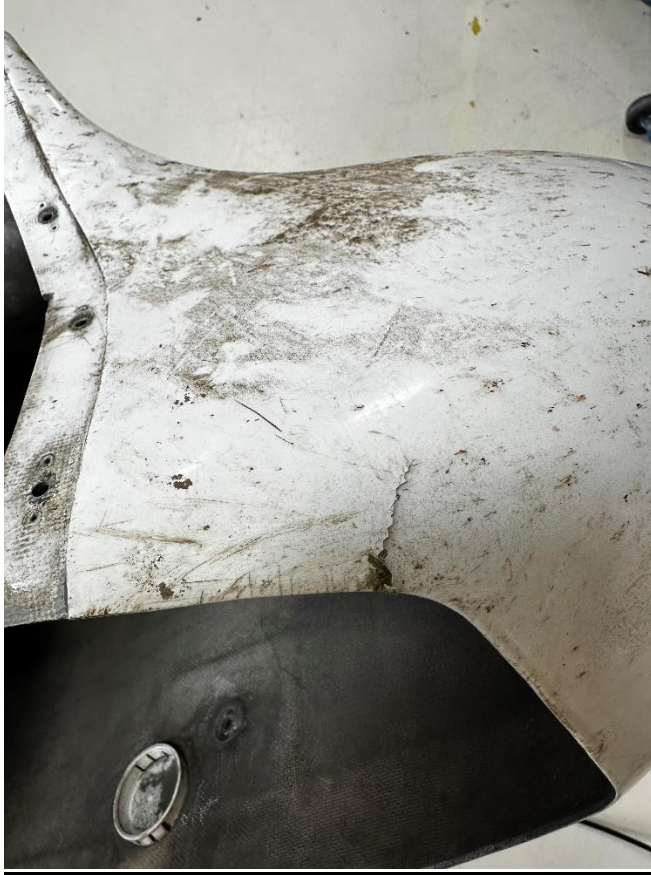
**Pic 15:**

LH MLG  
Wheel Pant  
Fairing

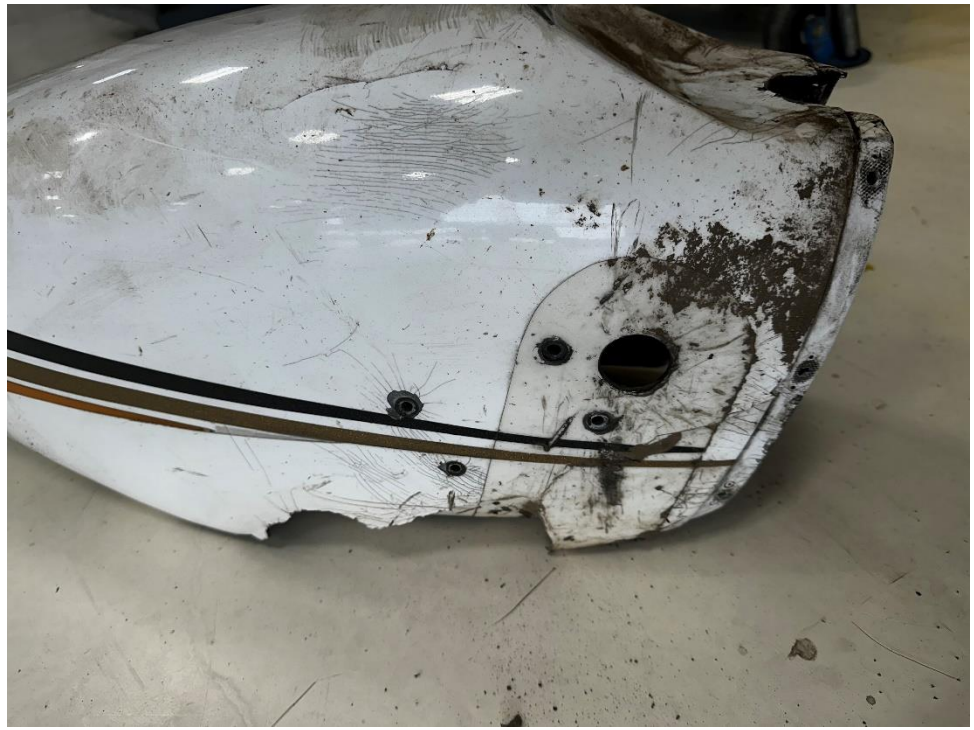
**Pic 16:**

- C. NLG fairing: Bottom side missing large chunk with cracks and delamination (see pic 16).
9. NLG Strut Assembly – Shock absorption pucks and tray damaged/torn.

NLG Wheel  
Pant Fairing
