CEN24LA233

## INVESTIGATION PHOTOGRAPHS

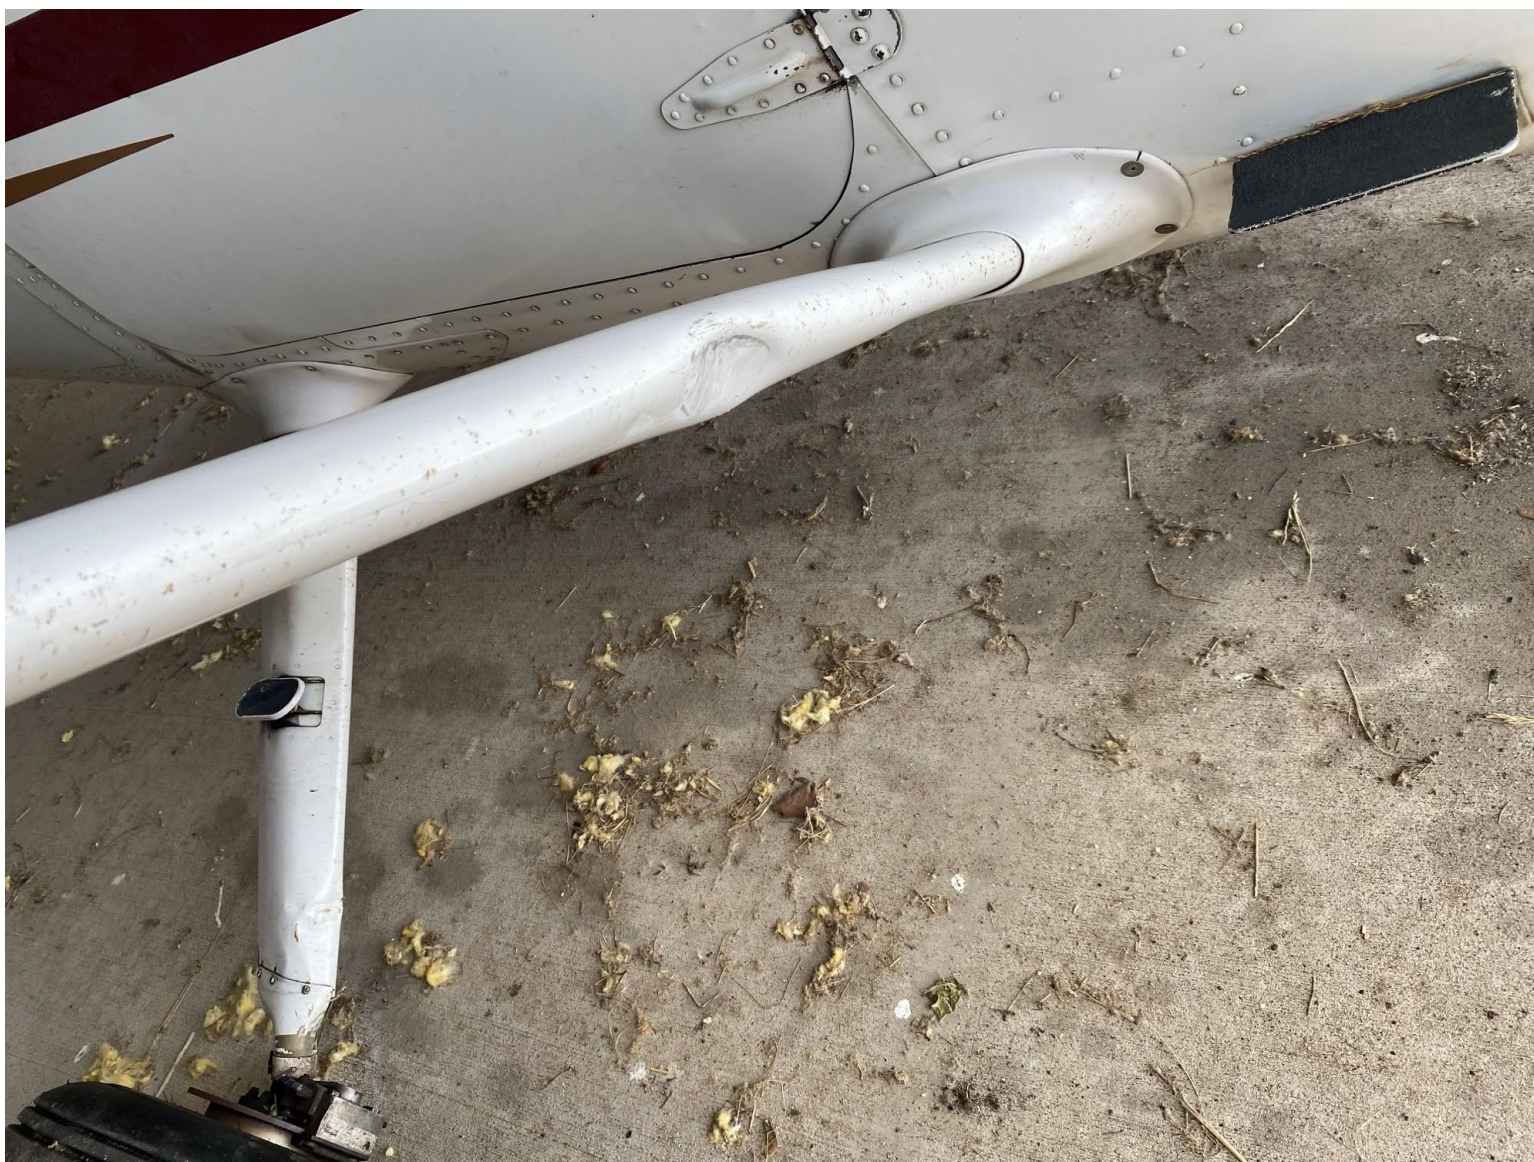
**Photograph 1 - Right Lift Strut Damage (Courtesy of Federal Aviation Administration)**
