CEN24LA236

## INVESTIGATION PHOTOGRAPHS

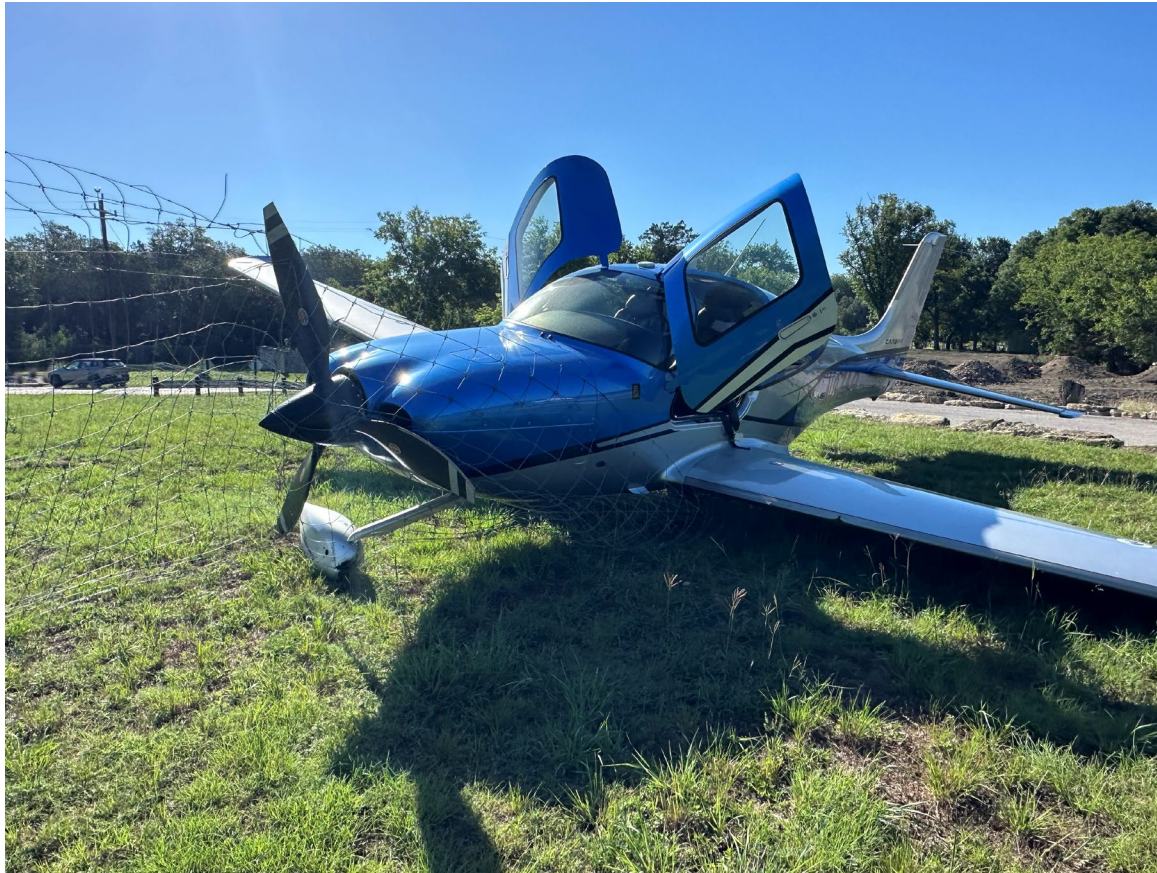
**Photograph 1 - Accident site (Courtesy of Flight School Manager)**

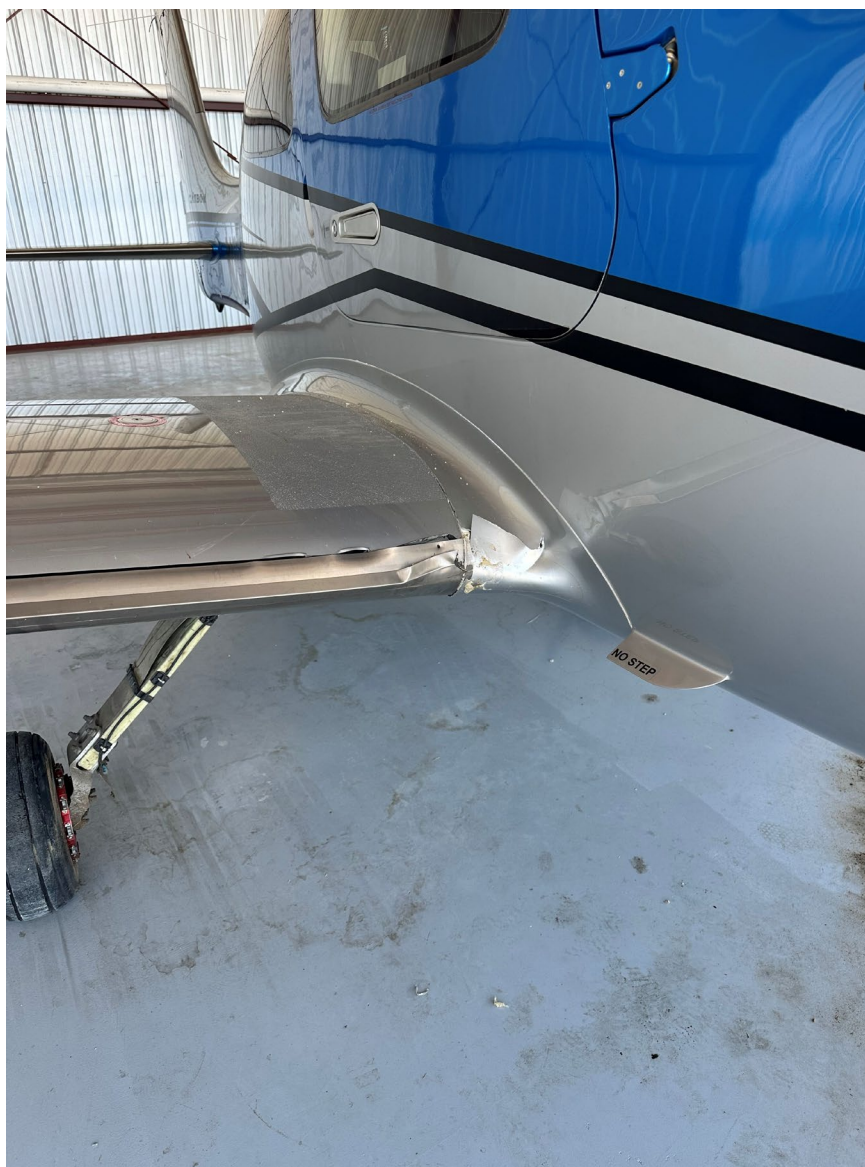
**Photograph 2 - Right wing root damage (Courtesy of Flight School Manager)**

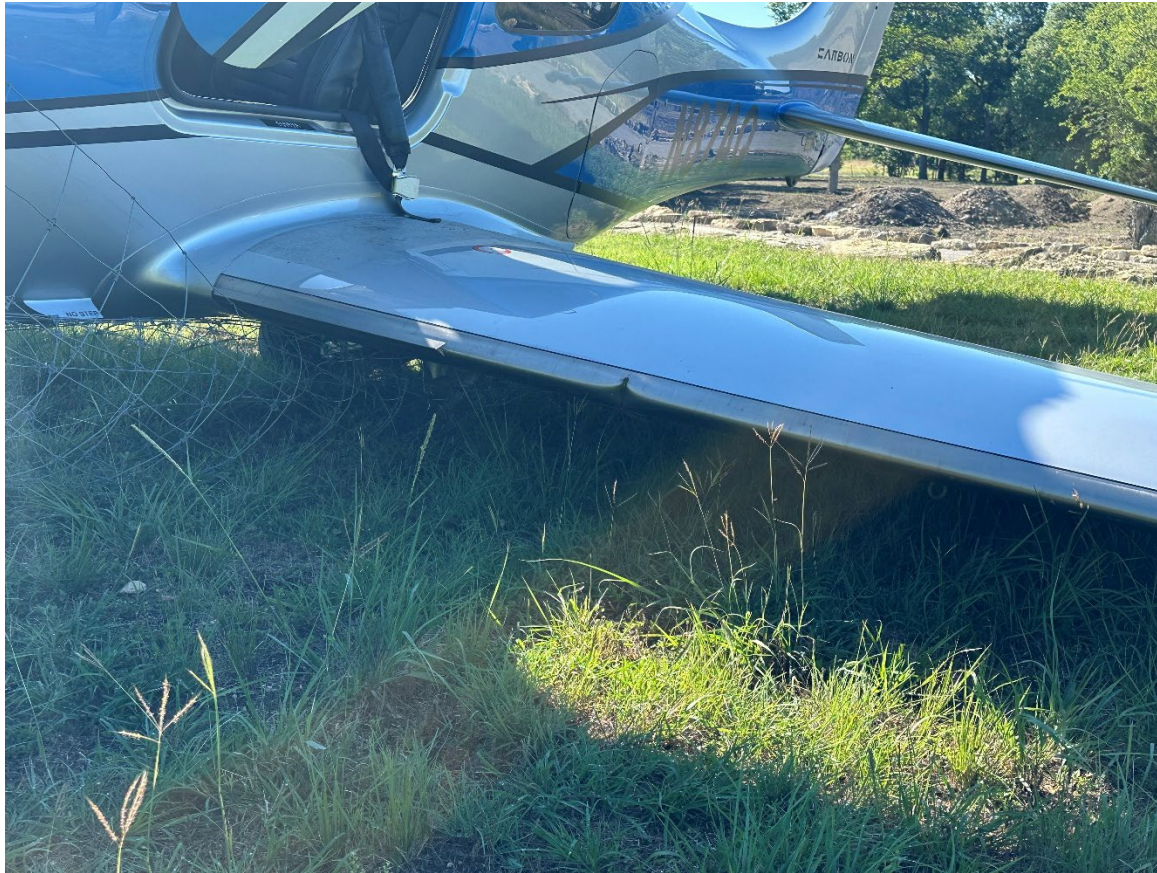
**Photograph 3 - Left wing damage (Courtesy of Flight School Manager)**

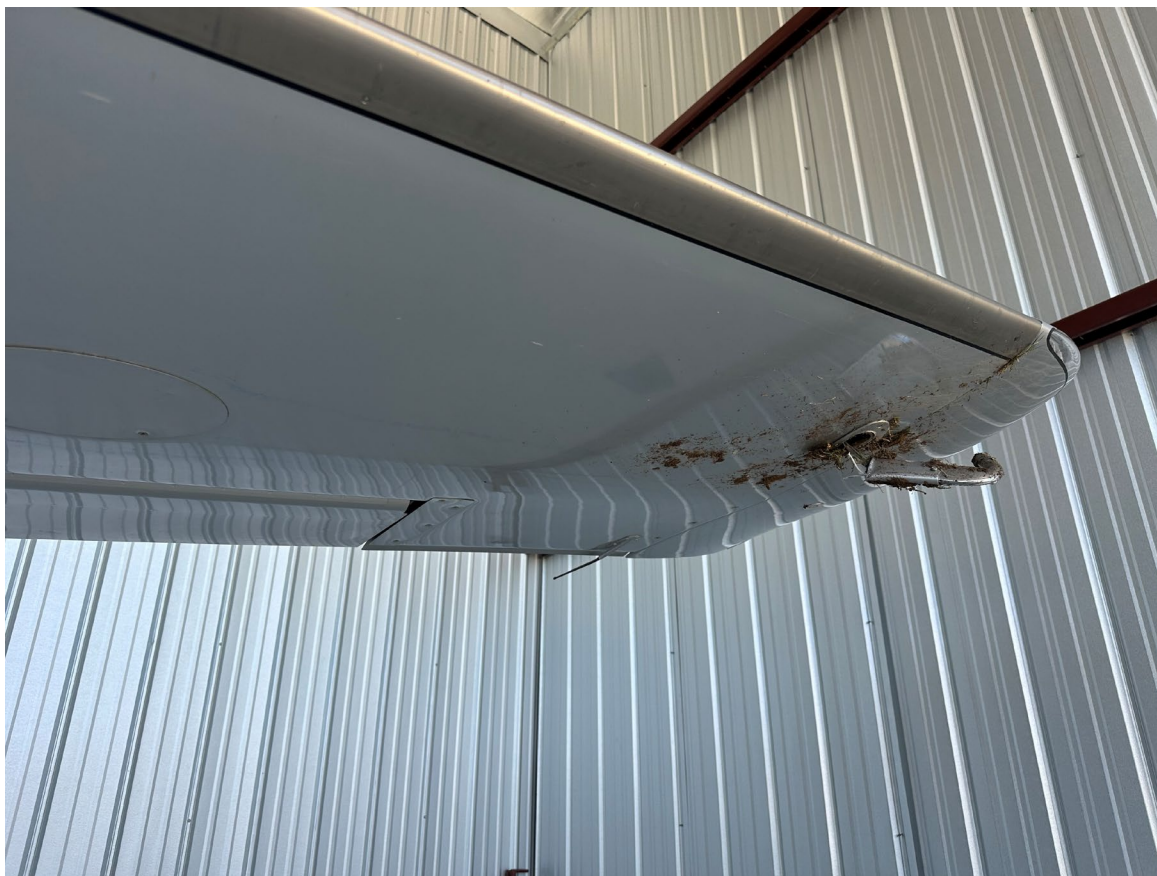
**Photograph 4 - Left wingtip damage (Courtesy of Flight School Manager)**
