# National Transportation Safety Board

CEN24LA239

## **POWERPLANT**

Group Chair's Factual Report

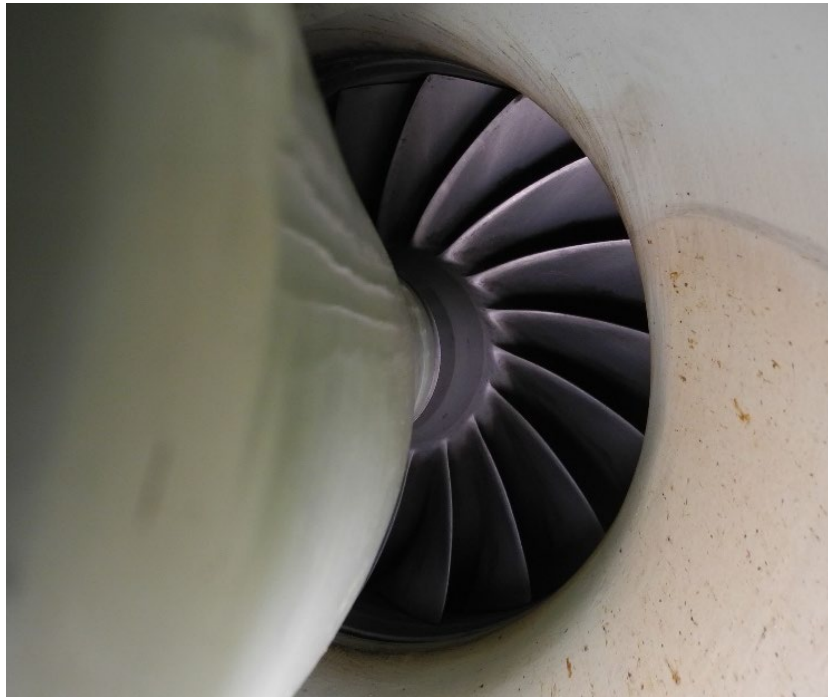
The 1<sup>st</sup> stage impeller as viewed through the inlet was undamaged (Figure 4).

**Figure 4.** 1<sup>st</sup> Stage Impeller - Undamaged

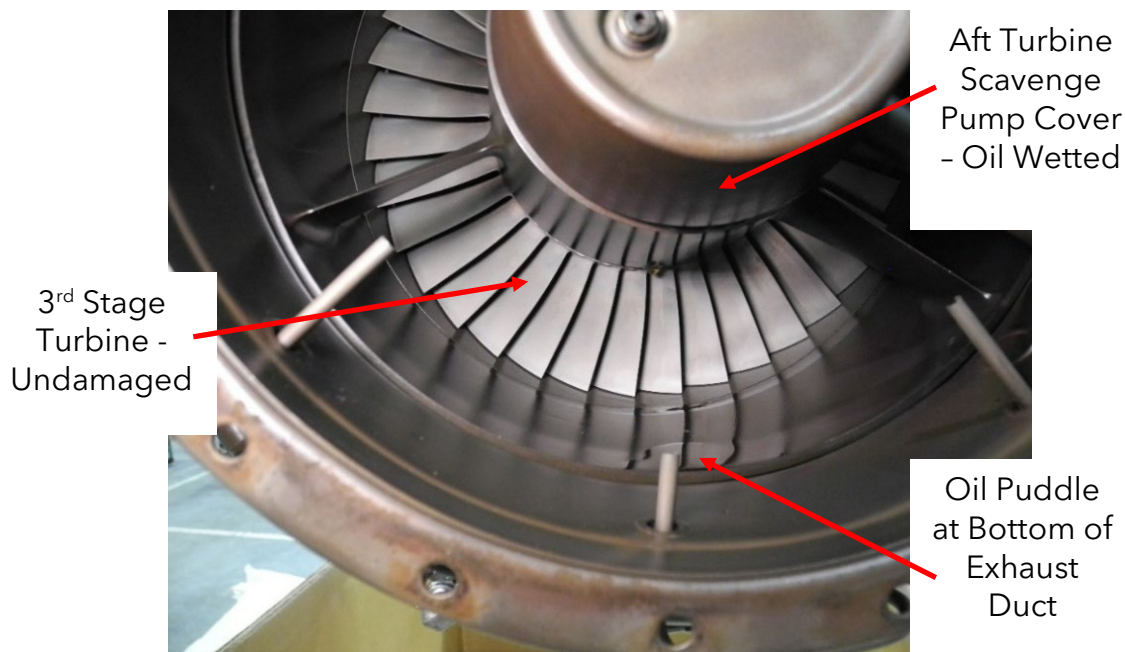
The 3<sup>rd</sup> stage turbine as viewed through the exhaust was undamaged (Figure 5). Oil was observed in the bottom of the inner surface of the exhaust duct. A small oil puddle was observed in the exhaust duct. Additionally, the turbine scavenge pump cover was oil wetted. The turbine scavenge pump cover was removed revealing oil in the outer sleeve of the turbine housing inner barrel.

**Figure 5.** Exhaust Duct - Oil Puddle Observed at Bottom

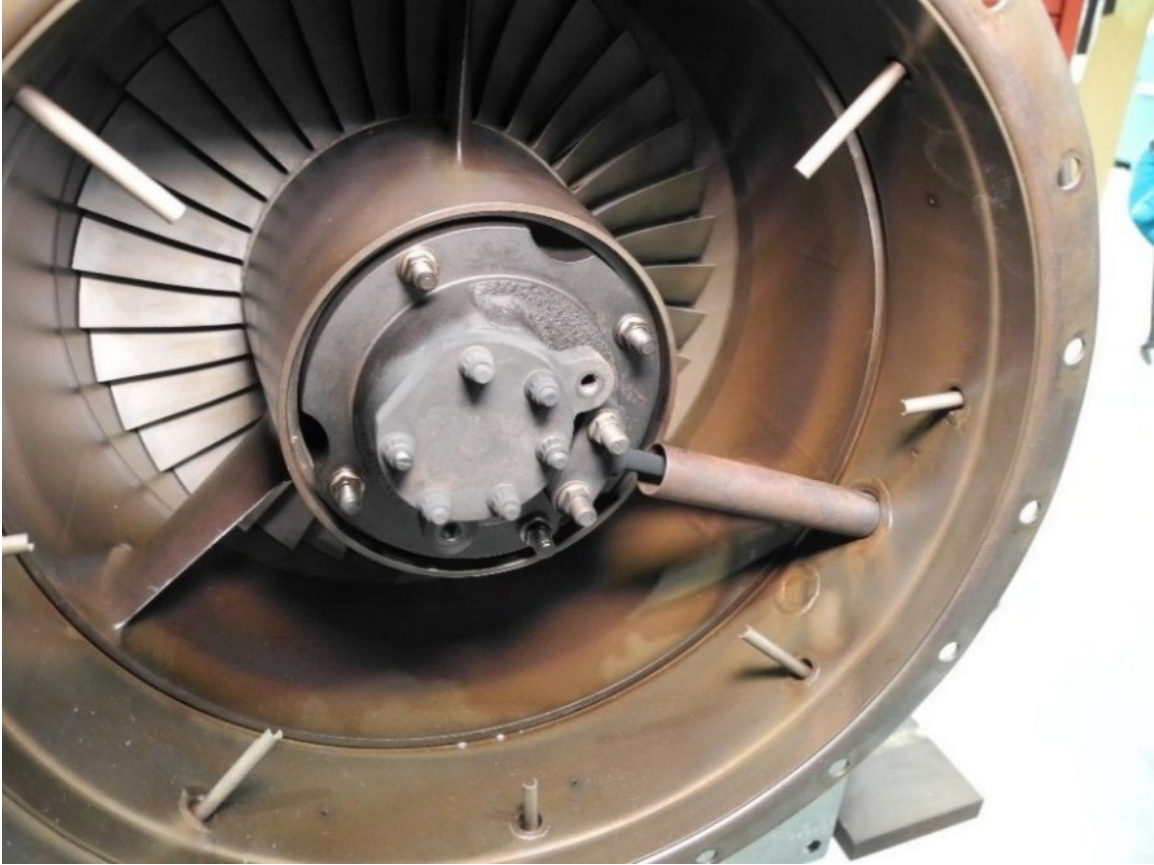
The scavenge pump (Figure 6) was undamaged; however, it was nominally sooty and dry.

**Figure 6.** Turbine Scavenge Pump Housing - Cover is Removed

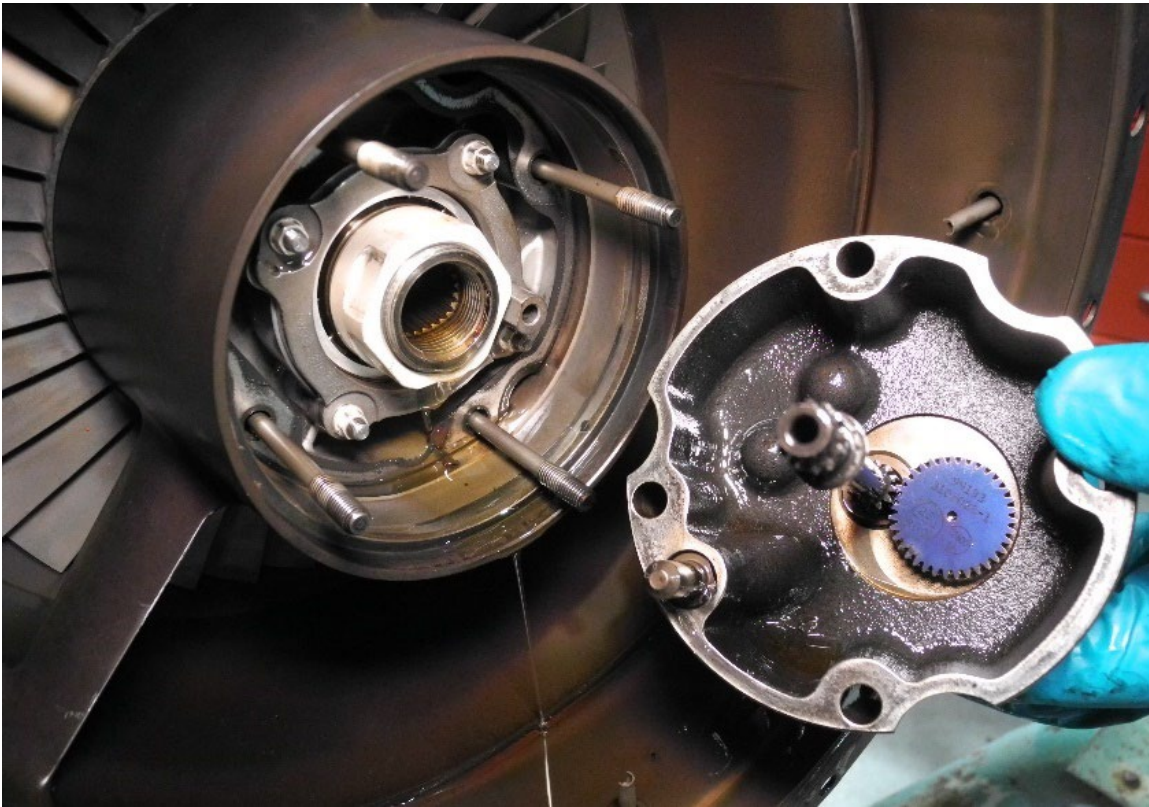
The turbine scavenge pump was removed, revealing undamaged oil wetted gears and splines (Figure 7) and an intact gasket.

**Figure 7.** Turbine Scavenge Pump - Undamaged

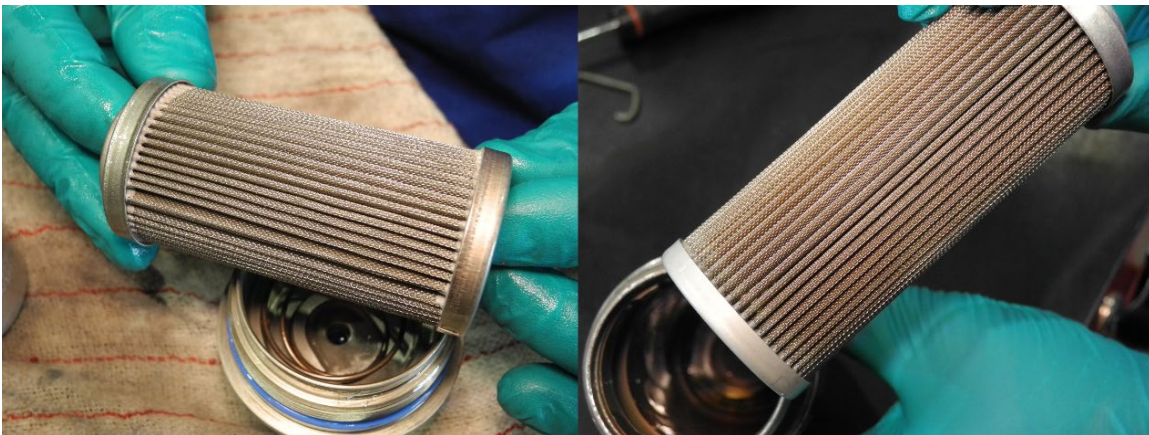
The fuel filter was removed and examined revealing a filter cavity full of fuel and a clean filter (Figure 8). The oil filter was clean.

**Figure 8.** Fuel Filter (Left), Oil Filter (Right) - Clean

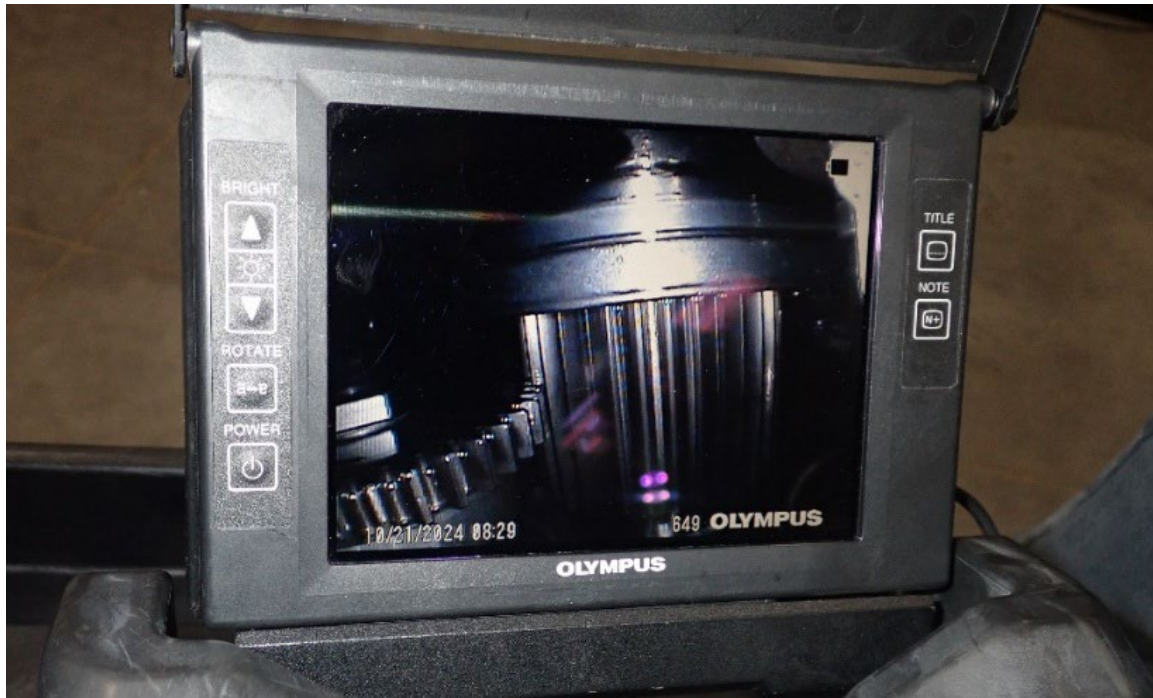
The AGB and propeller flange were undamaged. The gearbox was drained of oil and an oil sample was collected. A borescope was inserted through the vent fitting to inspect the high-speed pinion to torque sensor gear mesh. Both gears were meshed, undamaged and oil wetted (Figure 9). The AGB was not further disassembled.

**Figure 9.** Borescope Image of High-Speed Pinion - Torque Sensor Gear Mesh

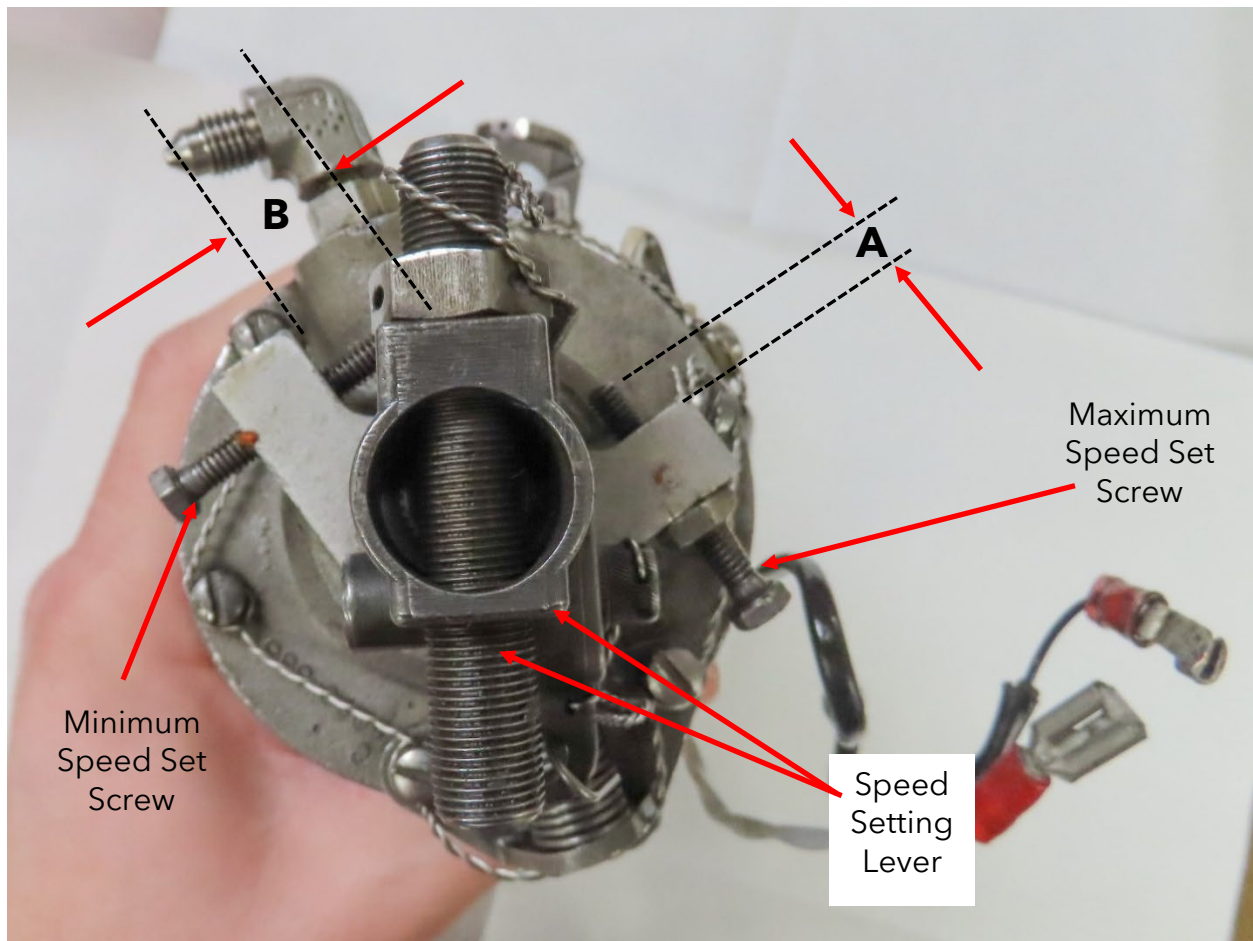
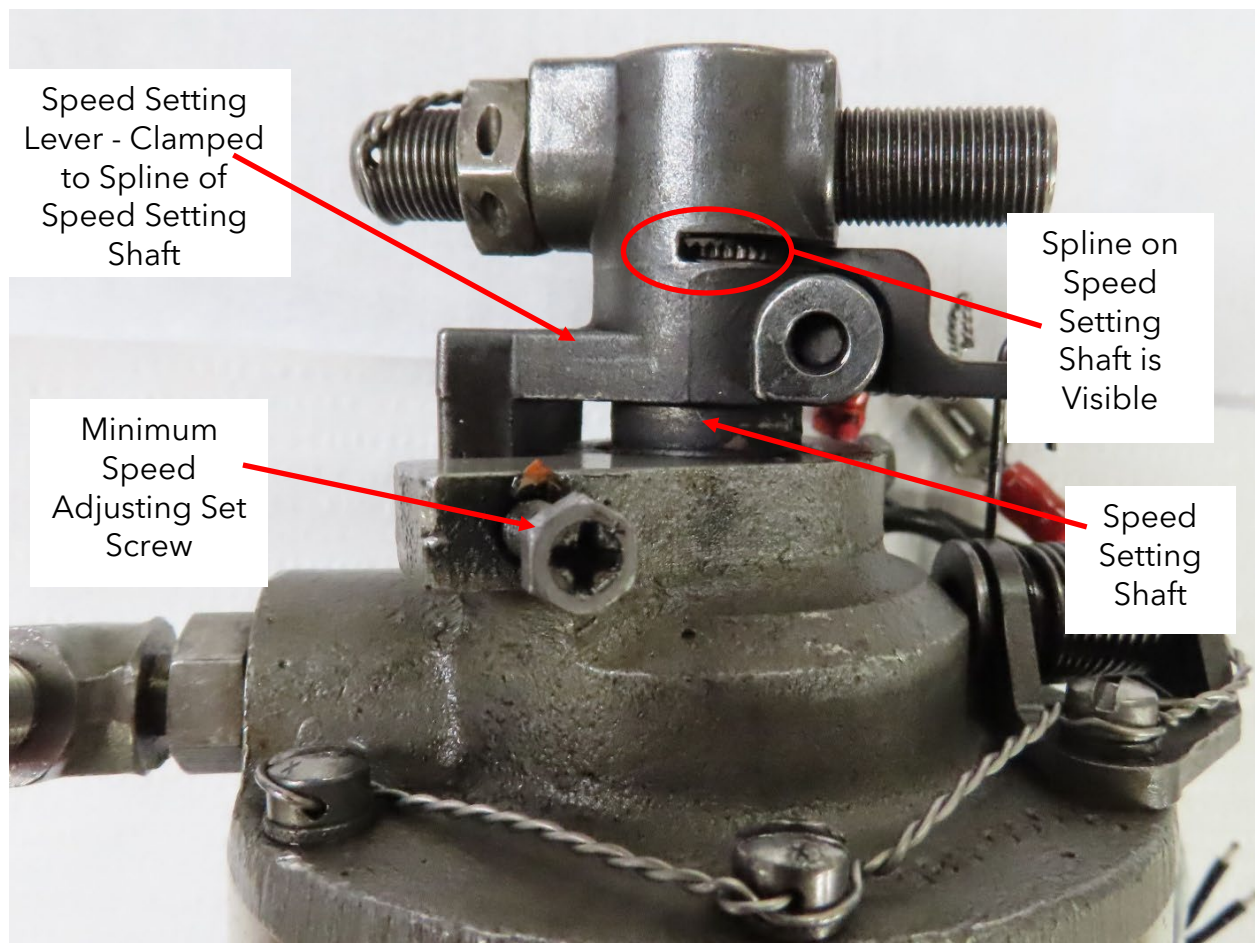
During the engine repair for the lightning strike in May 2024, it was reported that the technician re-indexed the speed setting lever by two splines to bring the angular relationship of the lever to a more neutral position which will decrease the propeller governing speed of the engine. According to the Honeywell Maintenance Manual 72-00-27 for the TPE331-10-511M engine model, a Temporary Revision No. 72-167 was issued on February 29, 2000, that added cautionary instructions when performing the PG RPM settings, stating 'CAUTION: NEVER ATTEMPT TO MEET THE PROPELLER GOVERNOR RPM SPEED REQUIREMENT BY REPOSITIONING SERRATED LEVER ASSEMBLY ON THE PROPELLER GOVERNOR SHAFT. Further, it stated that if the relationship between the lever and the shaft is not maintained, then the PG must be returned to an authorized facility to be recalibrated.

The maximum and minimum speed settings of the PG are established at the factory by adjusting the position of two set screws on the propeller speed setting shaft (Photo 12). Normally the extended threads of the maximum and minimum set screws are approximately even. The two set screws of the event PG were present and locked; however, they were asymmetrically positioned by approximately 20° (See dimensions A & B in Figure 14 and Figure 15). Minor adjustments of the speed set screws are allowed in the field as part of the rigging adjustment procedure; however, the Woodward technicians noted this to be an unusually large variance.

**Figure 13.** Details of Speed Setting Lever on Speed Setting Shaft

**Figure 14.** Detail of Speed Setting Lever on Speed Setting Shaft

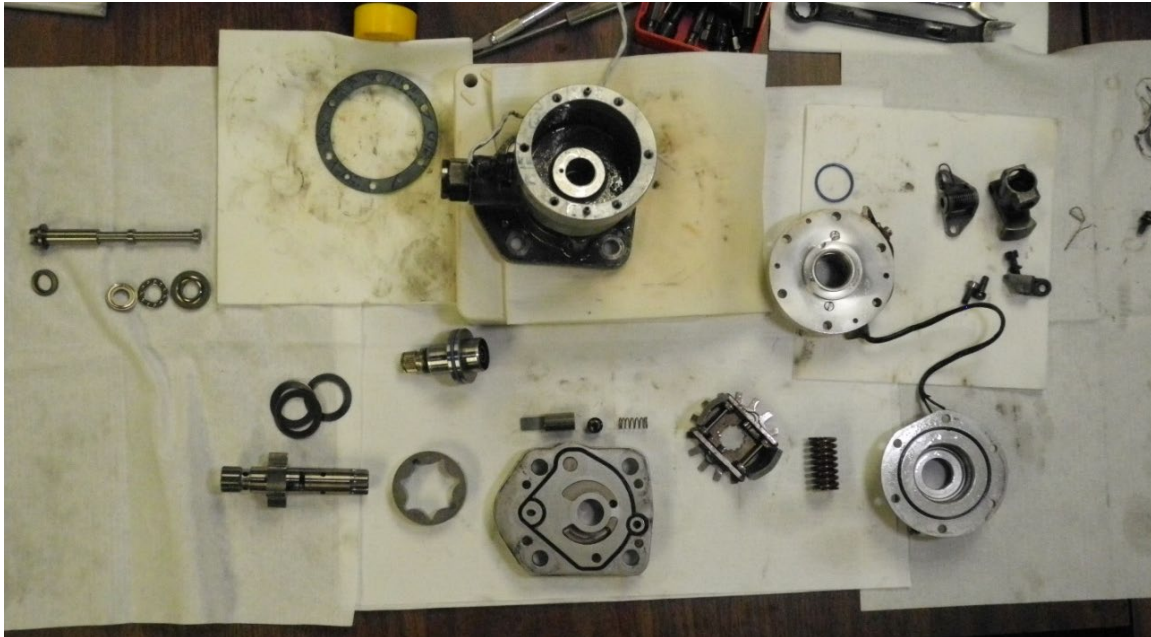
The PG was disassembled (Figure 20) and no abnormalities were found.

**Figure 19.** PG - Disassembled

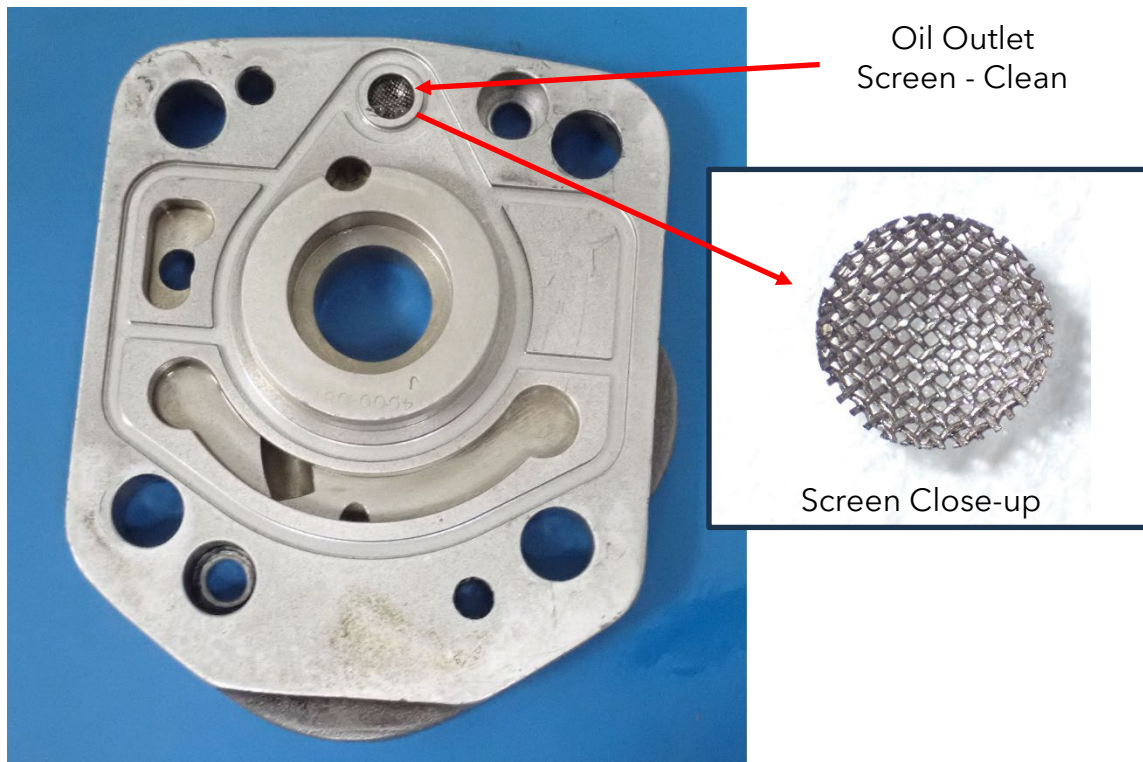
Because the PG had already been disassembled at the Woodward facilities and returned to Honeywell, the PG mounting flange (Figure 23) was examined for integrity and contamination. The filter screen and its retaining clips were still present in the flange recess; the screen was removed and found to be clear of any debris.

**Figure 21.** Oil Outlet Screen on PG Mounting Flange - Clean

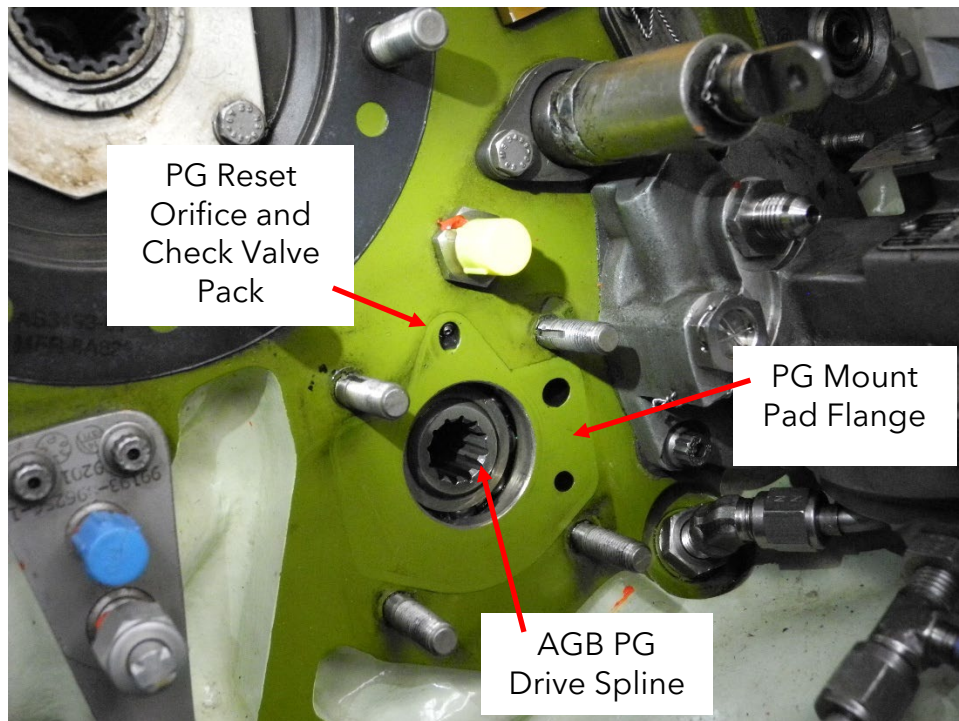
The PG flange pad and surrounding area were examined and found to be clean, oil wetted and undamaged (Figure 24).

**Figure 22.** AGB PG Flange Area

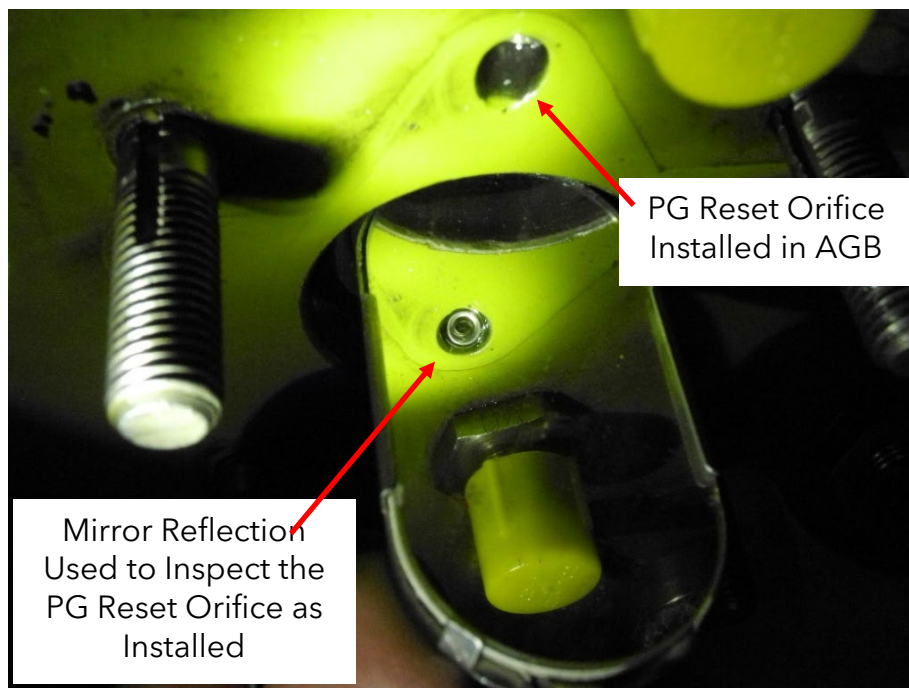
The external entrance of the installed PG reset orifice and check valve was examined and found to be clean (Figure 25).

**Figure 23.** PG Reset Orifice in Location - Clean

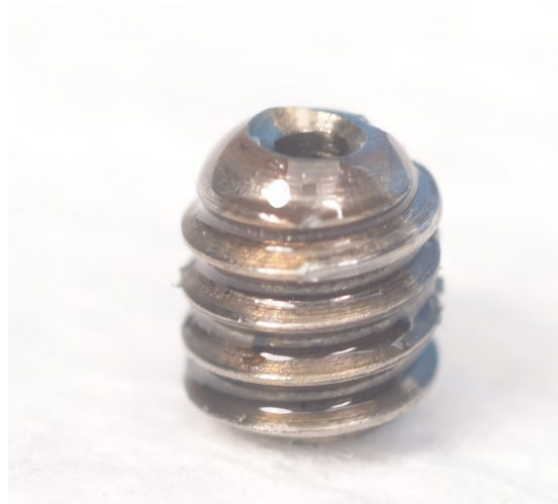
The PG reset orifice (Honeywell P/N 897026-2) (Figure 27) was unscrewed and removed with no difficulty from its recess in the AGB (Figure 26) and found to be clean.

**Figure 25.** PG Reset Orifice - Clean

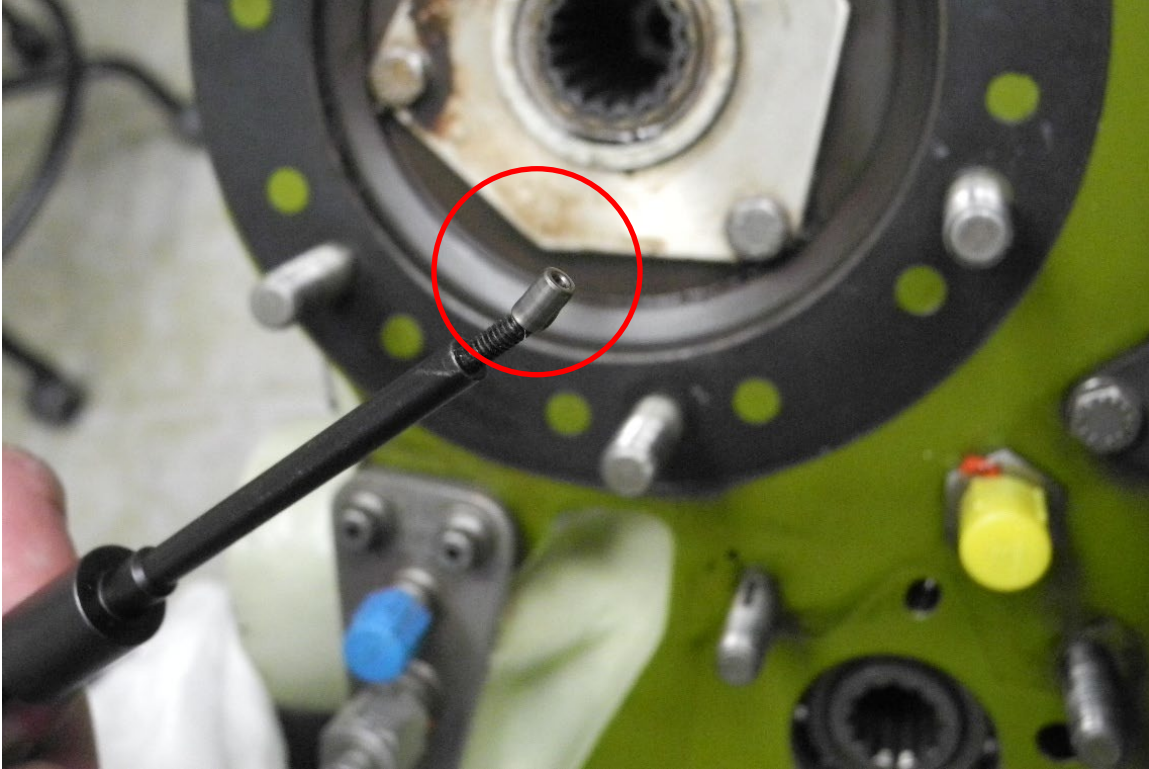
The Lee valve expander pin (part of the PG check valve assembly - Honeywell P/N 771-590-9001) was removed in the normal manner using a small slide hammer (Figure 28) and found to be undamaged.

**Figure 26.** Lee Valve Expander Pin - Withdrawn from AGB

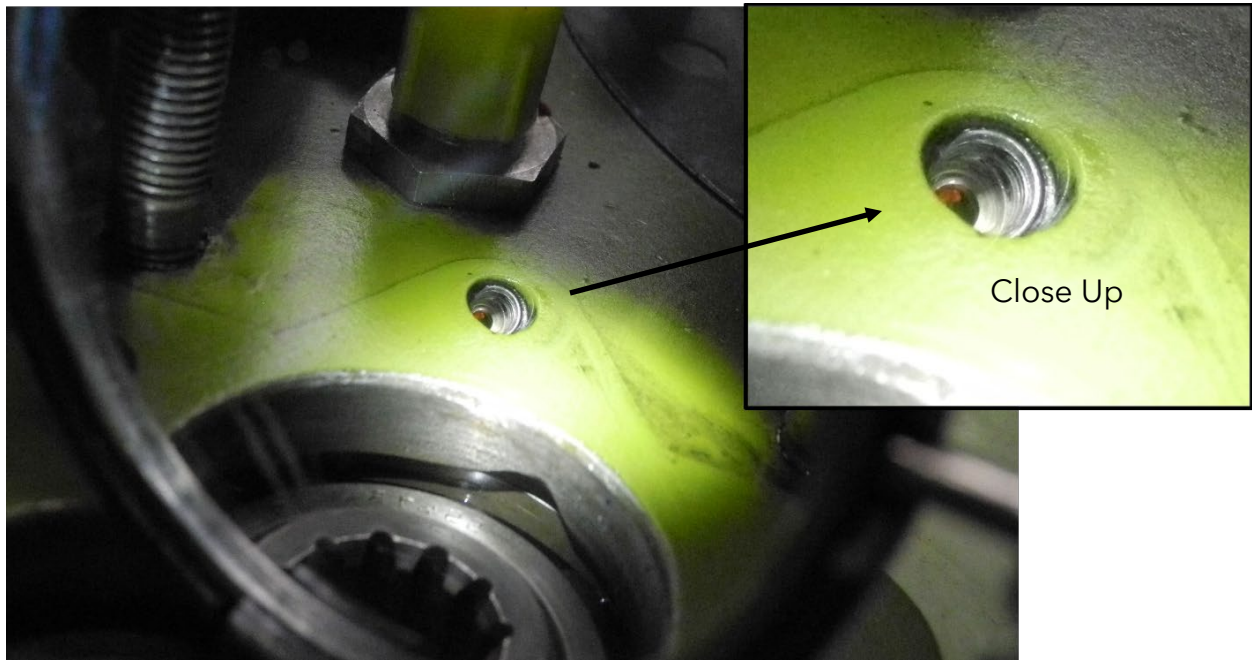
Blockage of the check valve orifice can prevent engine oil from being correctly ported to the NTS system and the PG reset piston and potentially impacting the PG's governing set point.

After the Lee valve expander pin was removed, the Lee valve was visually examined in-situ, revealing a small red-colored irregularly shaped foreign object (Figure 29).

**Figure 27.** Lee Valve In-Situ - Note Red Foreign Object in Close Up

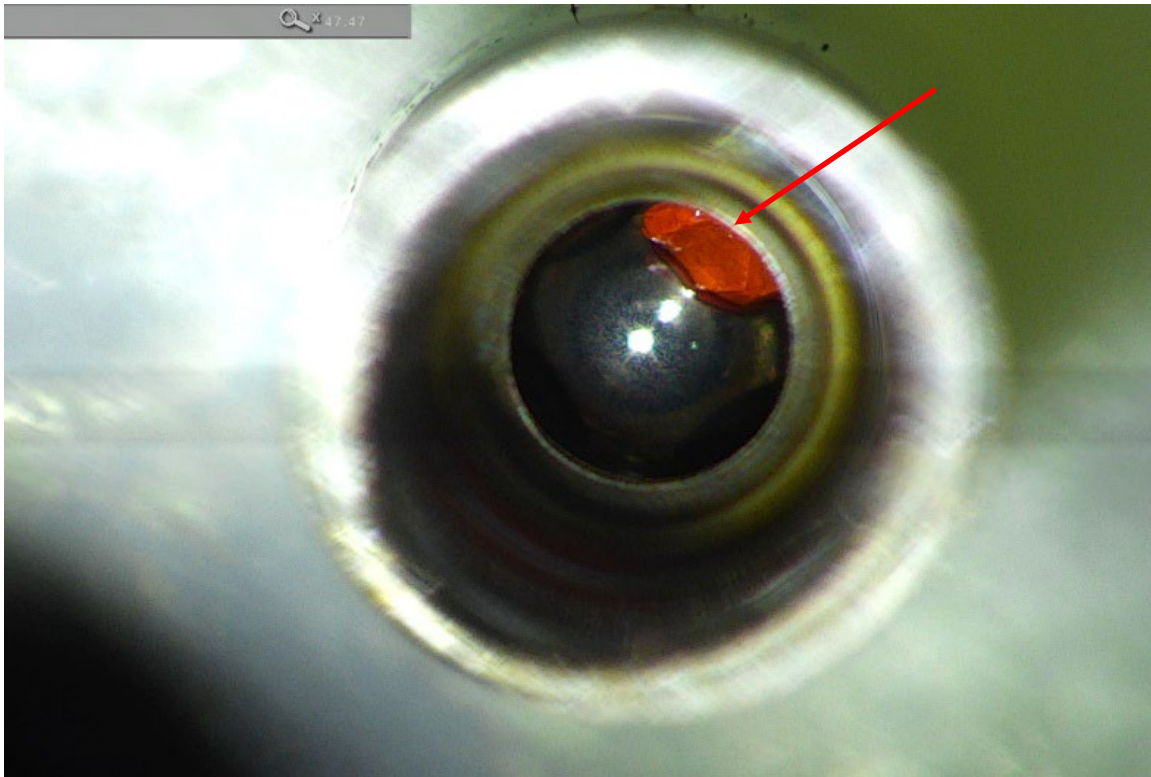
Further examination of the oil passages and in-line fittings of the engine accessory gearbox was carried out. A small red colored piece of debris was found within the PG reset orifice and check valve,, an in-line flow control component in the PG oil system. The debris appeared to be the same color and consistency as the torque stripe<sup>2</sup> paint that was applied to other engine line connectors; material analysis confirmed the composition was consistent with the torque stripe paint.

The Lee valve was examined using a microscope, which confirmed a small red-colored irregularly shaped foreign object inside the barrel of the valve that appeared to be captured between the ball and seat of the valve (Figure 31); however, because of the small size and shape of the Lee valve, it was not impossible to confirm this observation. Therefore, the Lee valve was sent to the Honeywell CT lab to confirm the location of the debris.

**Figure 29.** Red Foreign Material Inside of the Lee Valve Barrel

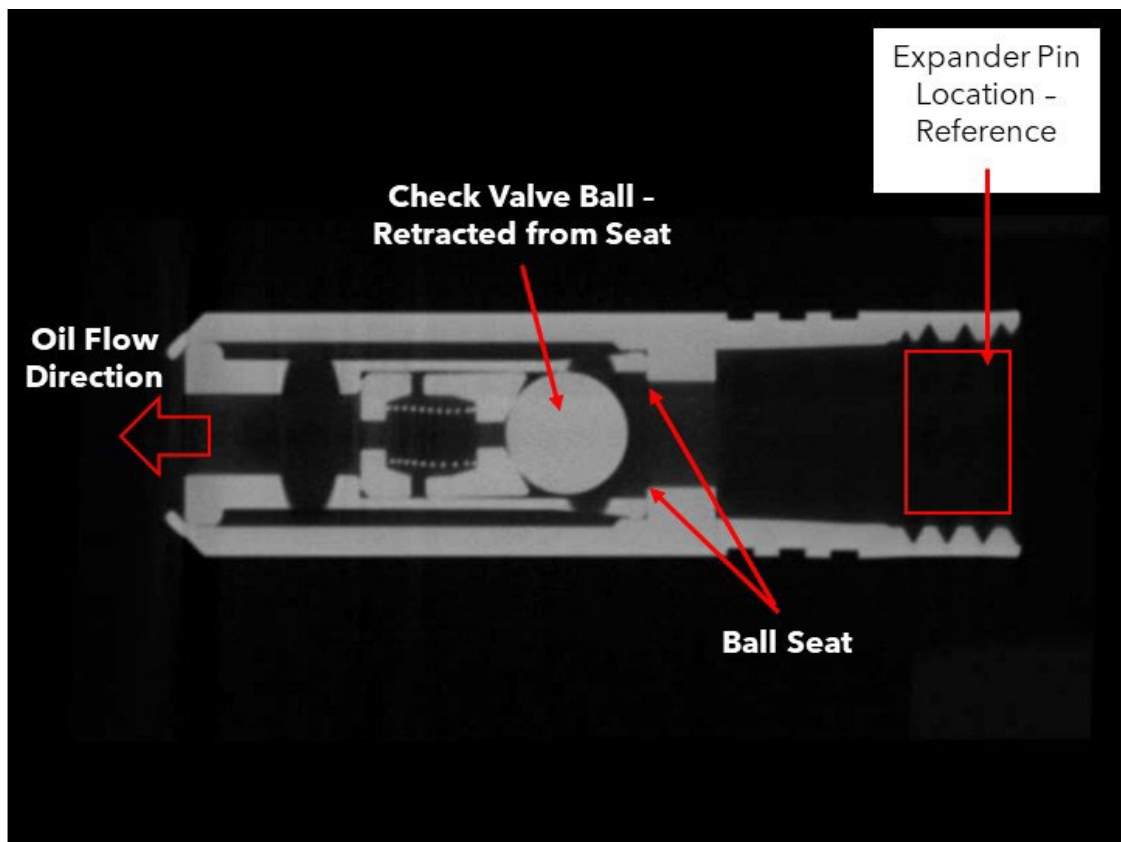
The CT image of the Lee valve revealed that the ball was not seated (Figure 32). The red debris could not be seen in the CT image because the debris was made of a low-density material.

**Figure 30.** CT scan of Lee Valve - Ball is Not Seated

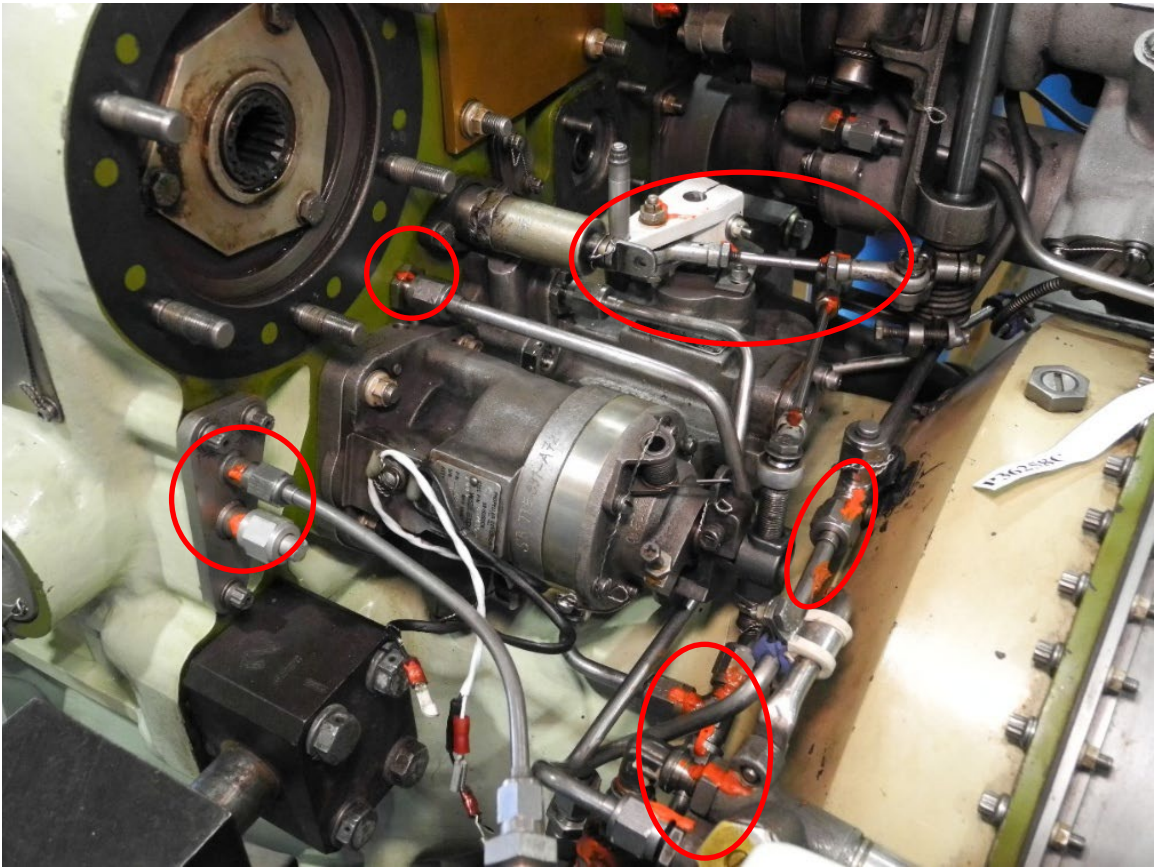
It was noted that most external fluid line connections on the engine were marked with a red colored torque stripe paint (Figure 33).

**Figure 31.** Engine as Received - Note Application of the Red Torque Stripe Material

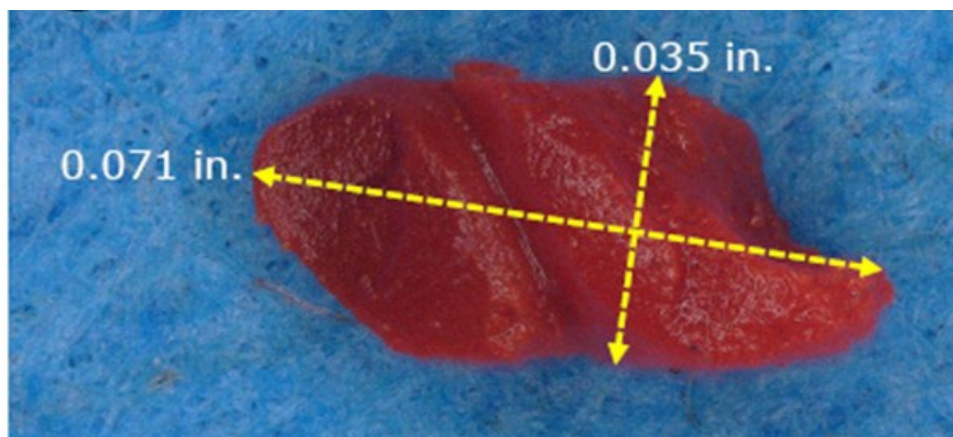
The debris recovered from within the NTS valve was measured to be approximately 0.071 inches long, 0.035 inches wide and 0.025 inches thick (Figure 33).

**Figure 32.** Dimensions of the Recovered Debris

The Lee valve with the debris and a sample of the torque stripe material from the line fittings were sent to the Honeywell materials laboratory for analysis. Fourier Transform Infrared (FTIR) analysis was performed on the debris and the torque stripe sample material which confirmed the chemical similarity between the debris and the torque stripe (Appendix 1).
