# National Transportation Safety Board

CEN24LA245

## **FUEL SYSTEM FACTUAL**

Location: Land O' Lakes, WI  
Date: June 30<sup>th</sup>, 2024  
Time: 11:15 Central Time  
Airplane: Make: Raytheon (Beechcraft) Model: A36  
Registration: N47RT

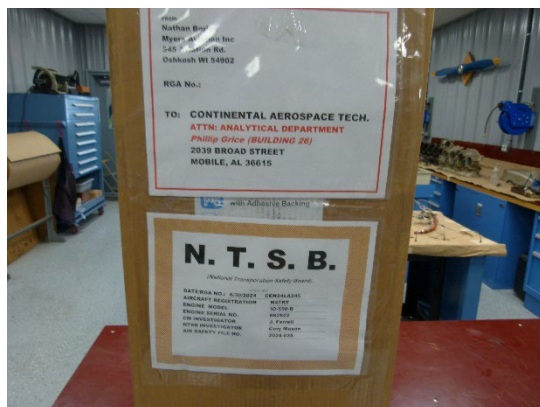
The fuel system components had remained in storage and sealed in the shipping box until time of examination. All the items were removed from the box and inspected for damage. Pictures 1 and 2 are the fuel system components as received by Continental and the Component Release Form that was inside the shipment.

Picture 1 Fuel System as Shipped

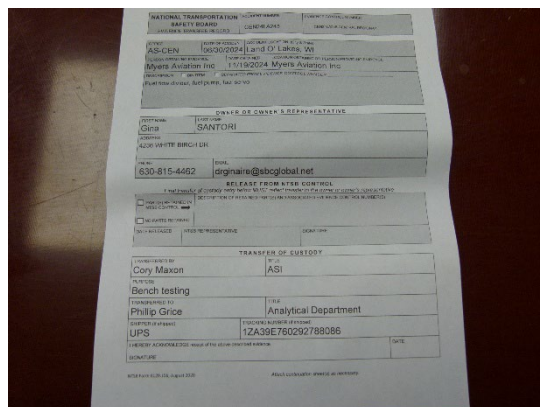
Picture 2 Component Release Form

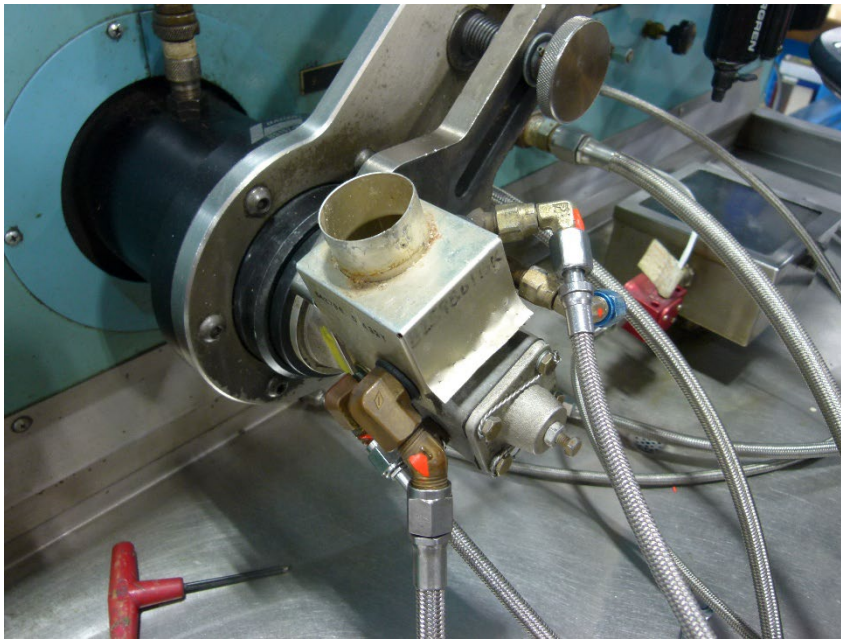
The fuel pump was visually inspected, turned by hand, and then mounted to Continental Aerospace's fuel pump test bench, picture 3. The test bench is used to do the initial setup on new fuel pumps. Picture 4 is a full screen shot showing the part and serial numbers of the pump, then picture 5 is a closeup of the pump results. The pump was evaluated at idle RPM (600), Full power RPM (2700), then repeated. The results are given in PPH (Pounds Per Hour). At idle the pump averaged 7.8 PPH for the two runs. The full power runs averaged 223.4 PPH. Adjusting the fuel pump pressure is part of the fuel control set up and will change with hours in service or when a fuel system component is replaced. No issues could be found that would prevent this fuel pump from producing full rated horsepower.

**Picture 3 Fuel Pump Running on the Test Bench**

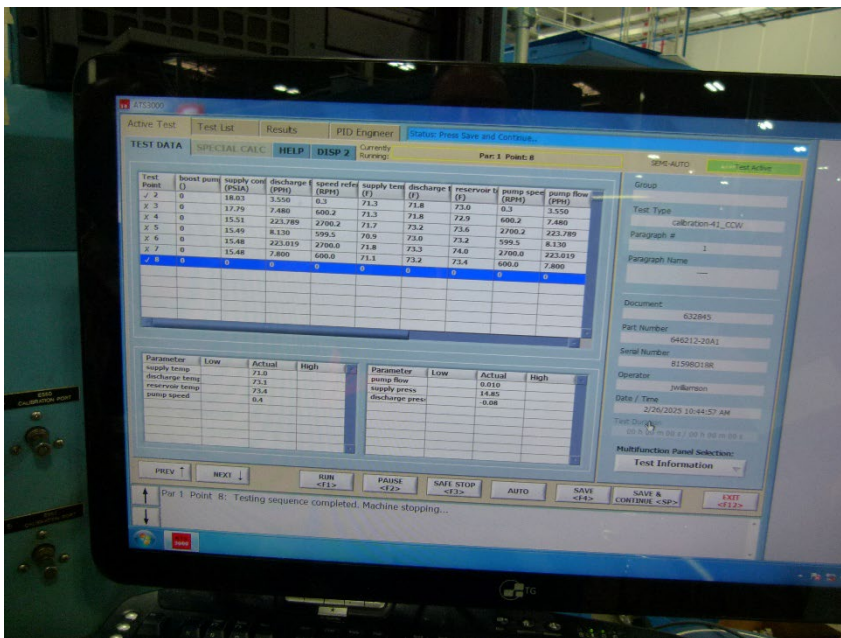
**Picture 4 Fuel Pump Results (Full Screen)**

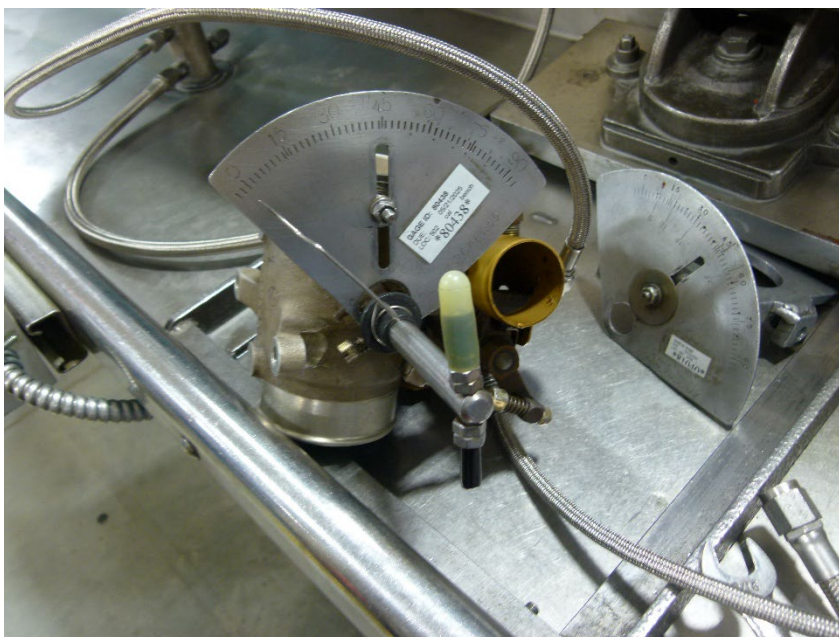
The fuel control, like the fuel pump, was mounted on the test equipment Continental Aerospace uses for the initial setup of fuel system components. Picture 6 shows the fuel control hooked up to the test bench with a throttle position degree tool mounted in place of the throttle arm. Picture 7 shows the test results. The Target Angles for testing (left side of the results) starts at idle, 2.0 degrees, and goes to 73 degrees, full throttle. The rest is self-explanatory with the "Targets" being your desired numbers and the "Measured" is what the fuel control is flowing, but this time in pounds per square inch (PSI), and again in PPH. A quick look will show the proper serial number for this control on the result's page, but the wrong part number. The fuel control being evaluated is no longer listed in the test equipment's software, so a compatible fuel control rated for the same engine and horsepower was chosen. Also, the tested unit failed. The fuel control ran a little rich until close to full power and then it leaned into the "green" results. The test bench is an initial setting only, a known starting point that will make an engine run. The engine must be fine tuned on the dyno when new, and again when installed on an aircraft. All this setup must be done again as the engine ages or anytime one of the components are changed. Another

Picture 6 Fuel Control on Bench

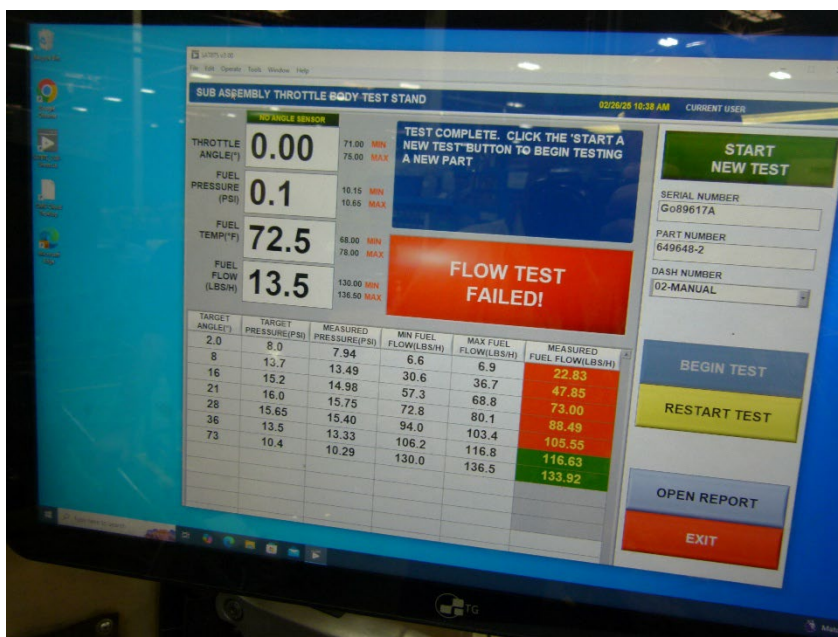
reason the pressures and flows are different are the aftermarket GAMI injectors that were installed. Picture 8 shows the condition of the fuel screen. No issues could be found that would prevent this fuel control from producing full rated horsepower.

Picture 7 Fuel Control Test Results

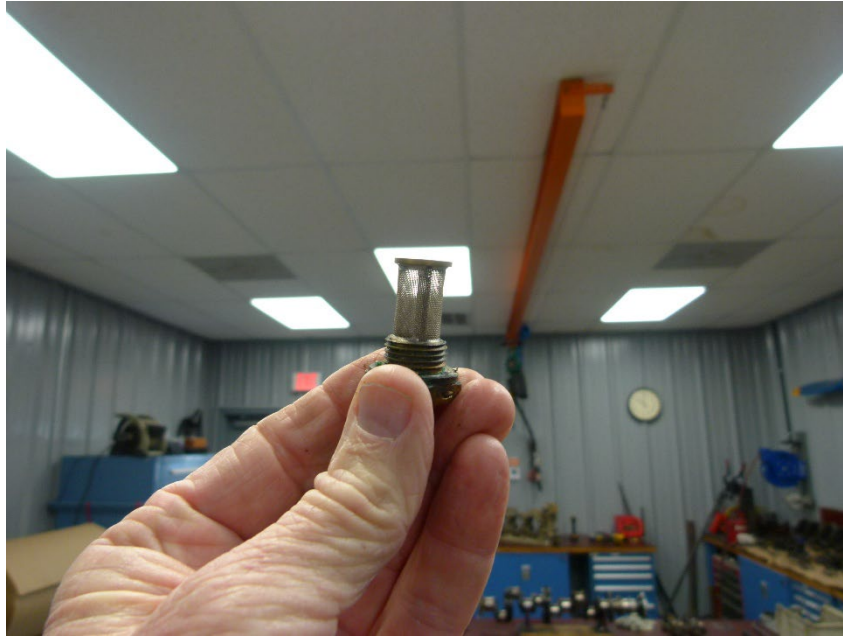
**Picture 8 Fuel Control Screen**

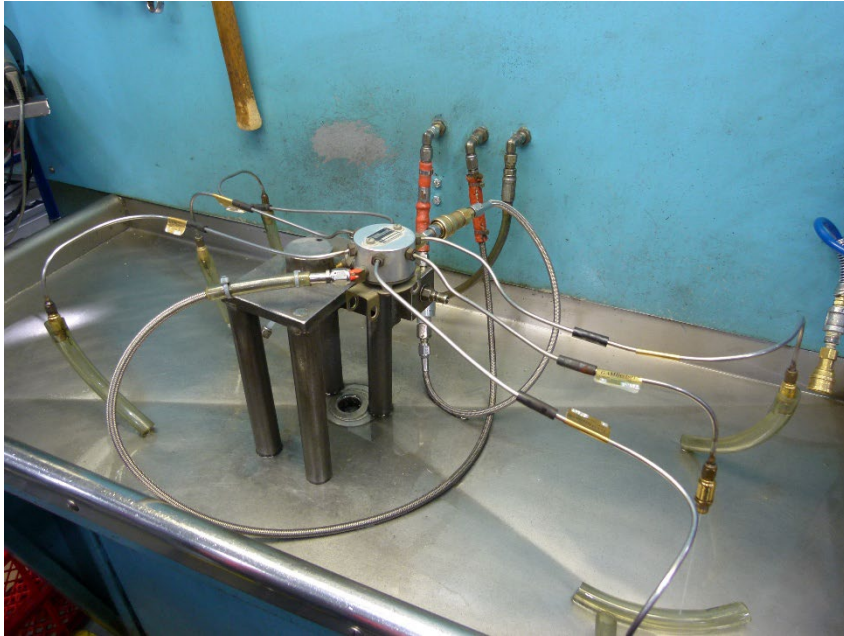
The fuel flow divider, including the fuel lines and GAMI fuel nozzles, was mounted on a test bench just as the other two components. Again, the results show the flow divider failed to the rich side, but one must take into consideration the same variables that caused the failure of the fuel control. The fuel system had been set up for this specific plane and for the aftermarket GAMI nozzles. Picture 9 shows the fuel flow divider on the test bench along with the fuel lines and GAMI injectors. The spray pattern of each nozzle, or injector, was observed and found satisfactory with no evidence of blockage. Picture 10 shows the results of the flow test, again on the rich side. The blue line depicted in the results should be in between the two red lines, again an initial set point for new equipment. The flow rates, pounds per square inch, and the limits are on the bottom left of the picture. The failure of the test means nothing as the components should have been adjusted for this specific aircraft. These fuel system items could have easily been changed to factory settings, but they are most likely adjusted properly for the installation from which they were removed. No issues could be found that would prevent this fuel flow divider, fuel lines, or GAMI injectors from producing full rated horsepower.

Picture 9 Fuel Flow Divider

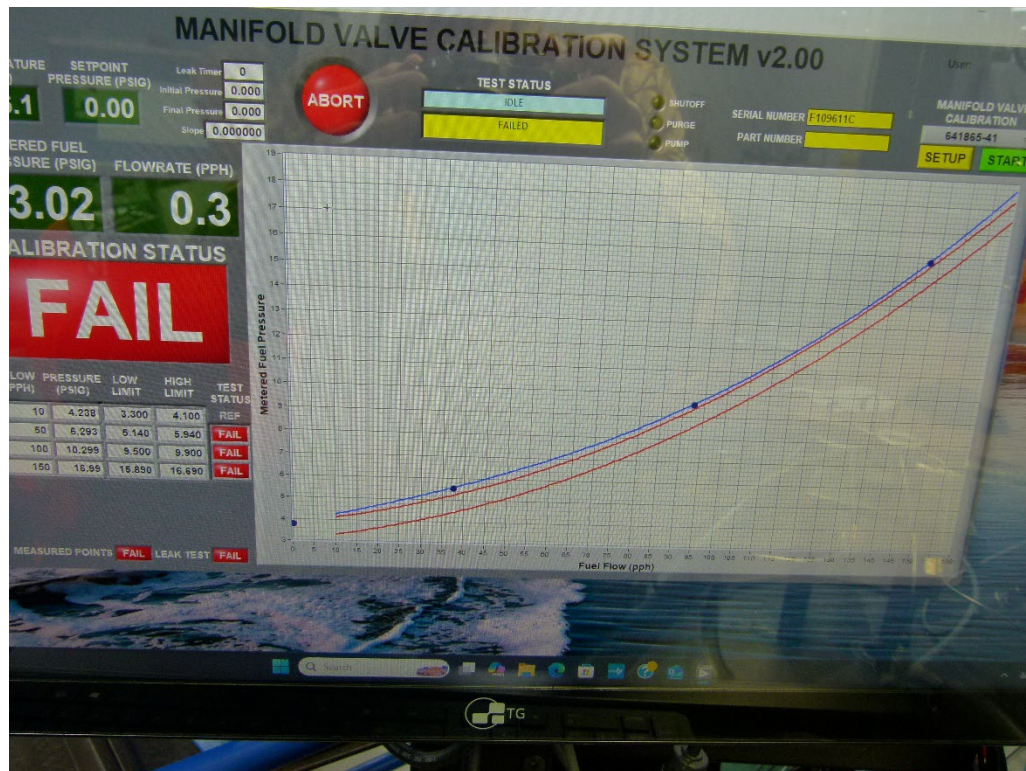
Picture 10 Flow Divider Results
