# National Transportation Safety Board

CEN24LA245

## EXAMINATION SUMMARY

Airplane: Raytheon Aircraft Company A36, N47RT

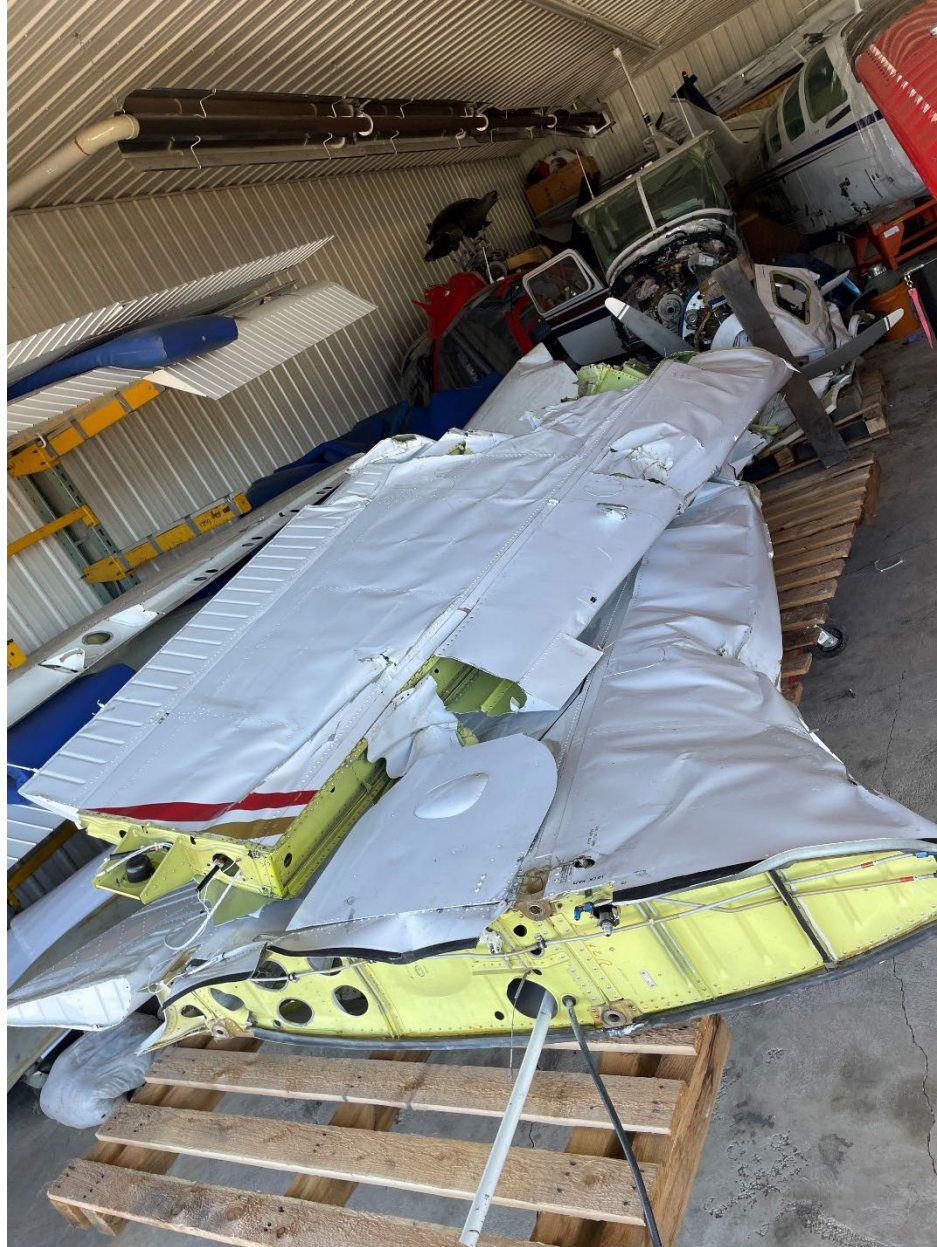
- The engine remained attached to the fuselage via engine mount, it was shifted forward and bent downward.
- Both wings were removed for recovery.
- Left wing had significant impact damage and the right wing had minor impact damage.
- Left wing tank was ruptured.

**Figure 1.** Left and Right wings.

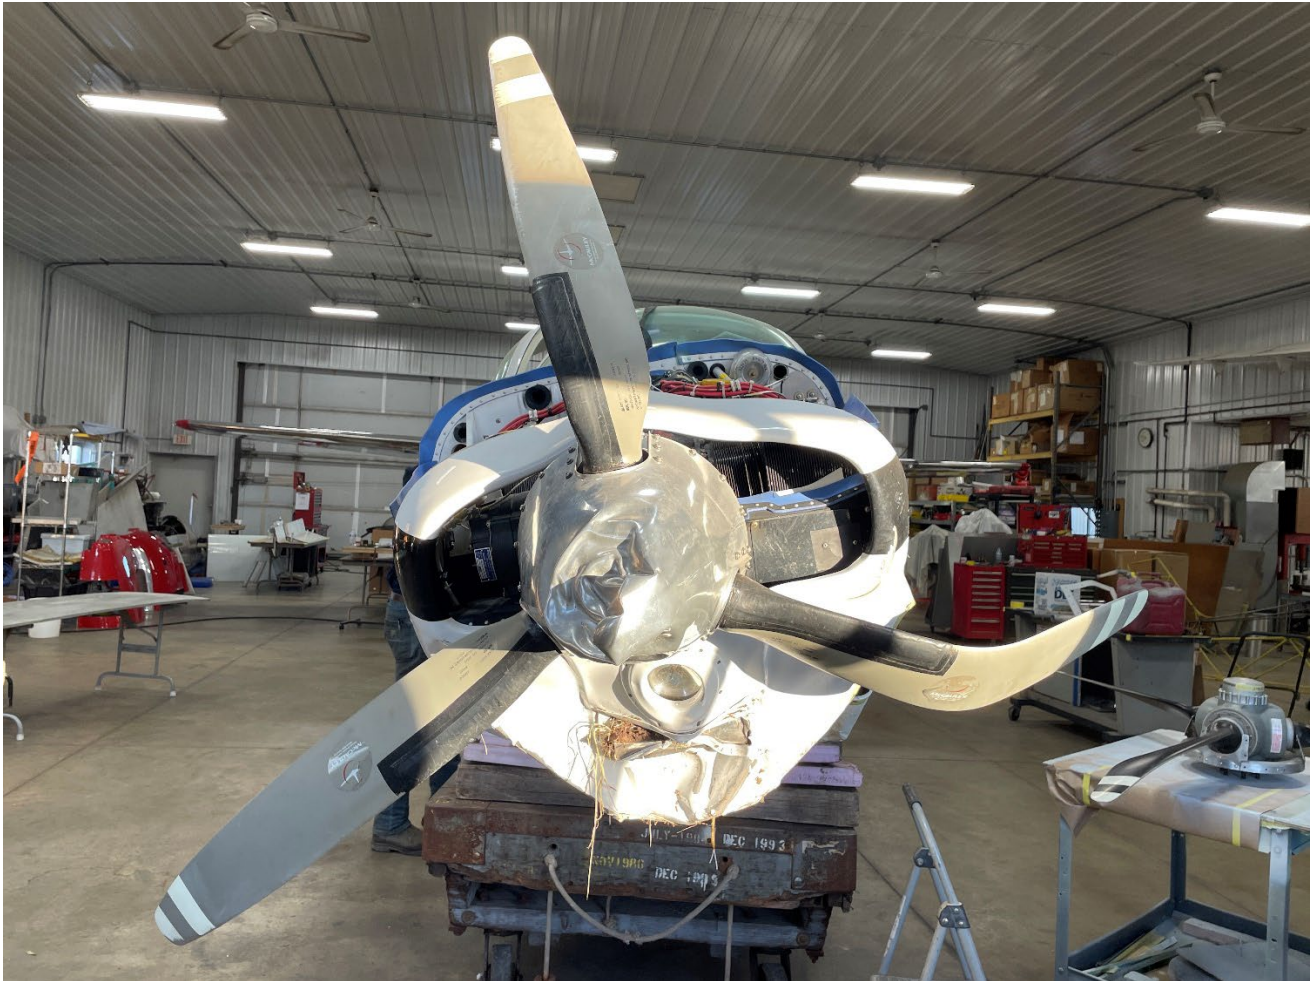
- All 3 of the aluminum propeller blades exhibited some rearward bending consistent to little or no power being produced at the time of impact.

**Figure 2.** Propeller and engine as presented for exam.

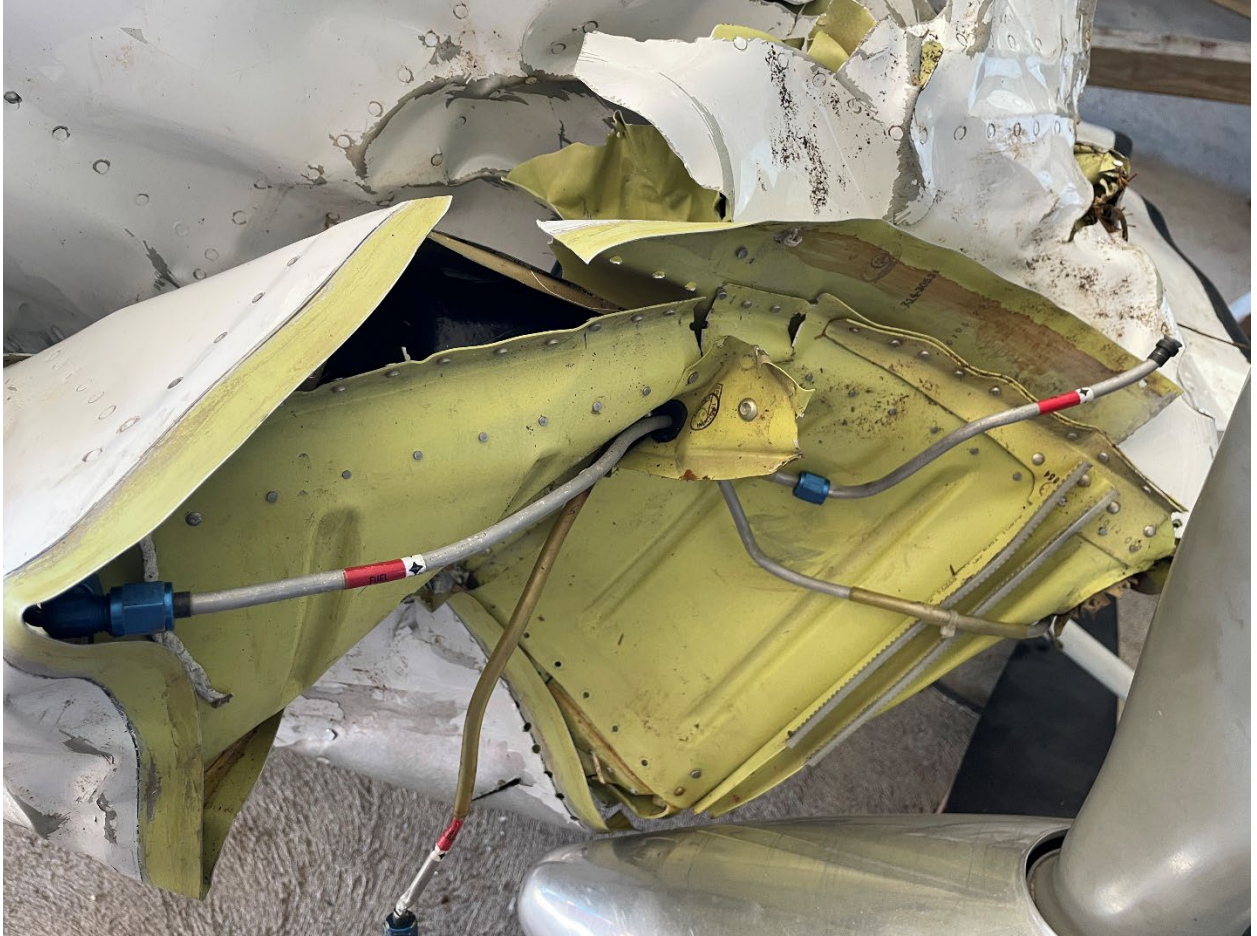
- The left wing fuel tank was ruptured.
- The left wing main supply line was bent and disconnected. When tested with pressurized air, no obstructions were found within the separated line.
- The left wing vent line was tested with pressurized air, no obstructions were noted.
- The right wing supply and vent line were pressure tested, no obstructions were noted.
- All fuel lines including the vapor return lines were tested and free of any blockages.
- The fuel selector valve was tested with pressurized air from the left and right main fuel lines and was consistent with normal operations.

**Figure 3.** Damaged Left wing fuel supply and vent line.
