National Transportation Safety Board

CEN24LA266

## **INVESTIGATION PHOTOGRAPHS**

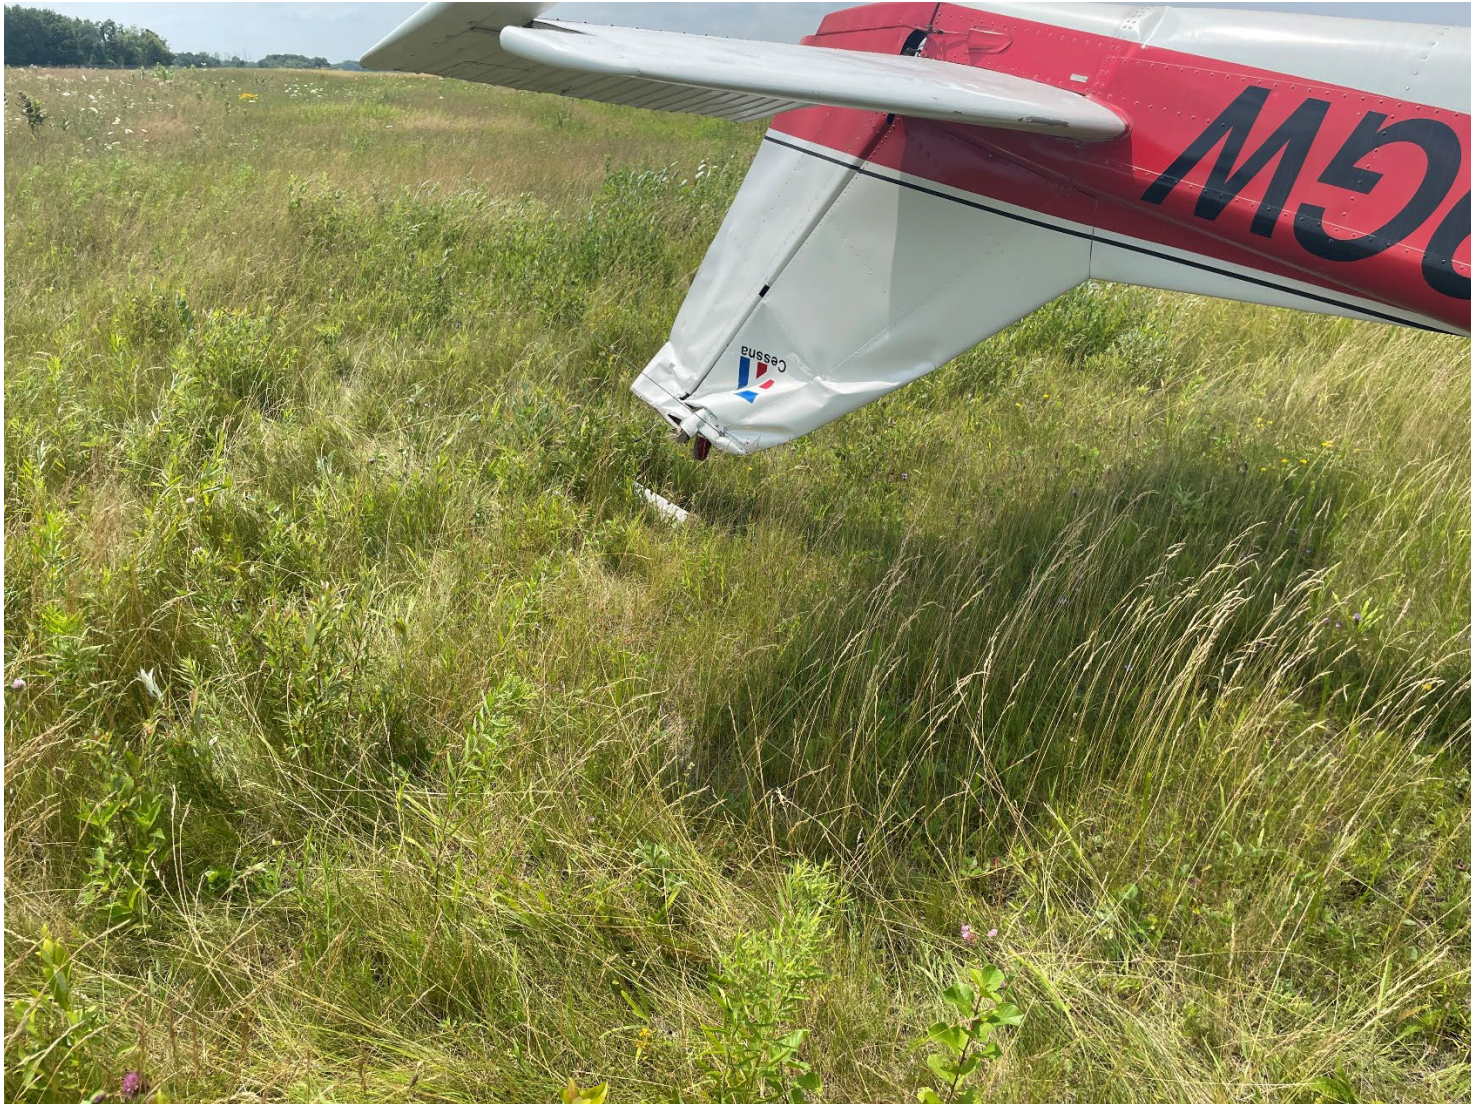
**Photograph 3 - Vertical Stabilizer Damage (Courtesy of FAA)**
