# National Transportation Safety Board

CEN24LA272

## **ENGINE MONITOR DATA SUMMARY**

Date: July 17, 2024  
Time: 1453 central daylight time (1953 UTC)  
Location: Oakland, Nebraska  
Airplane: Air Tractor AT-602  
Registration: N622AW

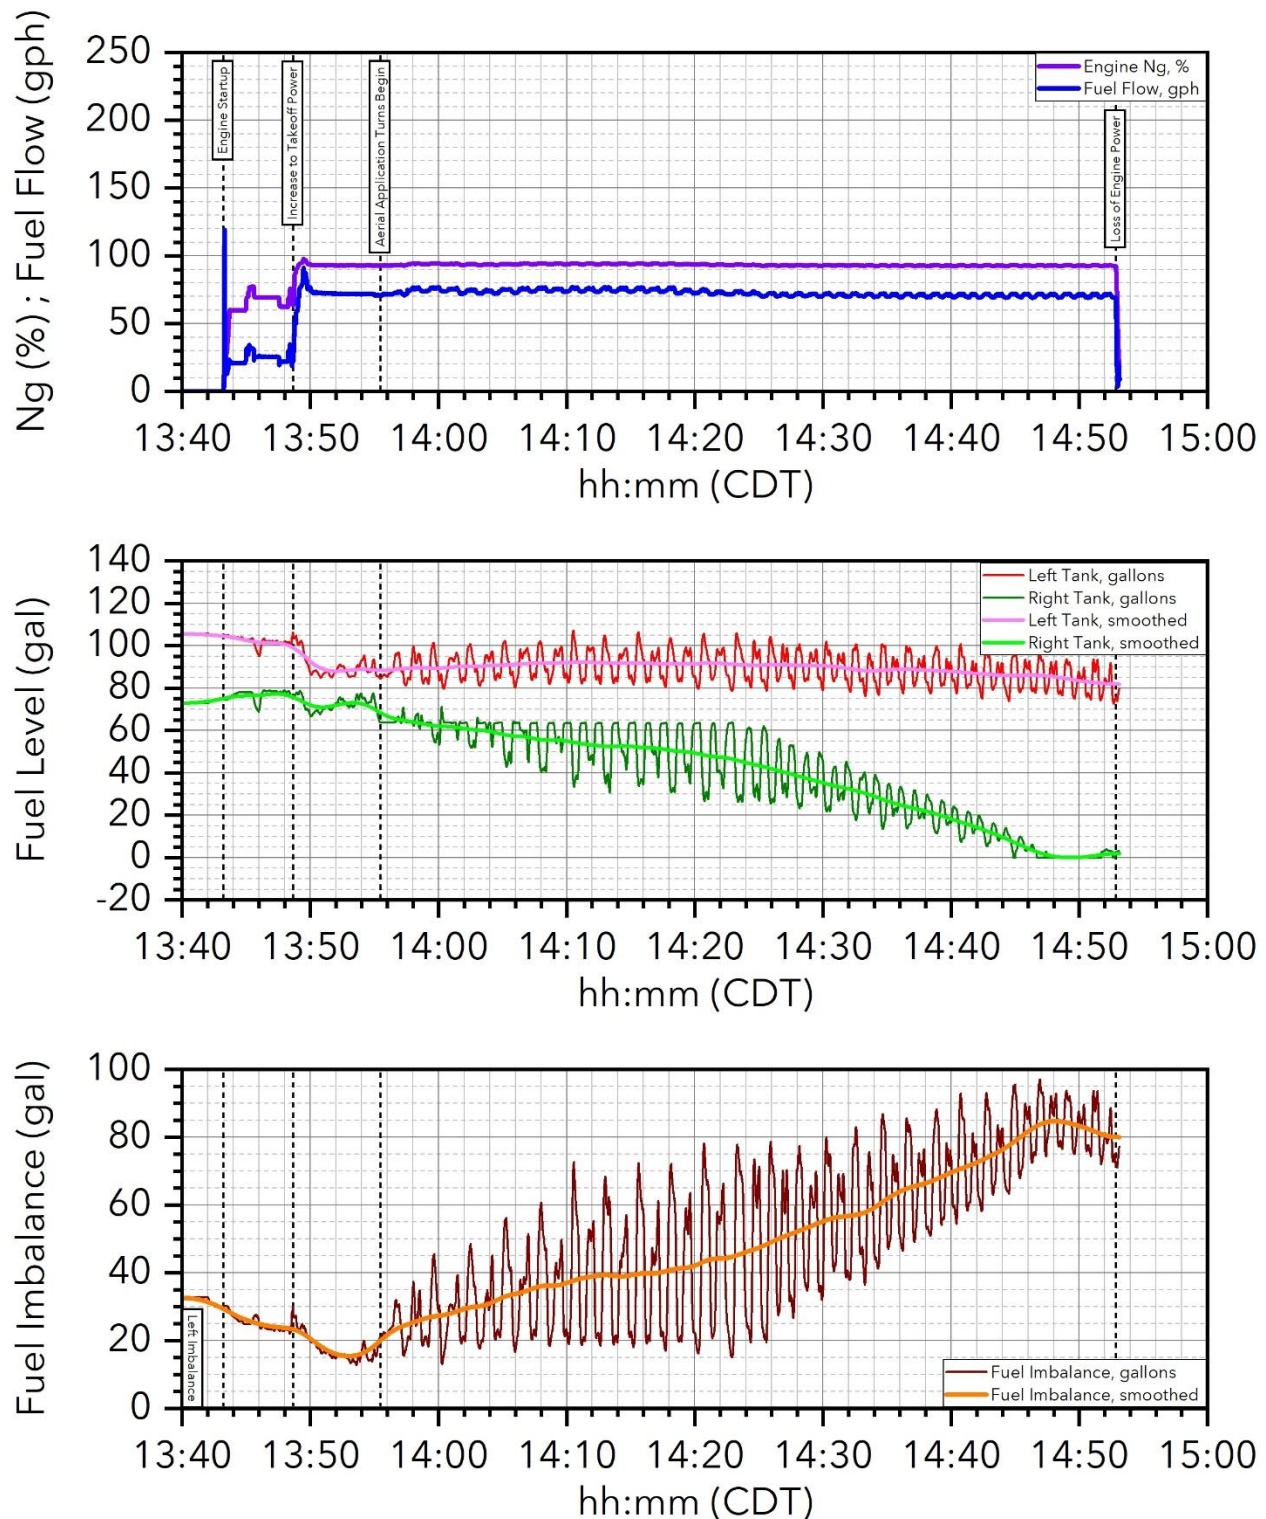
At 1348:40, the gas generator speed (Ng), propeller speed (Np), engine torque, and fuel flow increased to takeoff power levels. After takeoff, the initial 30-gallon fuel imbalance between the wing fuel tanks decreased to about 15 gallons while enroute to the field to be sprayed, as shown in figure 1. According to the Air Tractor AT-602 airplane flight manual (AFM), the wing fuel tanks are interconnected by a 2-gallon header tank and cannot be individually selected.

According to the recorded fuel level in each wing tank, as the pilot conducted aerial-application spray passes there was an overall decrease of fuel from the right-wing fuel tank and a minimal decrease of fuel from the left-wing fuel tank. About 57 minutes 27 seconds after engine startup, the fuel level in the right-wing fuel tank decreased below 11 gallons and engine monitor's master caution parameter activated, as shown in figure 2. The master warning parameter can be activated by several factors; however, at that time the recorded fuel level in the right-wing tank (less than 11 gallons) was the only parameter that would have activated the master caution. Similarly, the AT-602 AFM states that the low fuel warning light in the cockpit illuminates when either fuel tank contains less than 11 gallons. About 24 seconds after the master caution parameter activated, the recorded fuel level in the right tank increased above 11 gallons and the master caution parameter reverted to an inactive status.

**Figure 1.** Plot of engine gas generator speed, fuel flow, fuel tank levels, and fuel imbalance for the entire flight.

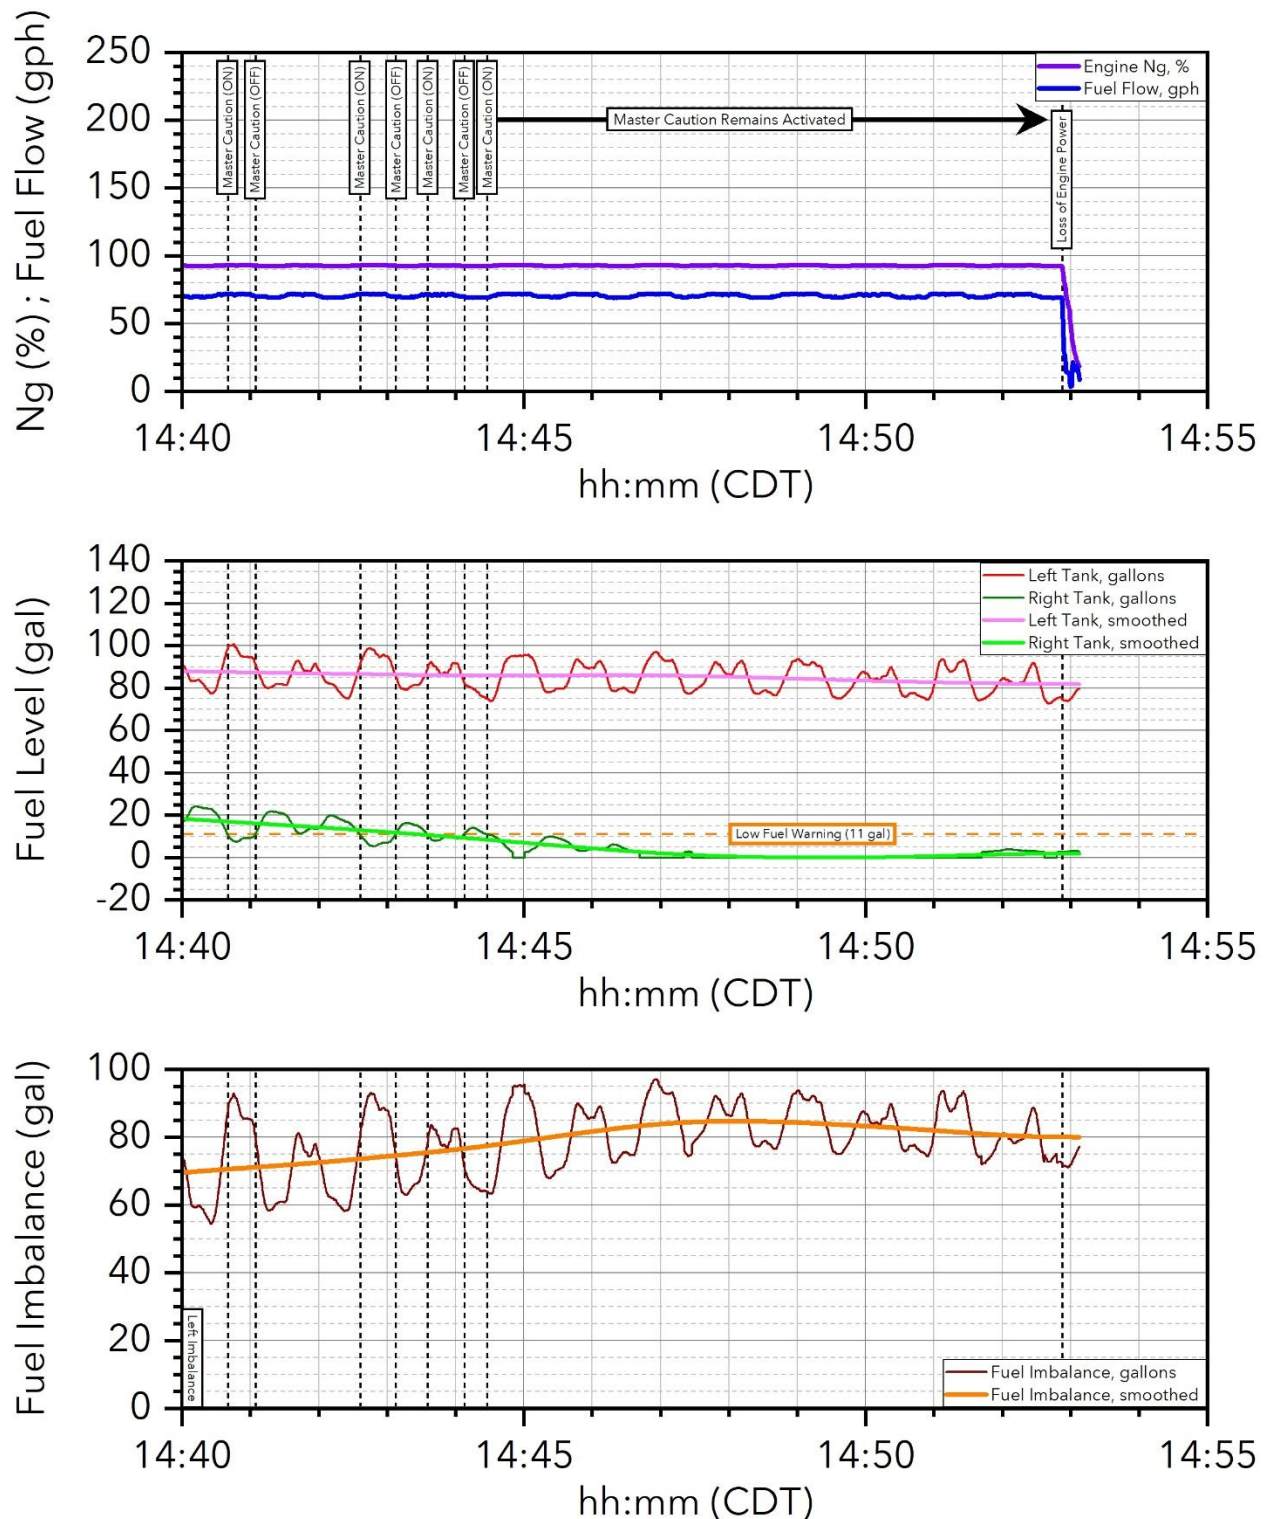
At 1 hour 3 minutes 29 seconds after engine startup, the fuel level of the right-wing tank decreased to 0 gallons. About 6 minutes later, at 1452:53, the engine monitor recorded a sudden loss of fuel flow and corresponding loss of engine power. During the 70 seconds before the loss of engine power, the fuel level of the right-wing tank fluctuated between 0 gallons and 3.8 gallons. According to the airplane owner's manual, the fuel tank sender units do not sense the last 2 gallons in either wing tank. Additionally, the 2 gallons of fuel contained in the header tank are also not indicated.

The loss of engine power occurred 1 hour 9 minutes 39 seconds after the engine startup. About 15 seconds later, at 1453:07, the engine monitor ceased recording data. At the end of the recorded data, the recorded fuel level of the left- and right-wing tanks were 79.8 gallons and 2.5 gallons, respectively.

**Figure 2.** Plot of engine gas generator speed, fuel flow, fuel tank levels, and fuel imbalance at the end of the flight.

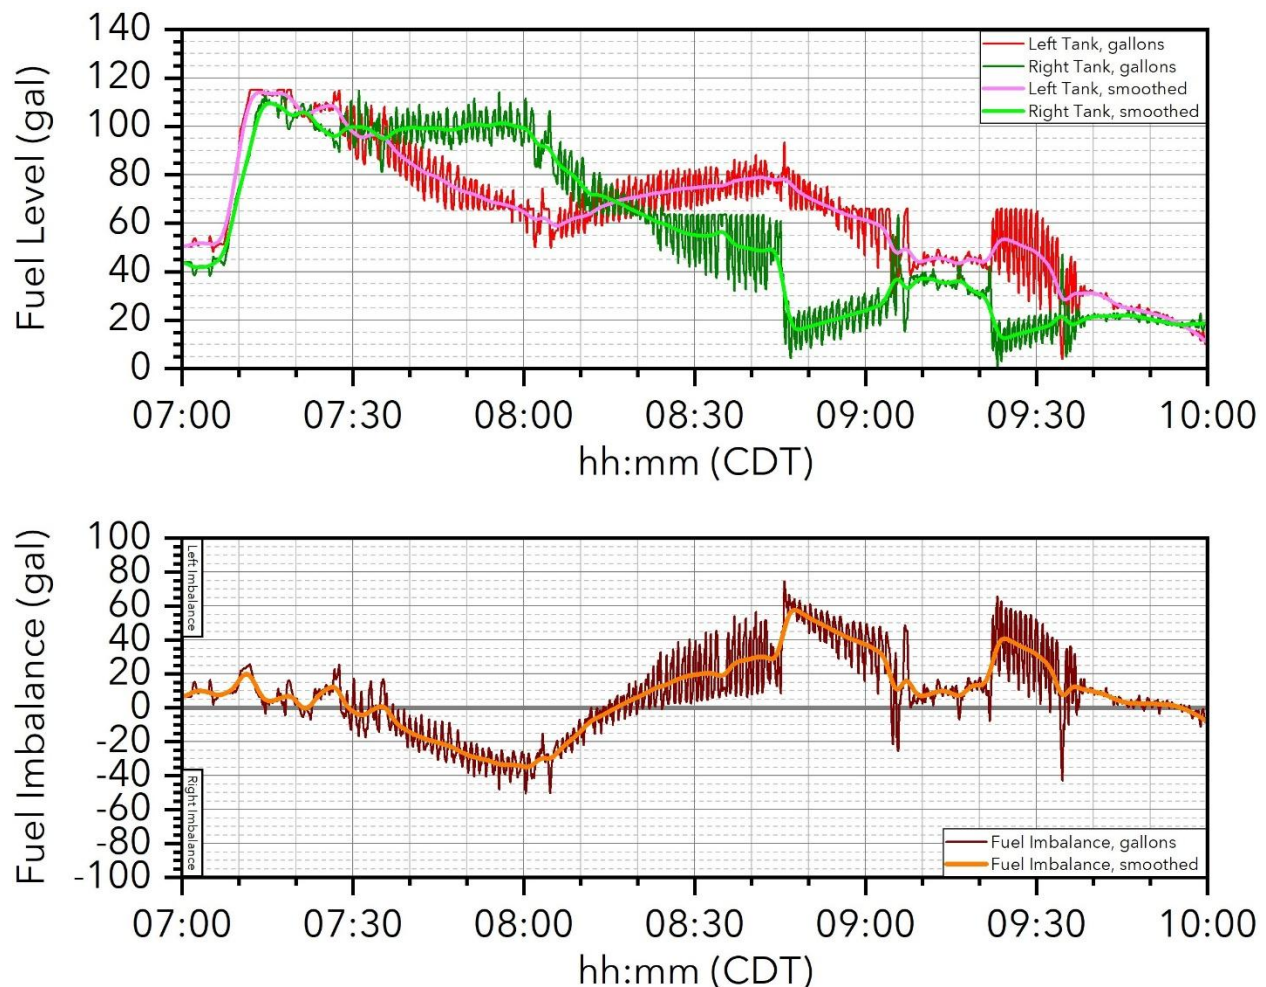
Additional review of the engine monitor data revealed a history of fuel imbalance during the previous 3 flights flown on the day of the accident. During these previous flights, the recorded fuel level in each tank would fluctuate at least  $\pm 10$  gallons during each spray pass. However, unlike the accident flight, after an initial decrease in fuel level from either the right- or left-wing fuel tank there was a recorded increase in fuel level to that same fuel tank, as shown in figure 3. This recorded increase in fuel level in a tank was observed in both the left- and right-wing fuel tanks during separate portions of the previous 3 flights that were reviewed.

Particularly, when one wing fuel tank recorded a decrease in fuel level the opposite wing fuel tank either yielded a minimal decrease or a net increase in fuel level as the flight progressed. This nonuniform depletion of fuel from each fuel tank was primarily observed while the pilot conducted aerial-application spray passes. There were other portions of the flight, likely as the pilot flew to/from a field, where any fuel imbalance trended toward a more balanced fuel load.

**Figure 3.** Plot of fuel tank levels and fuel imbalance during a previous flight.
