Jennifer Rodi  
Senior Air Safety Investigator  
Central Region

**Date:** July 24, 2024

**Subject:** CEN24LA282 - Flap System Examination

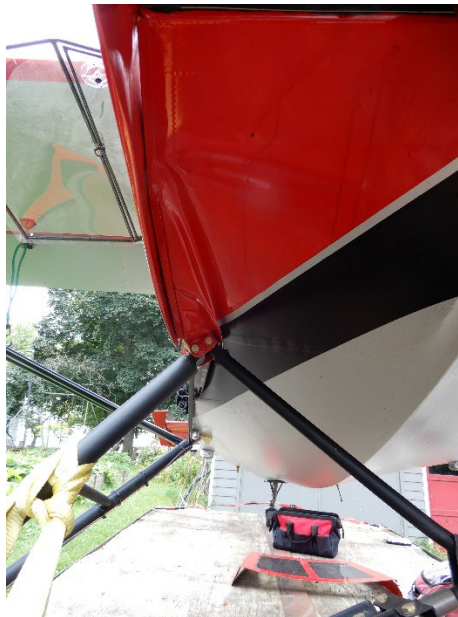
The airplane was strapped to a trailer and the wings were positioned back in place to facilitate the examination. Substantial damage was observed on the right side of the fuselage structure forward of the main landing gear. (Figure 1)

Figure 1. Substantial damage on right side of fuselage

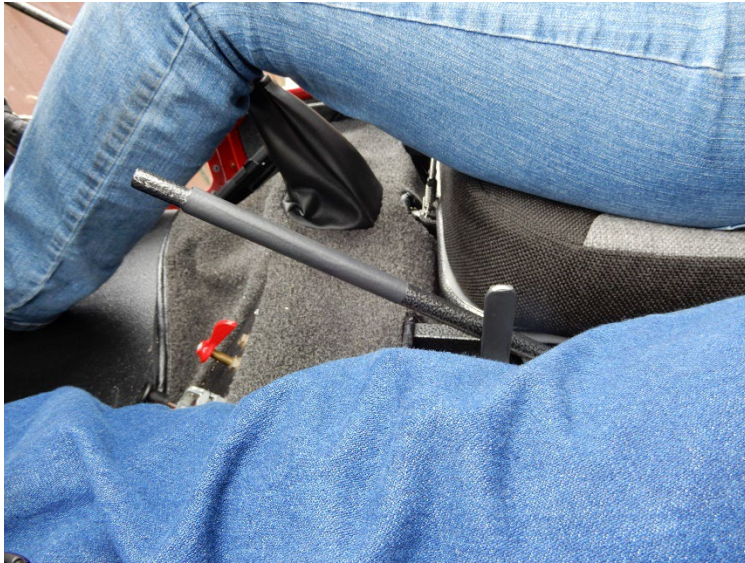
The flap handle was positioned between the right and left seat. (Figure 2) There were 3 positions of flaps with full flaps at 40°. A clear detent existed in each position with a cupped notch for each of the 3 flap positions. (Figure 3) The button at the top of the flap handle depressed about 1/4 inch to release the interlock and extend or retract the flaps.

Figure 2. Flap handle on the floor between the right and left seat.

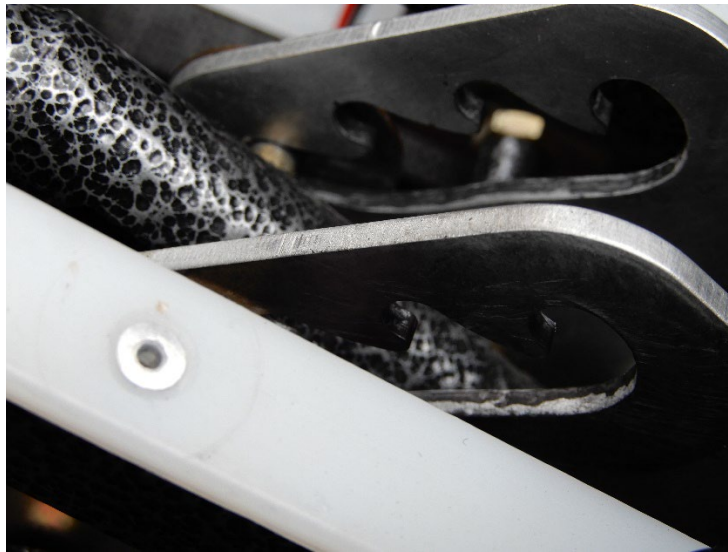
Figure 3. Flap detent.

The flaps were manipulated in and out of the fully extended flap position using the flap actuator handle. The flap controls were continuous and extended and retracted the flaps as designed. The flap actuator handle remained secure in the detent. Investigators were unable to duplicate the uncommanded retraction of the flaps from 40° to 0°.
