# National Transportation Safety Board

CEN24LA282

Specialist's Factual Report

Location: Oshkosh, WI  
Date: July 20, 2024  
Time: 1721 central daylight time (CDT)  
Airplane: Just Highlander, Private, N707KM

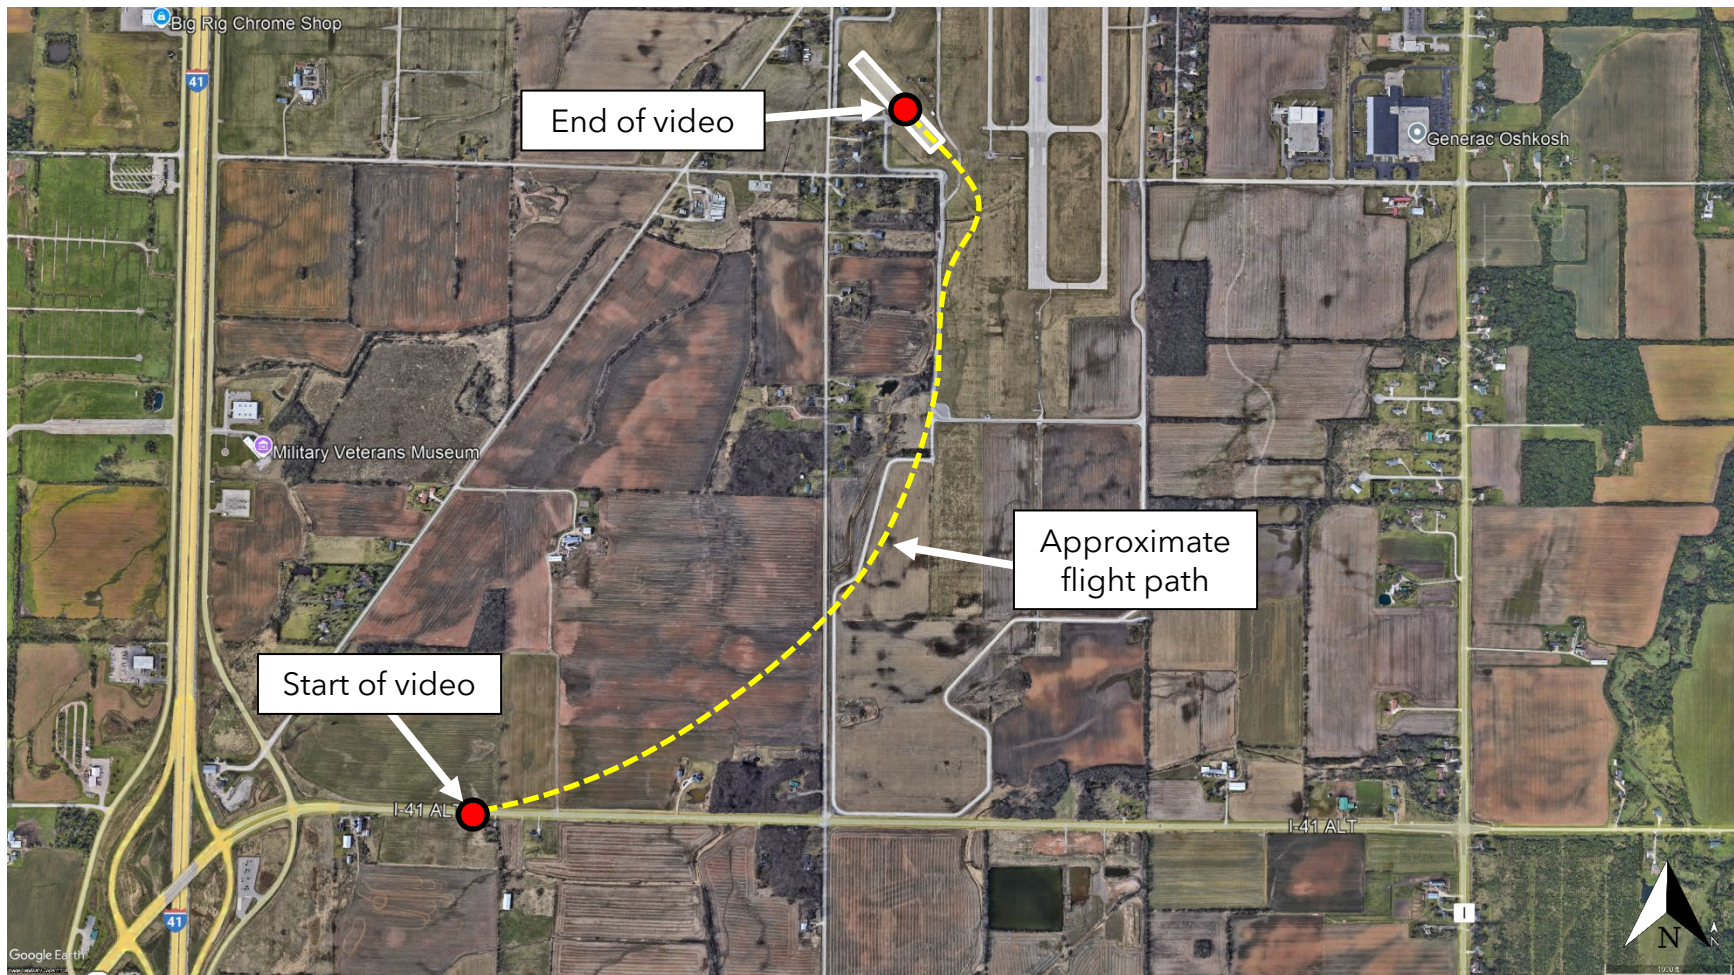
An approximation of the aircraft's ground track, overlaid on Google Earth as determined from the video, is shown in Figure 1. Note that the weather and lighting conditions in the overlay may not represent the conditions at the time of the accident.

**Figure 1.** Approximate flight path of accident aircraft from video (Source: Google Earth; annotated by NTSB).
