CEN24LA286

## INVESTIGATION PHOTOGRAPHS

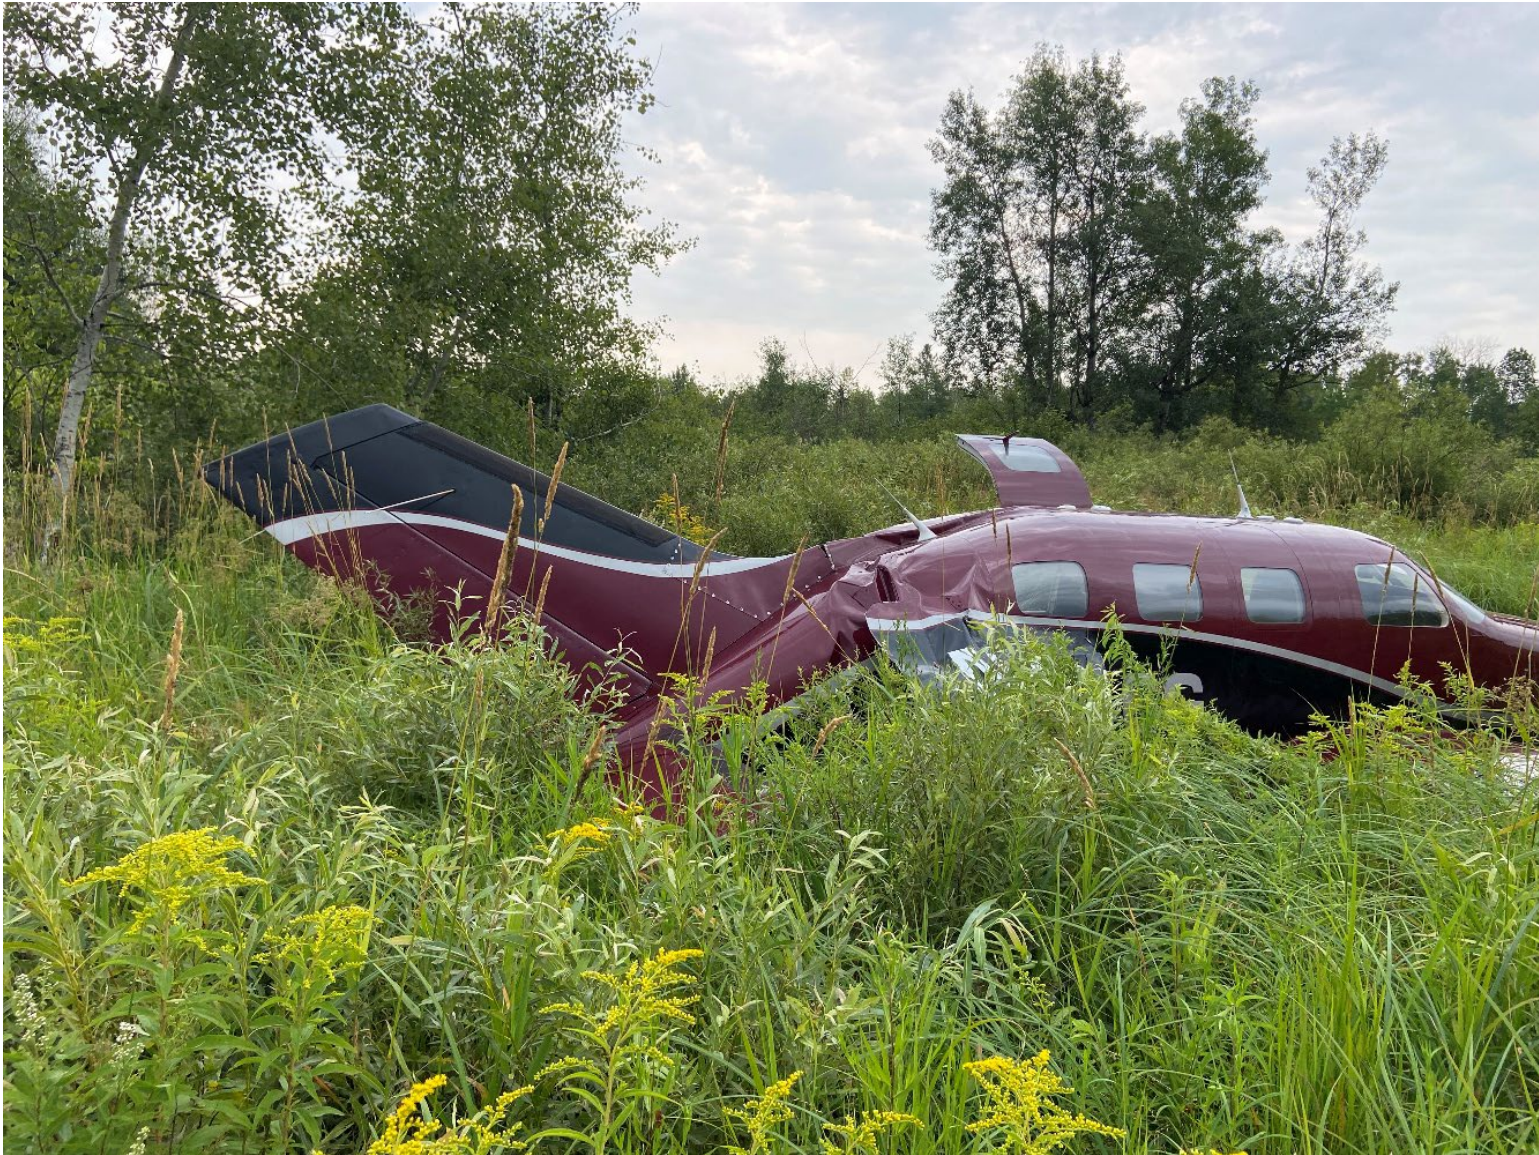
**Photograph 1 - View of the right side of the airplane at the accident site (courtesy of the Federal Aviation Administration)**

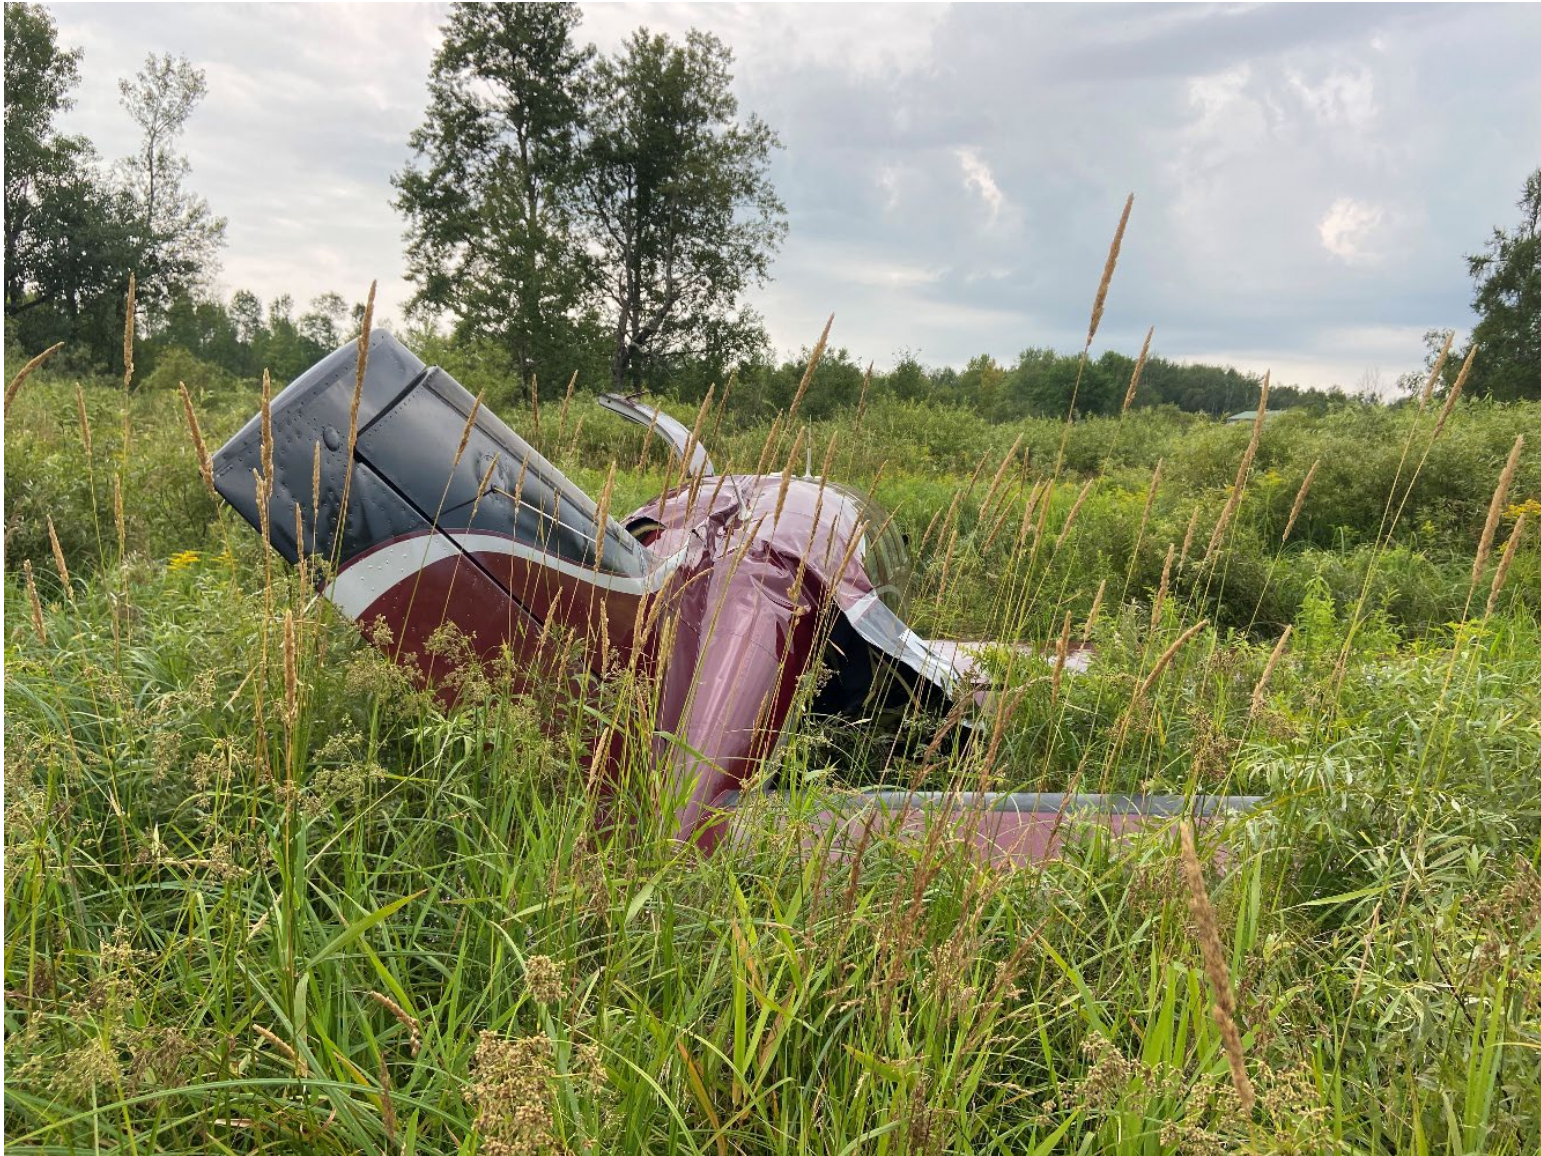
**Photograph 2 - View of the rear of the airplane at the accident site (courtesy of the Federal Aviation Administration)**

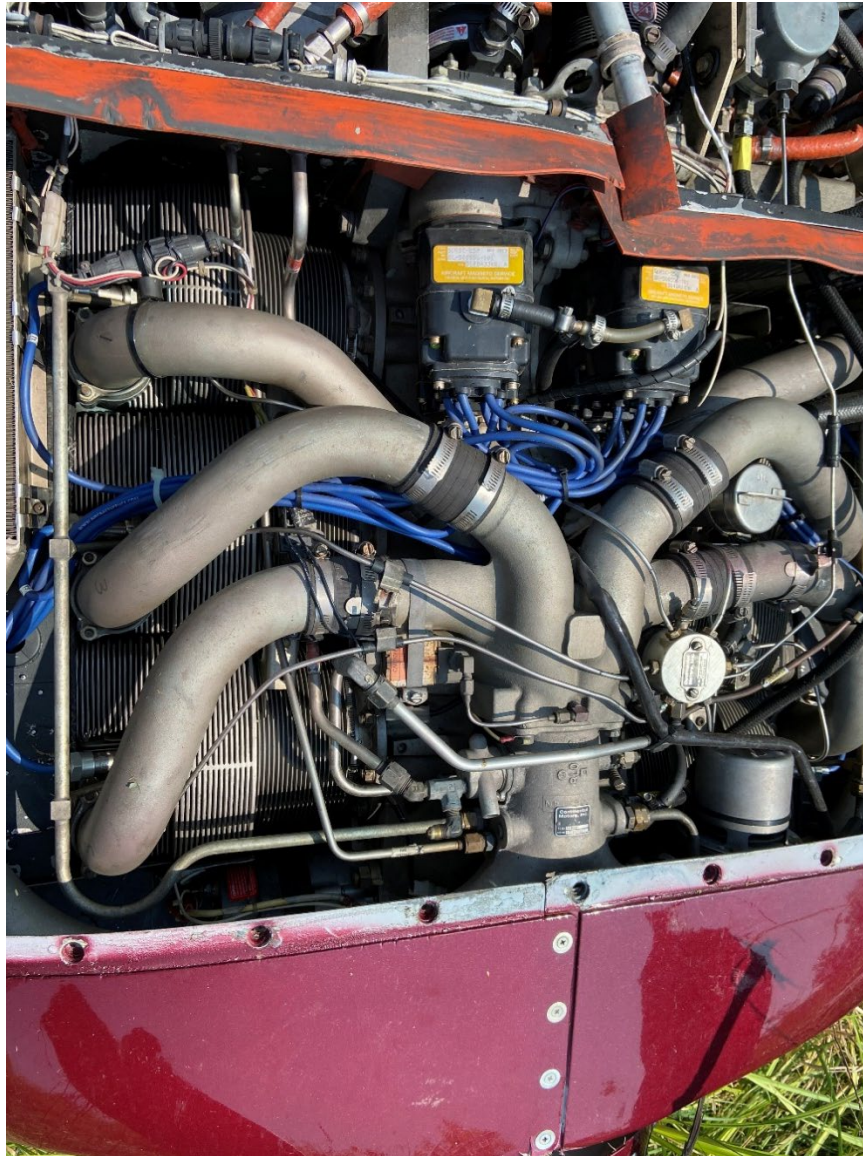
**Photograph 3 - View of the engine at the accident site (courtesy of the Federal Aviation Administration)**

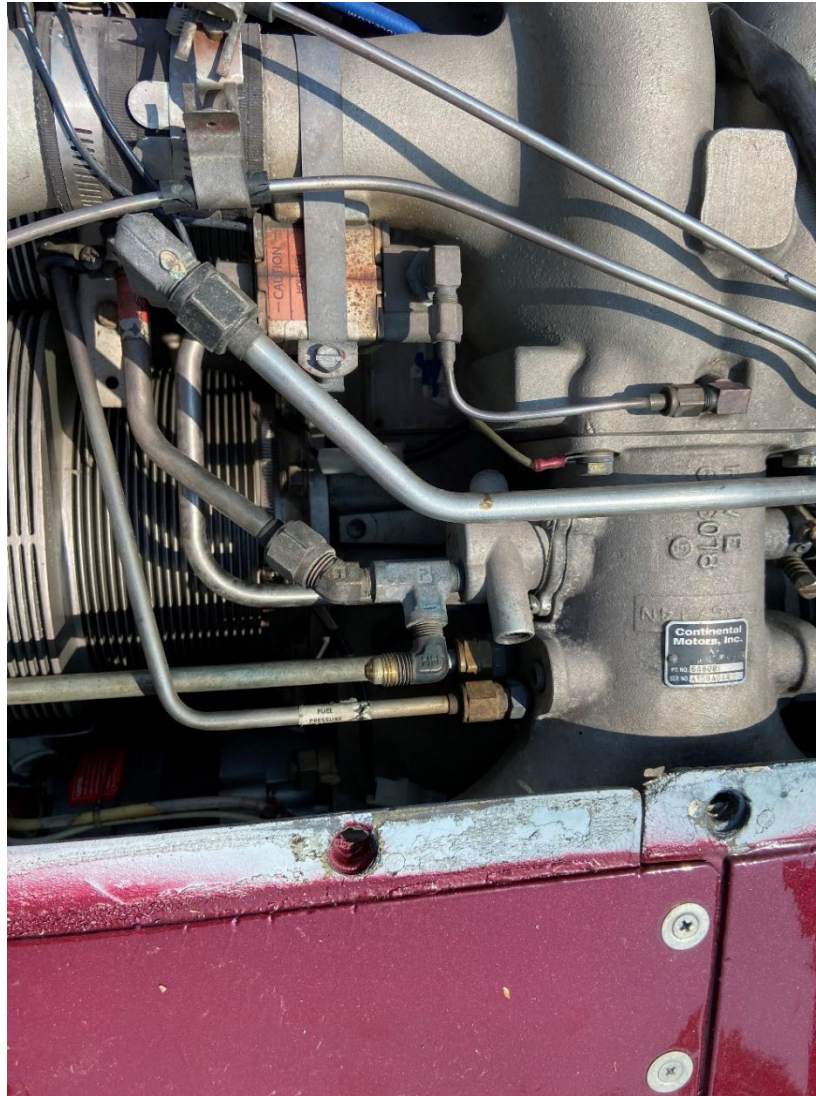
**Photograph 4 - View of the metered pressure test fitting at the accident site, with the protective cap not installed and blue staining present on the fitting (courtesy of the Federal Aviation Administration)**

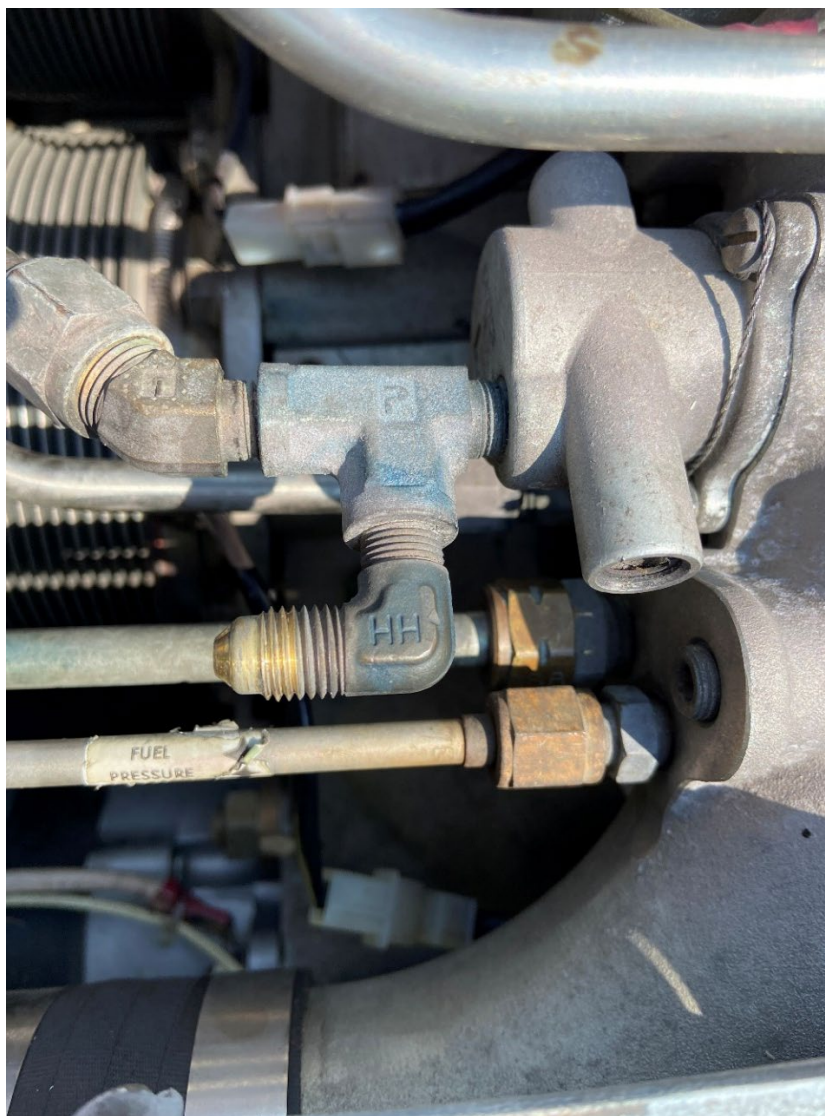
**Photograph 5 - View of the metered pressure test fitting at the accident site, with the protective cap not installed and blue staining present on the fitting (courtesy of the Federal Aviation Administration)**
