National Transportation Safety Board

CEN24LA288

## **INVESTIGATION PHOTOGRAPHS**

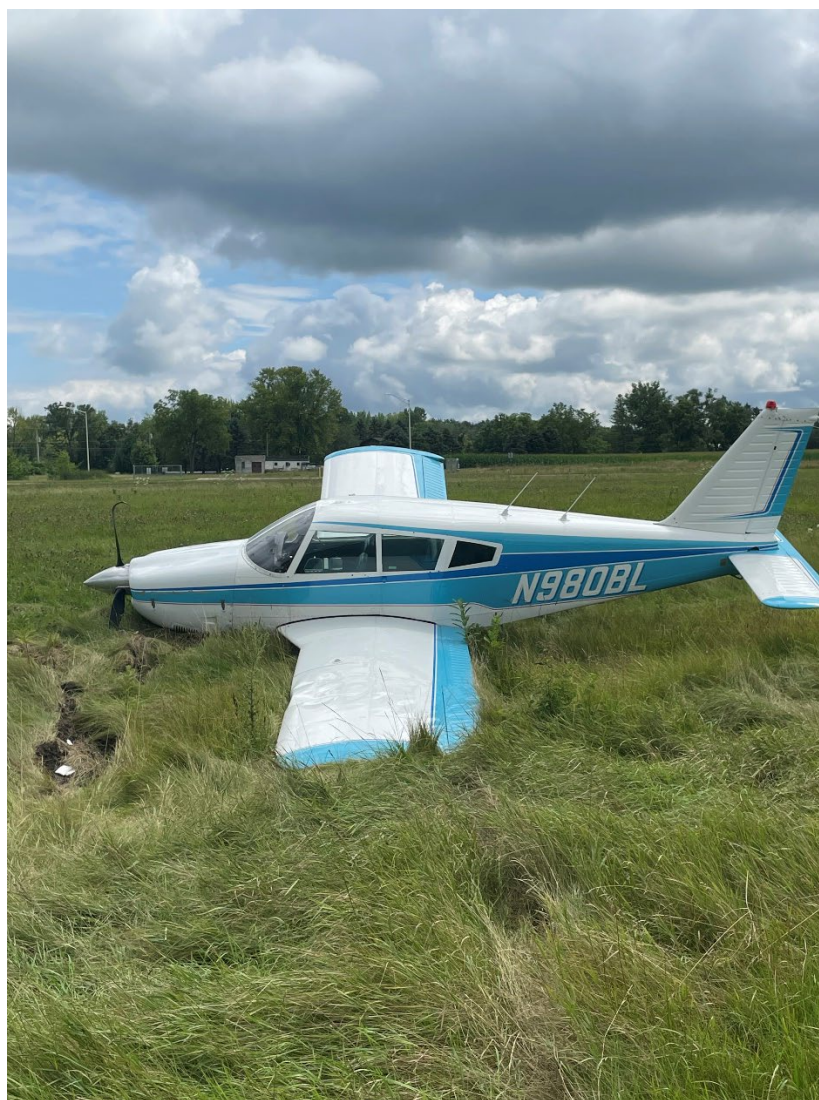
**Photograph 1 - Accident site (Courtesy of FAA)**

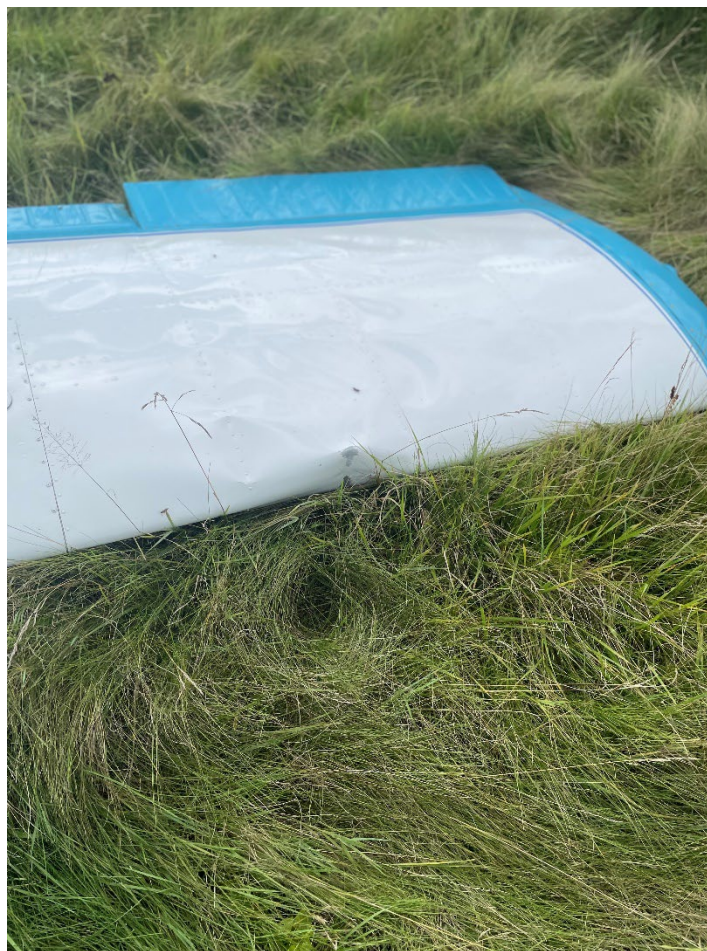
**Photograph 2 - Outboard end of left wing (Courtesy of FAA)**

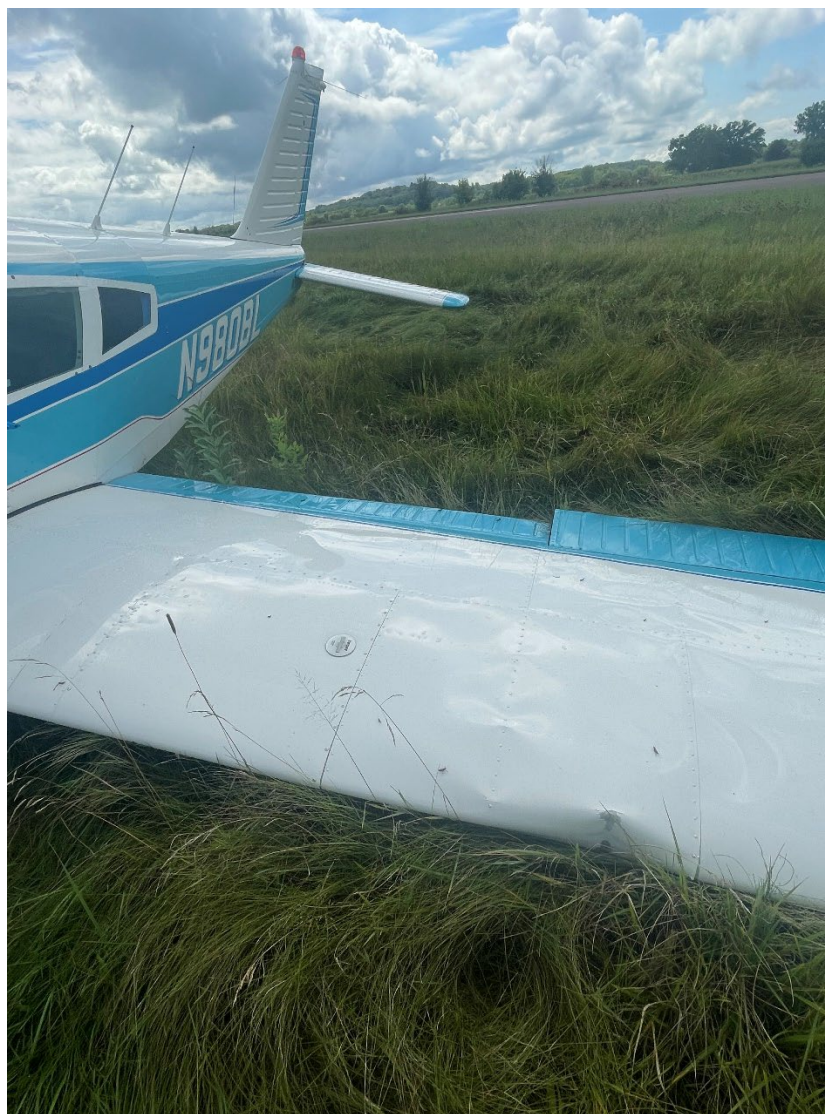
**Photograph 3 - Left wing inboard to mid-span (Courtesy of FAA)**

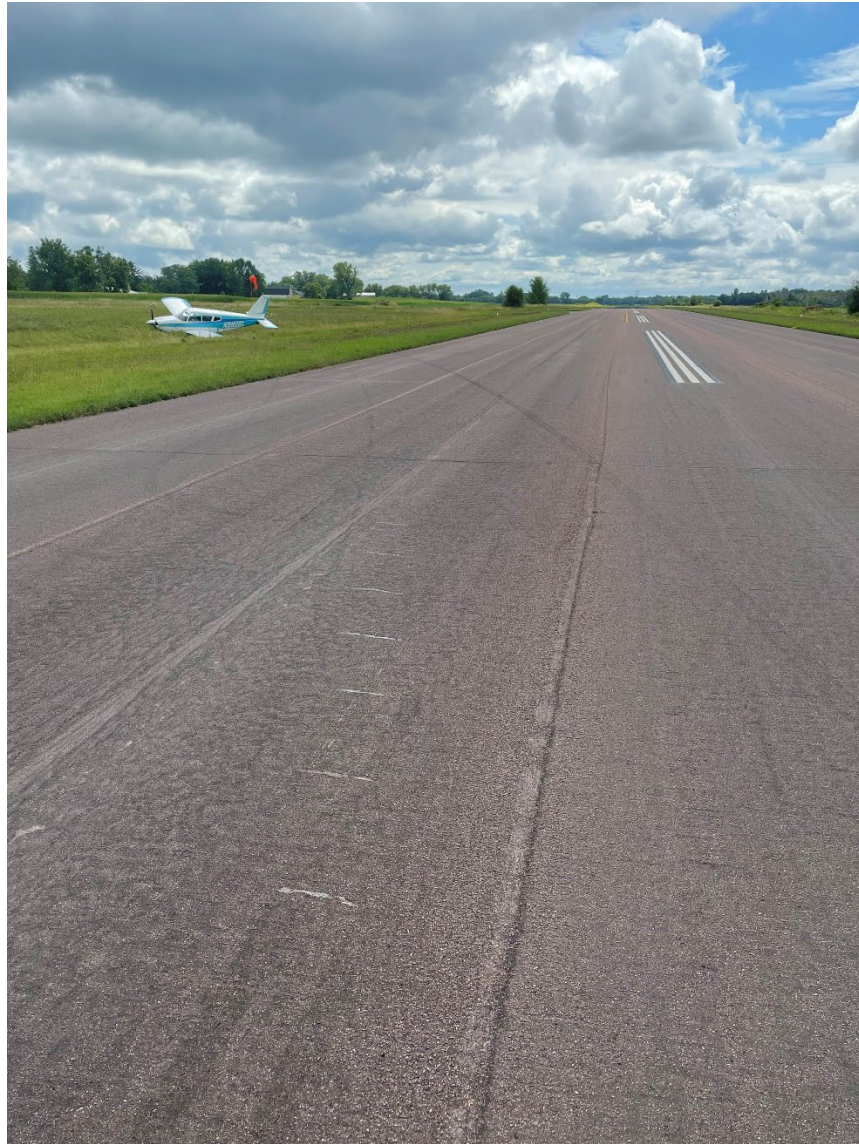
**Photograph 4 - Ground scars on runway (Courtesy of FAA)**
