CEN24LA300

## INVESTIGATION PHOTOGRAPHS

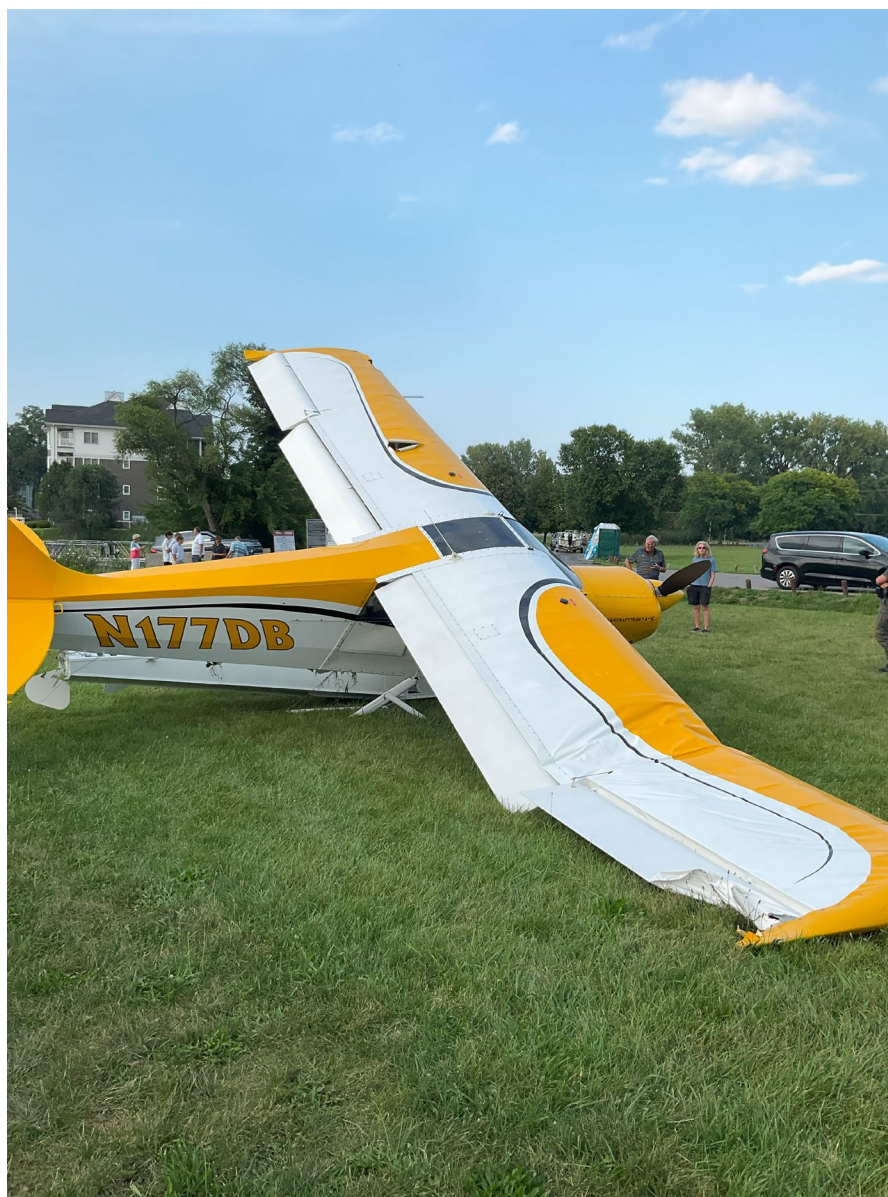
**Photograph 1 - Right Wing and Aileron Substantial Damage (Courtesy of FAA)**

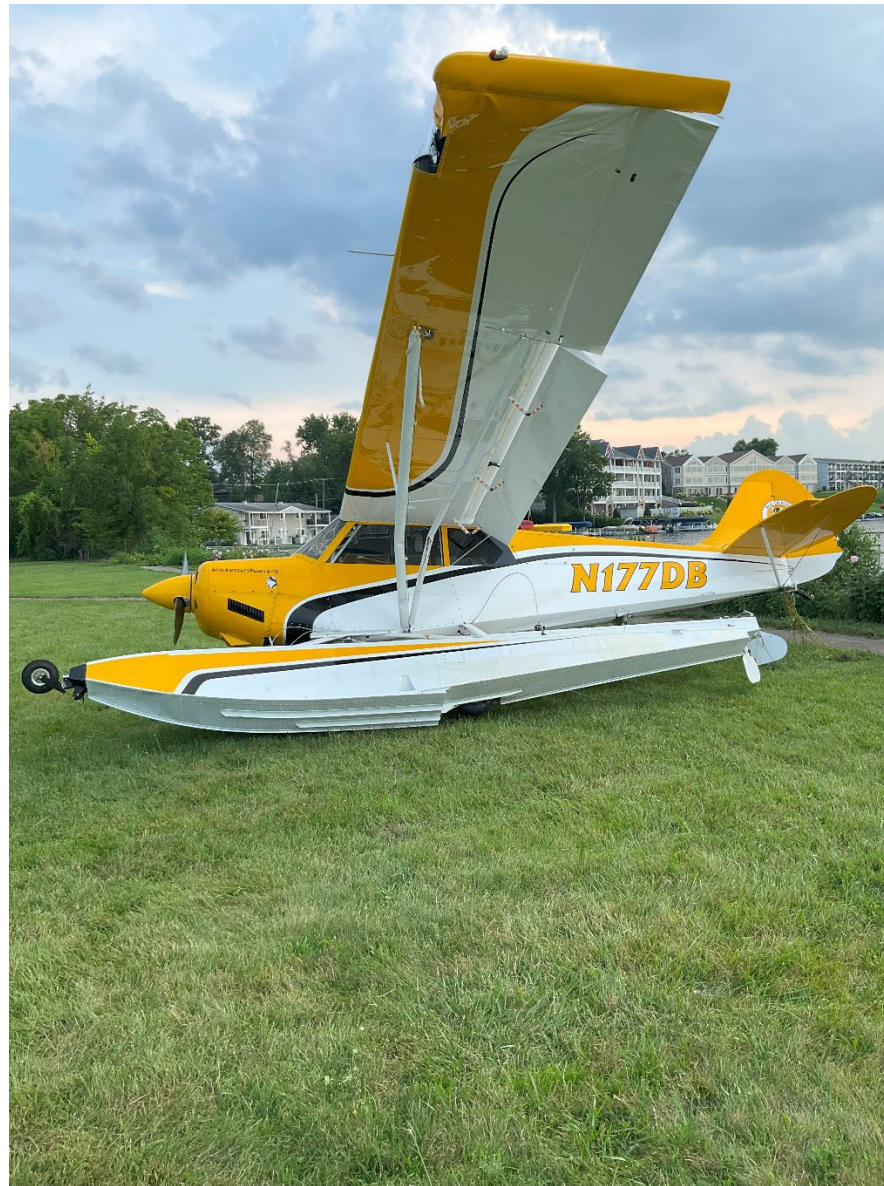
**Photograph 2 - Left Wing Strut Substantial Damage (Courtesy of FAA)**
