# Carburetor Icing Probability Graph – CEN24LA301

Airplane: Dendy Tailwind W10

Accident Date: 08/03/2024

Accident Location: West Livingston, TX

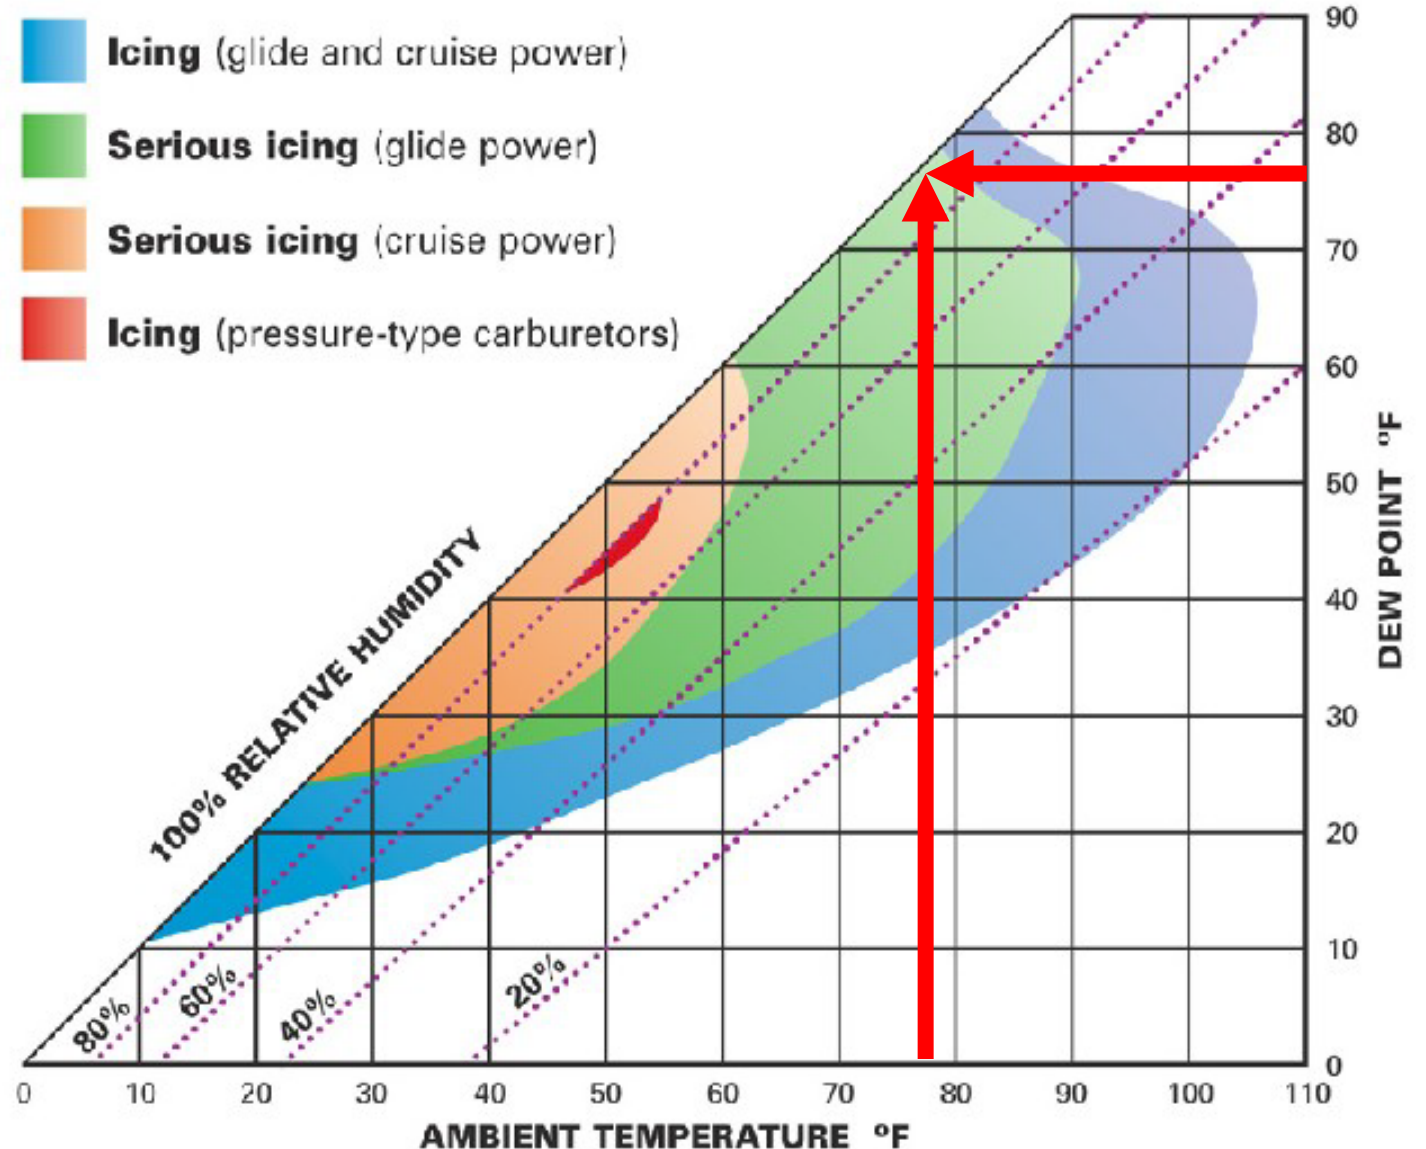
Weather: Local METAR temperature 78.8° F; dew point 77° F
