CEN24LA303

## INVESTIGATION PHOTOGRAPHS

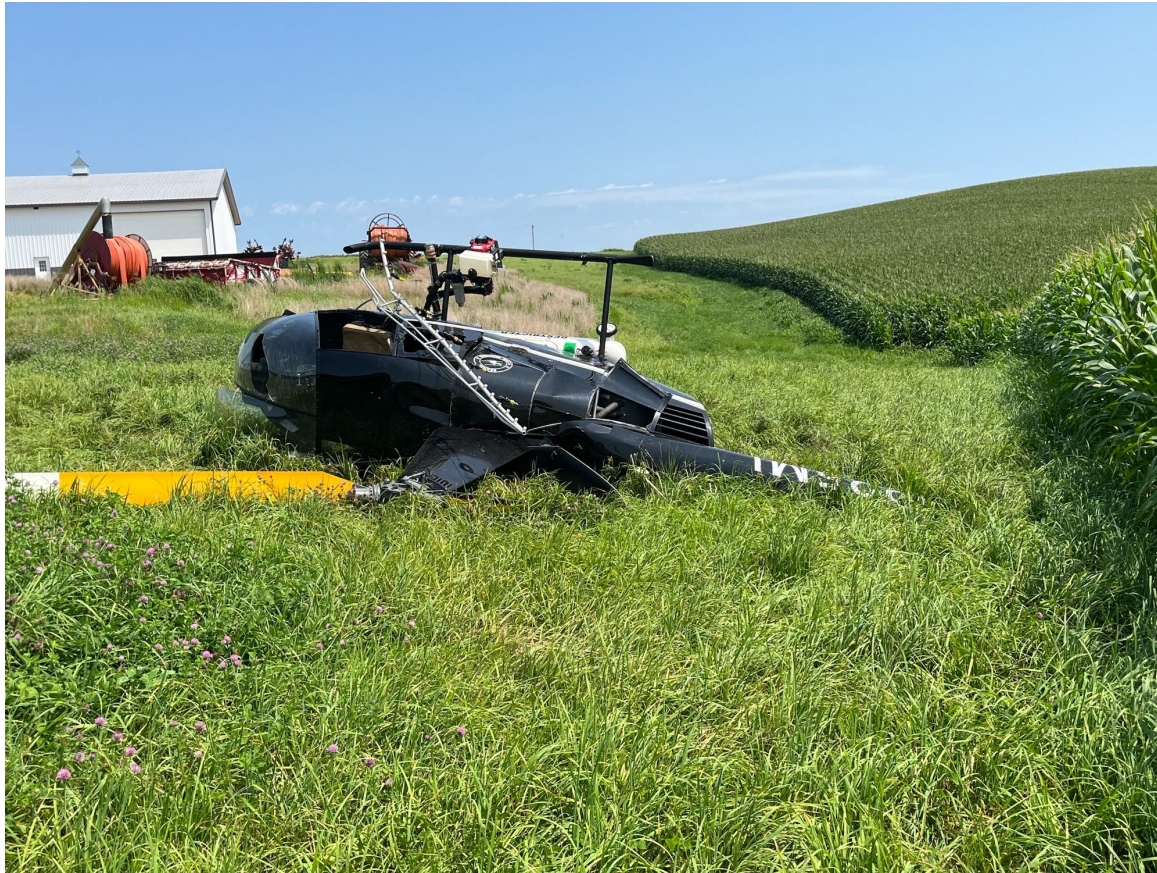
**Photograph 1 - Helicopter at accident site (Courtesy of FAA)**

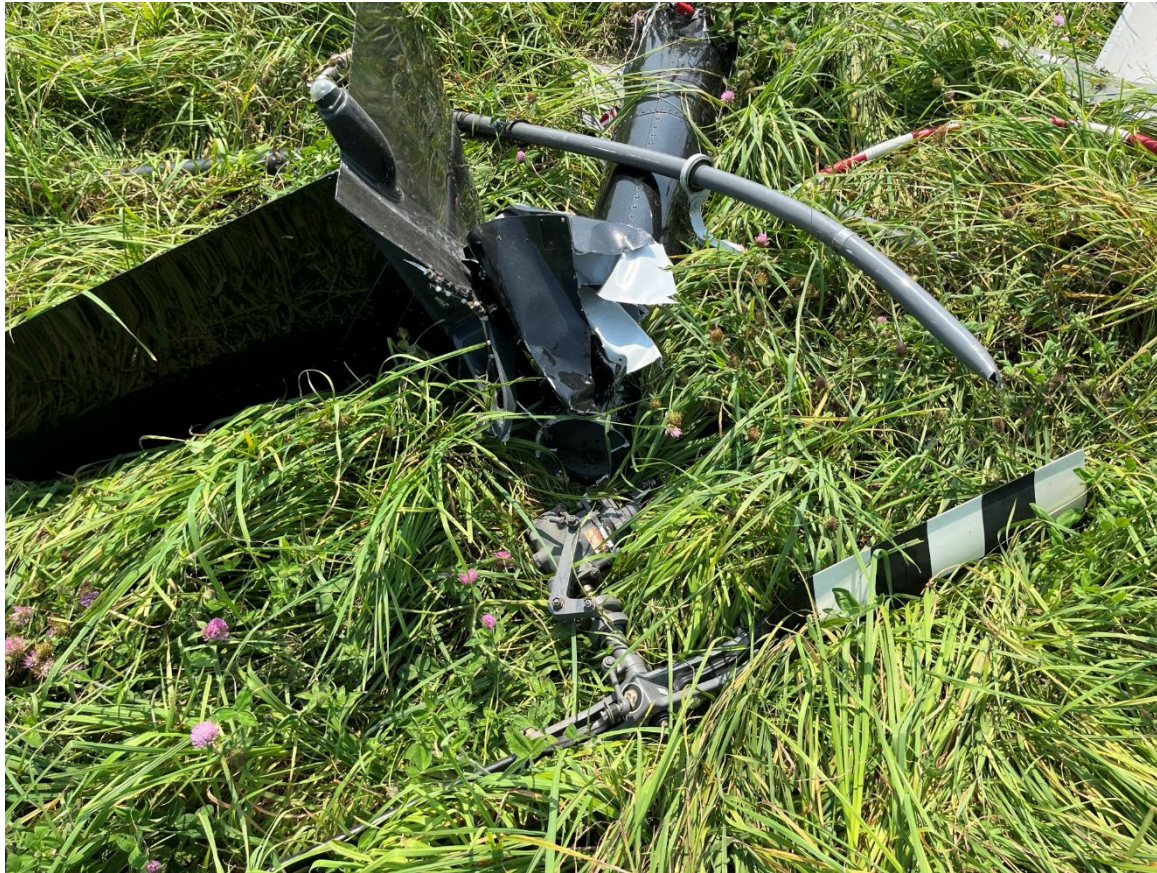
**Photograph 2 - Helicopter tail rotor gearbox (Courtesy of FAA)**
