# National Transportation Safety Board

CEN24LA303

## EXAMINATION SUMMARY

Location: Bryant, Iowa  
Date: August 3, 2024  
Time: 1415 central daylight time  
Helicopter: Robinson R44, N225ML

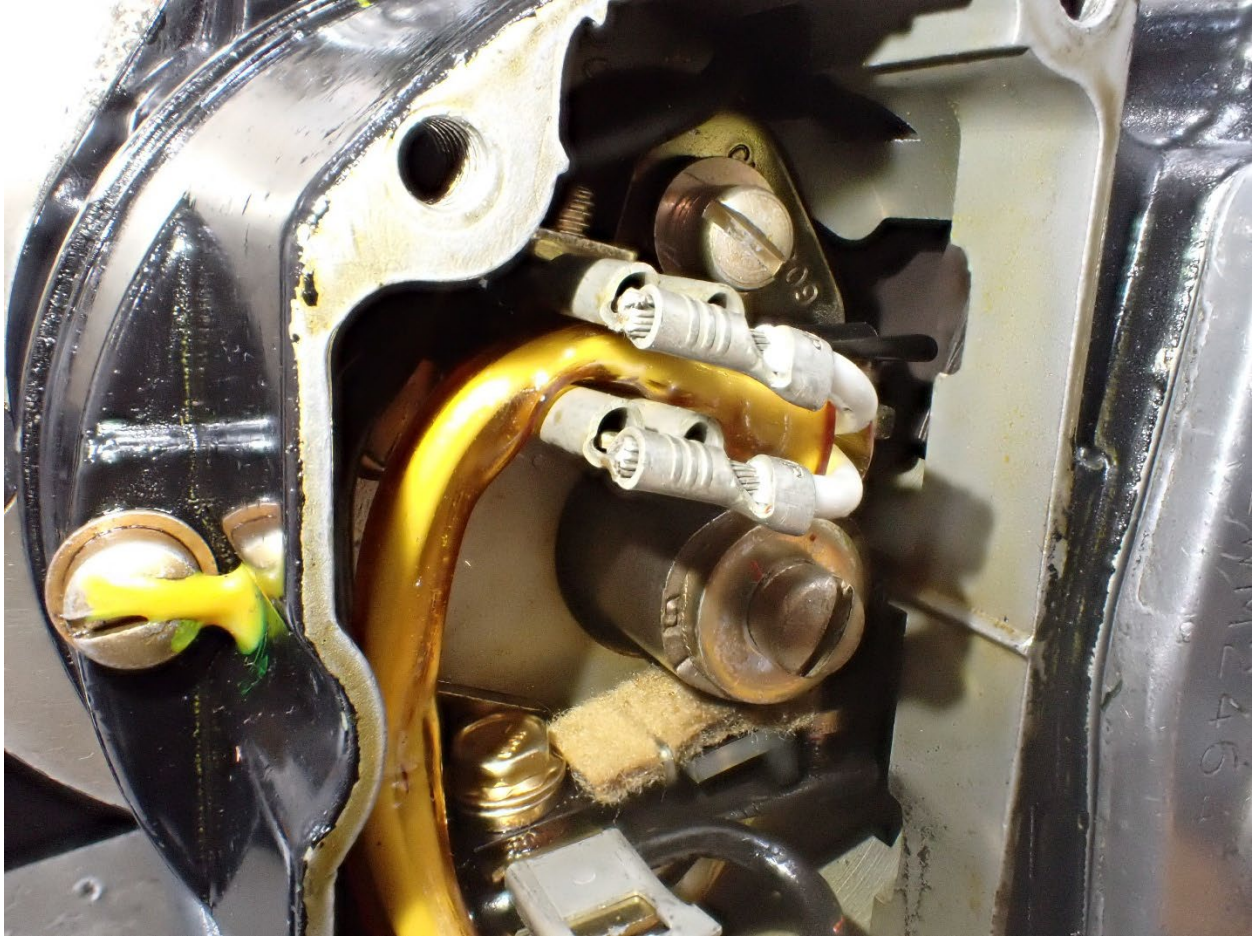
The governor system components were attached to a test bench. The magneto was tested at various speeds with no anomalies noted. The coming in speed was below 500 rpm for the magneto. The tachometer wires in the magneto had a protective tubing installed. The wires were improperly routed through the points compartment as shown in figure 1. Electrical continuity was verified with the points closed and continuity was broken when the points were open. Although the wires were improperly routed, no damage was found to the wires and functioned normally when tested. The point gap was measured at .020 in. The specification for the point gap is .019 in +/- .003.

Figure 1. Tachometer wires inside magneto points compartment.
