CEN24LA306

## INVESTIGATION PHOTOGRAPHS

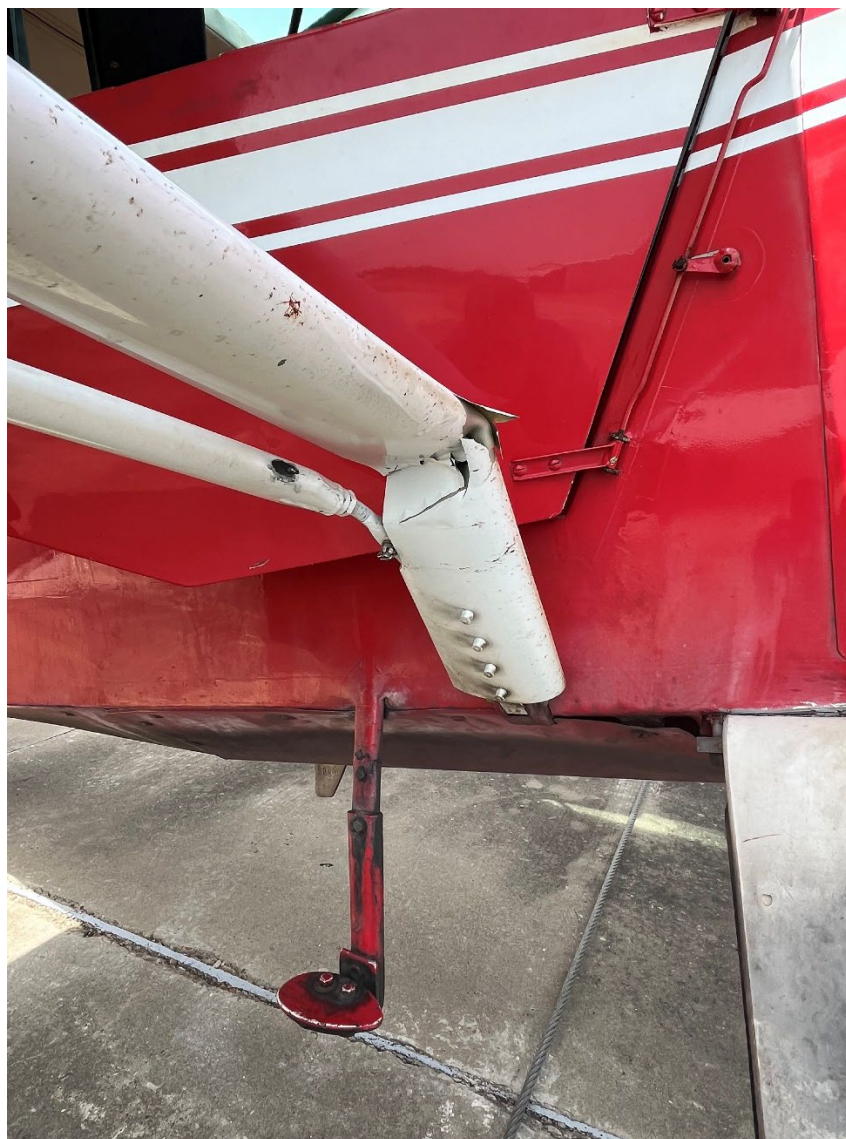
**Photograph 1 - Right Wing Strut Damage (Source - Federal Aviation Administration)**

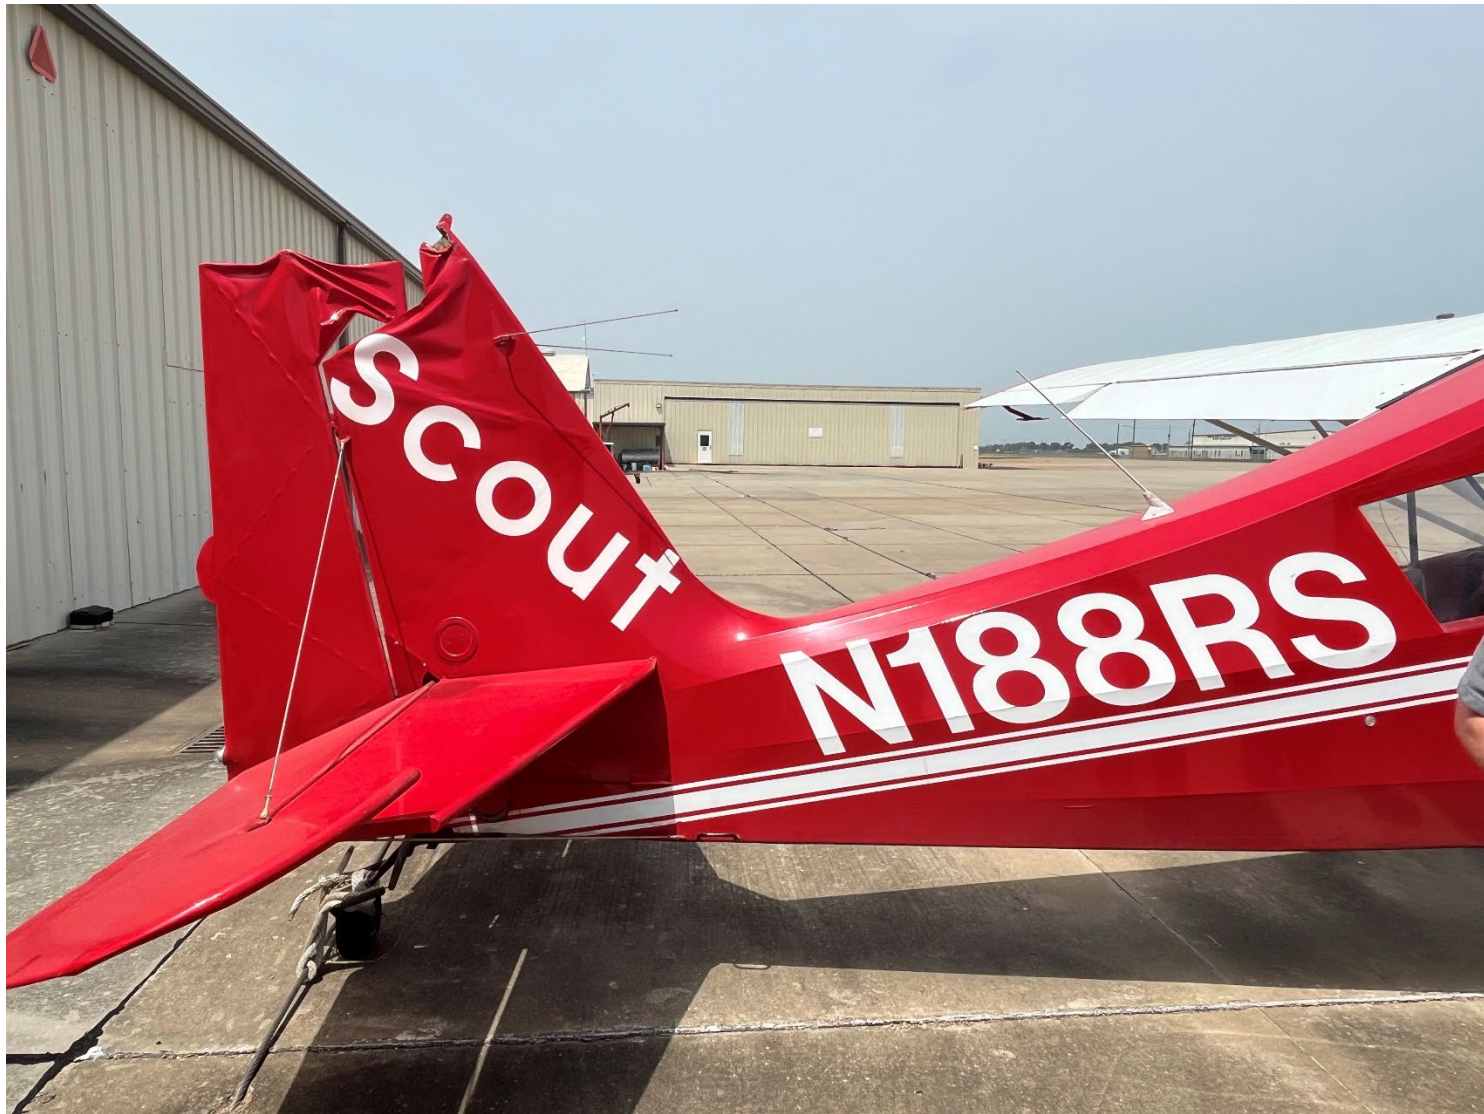
**Photograph 2 - Vertical Stabilizer and Rudder Damage (Source - Federal Aviation Administration)**
