CEN24LA308

## INVESTIGATION PHOTOGRAPHS

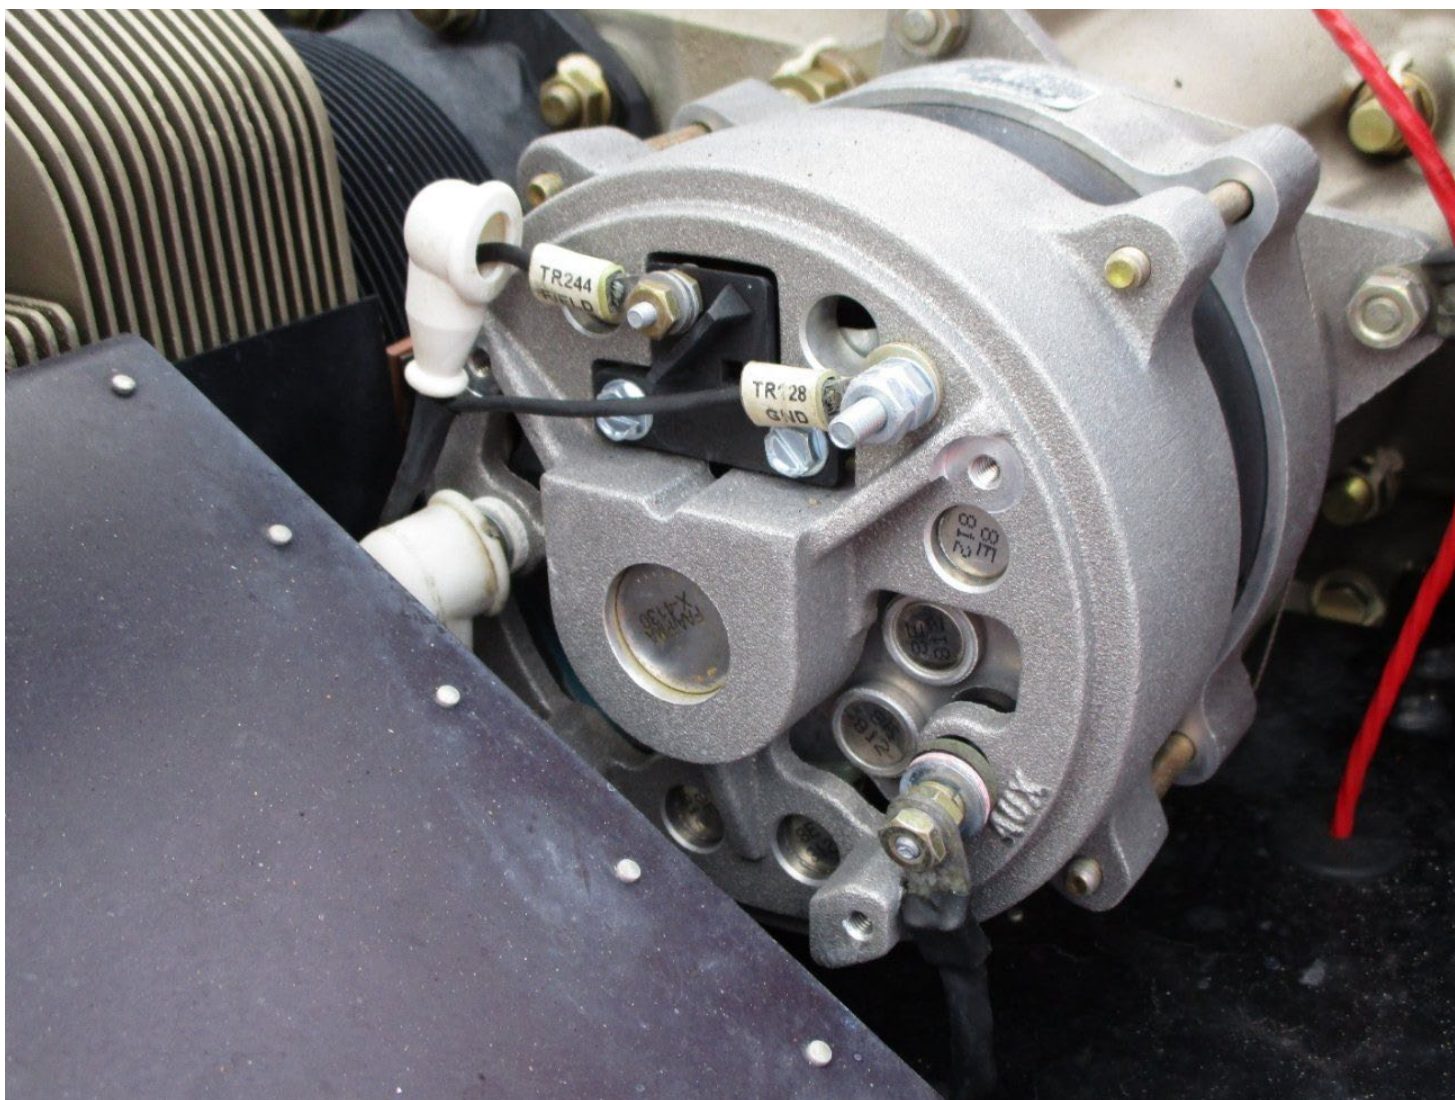
**Photograph 1 - Alternator Installation at Time of the Accident (Courtesy of the Federal Aviation Administration)**

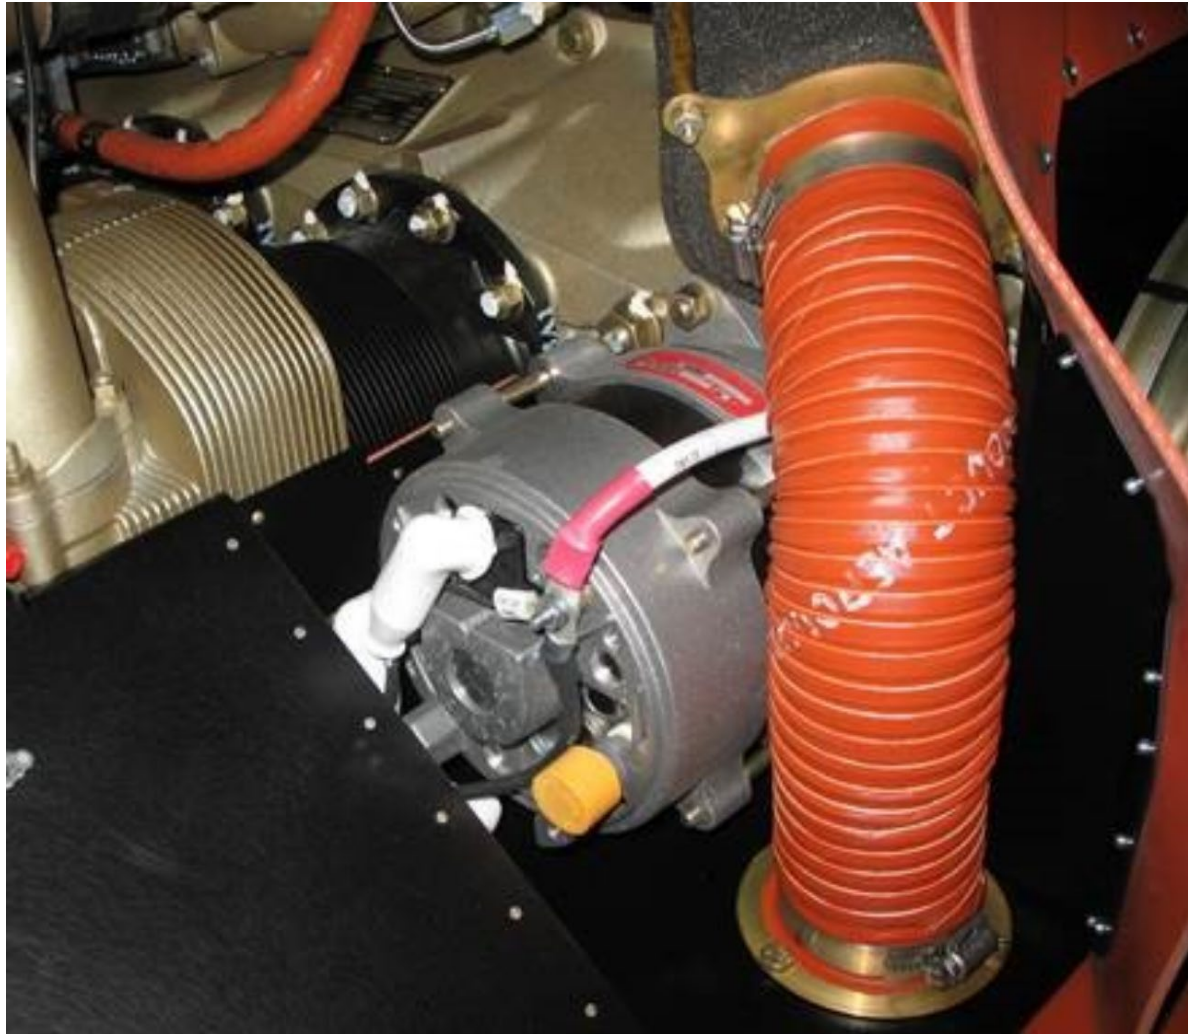
**Photograph 2 - Alternator Installation in Accordance with the Cirrus Maintenance Manual Models SR22 and SR22T (Courtesy of Cirrus Aircraft)**

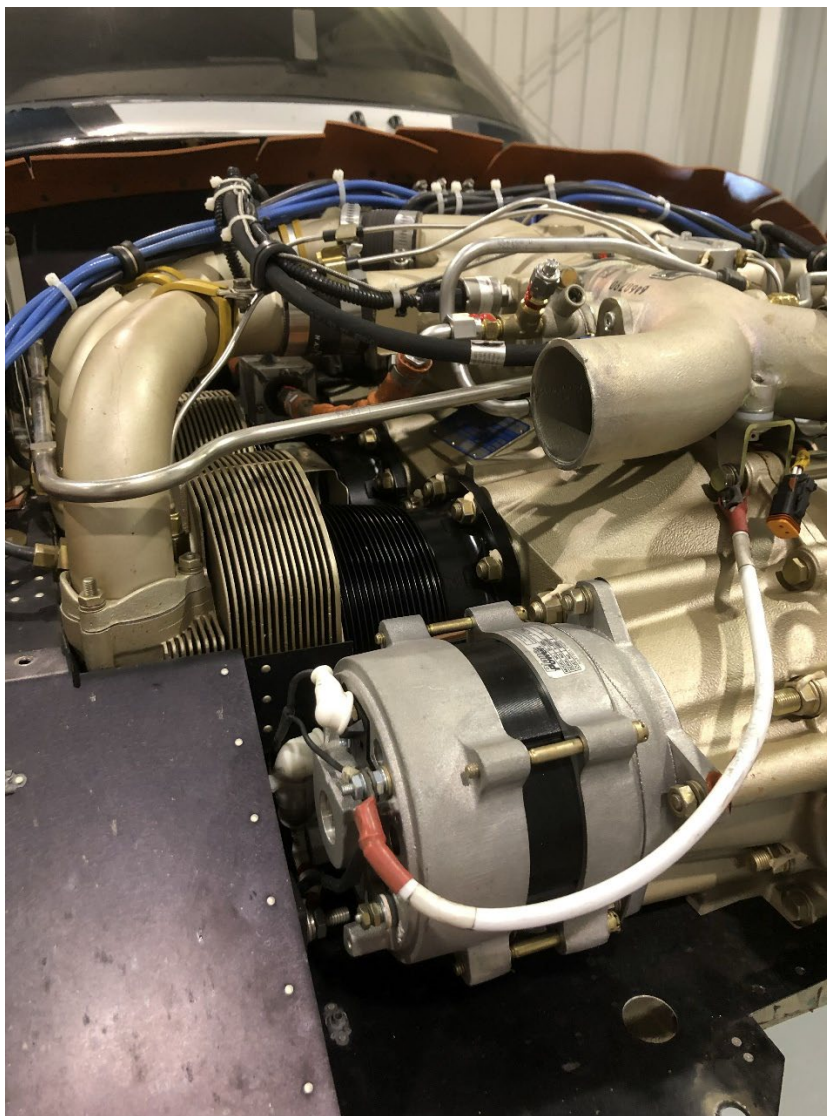
**Photograph 3: Photo Prior to Engine/Alternator Removal (Courtesy of the Airframe and Powerplant Mechanic)**

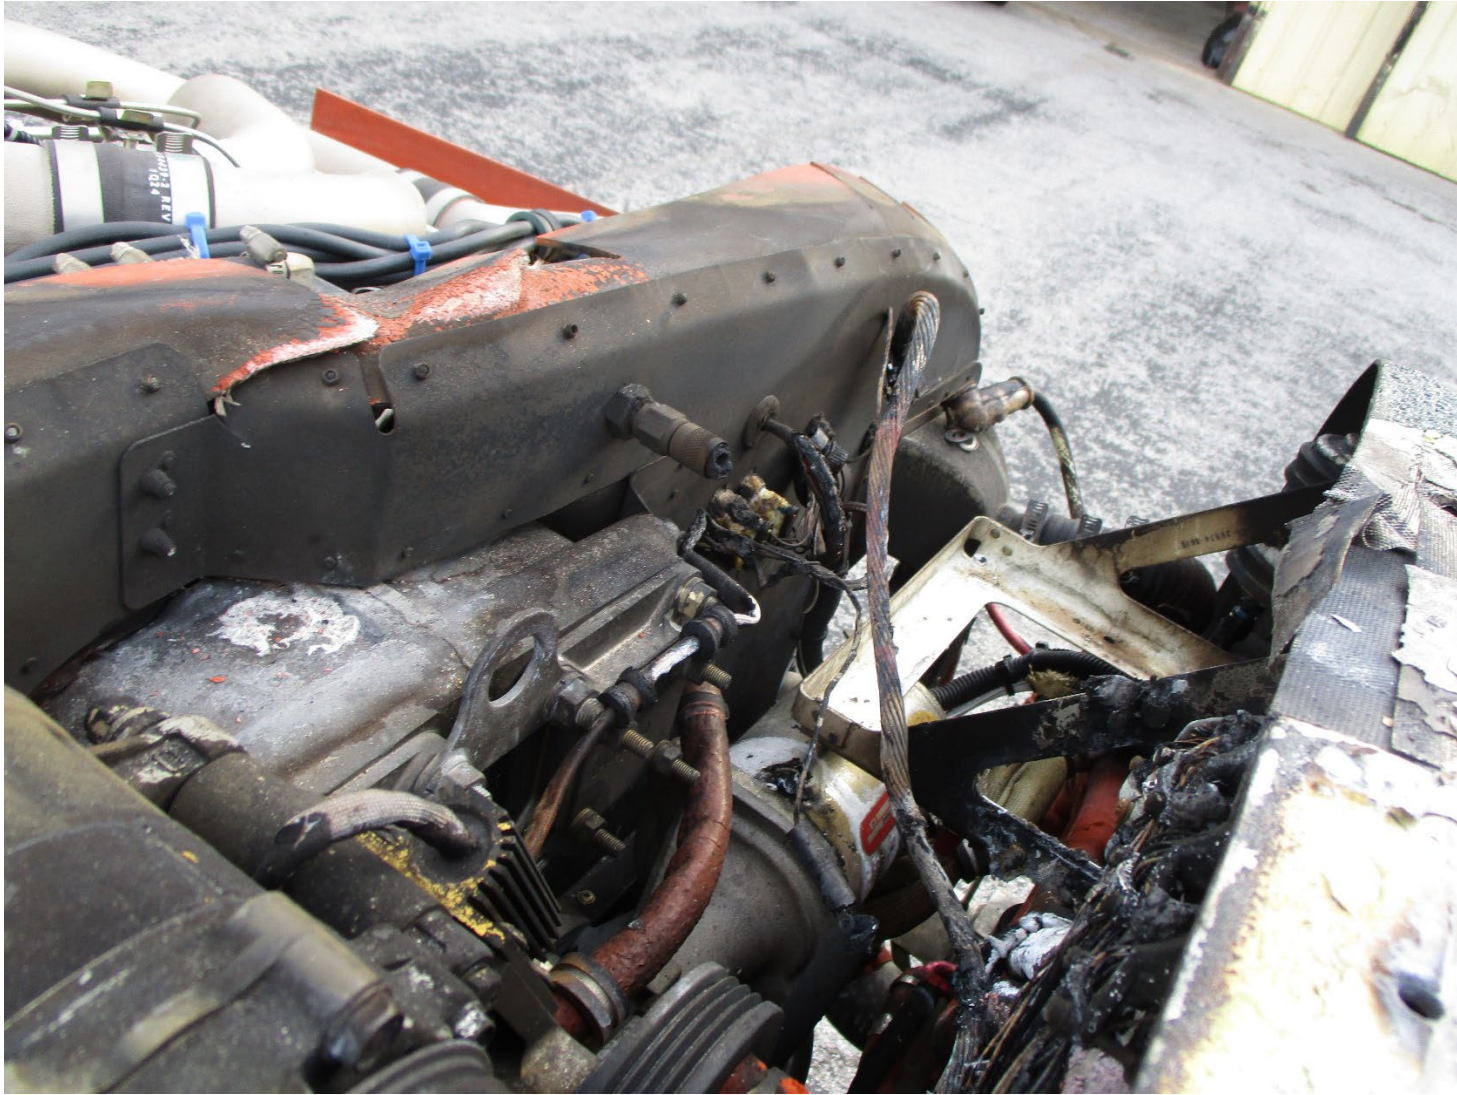
**Photograph 4: Engine Compartment Thermal Damage (Courtesy of the Federal Aviation Administration)**

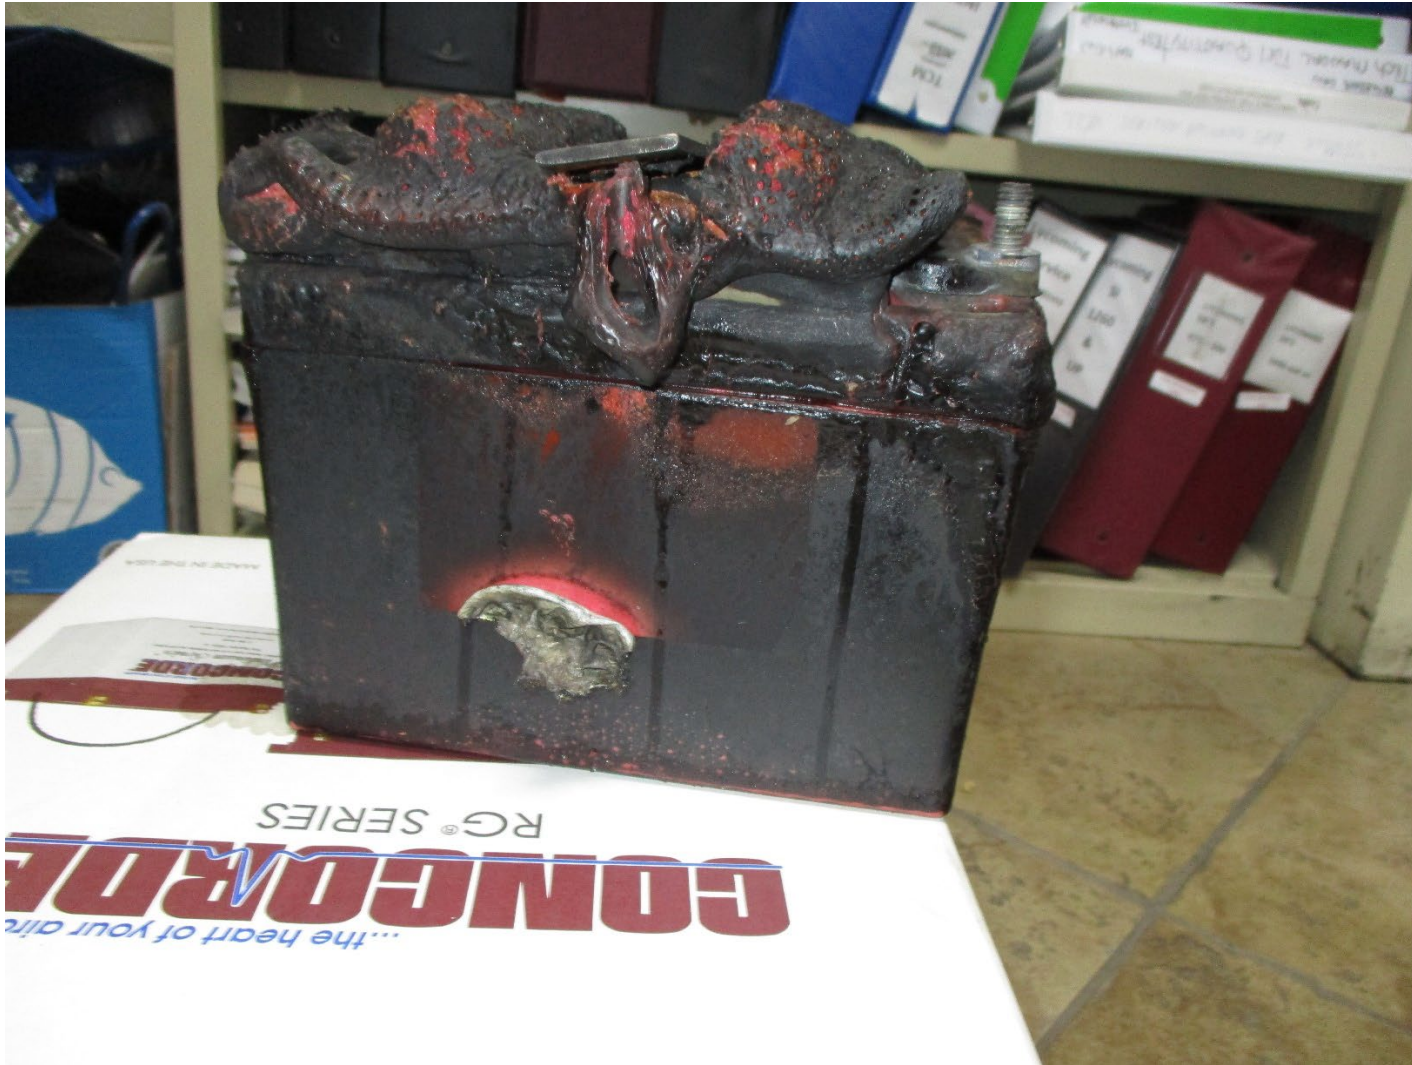
**Photograph 5: Damage to Battery (Courtesy of the Federal Aviation Administration)**

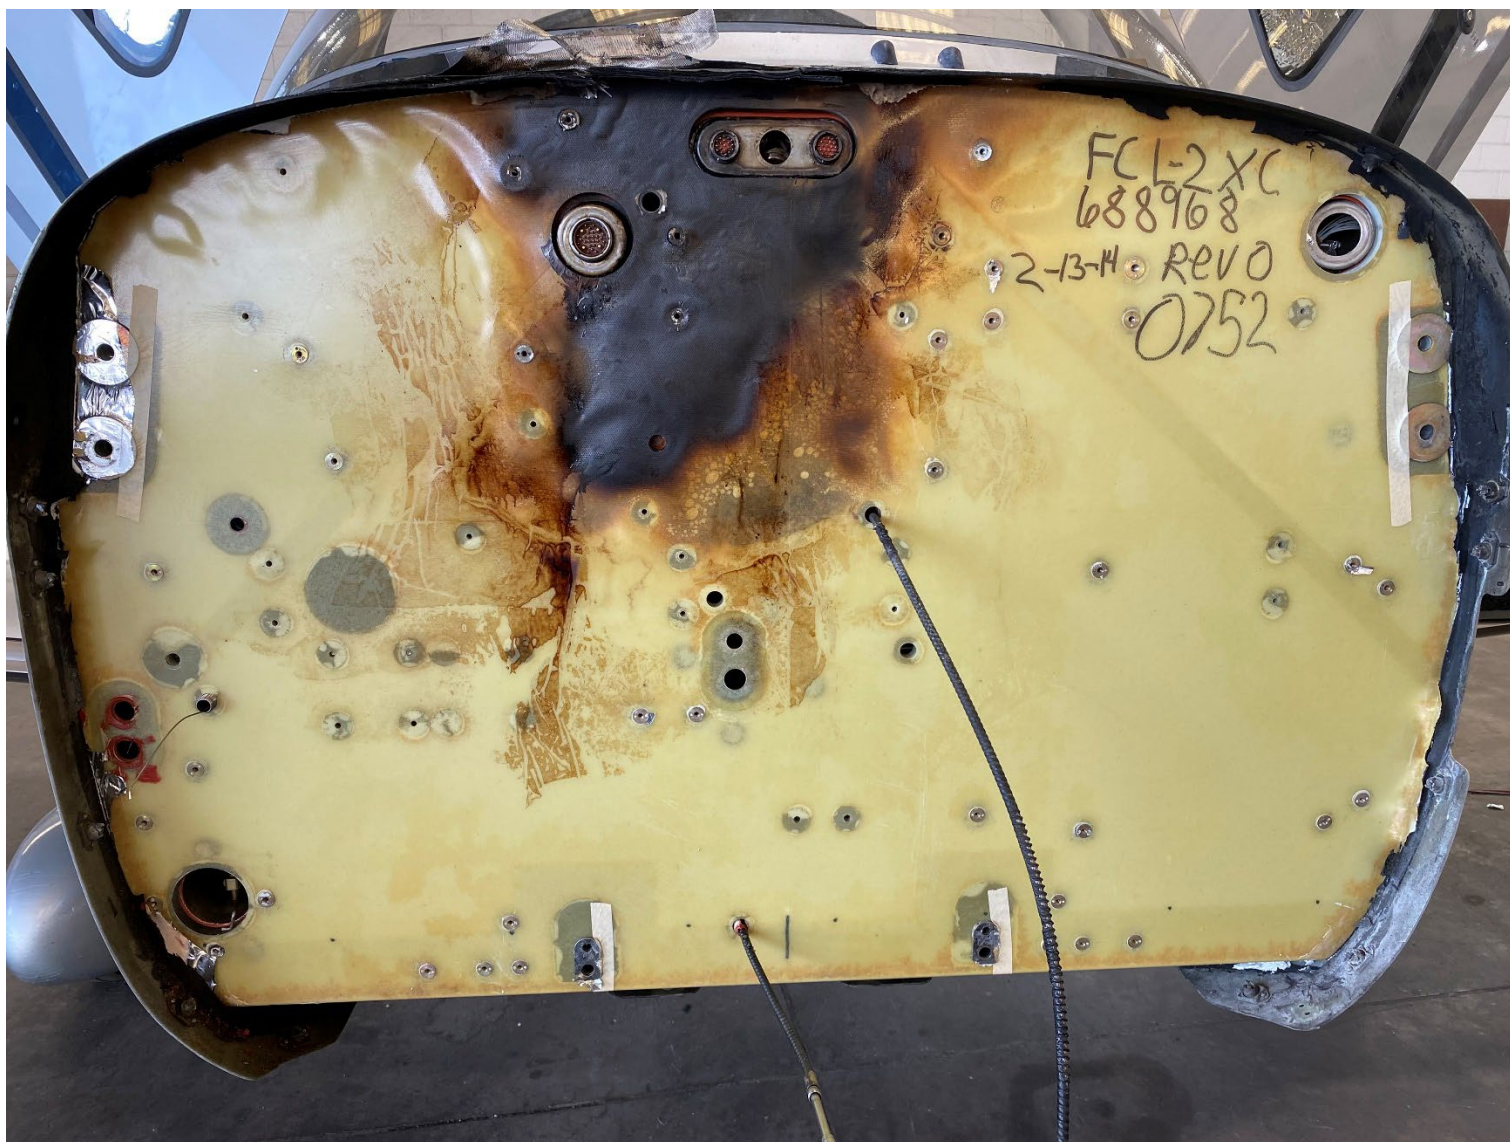
**Photograph 6: Firewall Damage (Courtesy of the Federal Aviation Administration)**
