CEN24LA310

## INVESTIGATION PHOTOGRAPHS

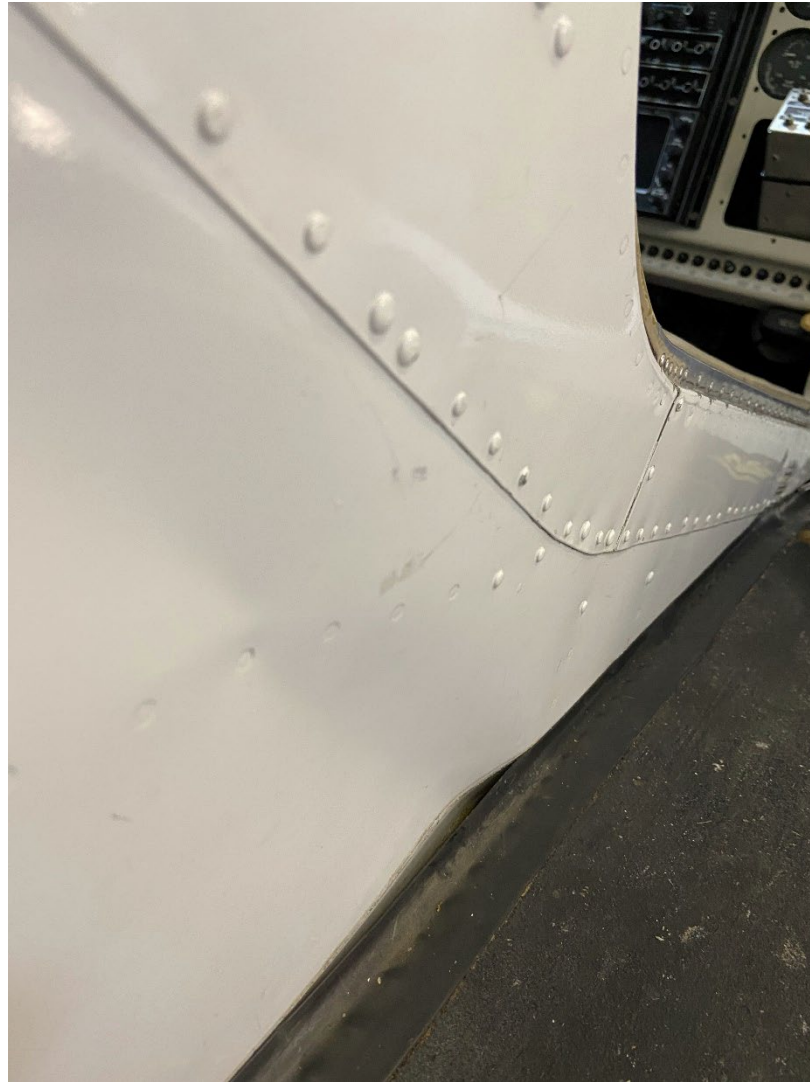
**Photograph 1 - Right side fuselage damage (Source: Federal Aviation Administration)**

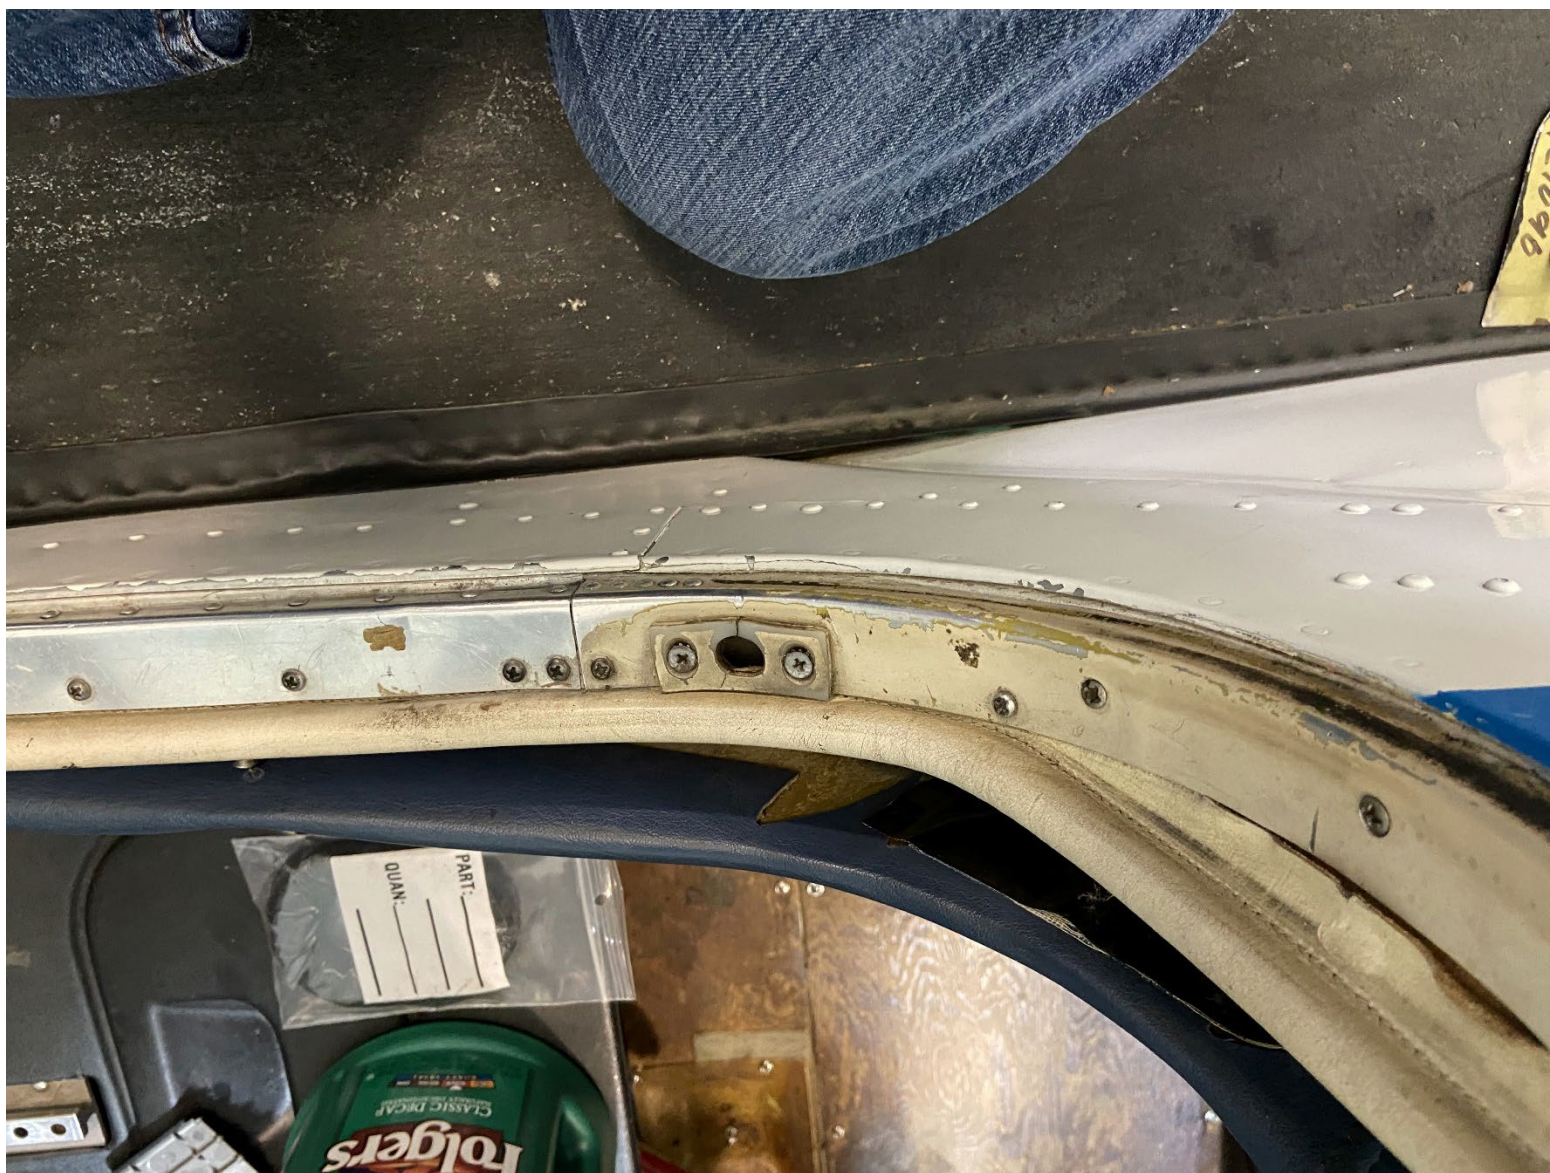
**Photograph 2 - Fuselage damage (Source: Federal Aviation Administration)**
