# **S & T AIRCRAFT ACCESSORIES, INC.**

## **AFTER INCIDENT INVESTIGATION REPORT**

24 November 2025

The component was a carburetor (P/N NAR9B [P/L # 391598-1]) with serial number 5671799 (Figure 1) which arrived 24 November 2025. The package was inspected for any outward signs of damage and none that would have damaged the component was present. This component is within the capabilities of this repair station. The request for the investigation was to perform an inspection of the unit and identify any cause for concern that would inhibit proper flight characteristics.

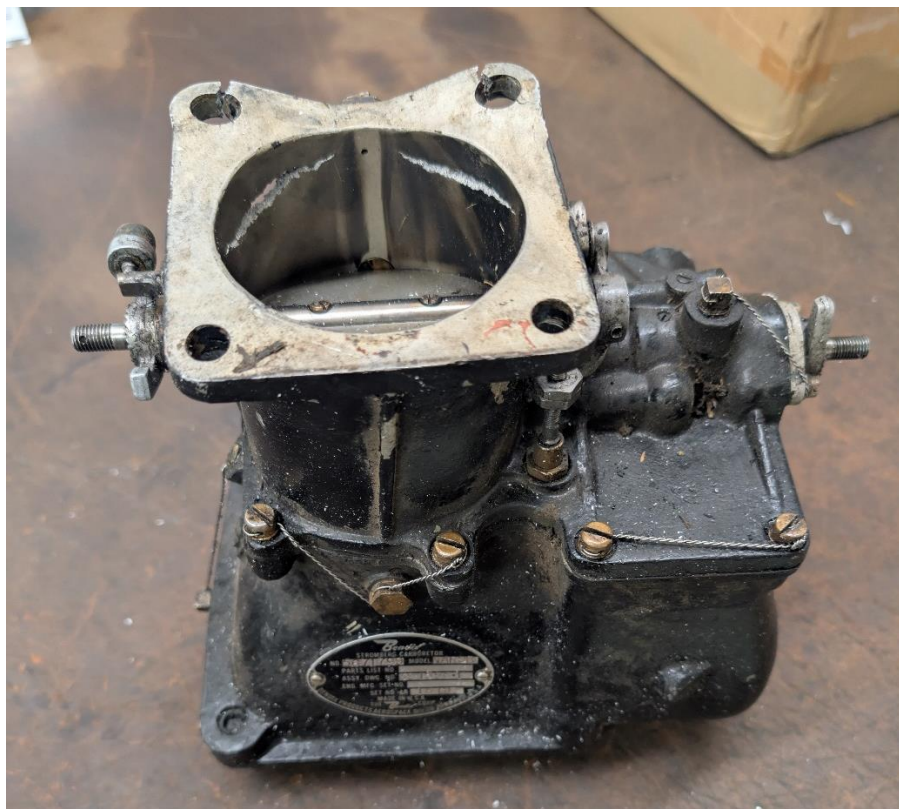
Figure 2

Preliminary inspection of the carburetor indicated that it had been in a crash and did not appear to have been in a fire. The flange to which the carburetor bolts to the engine was severely damaged causing breakage to the stud holes (Figure 2 through 4) and tearing to the carburetor throat (Figure 2). The carburetor throat had also become slightly twisted causing the butterfly valve to hang and bind on the throat sidewalls. This in turn prevented the throttle shaft's ability to be moved. The safety wire appeared to be intact and was all consistent with other safety wire which indicate that the unit may have not been tampered with, but this cannot be completely ruled out.

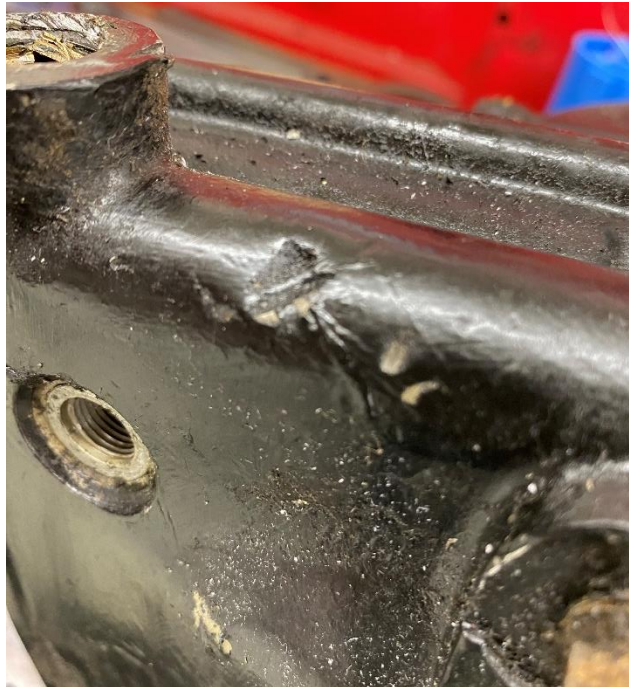
Figure 5

The inspection began with an attempt to remove the fuel strainer from the body to determine if any sediment had clogged the fuel inlet. There was a dent in the body (Figure 5) which prevented the removal of the strainer assembly from the carburetor. It was decided to leave the strainer in place to prevent further damage and only remove it for inspection should no other cause of concern be found.

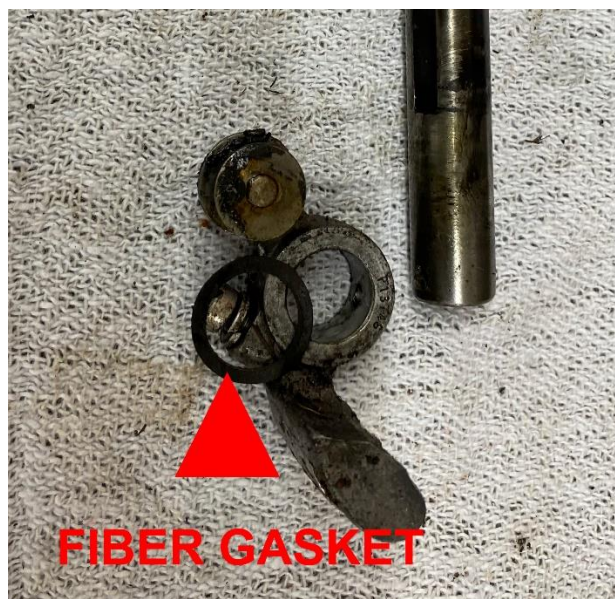
Figure 6

The economizer pump lever was removed from the throttle shaft, and it was noticed that there was a fiber gasket (Figure 6) that was installed between the throttle shaft bushing and the economizer pump lever that does not belong there. This gasket was likely installed in this location to remove some of the end play or was mistakenly installed in this position instead of under the seat where it belongs which is used to adjust the float level. It is no cause for concern that this gasket is here unless it was not installed under the seat as required. The throttle shaft was then removed from the body. Due to the body being twisted the throttle shaft was locked in place and had to be removed with percussive force. After removal of the throttle shaft, it was noticed that there was scoring on the shaft (Figure 7) as well as inside the shaft bushing (Figure 8) in the same location. This indicates that there may have been foreign material inside this bushing that was not removed during previous maintenance, or that the bushing was not inspected or replaced during previous maintenance. It was evident that this wear was caused over a period of time.

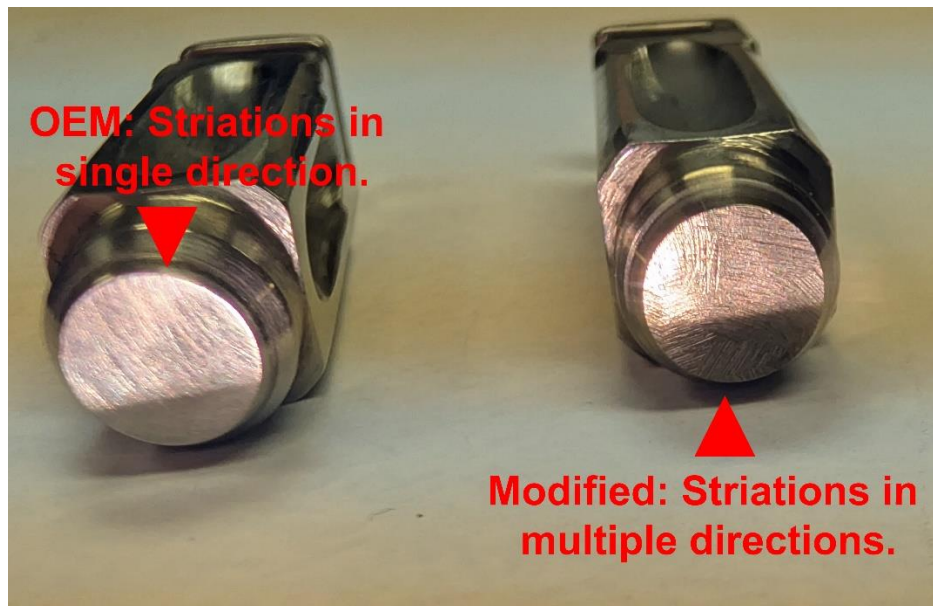
Figure 9

The carburetor was split in half along the seam, and the float needle was removed. It was noticed that the part number of the needle was not correct but had been previously modified to be the correct one (Figure 9). To the best of our knowledge, there exists no technical data that permits this modification. However, these carburetors were originally used for military applications, so it is within the realm of possibility that this needle was modified to support the efforts during World War 2 as a lot of basic modifications like this occurred to boost production of aircraft. Doing a record check for this serial number, this carburetor has not been at this repair station at least going back to 2000 when digital record keeping began at S & T Aircraft. Without having a complete history of work performed on this carburetor, it cannot definitively be stated that this needle was modified to support the war effort. A dimensional analysis of the needle indicates that it is mostly accurate to the correct needle, and I don't believe this modification would have caused any issues during operation.

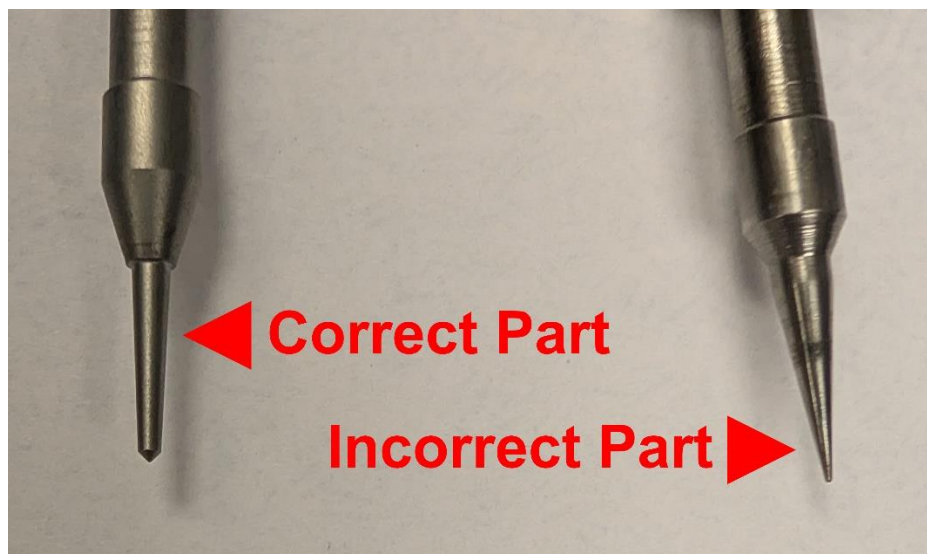
Figure 10

The economizer needle was then removed, and it was evident that this needle has significant issues with it. Starting with the needle being the wrong part (Figure 10). The correct needle is more cylindrical than conical such as the incorrect part. It was also noticed that the graphite packing on this needle was so tight that it prevented the needle spring from being able to hold the needle down in its seat (Figure 11). This essentially allowed the needle to stay in an upward position which would cause the engine to run extremely rich. This would be most evident at idle. Additional effects from the engine running rich for prolonged periods would be smell of gas during operation, fouled spark plugs and rough running engine. If the pilot managed to get the aircraft off the ground, and they had ignition issues during flight, this most certainly would have been the cause of the incident.

It is my belief that this incident was precipitated by an inadequacy of maintenance on the aircraft and the MRO that performed the maintenance on the carburetor. Additionally, because this needle would be stuck causing a rough running engine, the unnecessary risk that the pilot took with their life should not be understated. Here at S & T Aircraft, when we train new mechanics, we make sure to drive home the point that an airplane is not like a car; you cannot pull over at the nearest cloud when something goes wrong. The work that our mechanics do has to be right the first time, or they will hurt someone at best, or destroy a family at worst. Our repair station's safety record and reputation are paramount to this training mentality. More emphasis needs to be placed on this line of thought for anyone working in aviation.

It should be further investigated whether the magnetos and spark plugs were operating within expected parameters. S & T Aircraft always recommends that a mag check be performed both before takeoff and after landing. The pre-flight mag check is a standard check list item, however the reason for the after-landing check is that magnetos rarely show ignition issues until they have reached full operating temperature. When magnetos reach their operating temperature the coil and condenser insulation of the magneto begin to show breakdown resulting in weaker or improper sparking that is rarely evident during the pre-flight mag check.
