# National Transportation Safety Board

CEN24LA316

## EXAMINATION SUMMARY

Location: Eveleth, Minnesota  
Date: August 14, 2024  
Time: 1500 central standard time  
Airplane: Cessna 185E, N2248T

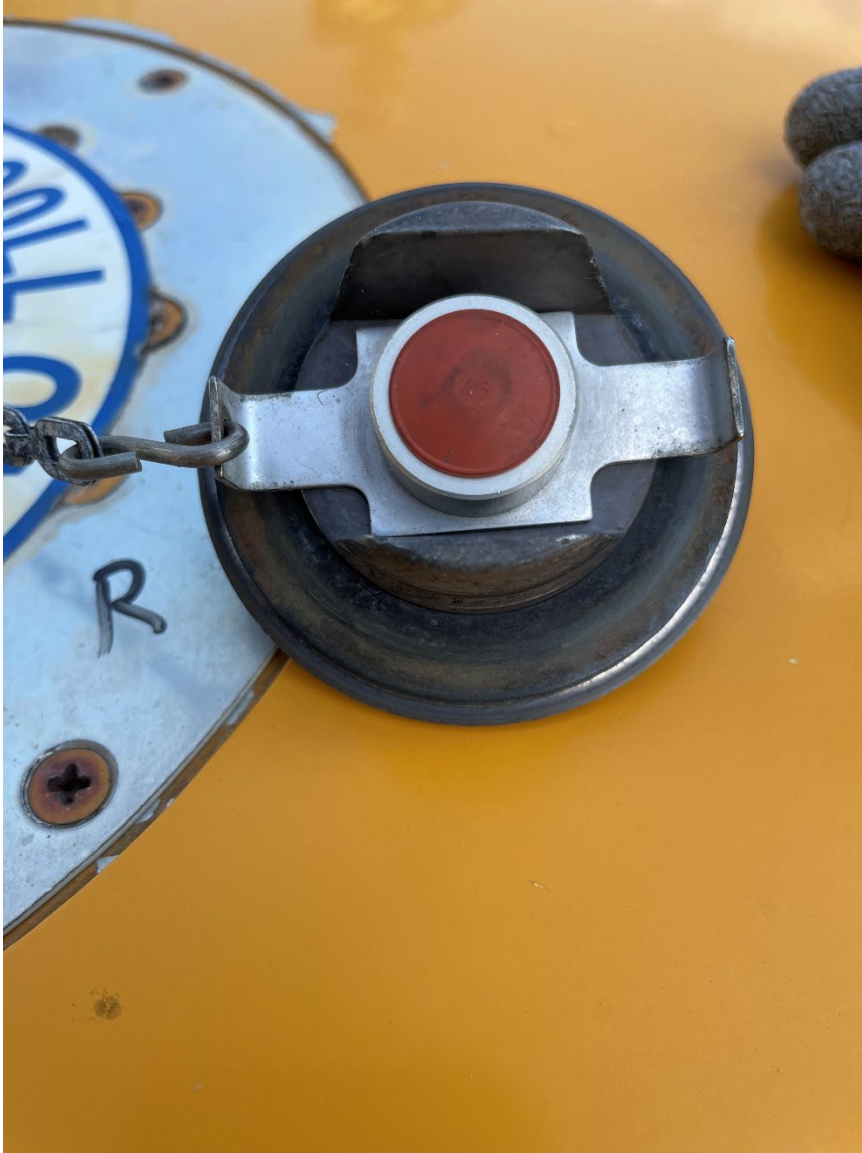
The wings were removed to facilitate recovery. The wings were drained of fuel by the recovery company and collected into a container. About 30 gallons of fuel consistent with 100 low lead aviation fuel was collected. The left and right wing fuel cap seals exhibited some deterioration and discoloration around the outer surface, but were otherwise pliable (Figure 1). The fuel cap sealing surfaces on both wings were corroded (Figure 2).

**Figure 1. Right Fuel cap seal.**

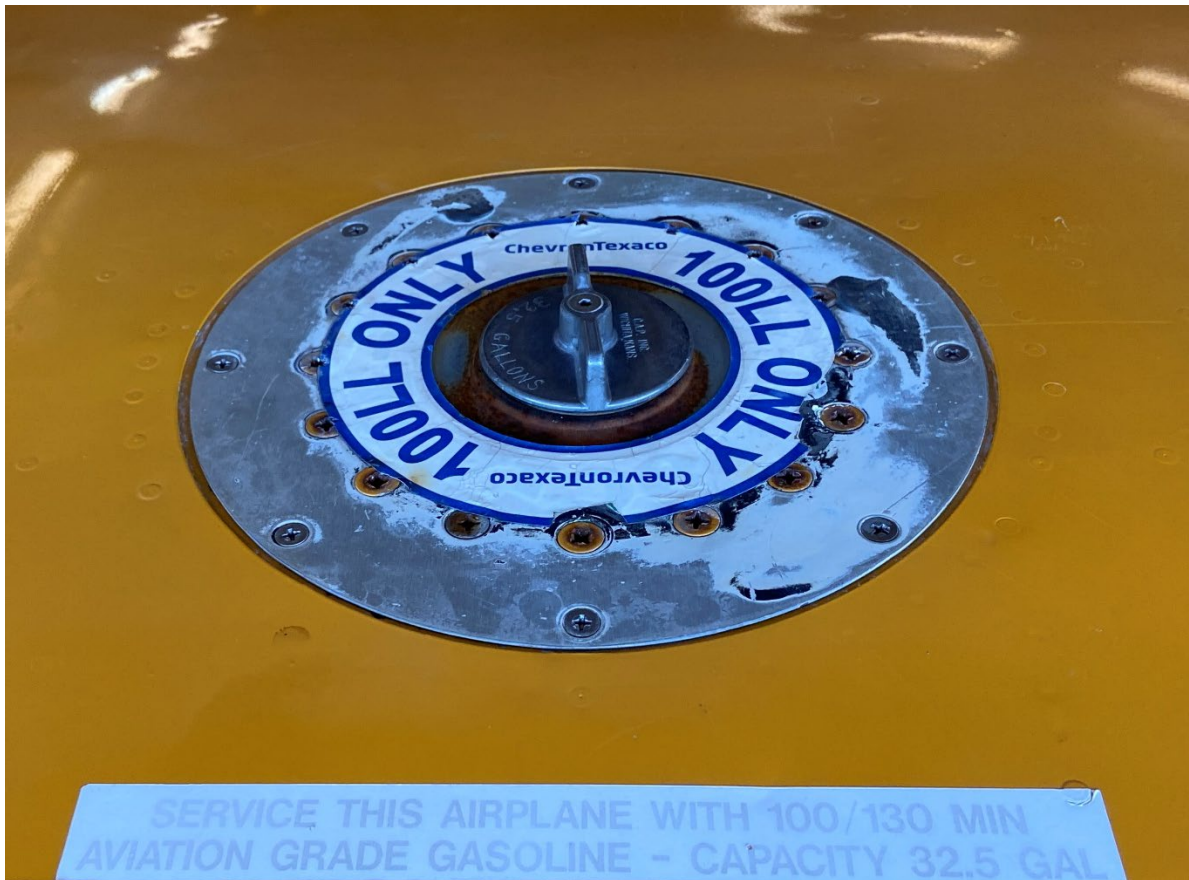
**Figure 2. Left Fuel cap installed (note corrosion at the sealing surface).**

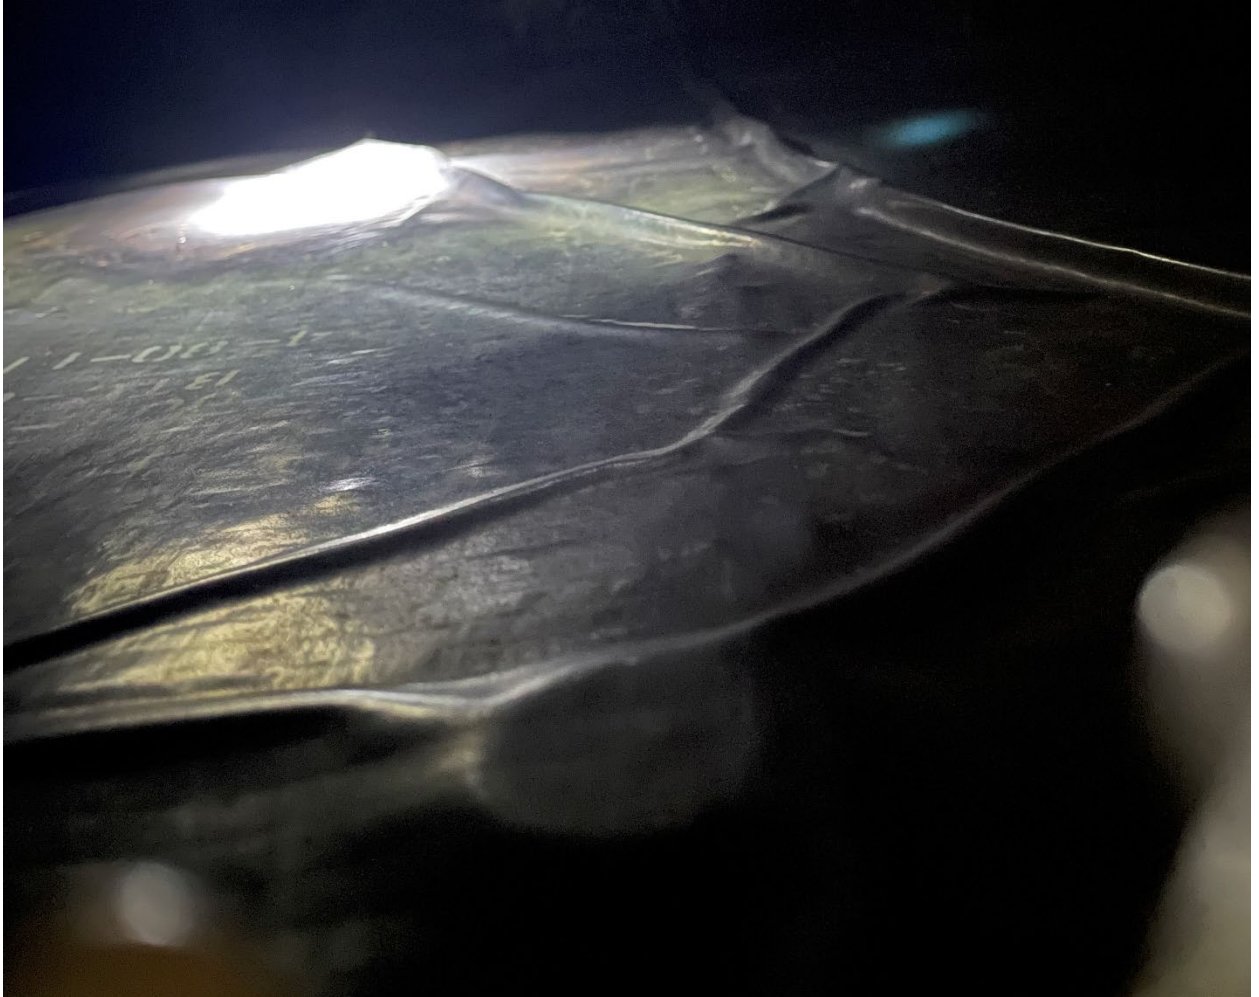
The wing main fuel tanks remained intact. The fuel tanks had rubber bladders, both having wrinkling on the lower surface (Figures 3 and 4). The fuel vents were not obstructed. The fuel that was collected at the accident scene tested positive for water with water finding paste. A visual examination of the collection tank revealed about 1 gallon of water in the bottom of the tank.

**Figure 3.** Right wing fuel bladder with wrinkling.

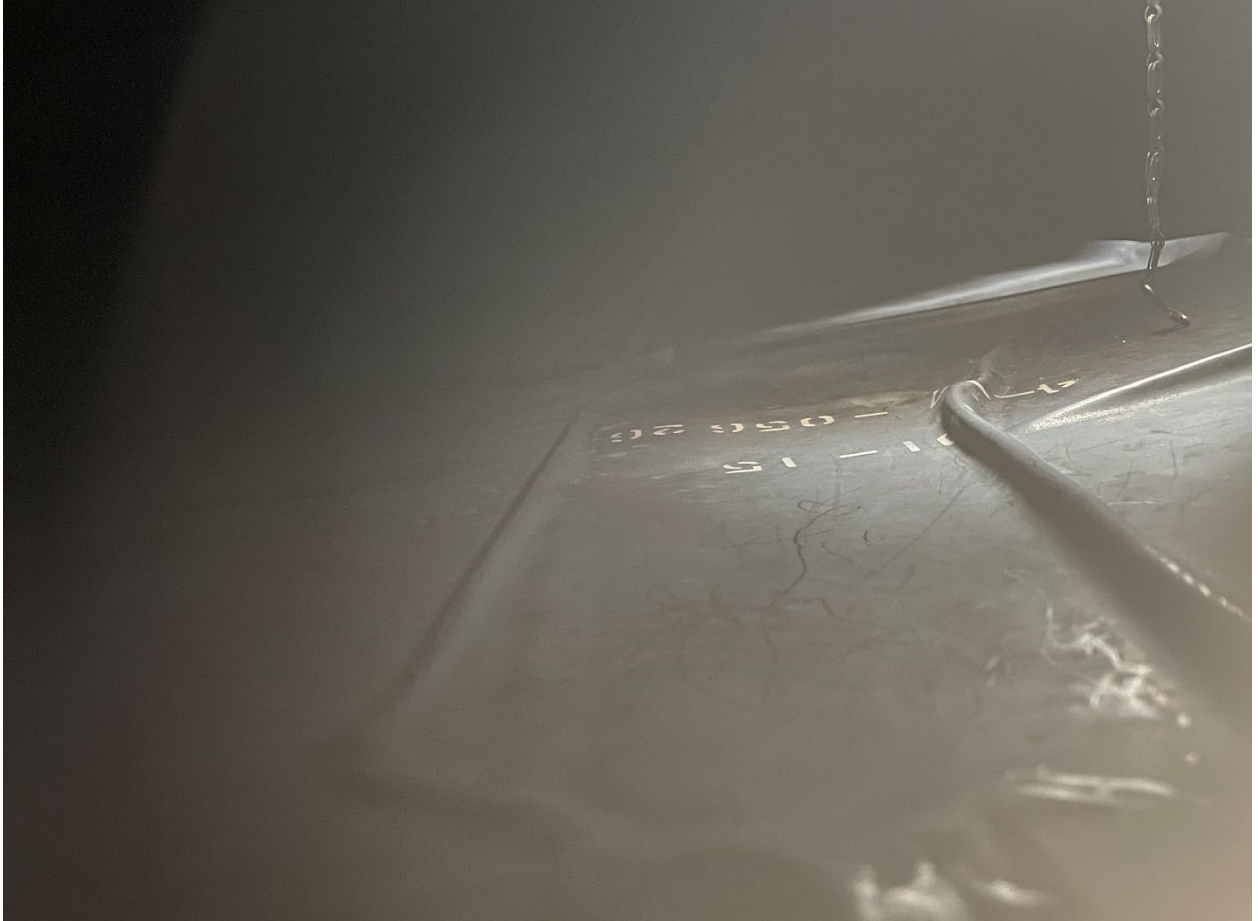
**Figure 4.** Left wing fuel bladder with wrinkling.
