# National Transportation Safety Board

CEN24LA317

## **ENGINE EXAMINATION SUMMARY**

Location: Guthrie, OK  
Date: 08/14/2024  
Time: 2021 CDT  
Aircraft: Vans RV-8A; N184DC

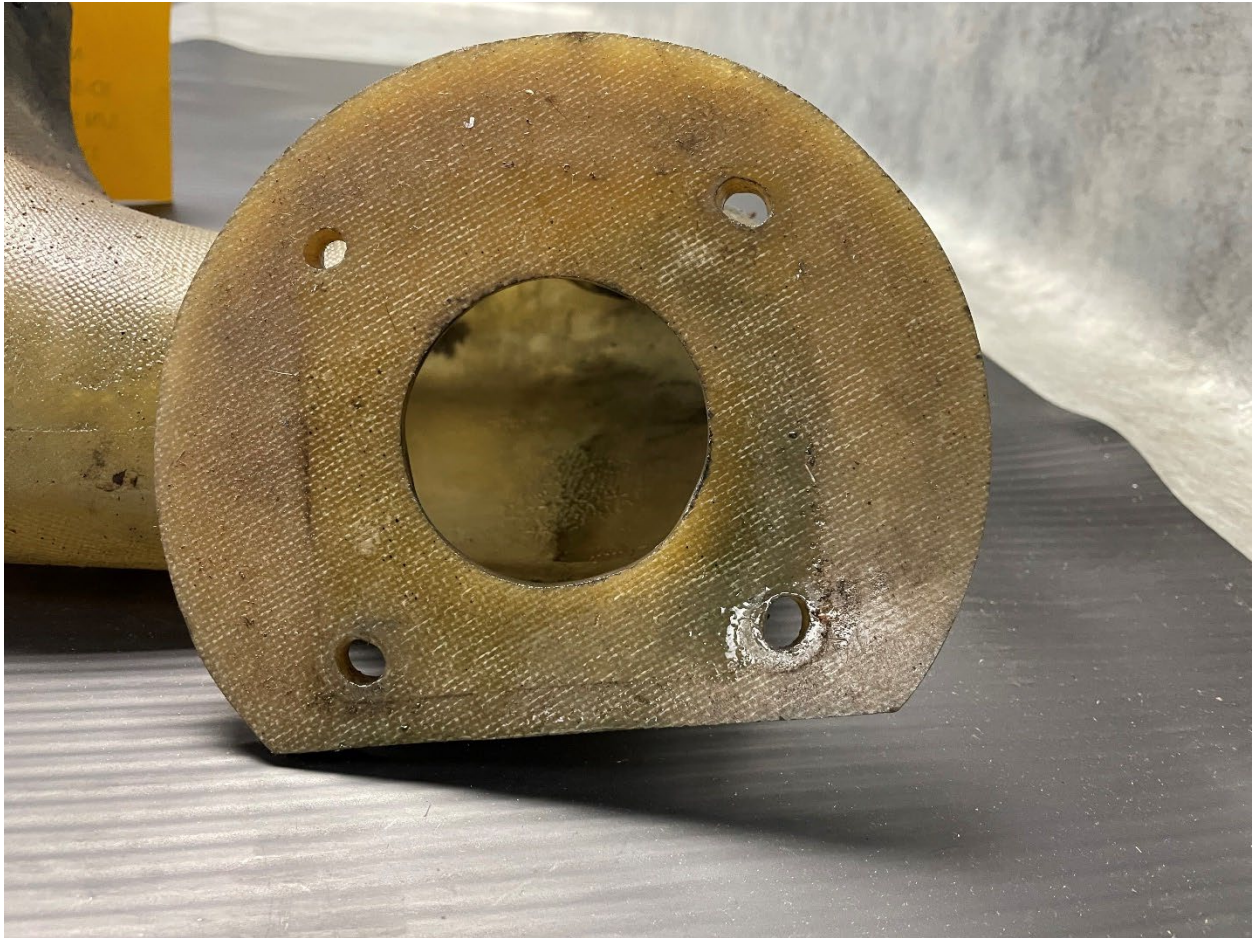
The fiberglass snorkel/air box was retained to the throttle body assembly with 3 of the 4 bolts; the 4<sup>th</sup> bolt was not installed (in a follow-up telephone call, the owner/builder stated that he did not install the 4<sup>th</sup> bolt due to difficult access to that attachment area). After removal of the snorkel, elongation was noted on 3 of the 4 snorkel bolt holes (see Figure 1.).

Figure 1. Fiberglass snorkel mount holes to throttle body assembly.

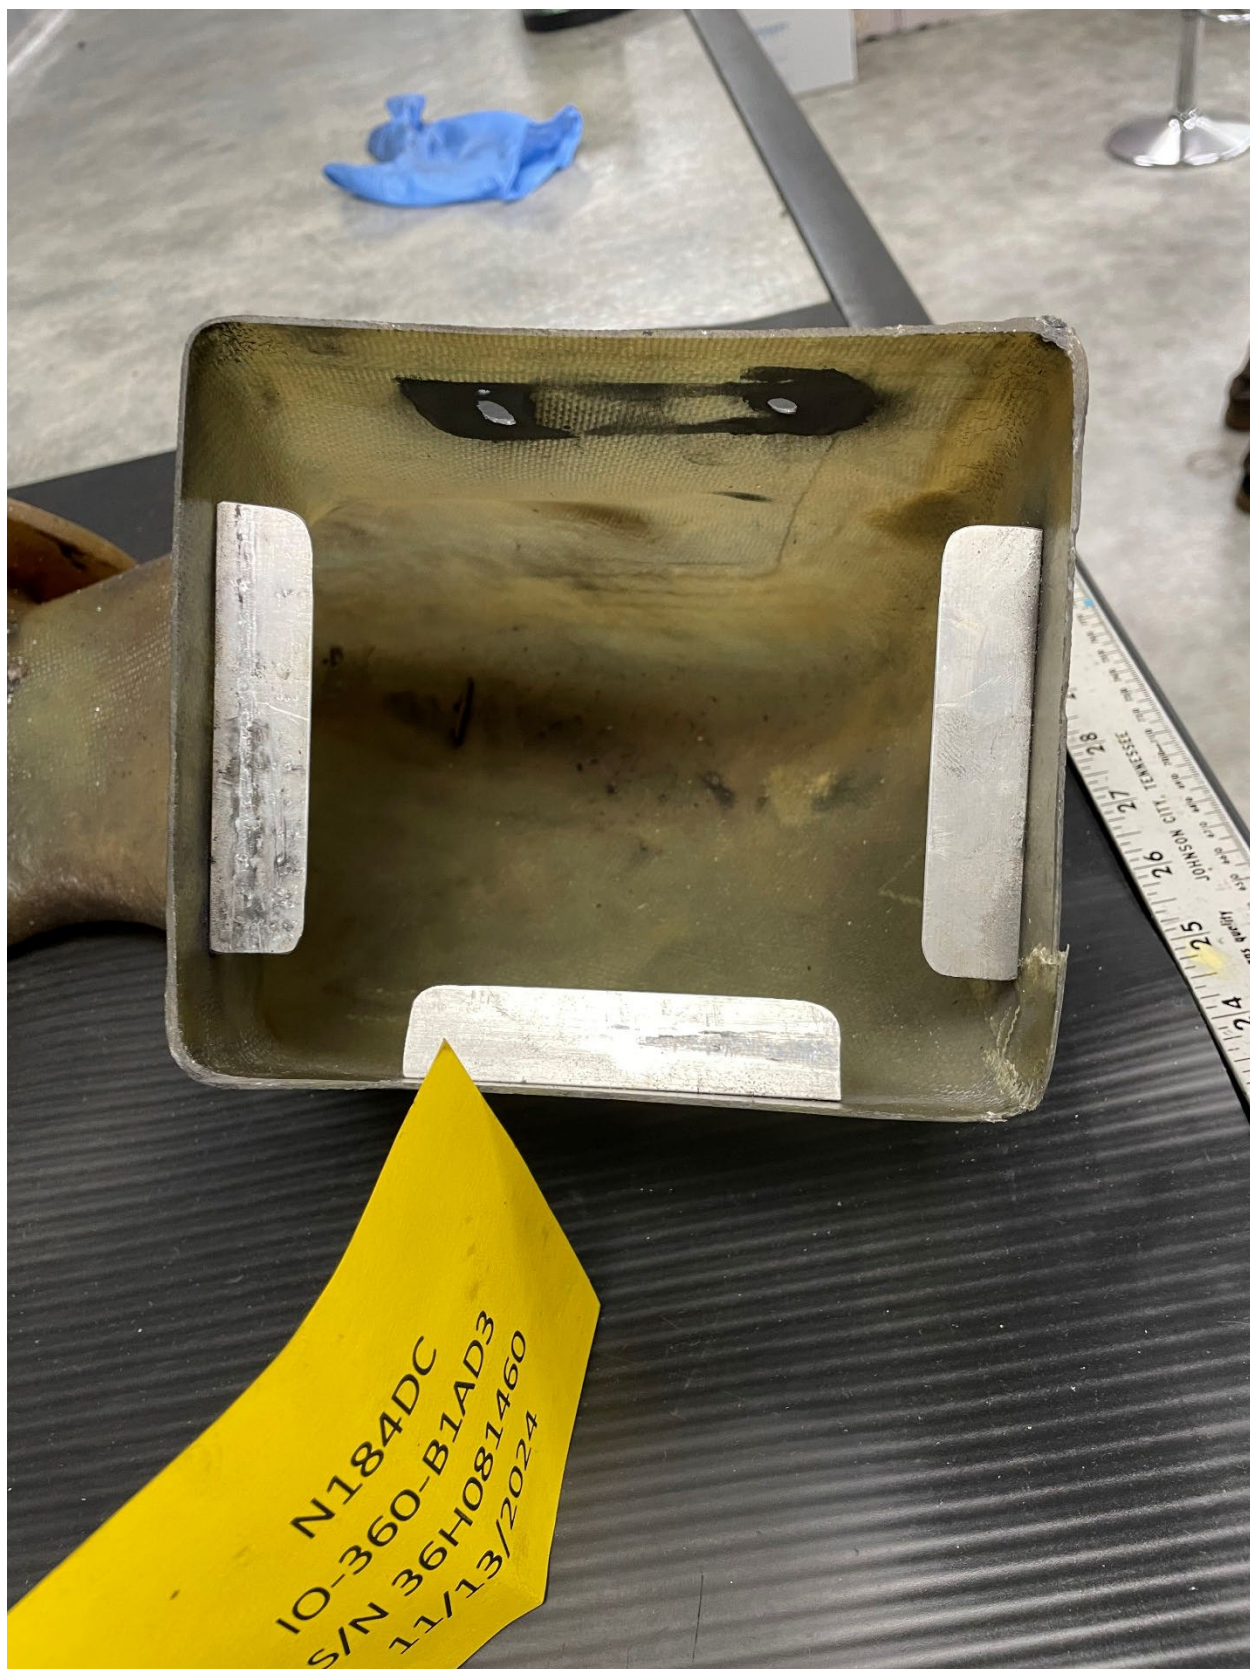
The air filter was removed from the snorkel, and one of the retaining brackets (rear) was missing (see Figure 2.).

Figure 2. Air filter retaining brackets (rear missing).

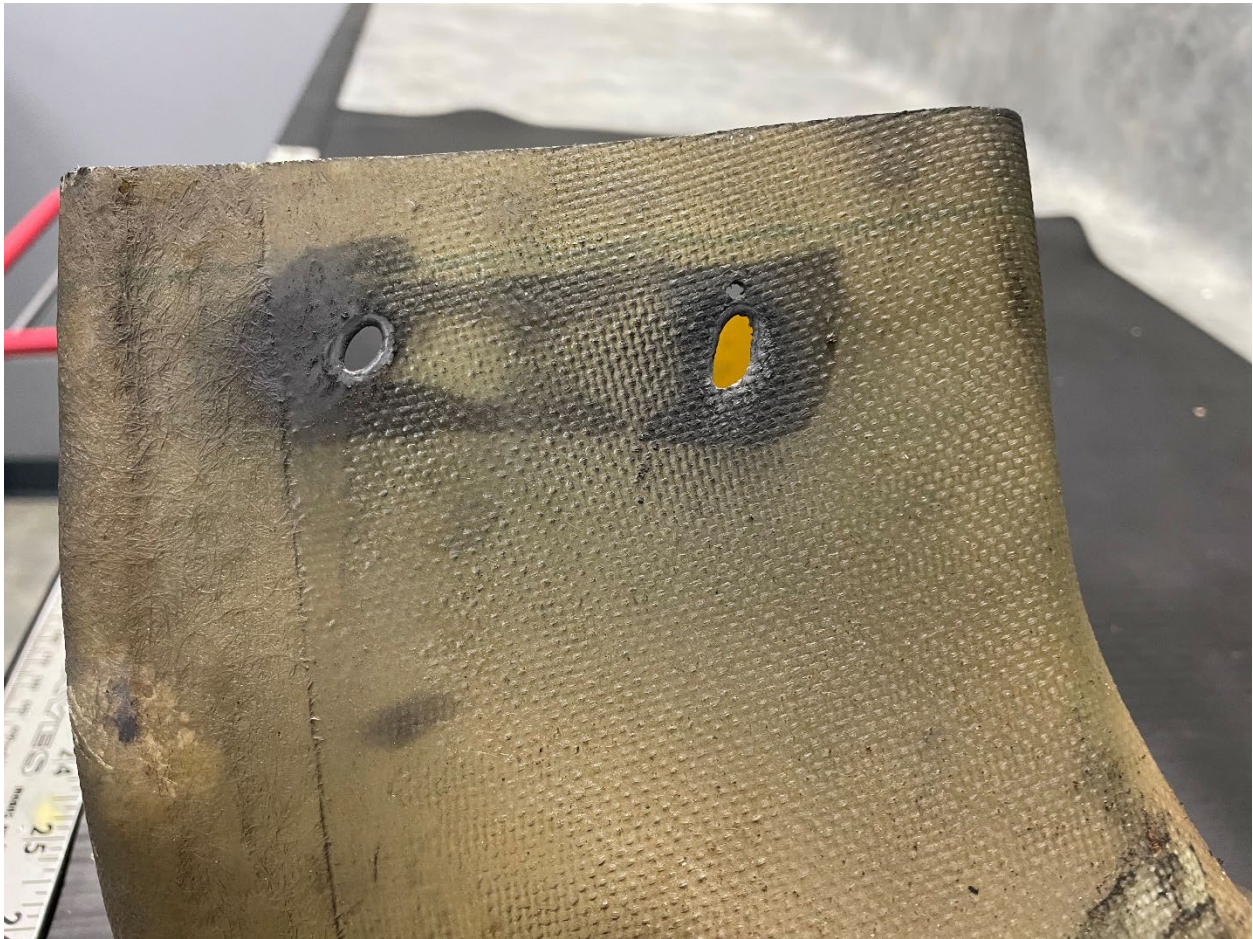
Elongation was noted on the fiberglass where the rivets secured the fabricated bracket. The subsequent photograph showed a view of another one of the installed brackets for comparison purposes (see Figures 3 and 4.).

Figure 3. Missing air filter retaining bracket and elongation of attachment rivet holes.

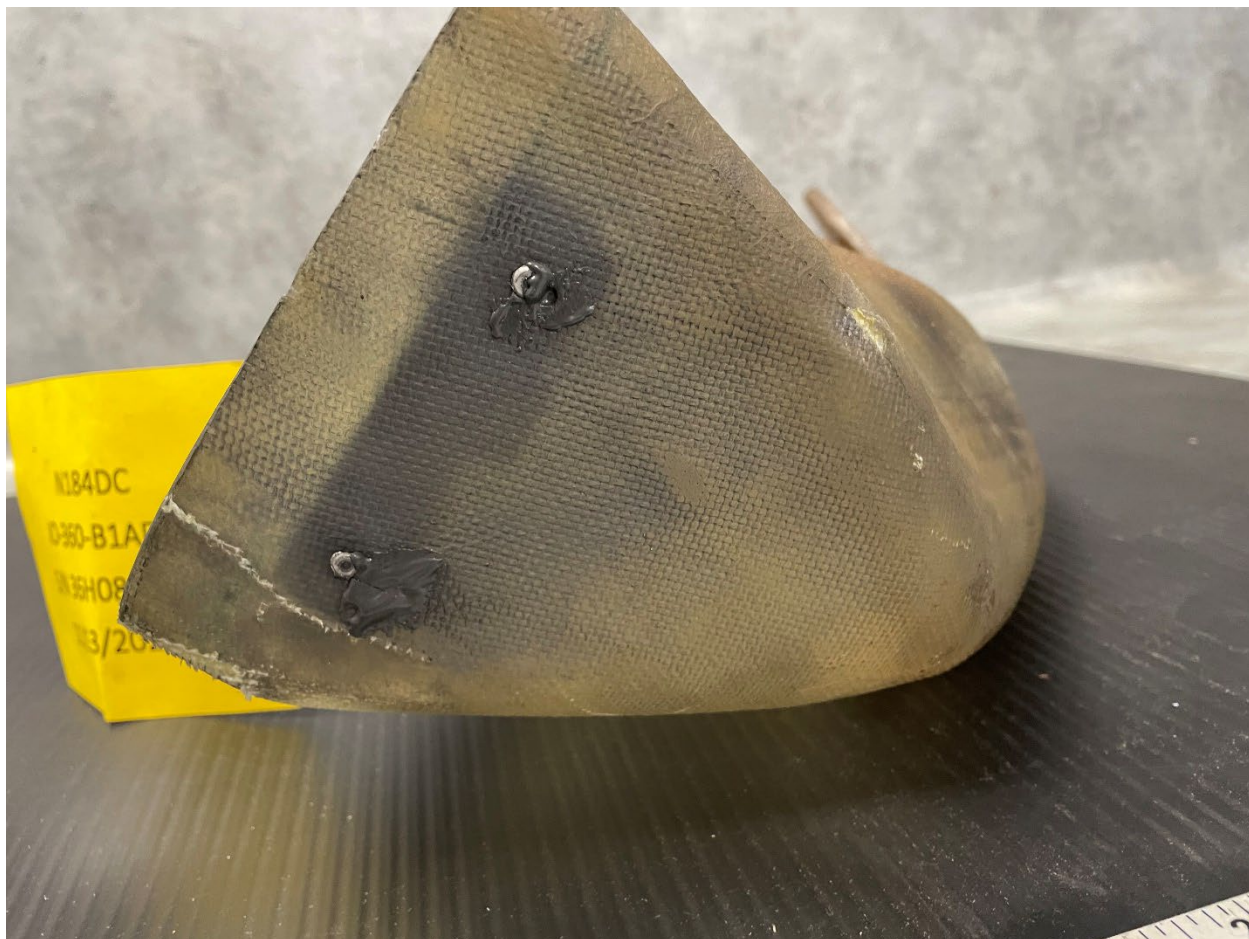
Figure 4. Other installed air filter retaining bracket and snorkel.

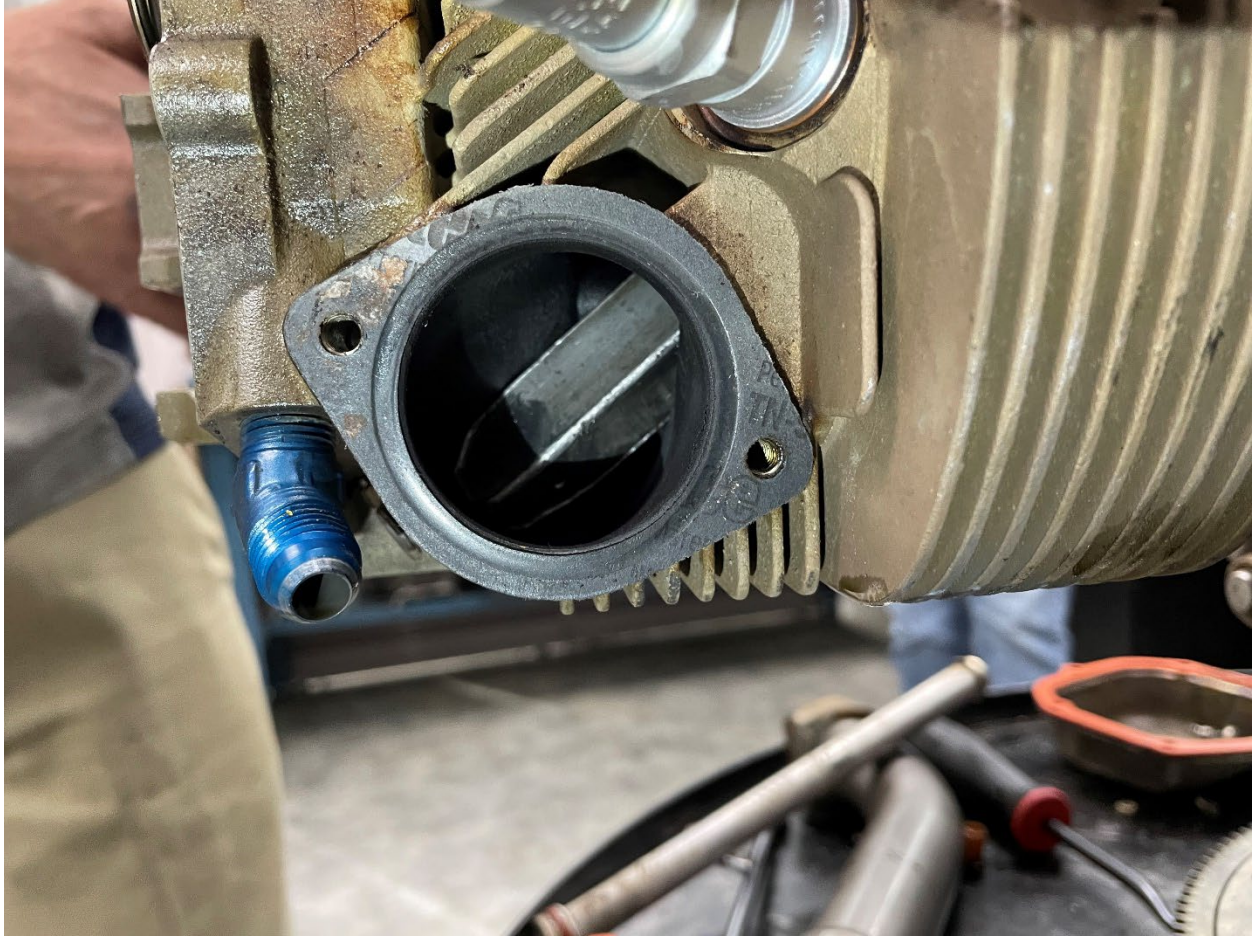
The No. 2 cylinder intake tube was removed. Inside the cylinder intake was a piece of foreign metal, consistent with the missing air filter retaining bracket (see Figure 5.).

Figure 5. Foreign metal debris in No. 2 cylinder intake.

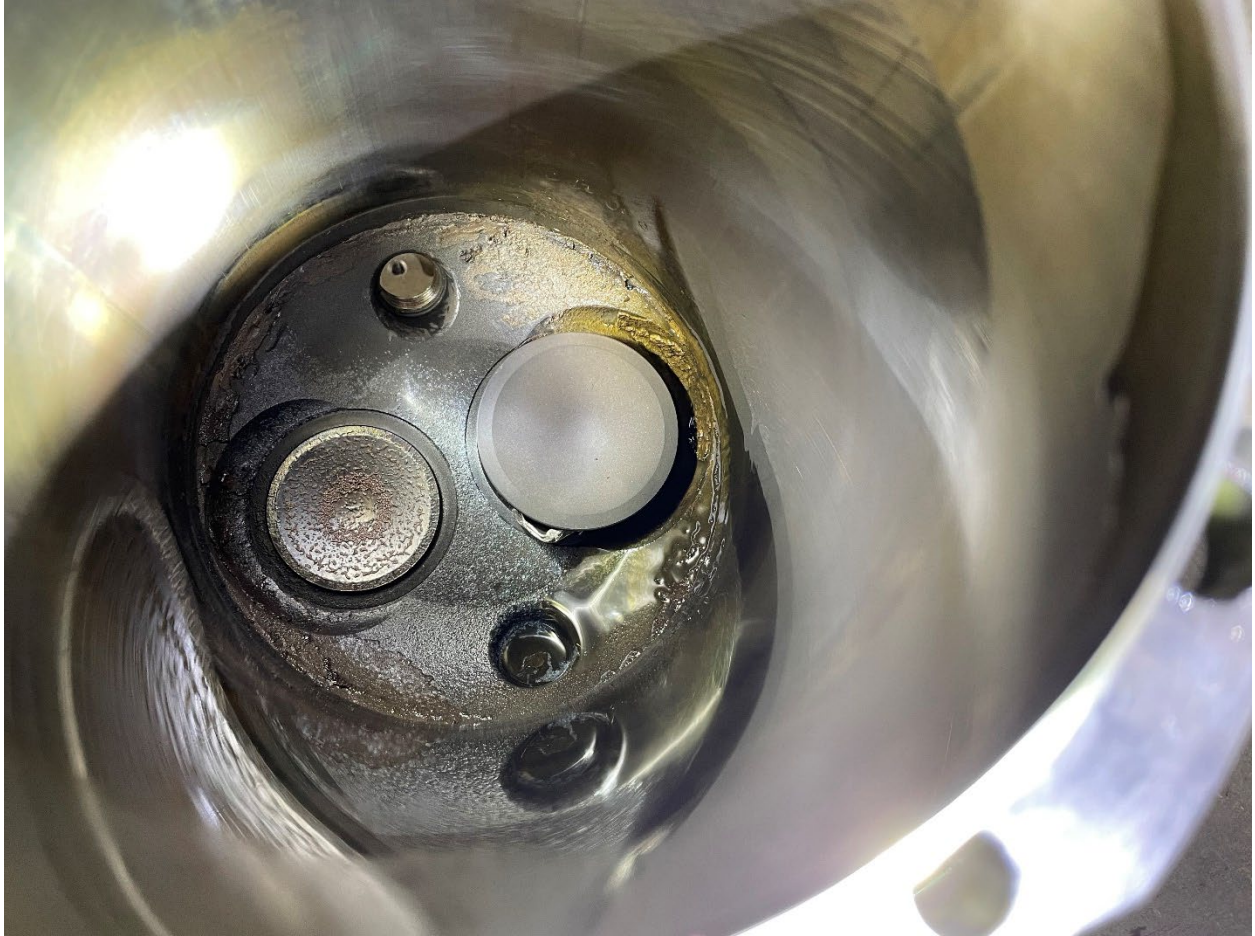
The bracket was jammed and could not be removed. The cylinder was then removed, and the bracket was jammed in the intake valve (see Figure 6.).

Figure 6. Separated air box bracket found jammed under intake valve seat.

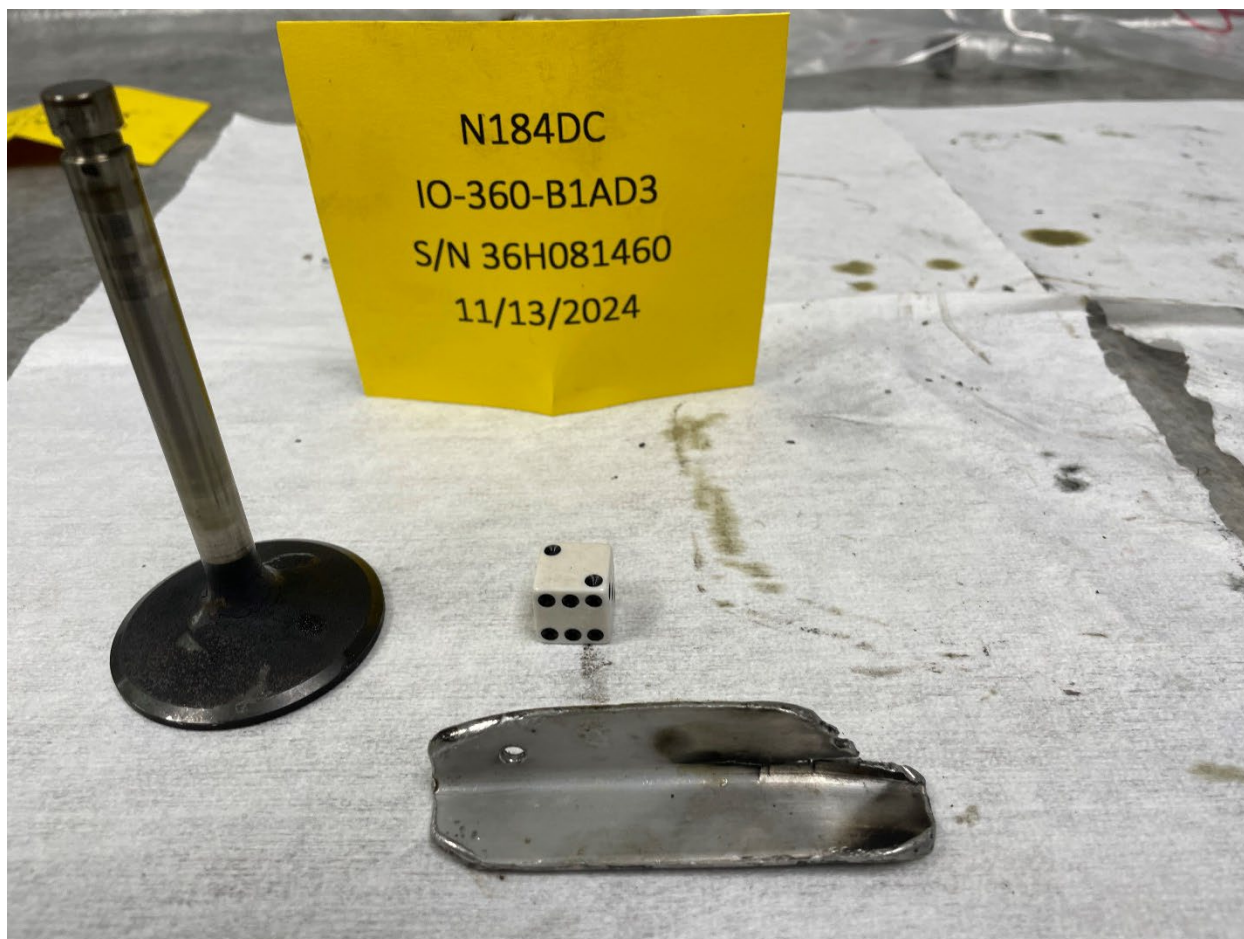
The intake valve was removed, and the air filter retaining bracket was removed from the cylinder (see Figure 7.). The bracket rivets were not located.

Figure 7. Missing air filter retaining bracket located in No. 2 cylinder.

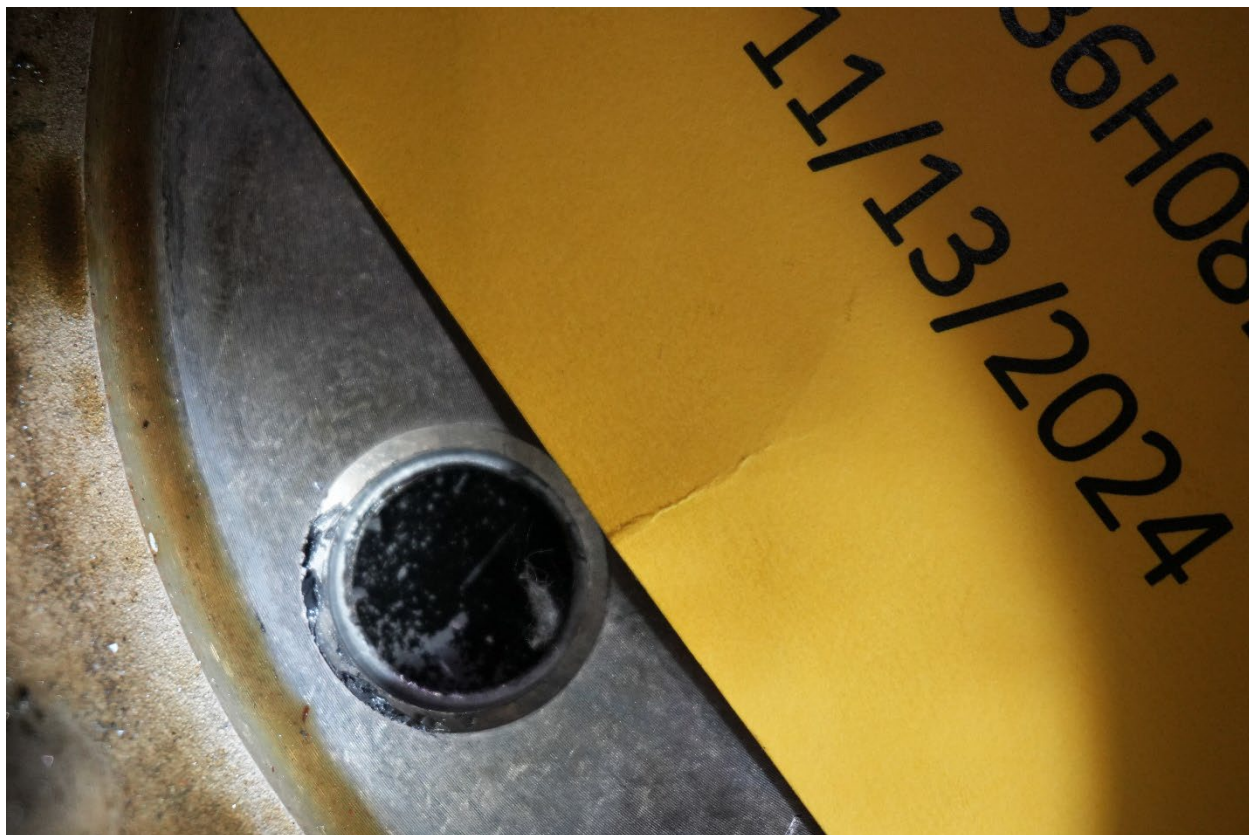
In addition, the starter ring support was improperly installed on the engine crankshaft (see Figure 9.). The support was installed incorrectly on the engine crankshaft bushings in about the 180° position. The improper installation did not adversely affect engine operation; however, magneto timing with reference to the support gear was off by 180°. Crankshaft to magneto timing was found to be correct.

Figure 9. Damage from crankshaft bushing on the rear of the starter ring support.
