CEN24LA318

## INVESTIGATION PHOTOGRAPHS

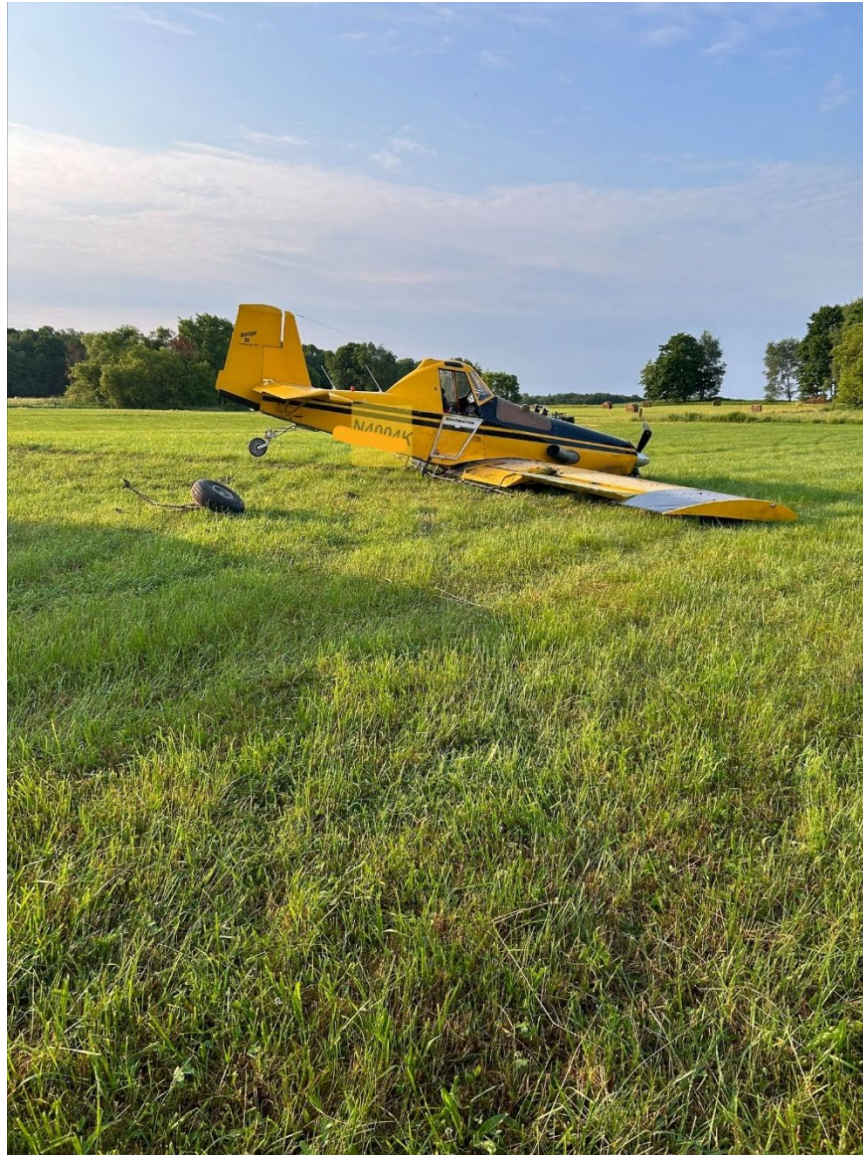
**Photograph 1 - View of the right side of the airplane at the accident site (courtesy of the Michigan State Police)**

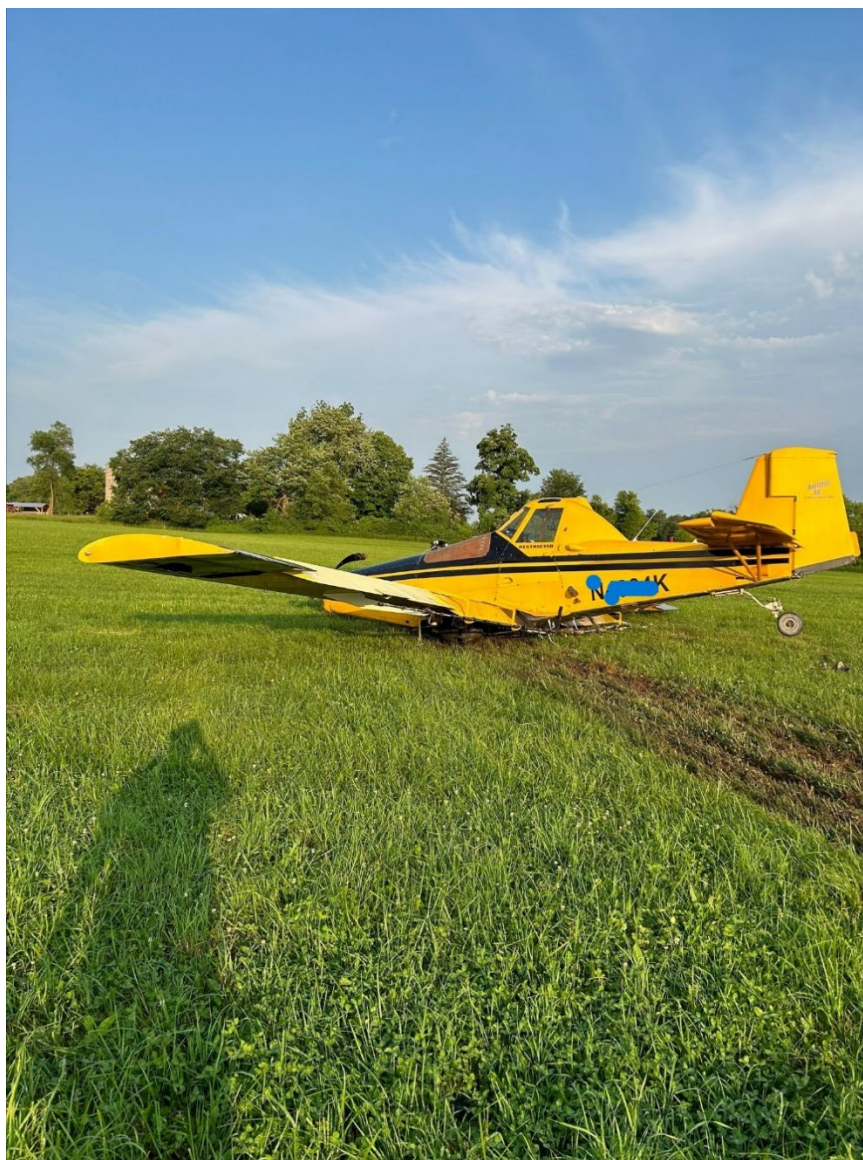
**Photograph 2 - View of the left side of the airplane at the accident site (courtesy of the Michigan State Police)**

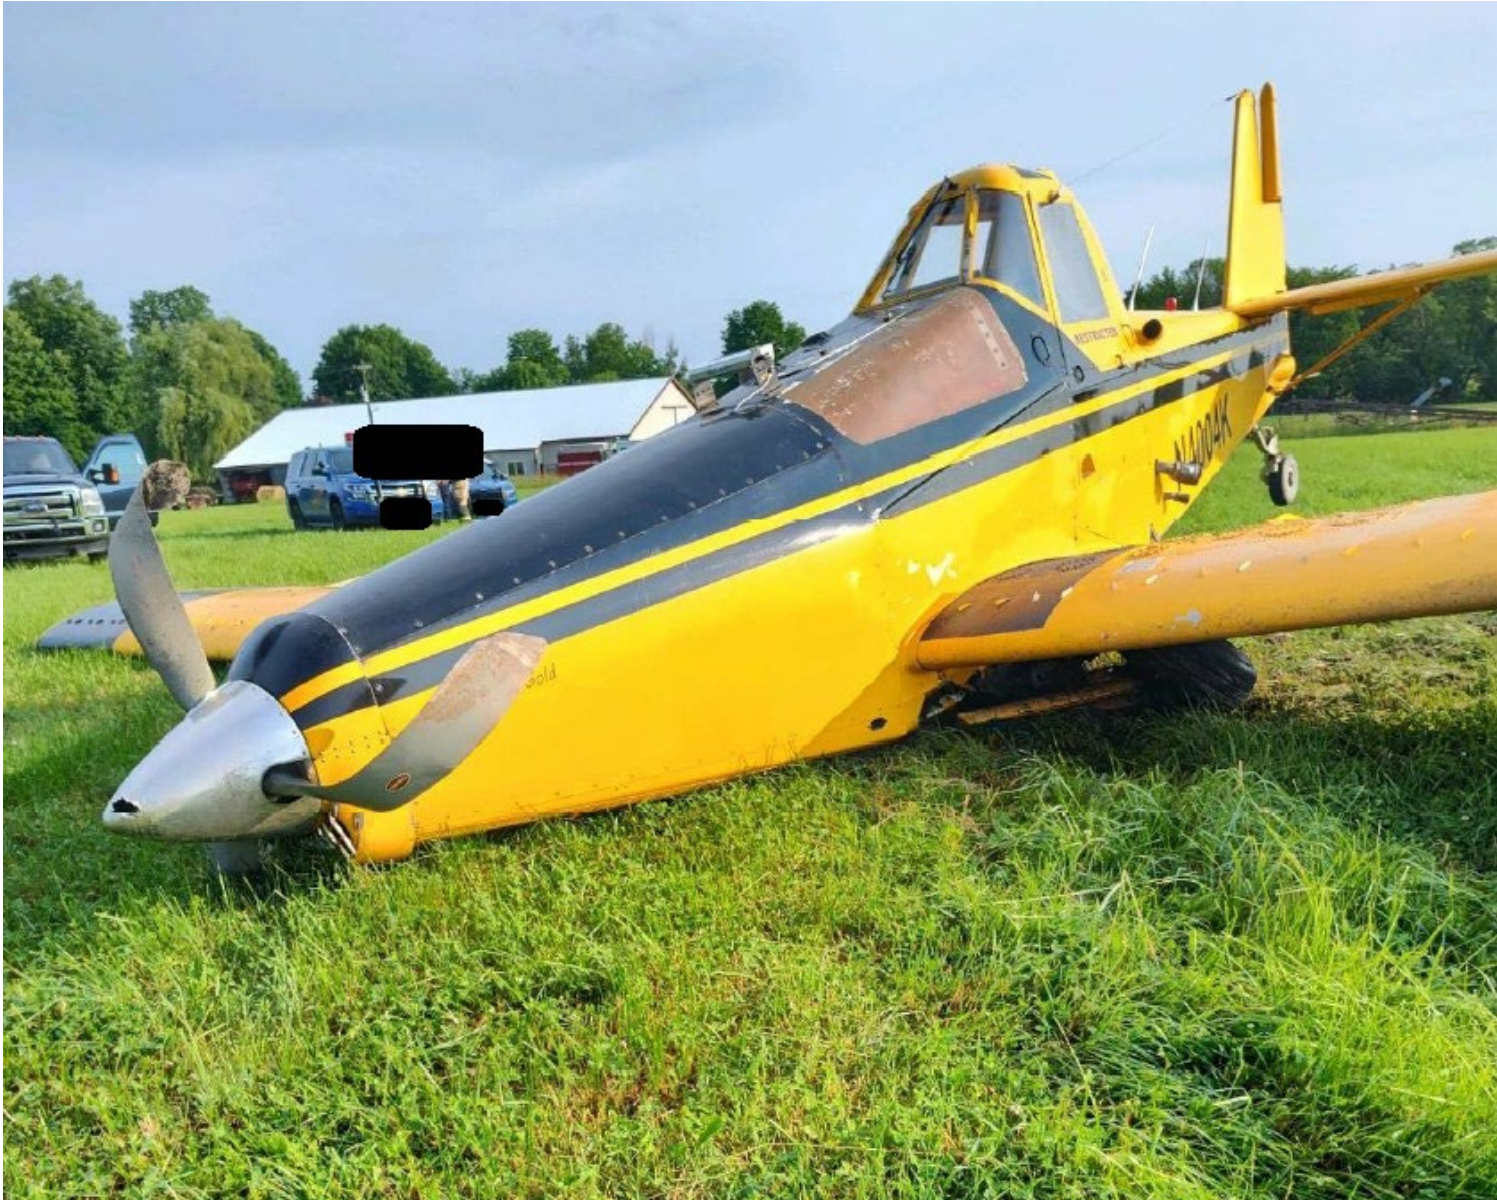
**Photograph 3 - View of the front of the airplane at the accident site (courtesy of the operator)**

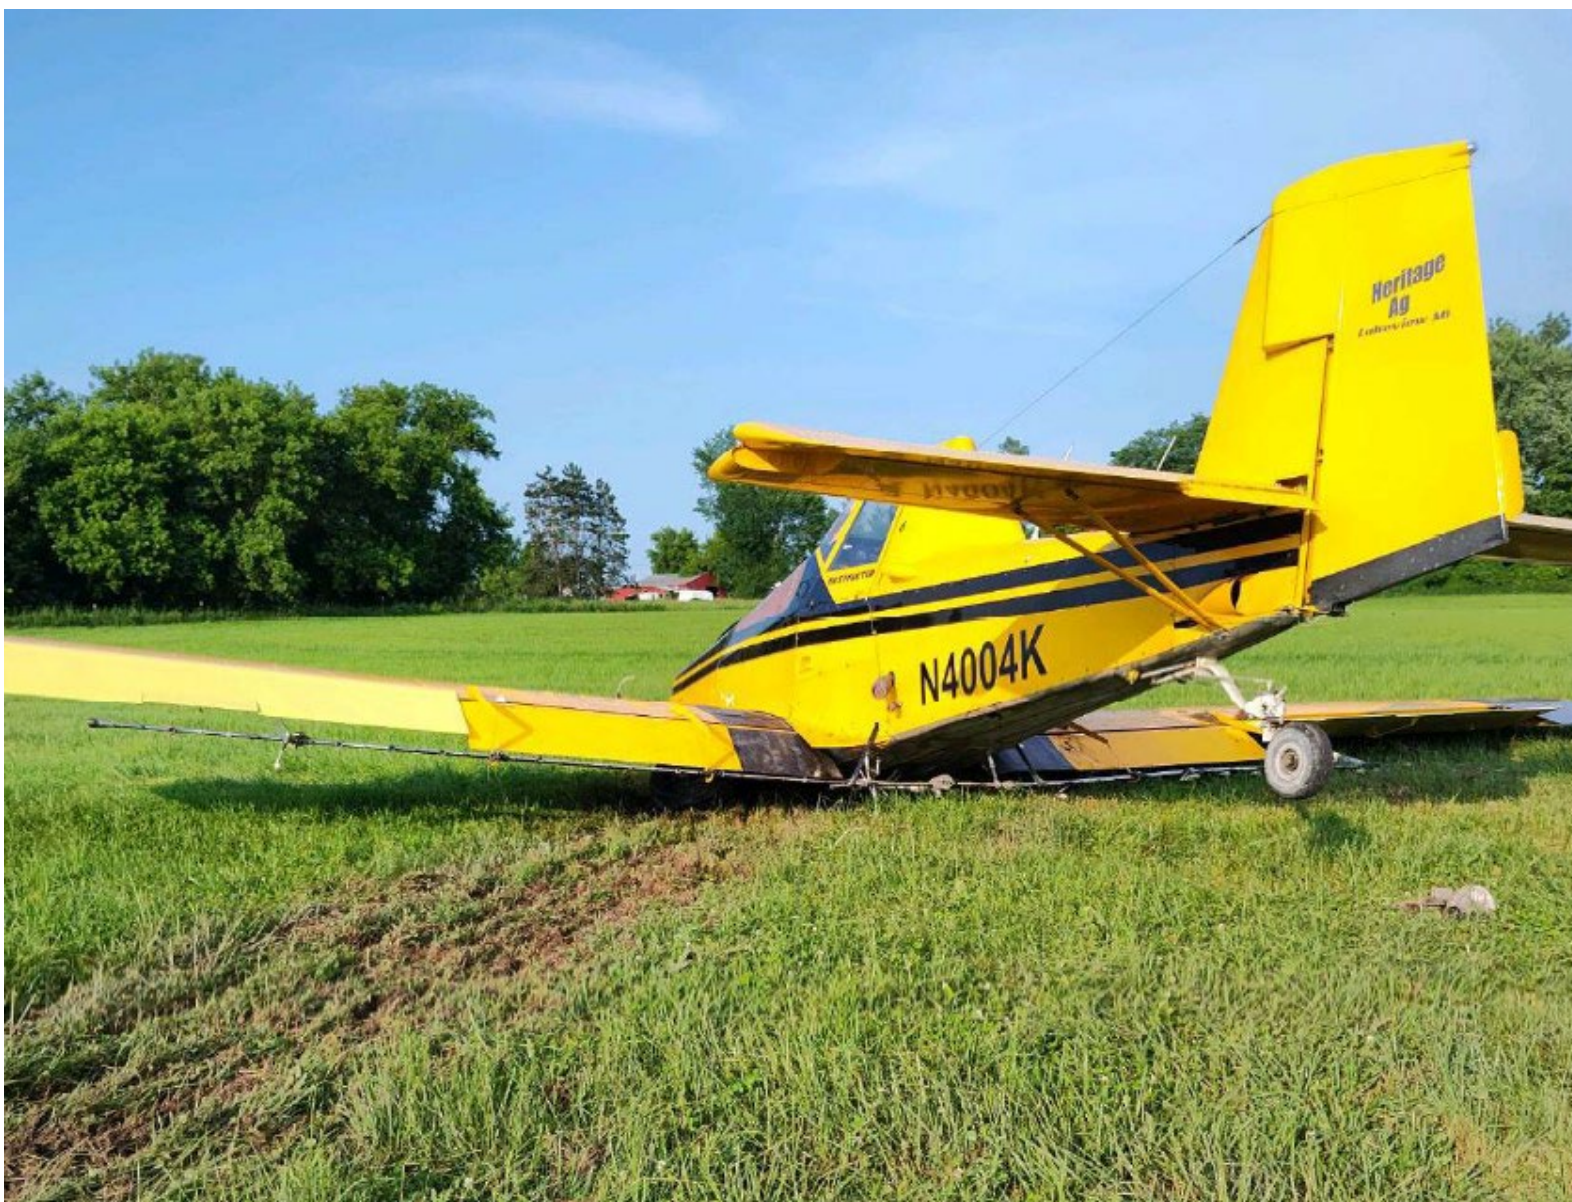
**Photograph 4 - View of the rear of the airplane at the accident site (courtesy of the operator)**

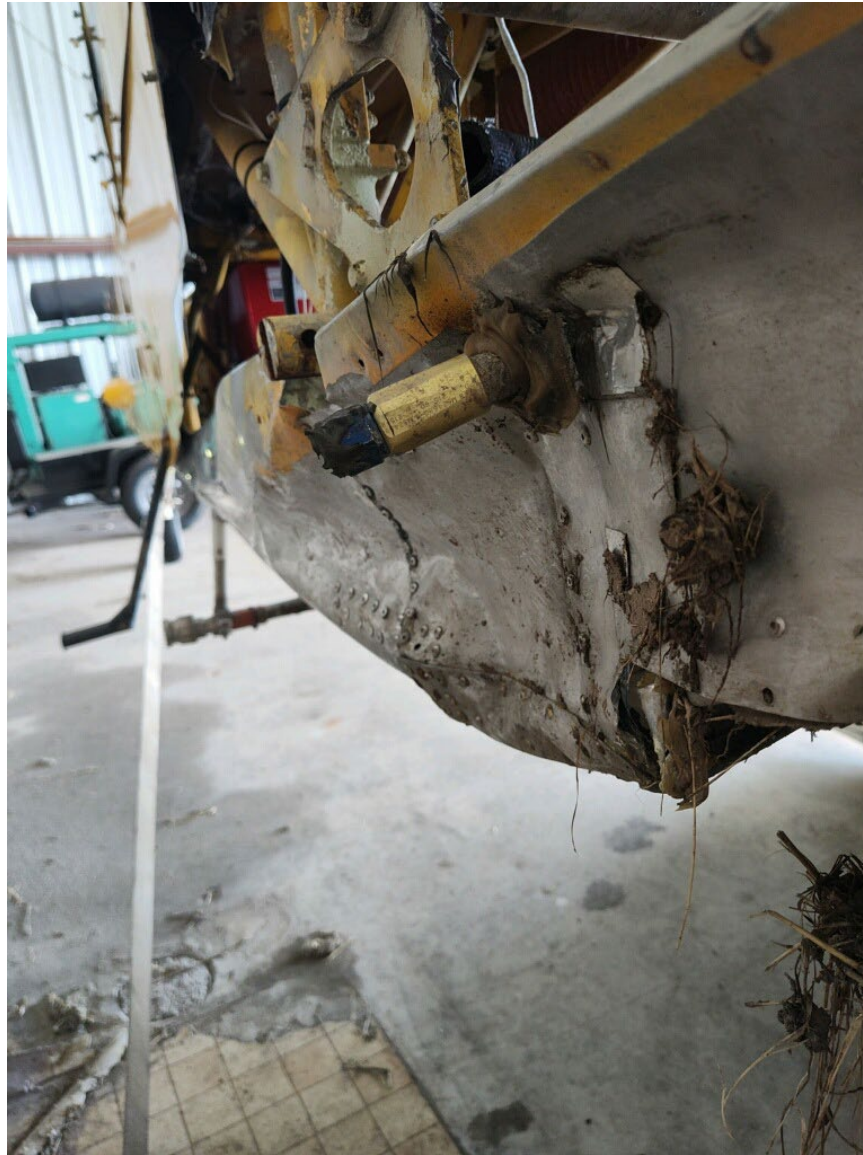
**Photograph 5 - View of the substantial damage sustained to the right side of the lower fuselage  
(courtesy of the operator)**

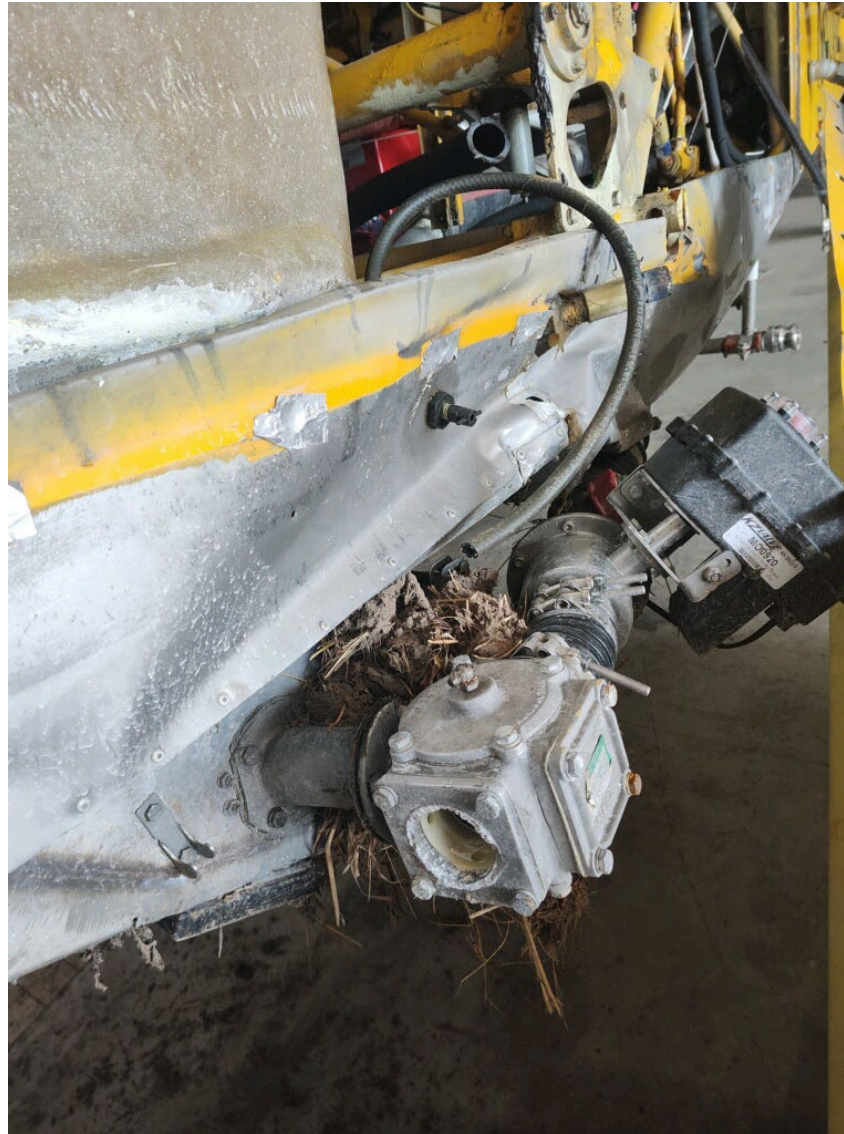
**Photograph 6 - View of the substantial damage sustained to the left side of the lower fuselage  
(courtesy of the operator)**

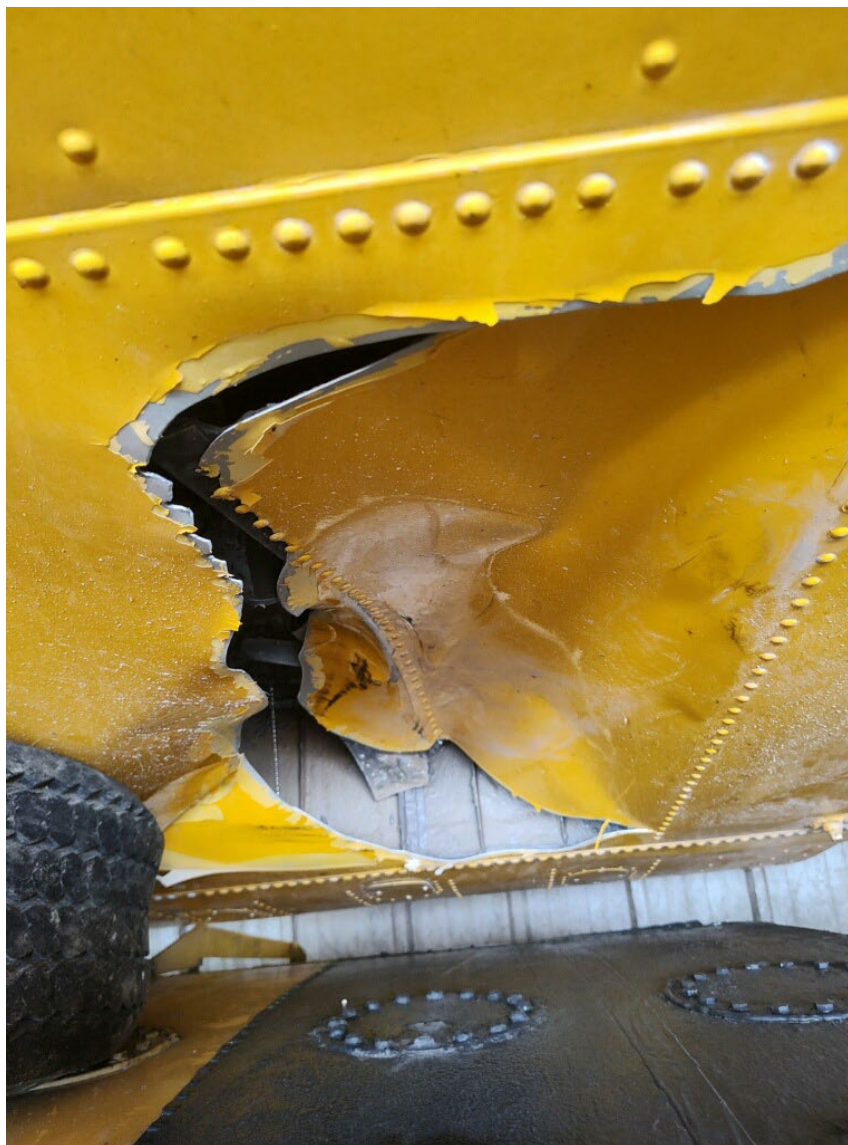
**Photograph 7 - View of the substantial damage sustained to the underside of the right wing  
(courtesy of the operator)**

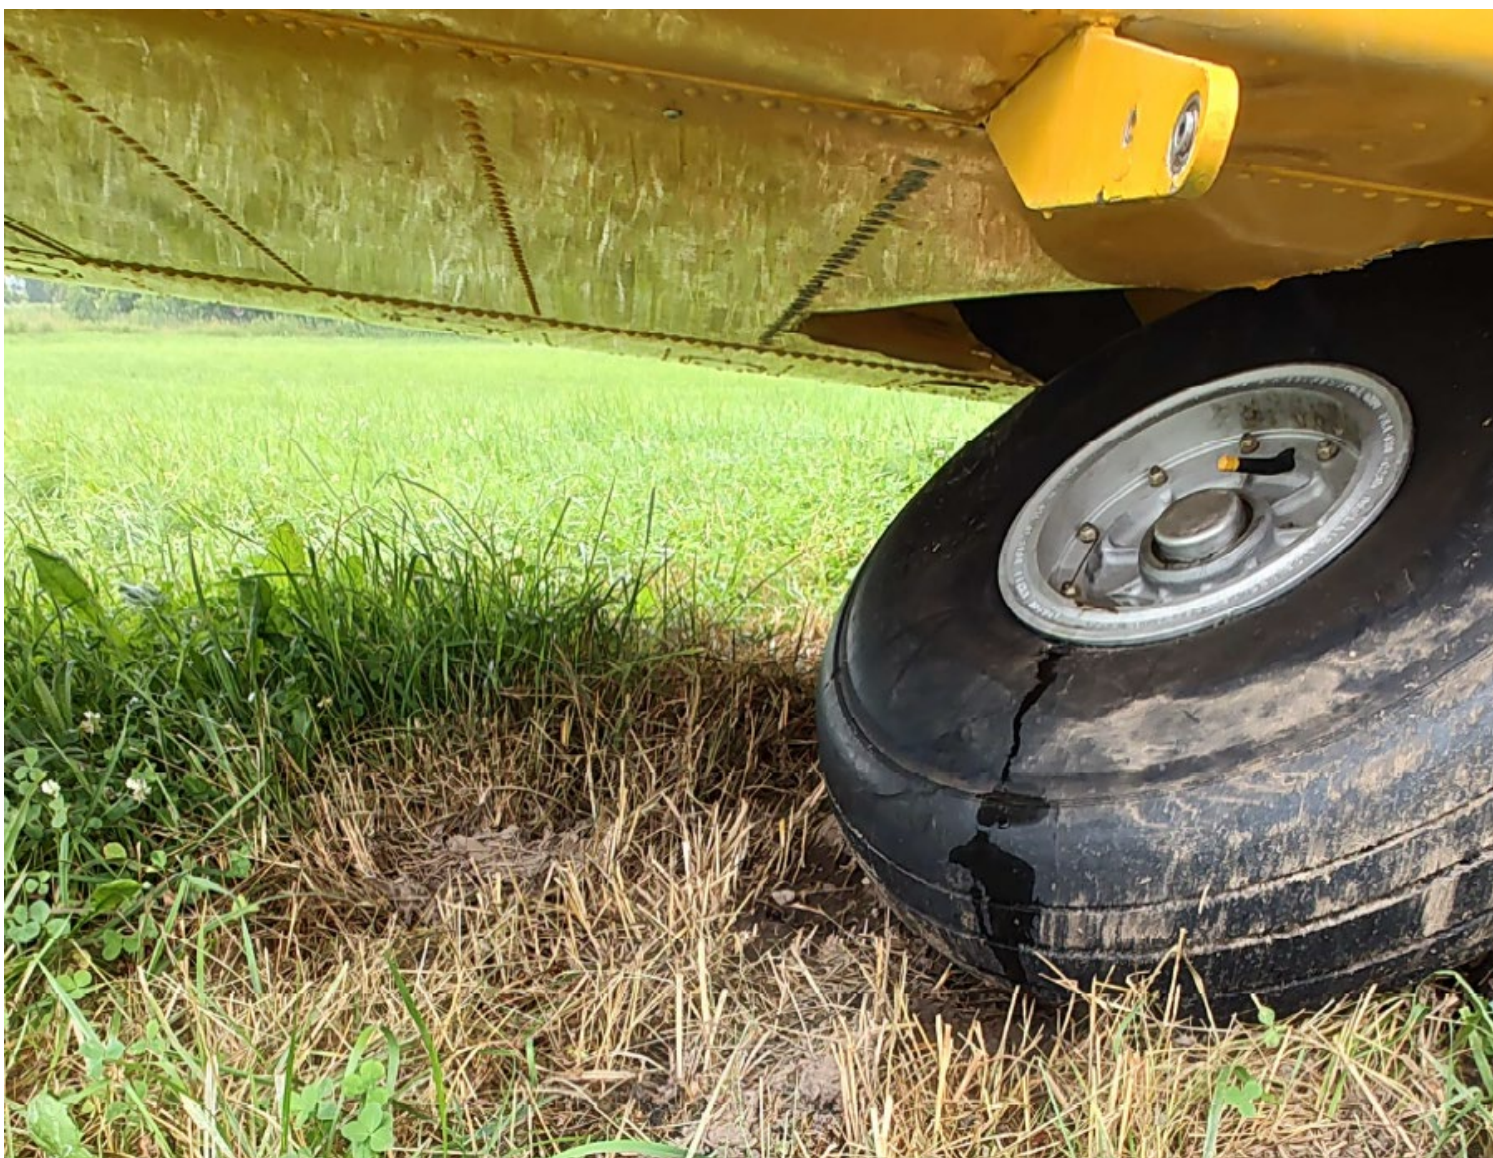
**Photograph 8 - View of the substantial damage sustained to the underside of the left wing  
(courtesy of the operator)**

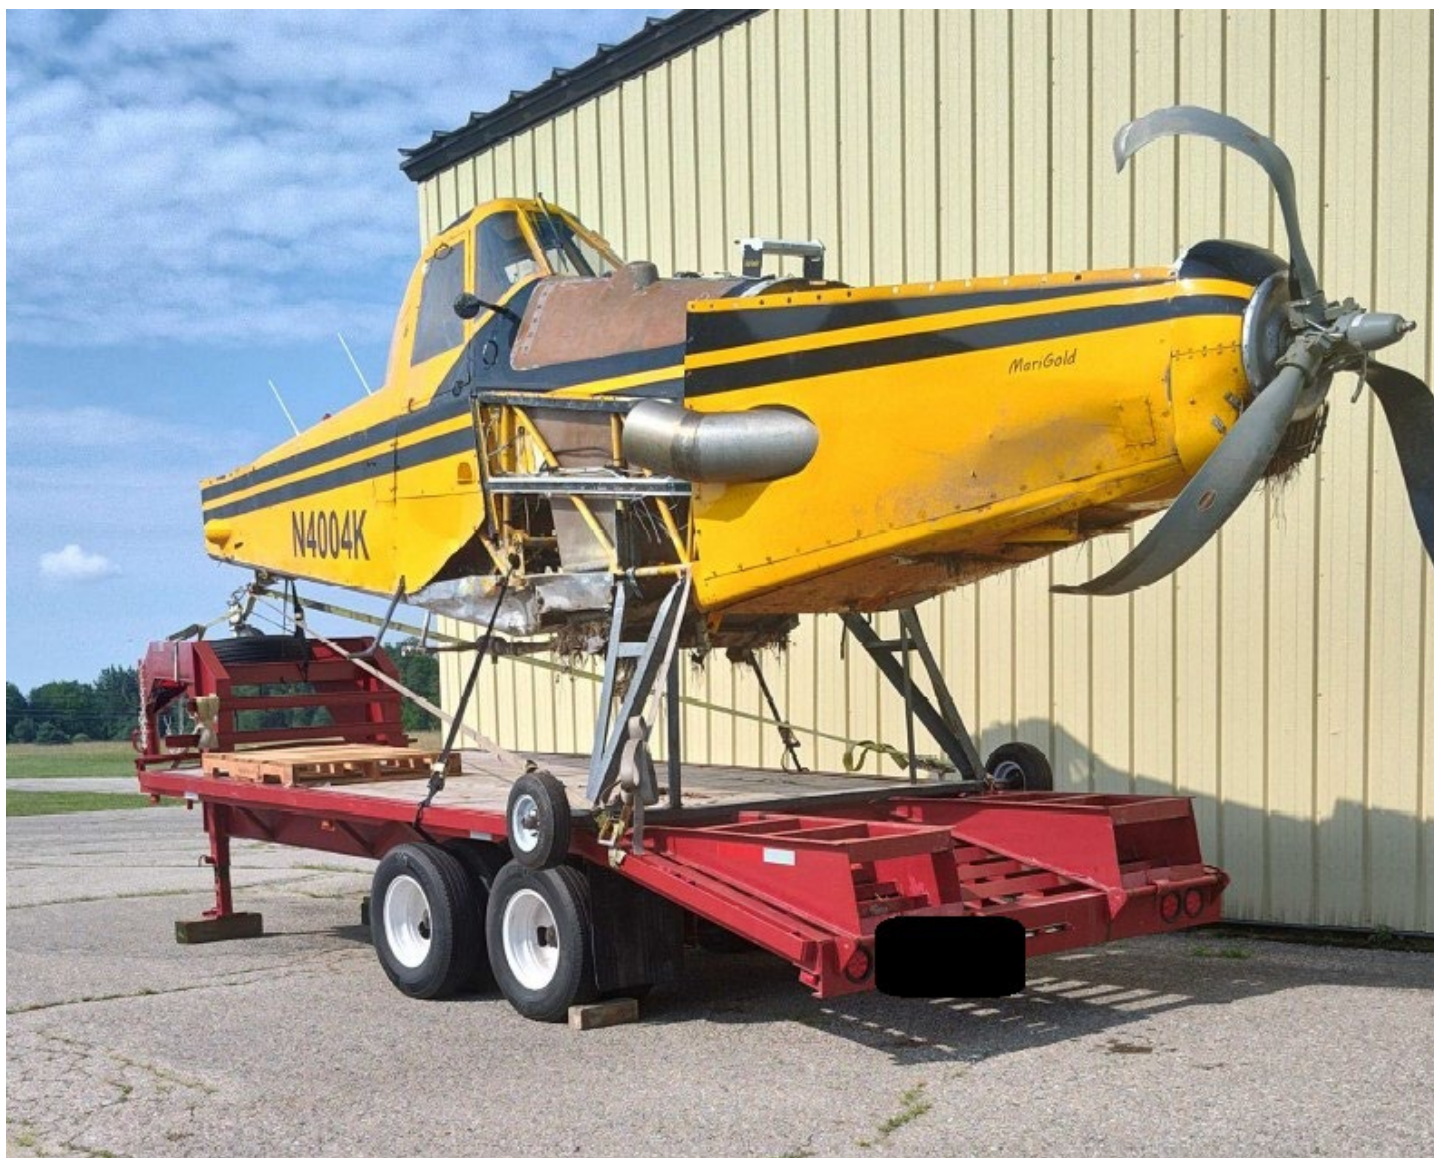
**Photograph 9 - View of the fuselage with both wings, the landing gear, and the empennage removed (courtesy of the operator)**
