**Beechcraft**

## Air Safety Investigations Aircraft Incident/Accident Technical Report

| Aircraft Incident/<br>Accident Information | Year: 2007 | Make: Beechcraft | Model: Hawker 900XP |
| Senior Air Safety Investigator: Ernest C. Hall | | Report #: ASI-24-CA-T | Report date: 02-03-25 |

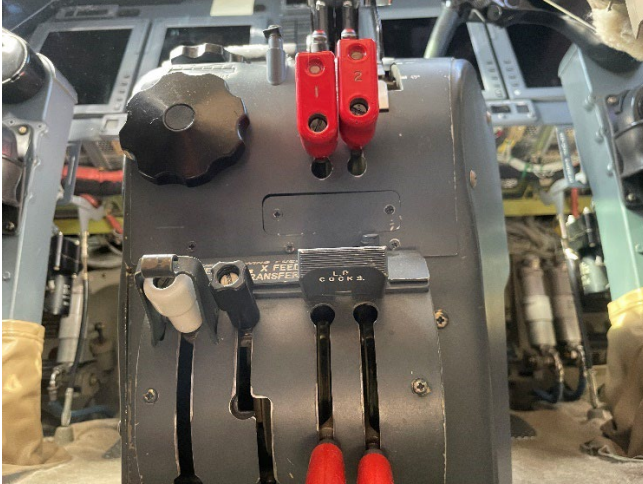
ASI-24-CA-102 – HP Fuel Valve Levers

The crossfeed and the ventral tank fuel valve levers located on the cockpit pedestal were found in the closed position. The left and right high pressure (HP) and the left and right low pressure (LP) fuel control valve levers were found above the cutoff/closed detent position. With hand force, this investigator either had difficulty to or could not push the HP/LP levers into the cutoff/closed detent position. Further examination revealed that the cockpit pedestal lower section attach points had buckled and shifted up and aft due to the nose landing gear protruding through the aircraft's bottom skin structure.

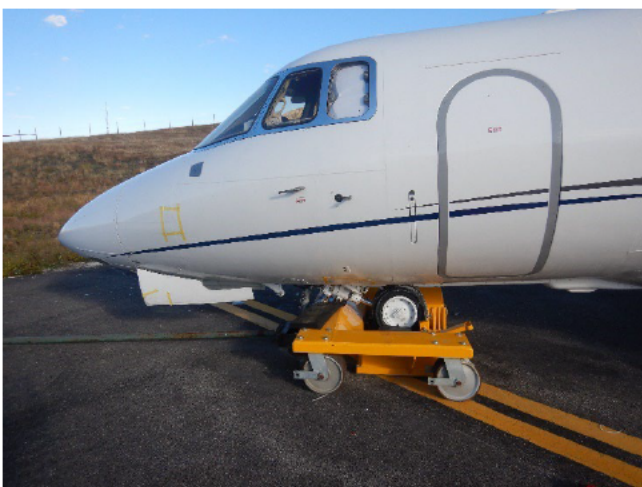
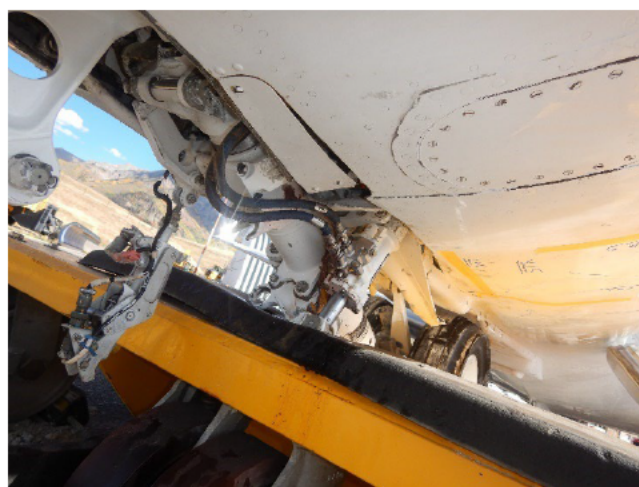
The extended nose landing gear collapsed aft and up into the bottom of the nose fuselage structure at the cockpit pedestal area.

ASI-24-CA-033 – Nose Landing Gear

ASI-24-CA-068 – Nose Landing Gear
