# **AVIATION INVESTIGATION REPORT**

## **A05Q0024**

### **LANDING BESIDE THE RUNWAY**

**SCOTT AVIATION**  
**HAWKER SIDDELEY HS 125-600A N21SA**  
**BROMONT AIRPORT, QUEBEC**  
**21 FEBRUARY 2005**

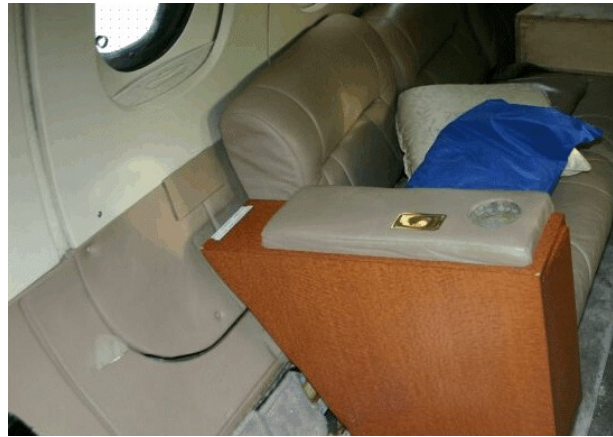
**Photo 1.** Armrest/cabinet

A cabinet that served as an armrest for the side seat was partially blocking the emergency exit (see Photo 1). The armrest/cabinet is connected to the seat by means of a rail along which it slides when it is necessary to remove it. According to Supplementary Type Certificate (STC) SA4147SW, a notice indicating that the armrest must be removed before each take-off and landing must be displayed when the armrest is in position. At the time of the accident, the armrest/cabinet was in position, and the notice stated that the cabinet should be pulled forward in order for the emergency exit to be used.

The emergency exit could not be opened due to structural damage, which delayed the evacuation and could have had serious consequences. As well, the armrest next to the side seat was blocking the access to the emergency exit. The notice on the armrest was not compliant with the STC, which required that the armrest be removed before each take-off and landing. STCs are not normally provided to pilots, so the flight crew had no way of knowing about this requirement.

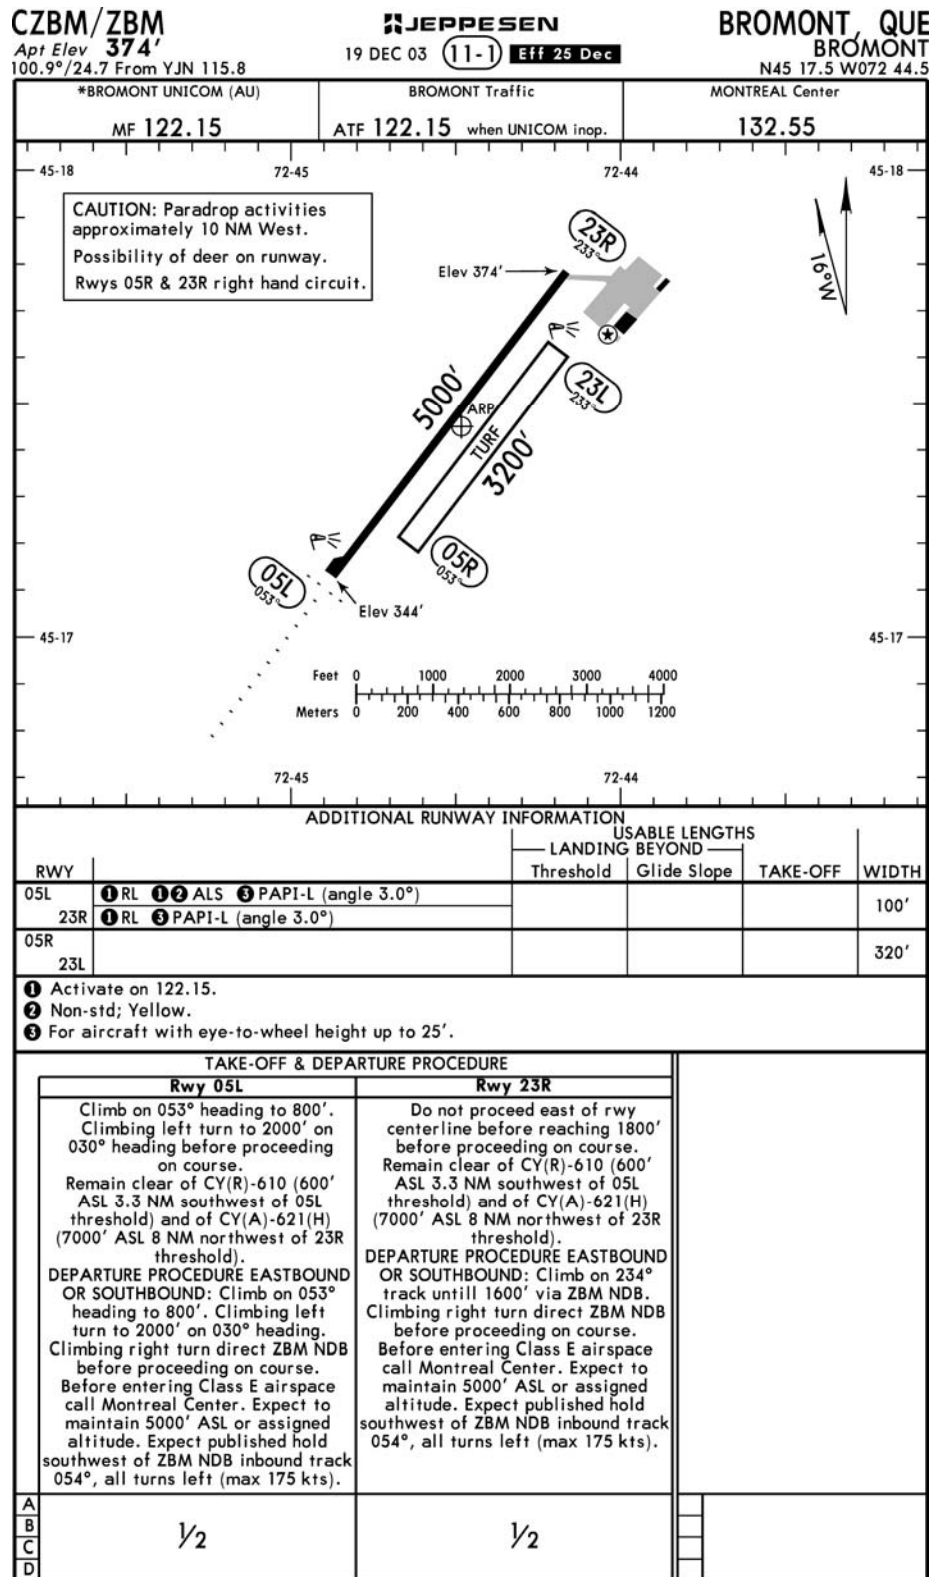
# Appendix A – Aerodrome Map

At approximately 1000 feet asl and five miles from the threshold, the flight crew had the approach lights and the PAPI in sight. It was not evident whether the PAPI was positioned on the right or the left side of the runway. The airport chart published by Jeppesen indicated "PAPI-L" (see Appendix A), and interpretation meant that the PAPI was on the left. In response to a query from the crew, the Bromont dispatcher indicated that the PAPI was on the right side of the runway. From his location facing the aircraft, the PAPI was to the dispatcher's right. The approach chart, also published by Jeppesen, showed the position of the PAPI by means of a pictograph, showing a drawing of the runway threshold and the approach lights with the word "PAPI" on the left side of the drawing (see Appendix B). Although that chart was referred to during the approach, there is no indication that the crew noticed the pictograph.
