CEN24LA328

## INVESTIGATION PHOTOGRAPHS

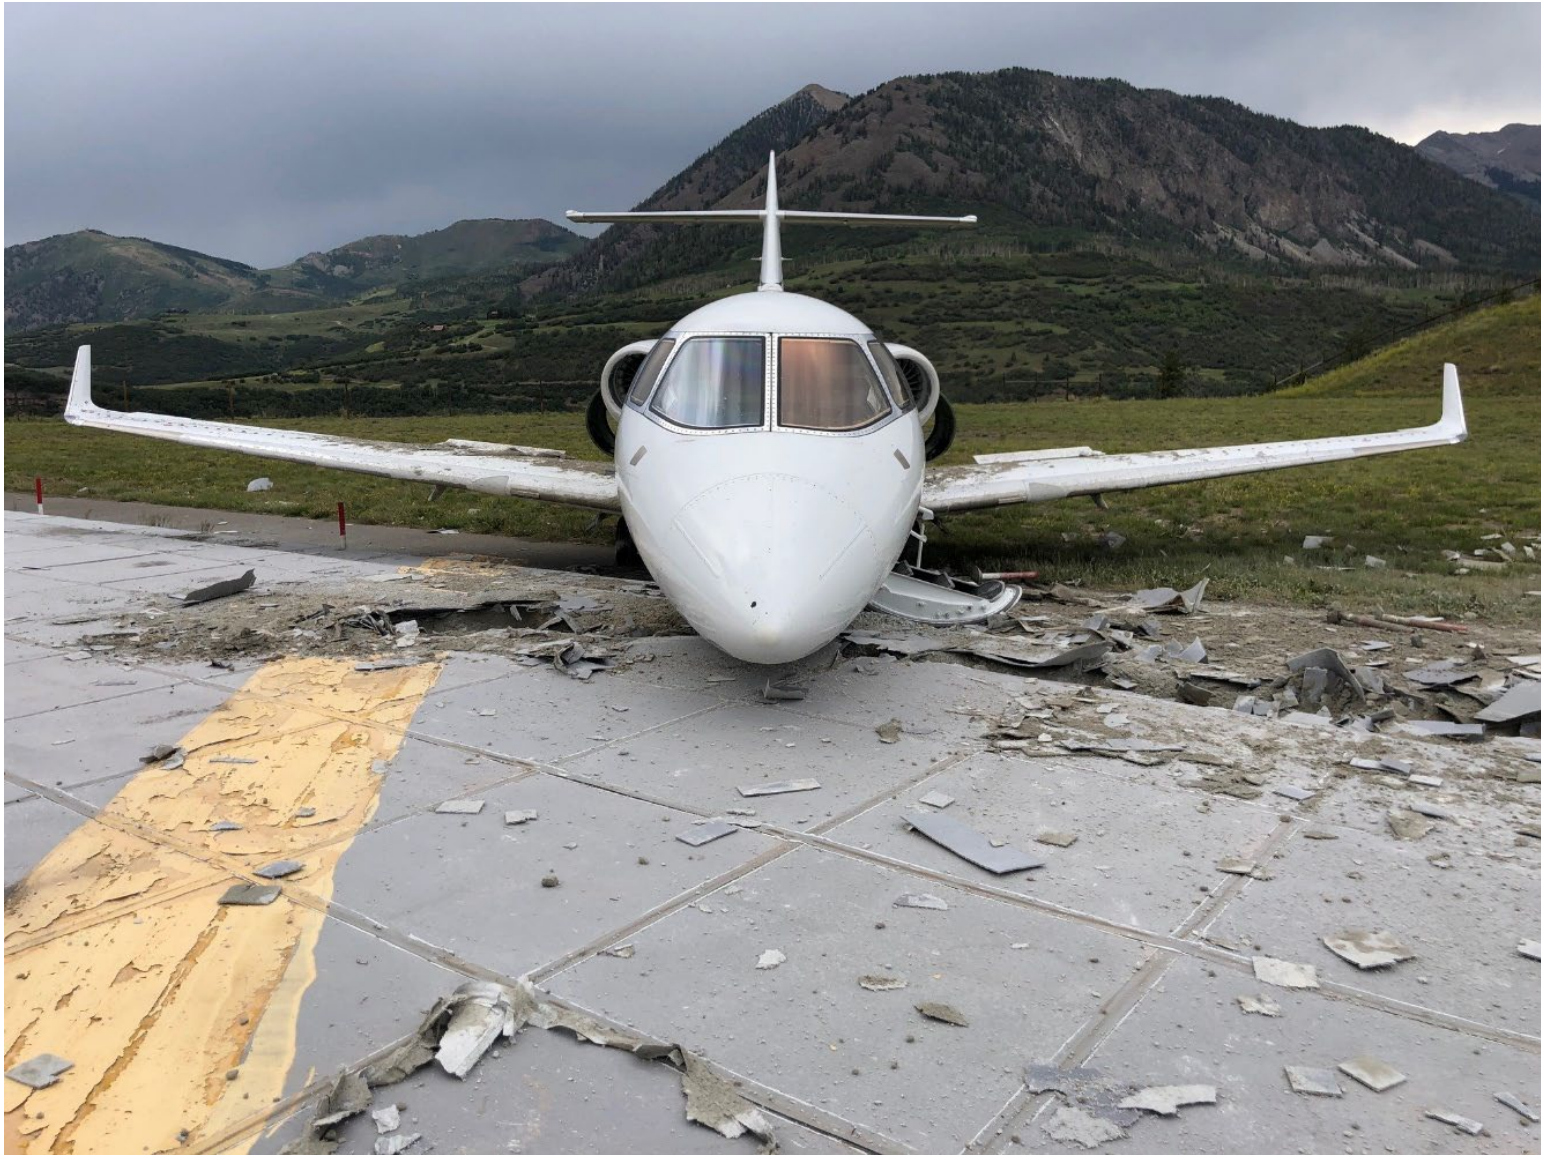
**Photograph 1 - View of the front of the airplane at the accident site (courtesy of airport operations)**

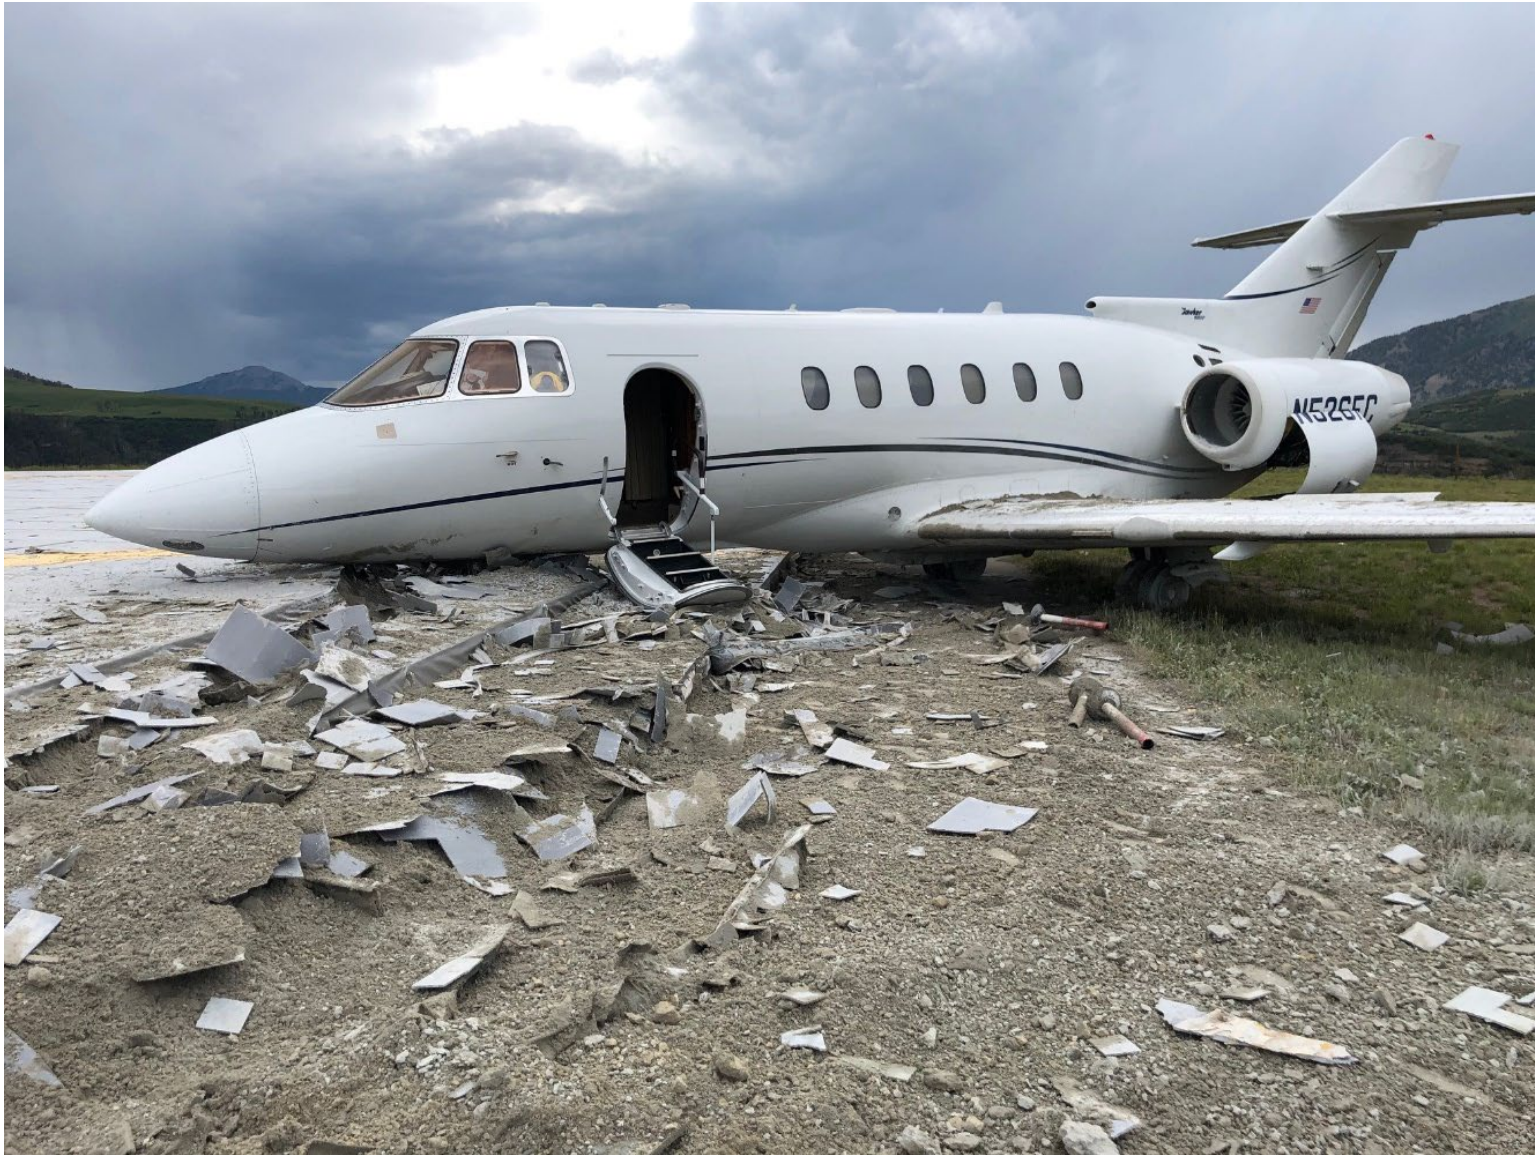
**Photograph 2 - View of the right side of the airplane at the accident site (courtesy of airport operations)**

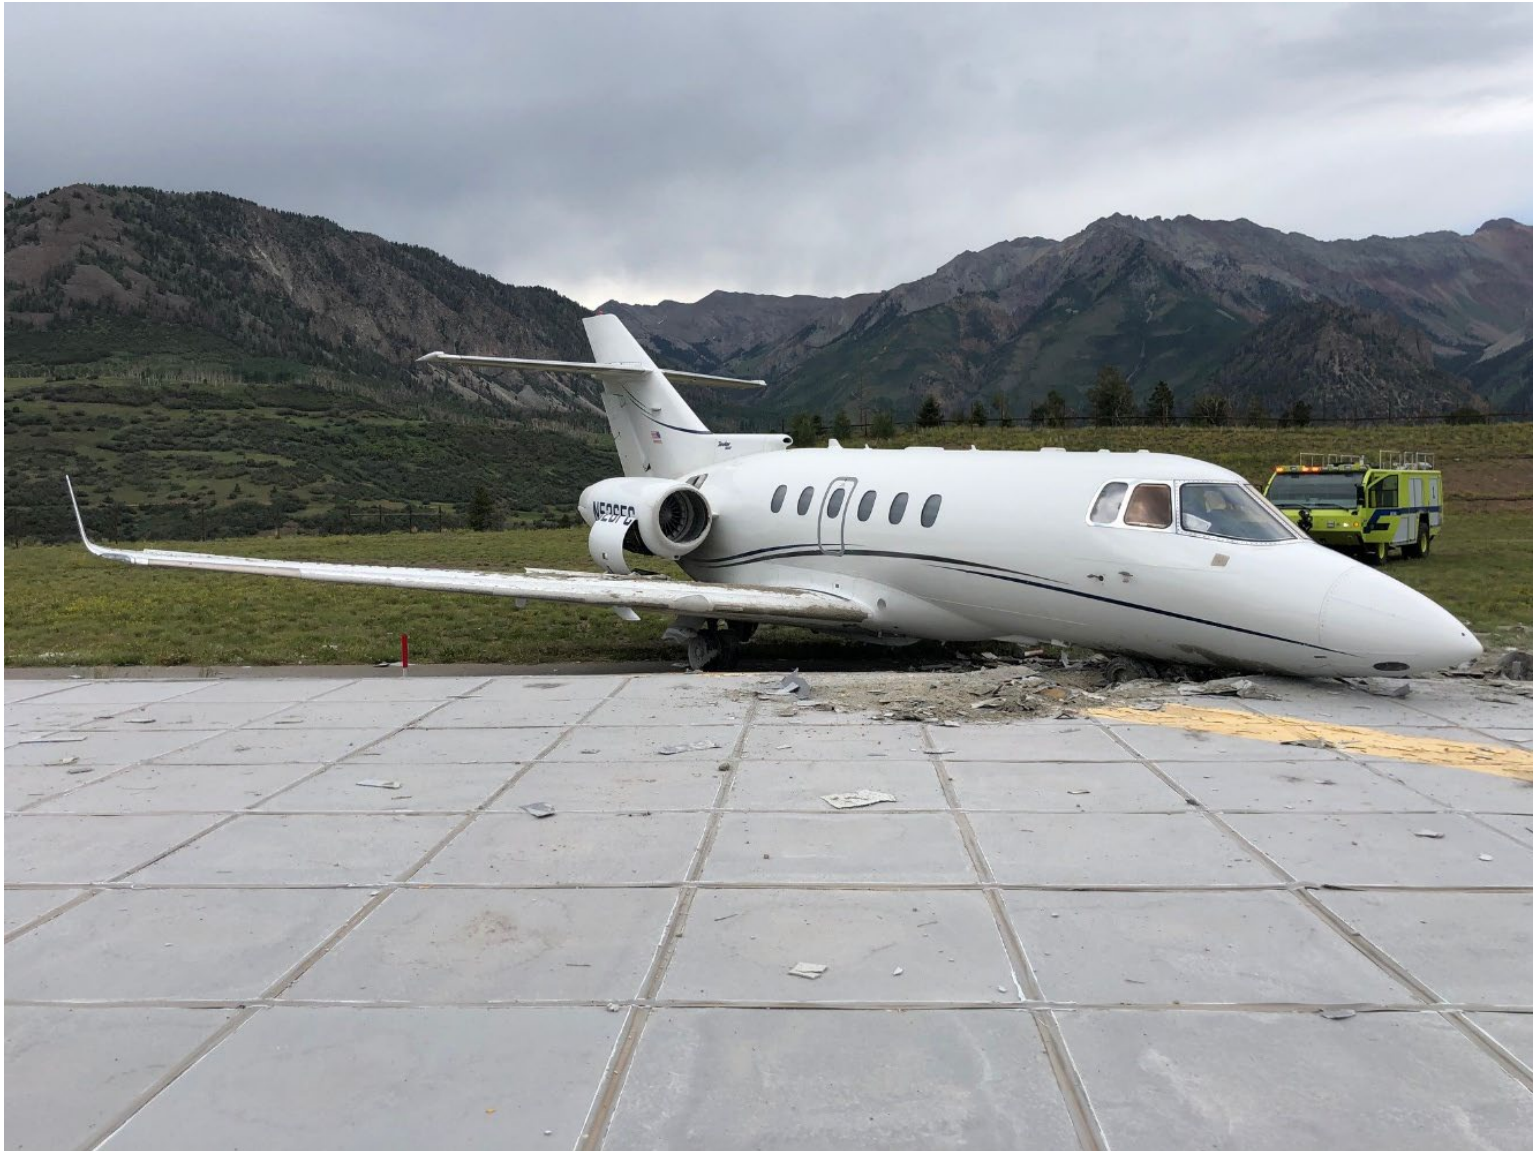
**Photograph 3 - View of the left side of the airplane at the accident site (courtesy of airport operations)**

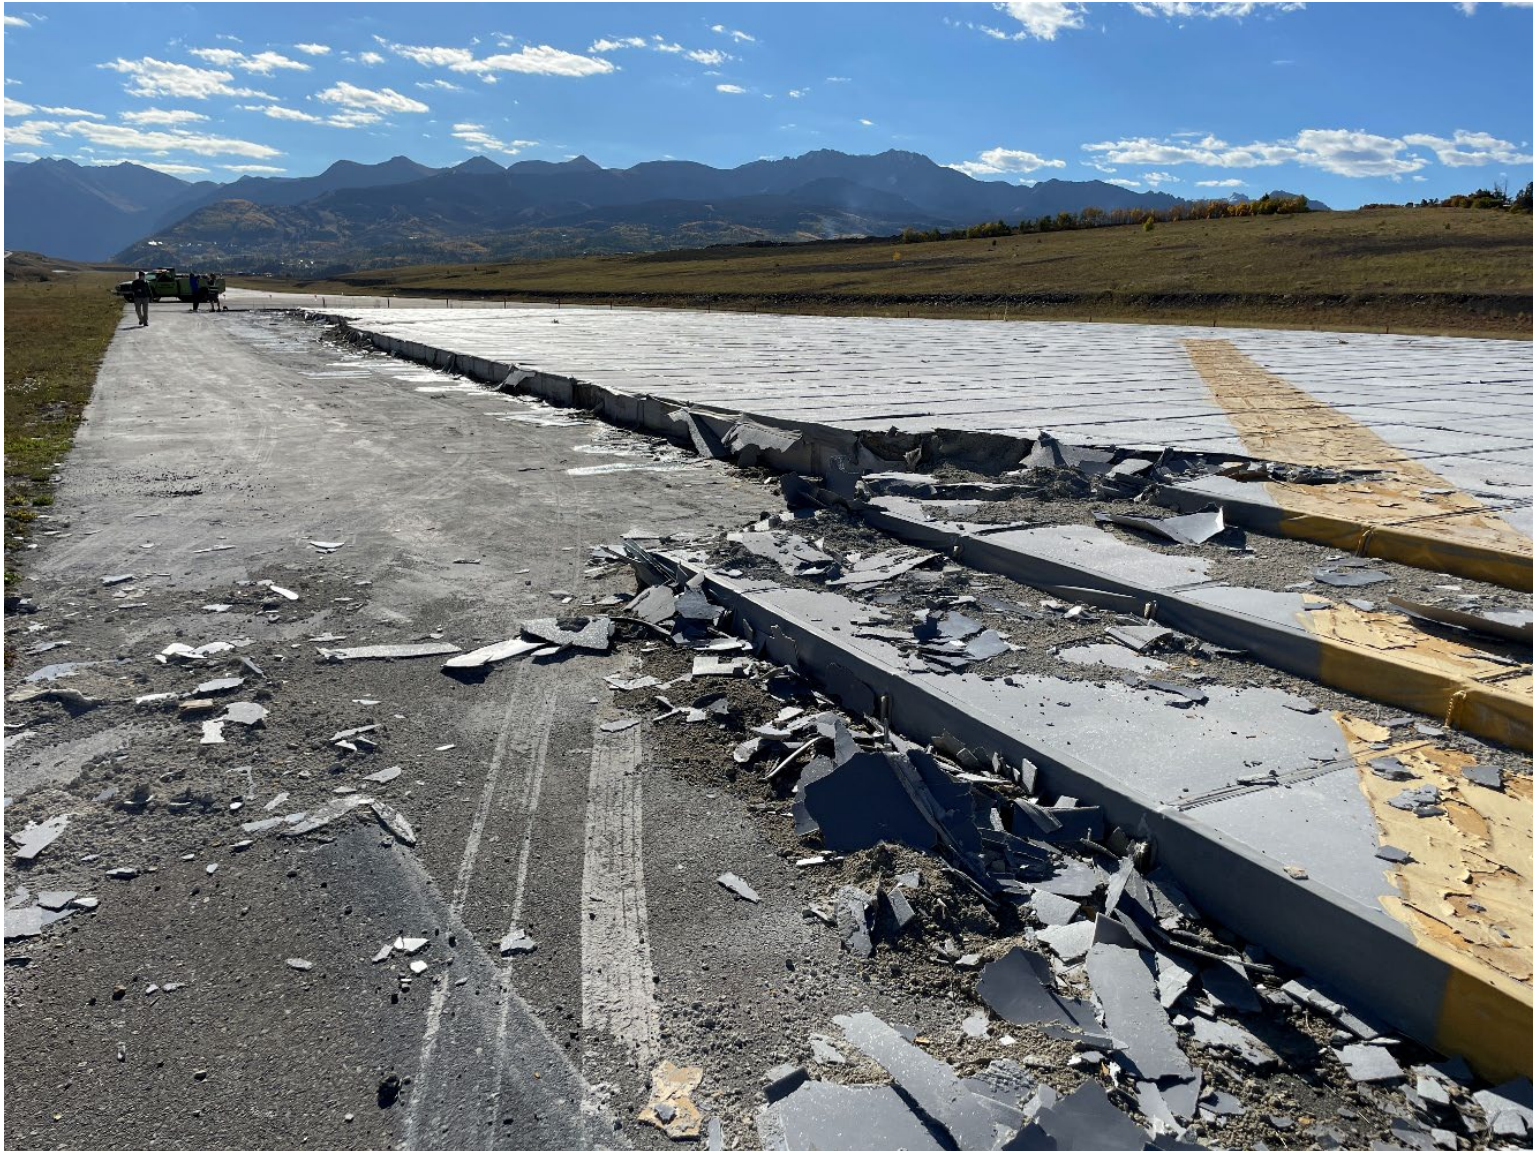
**Photograph 4 - East facing view of the damage sustained to the engineered material arresting system from the airplane**

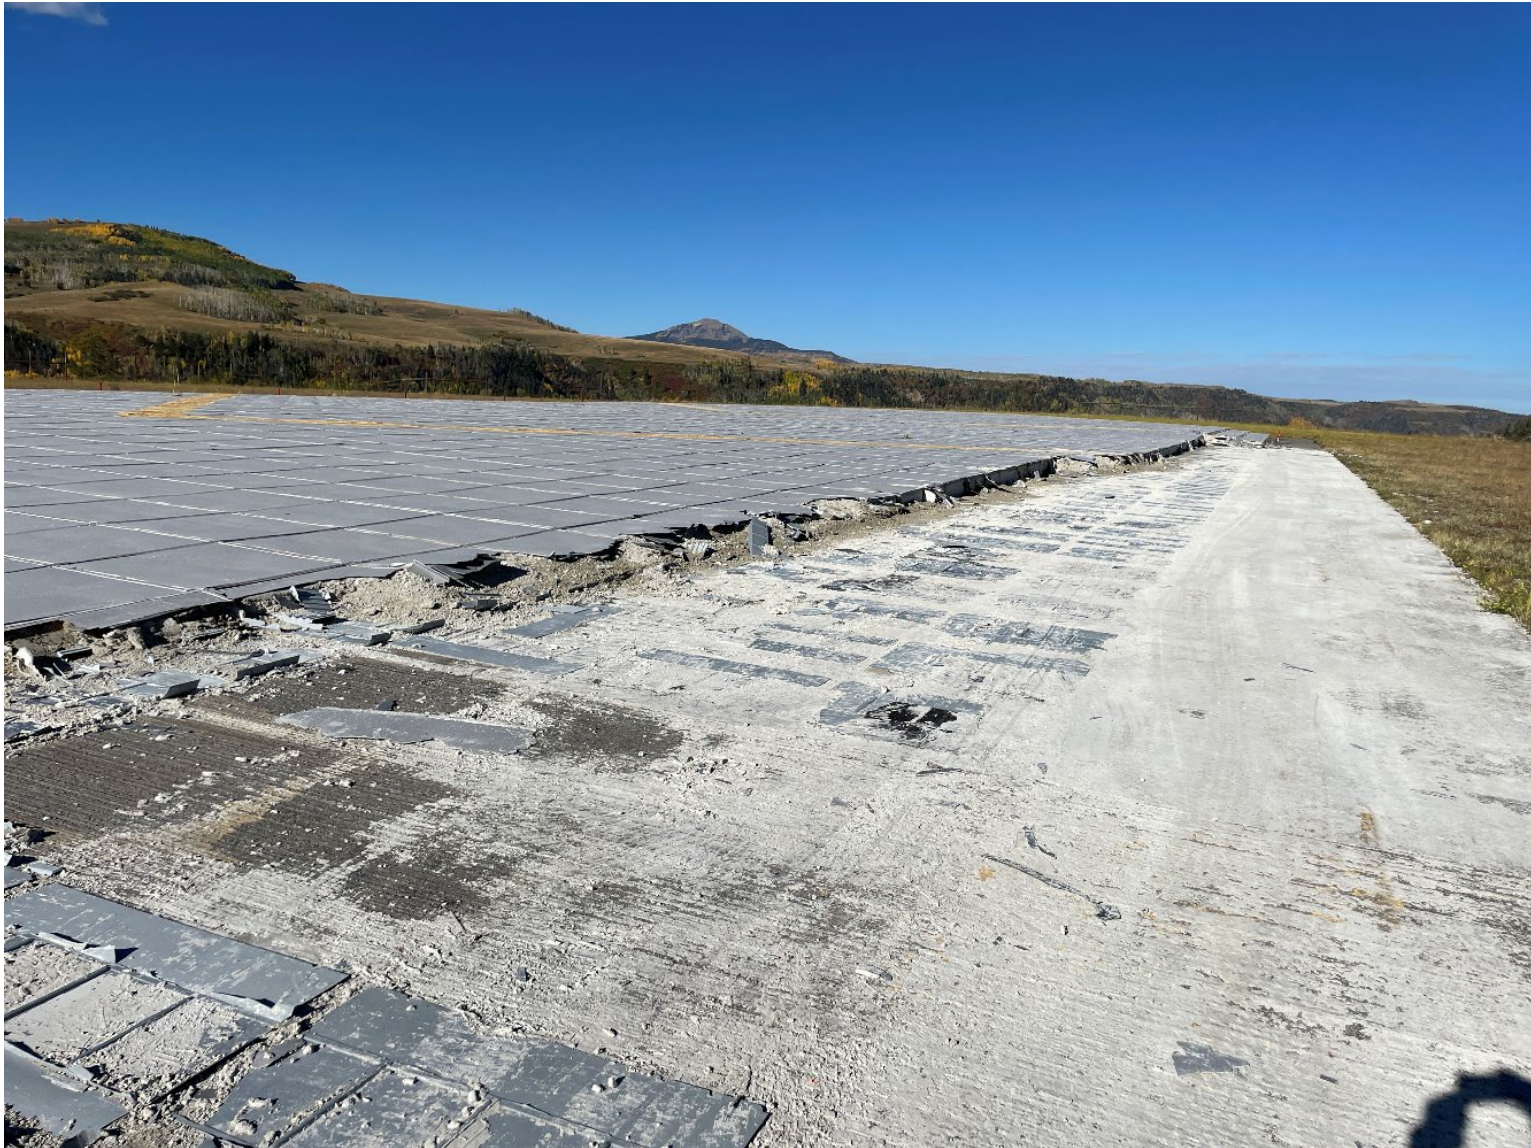
**Photograph 5 - West facing view of the damage sustained to the engineered material arresting system from the airplane**

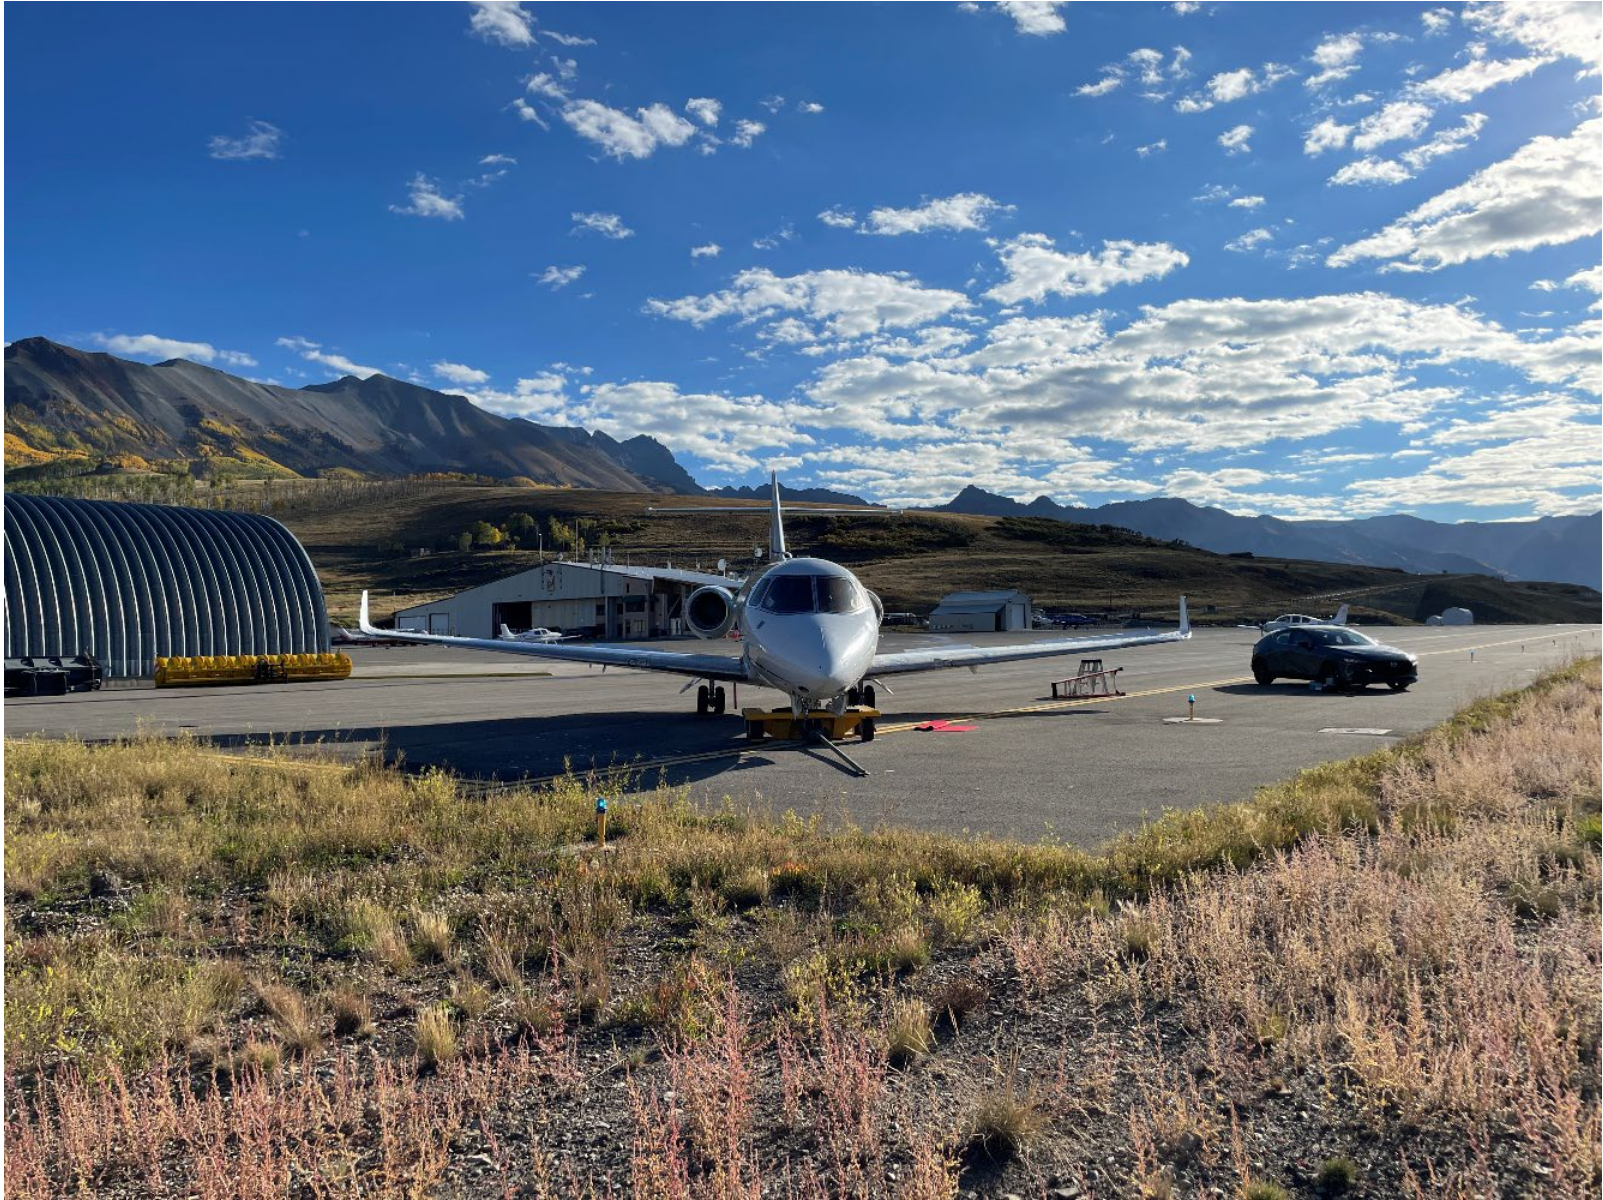
**Photograph 6 - View of the front of the airplane on the ramp**

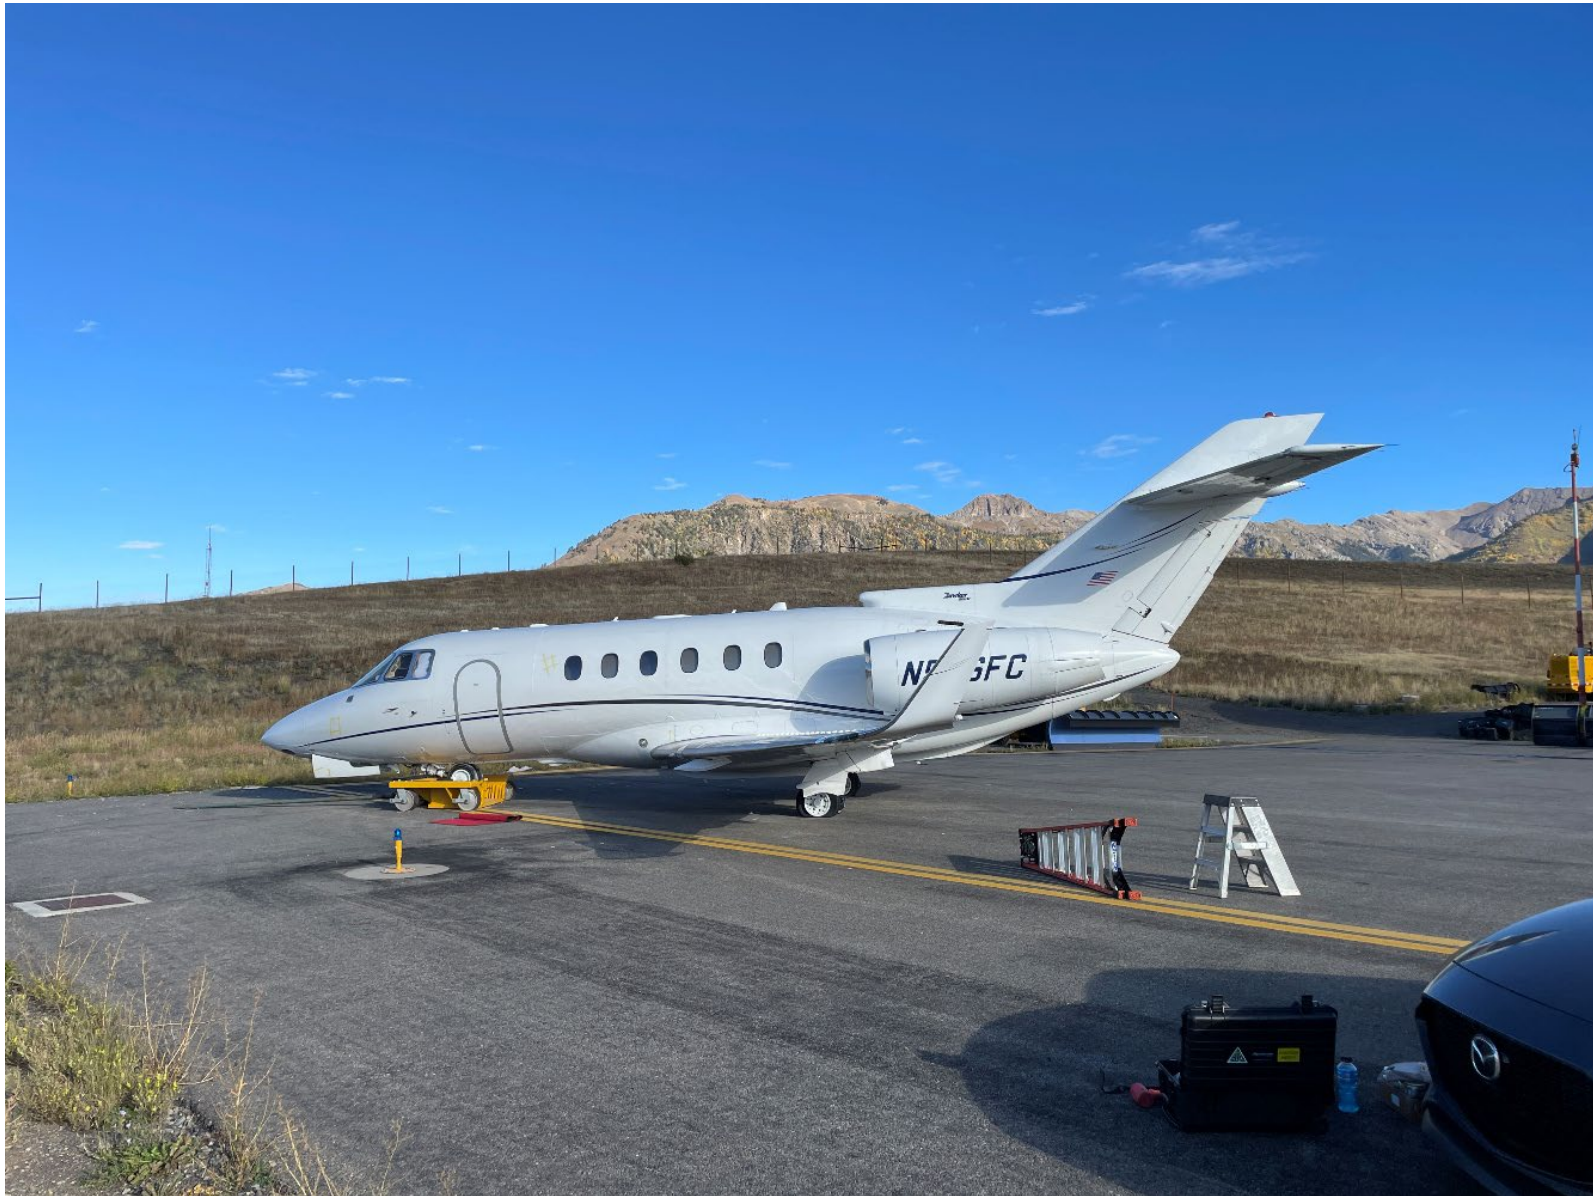
**Photograph 7 - View of the left side of the airplane on the ramp**

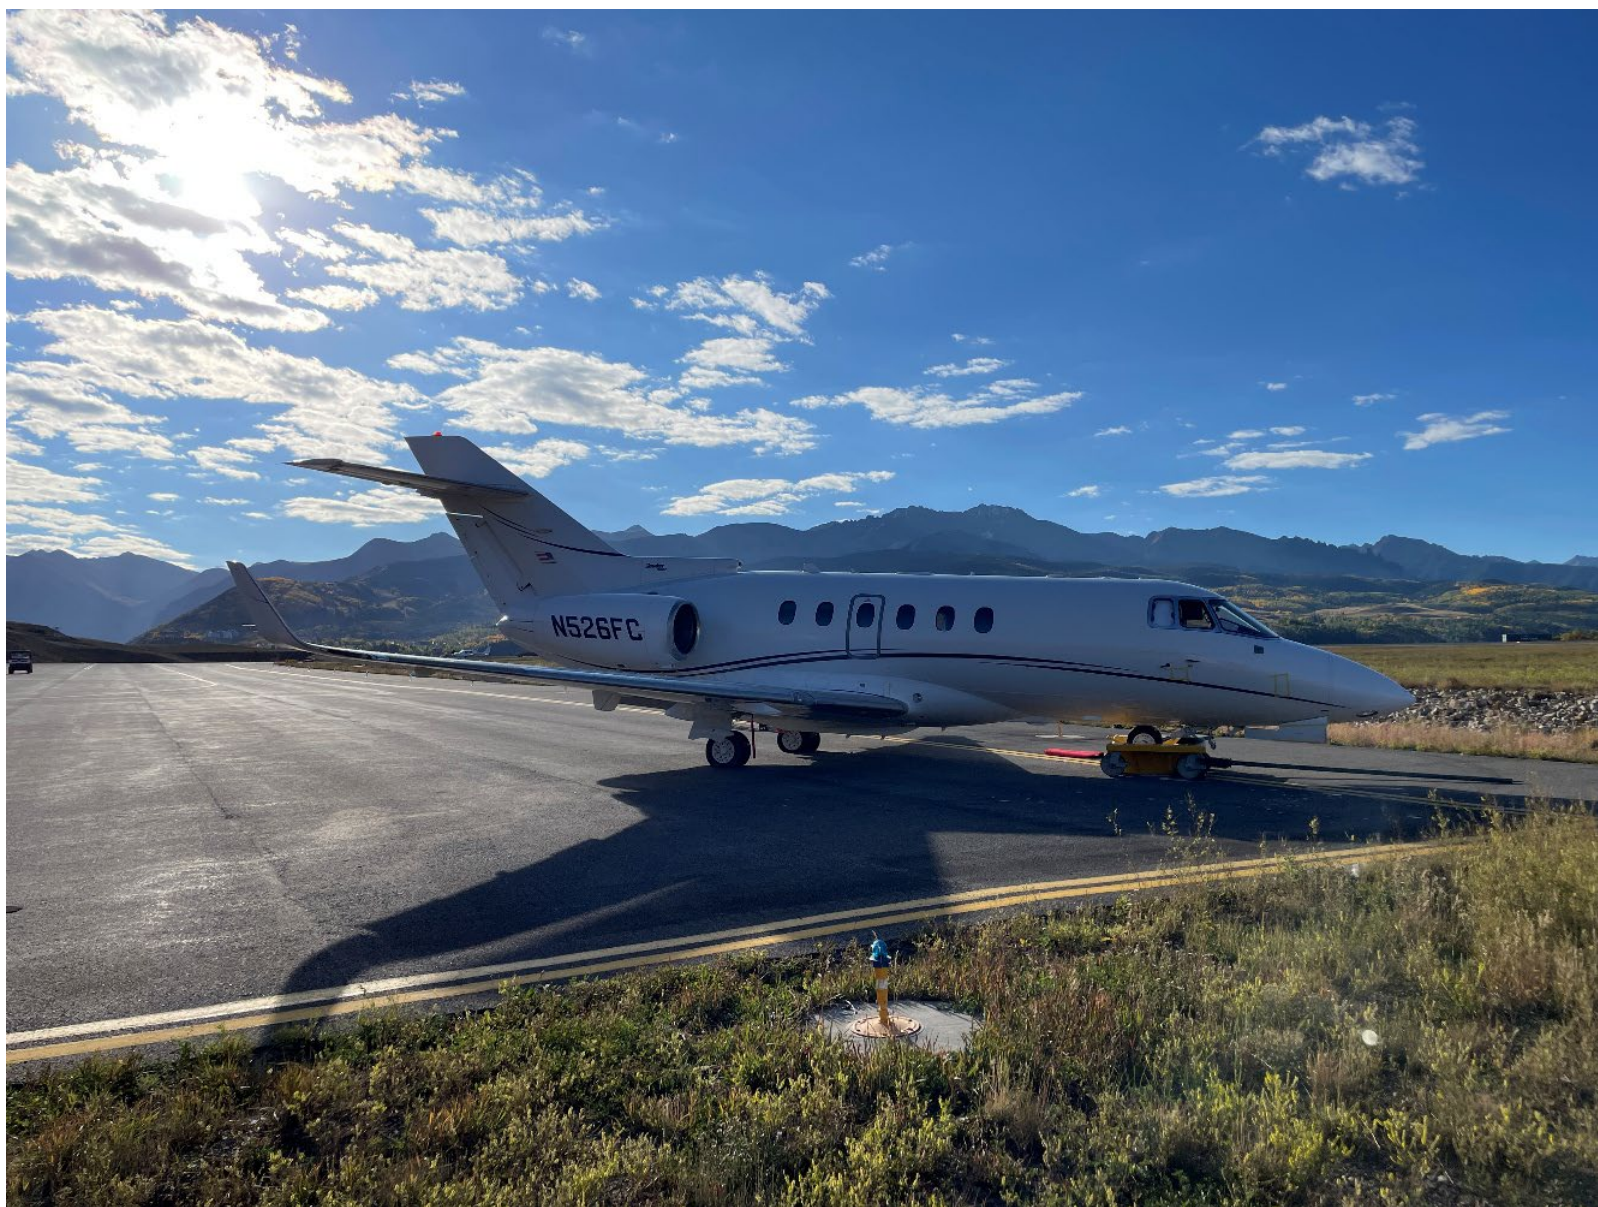
**Photograph 8 - View of the right side of the airplane on the ramp**

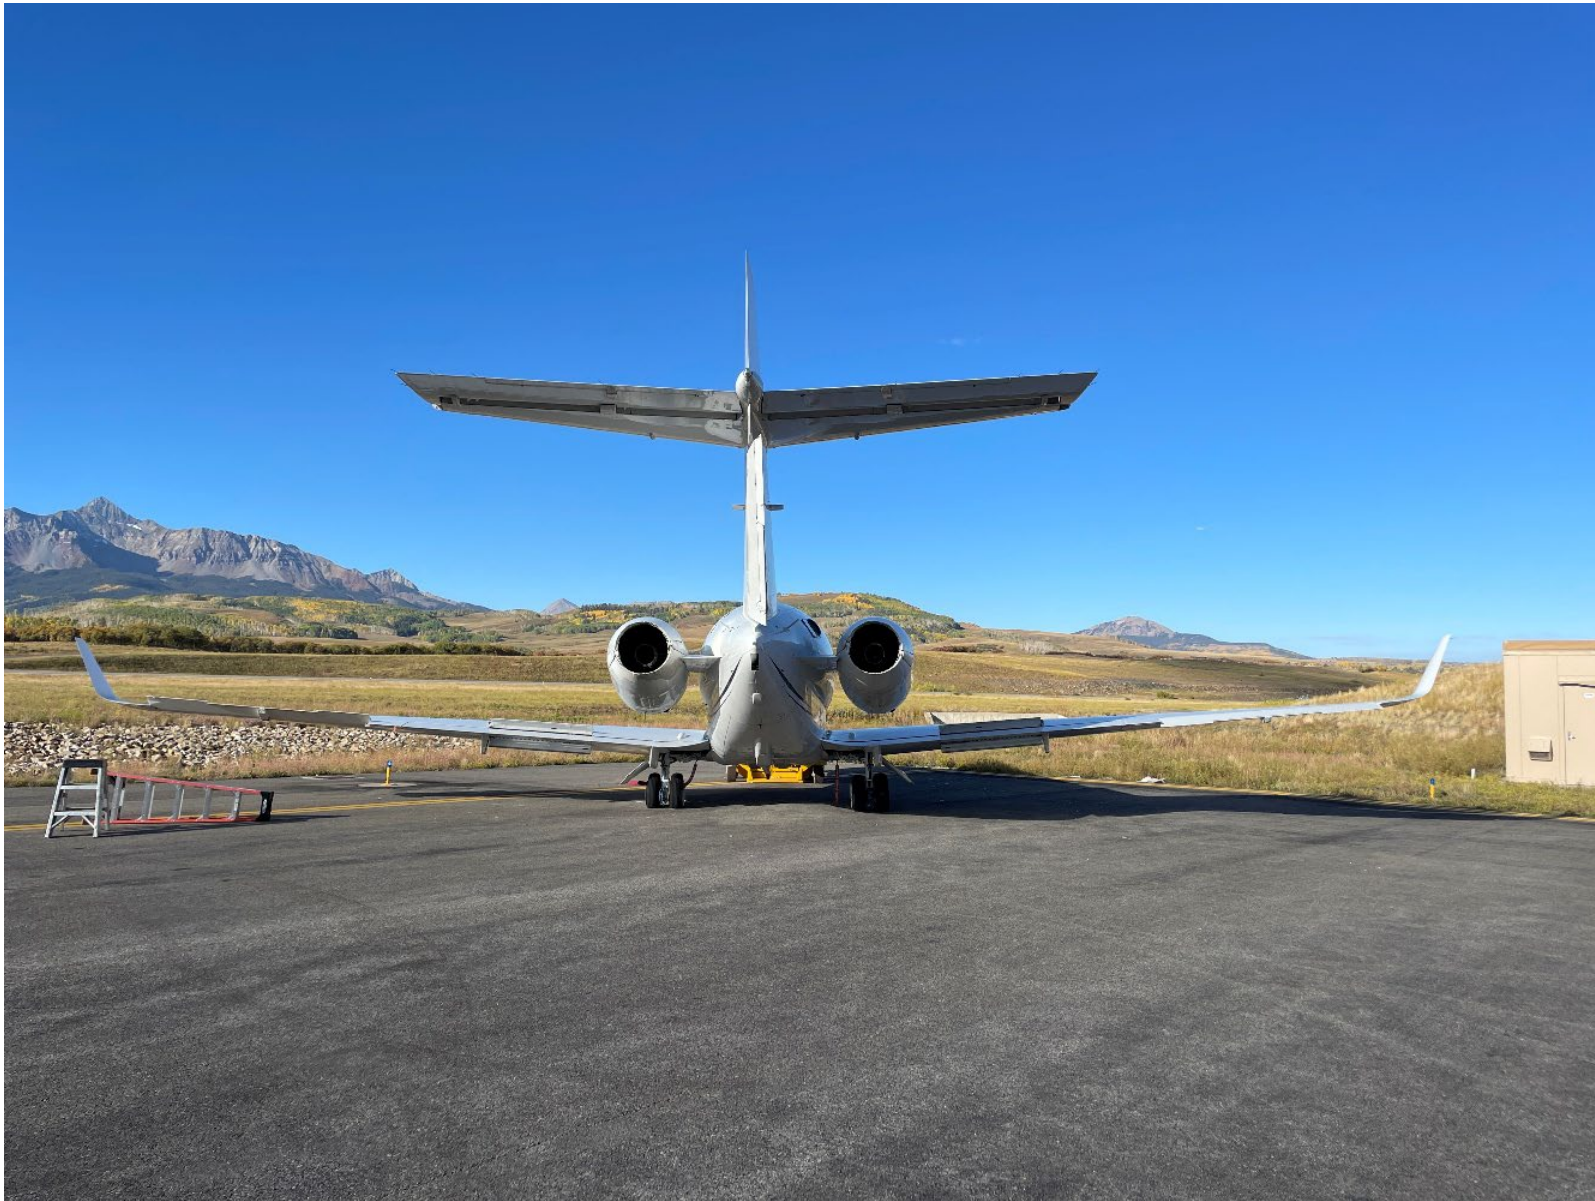
**Photograph 9 - View of the rear of the airplane on the ramp**

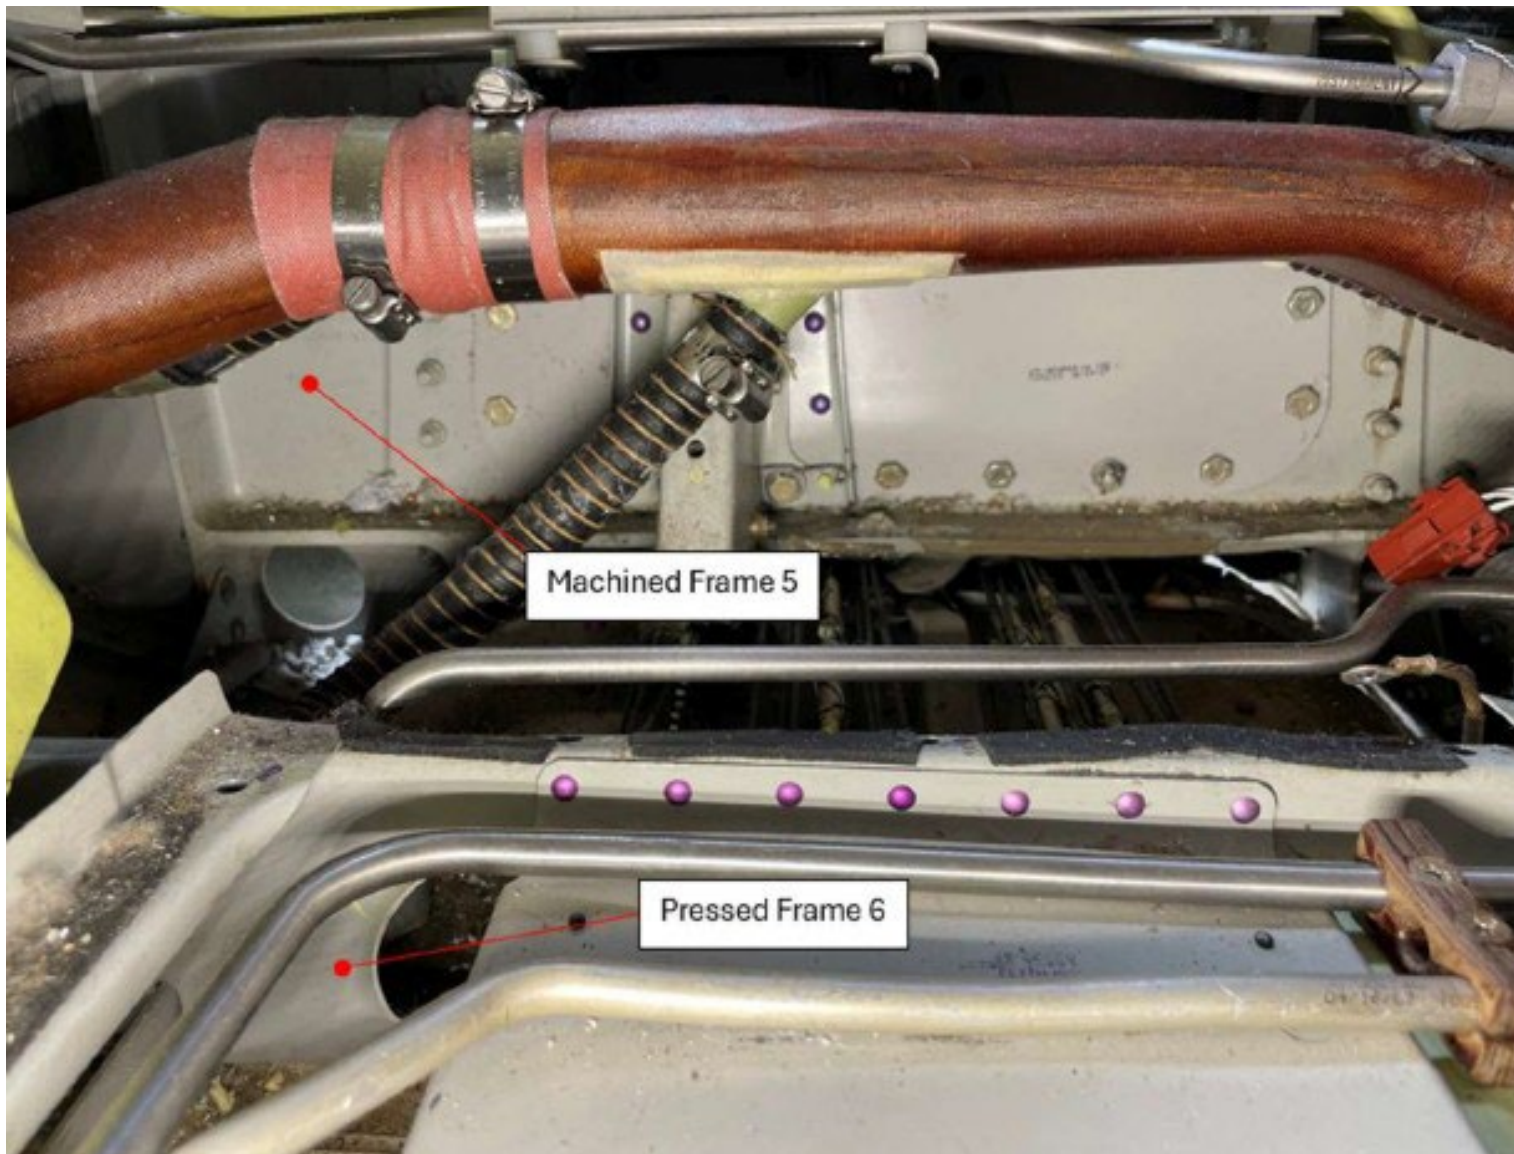
**Photograph 10 - View of the substantial deformation damage sustained to the frame 5 lower assembly and the lower frame 6 pressing (courtesy of Textron Aviation)**

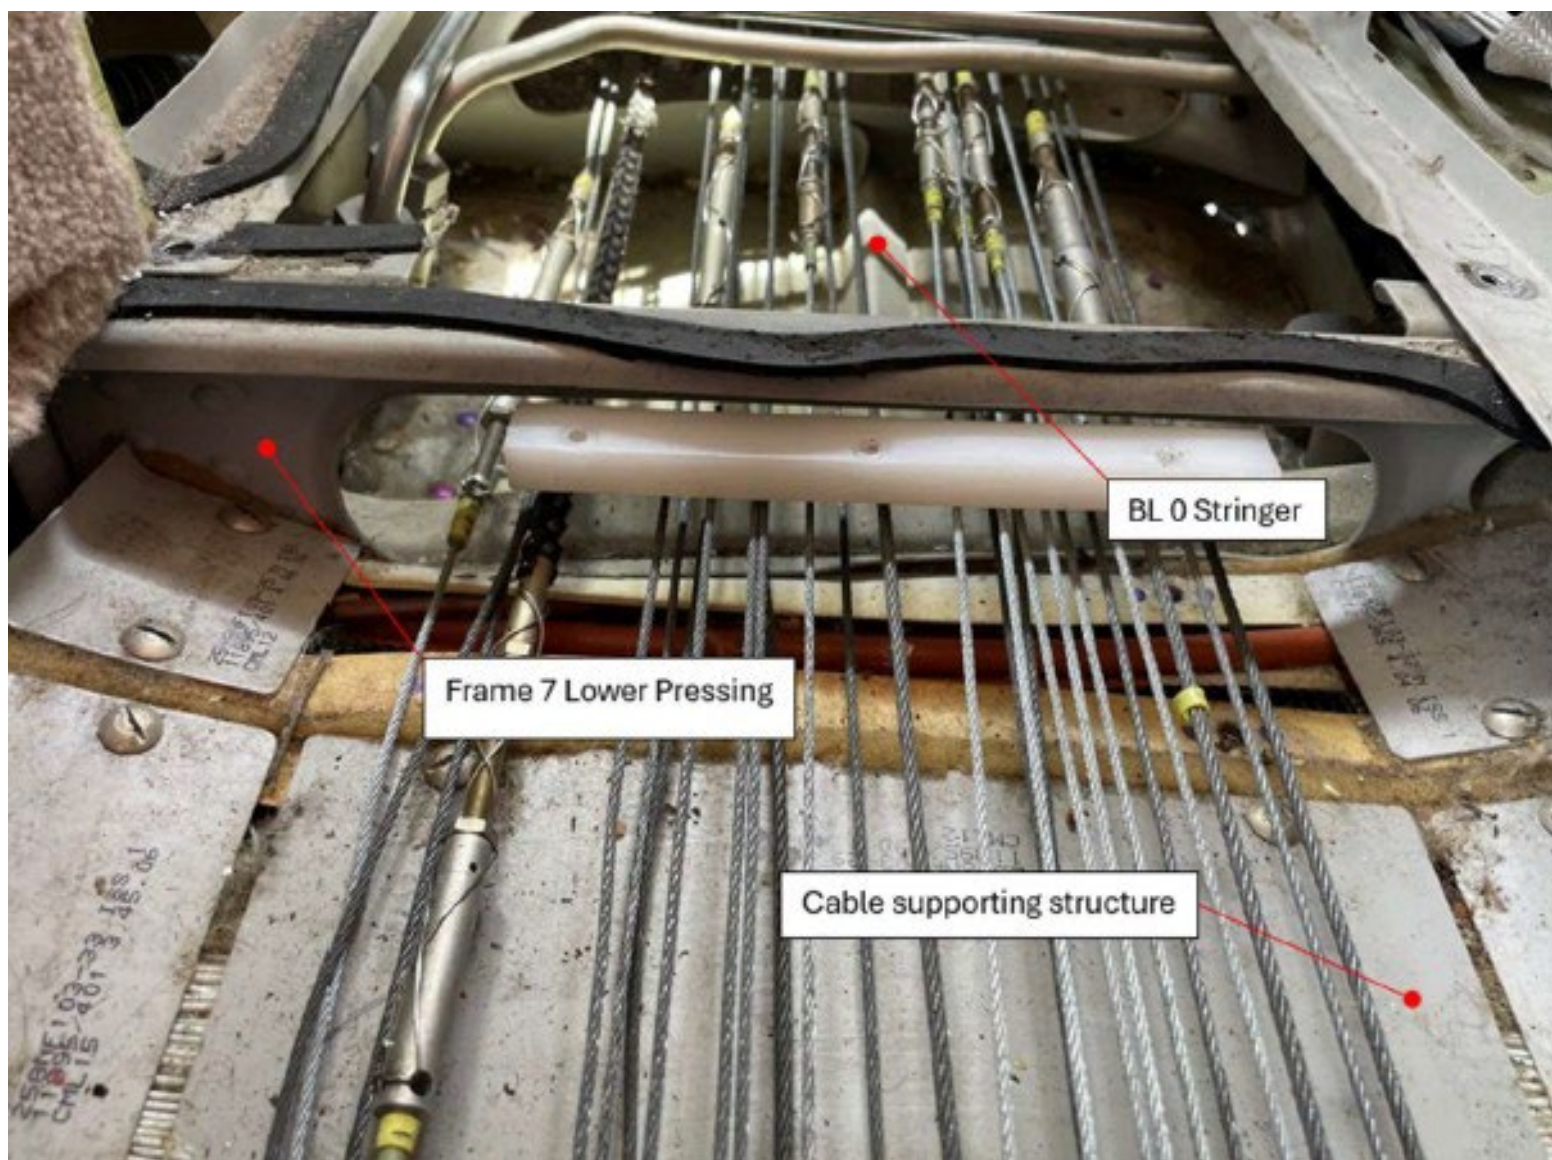
**Photograph 11 - View of the substantial deformation damage sustained to the frame 7 lower assembly (courtesy of Textron Aviation)**

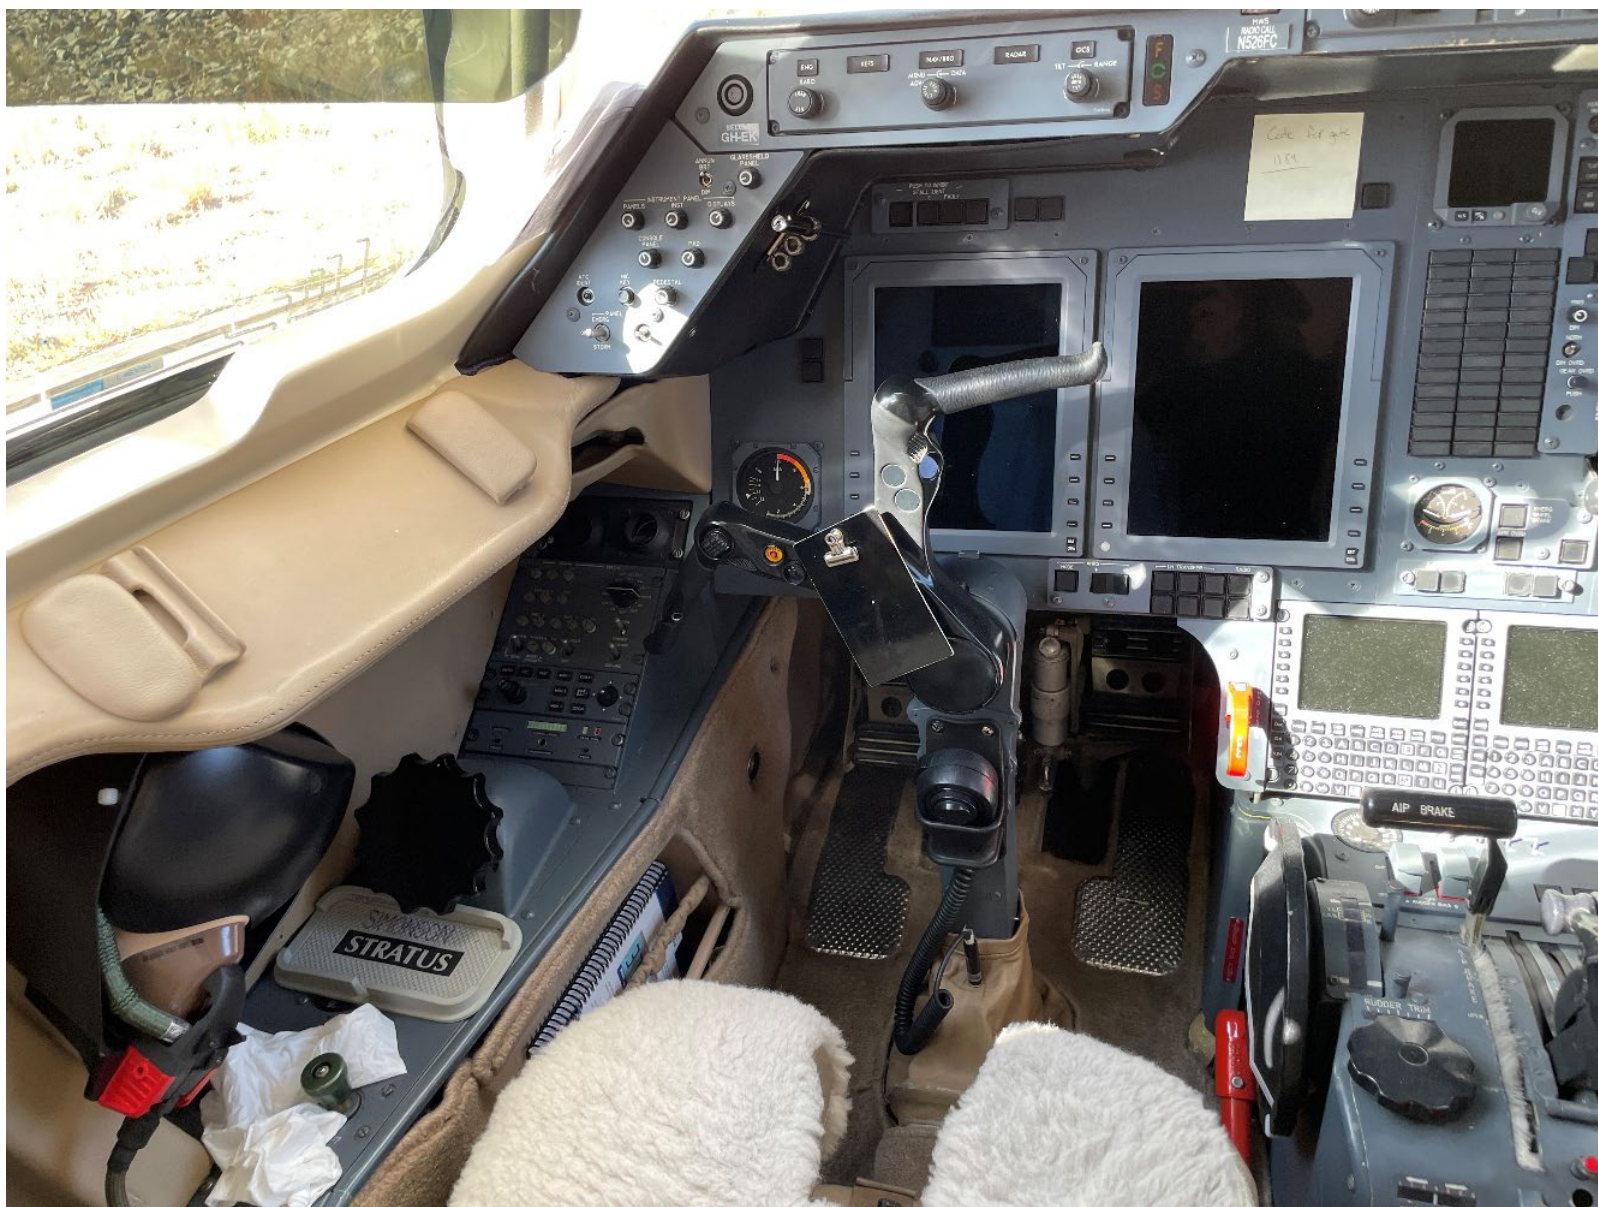
**Photograph 12 - View of the left side of the cockpit**
