CEN24LA328

## INVESTIGATION PHOTOGRAPHS

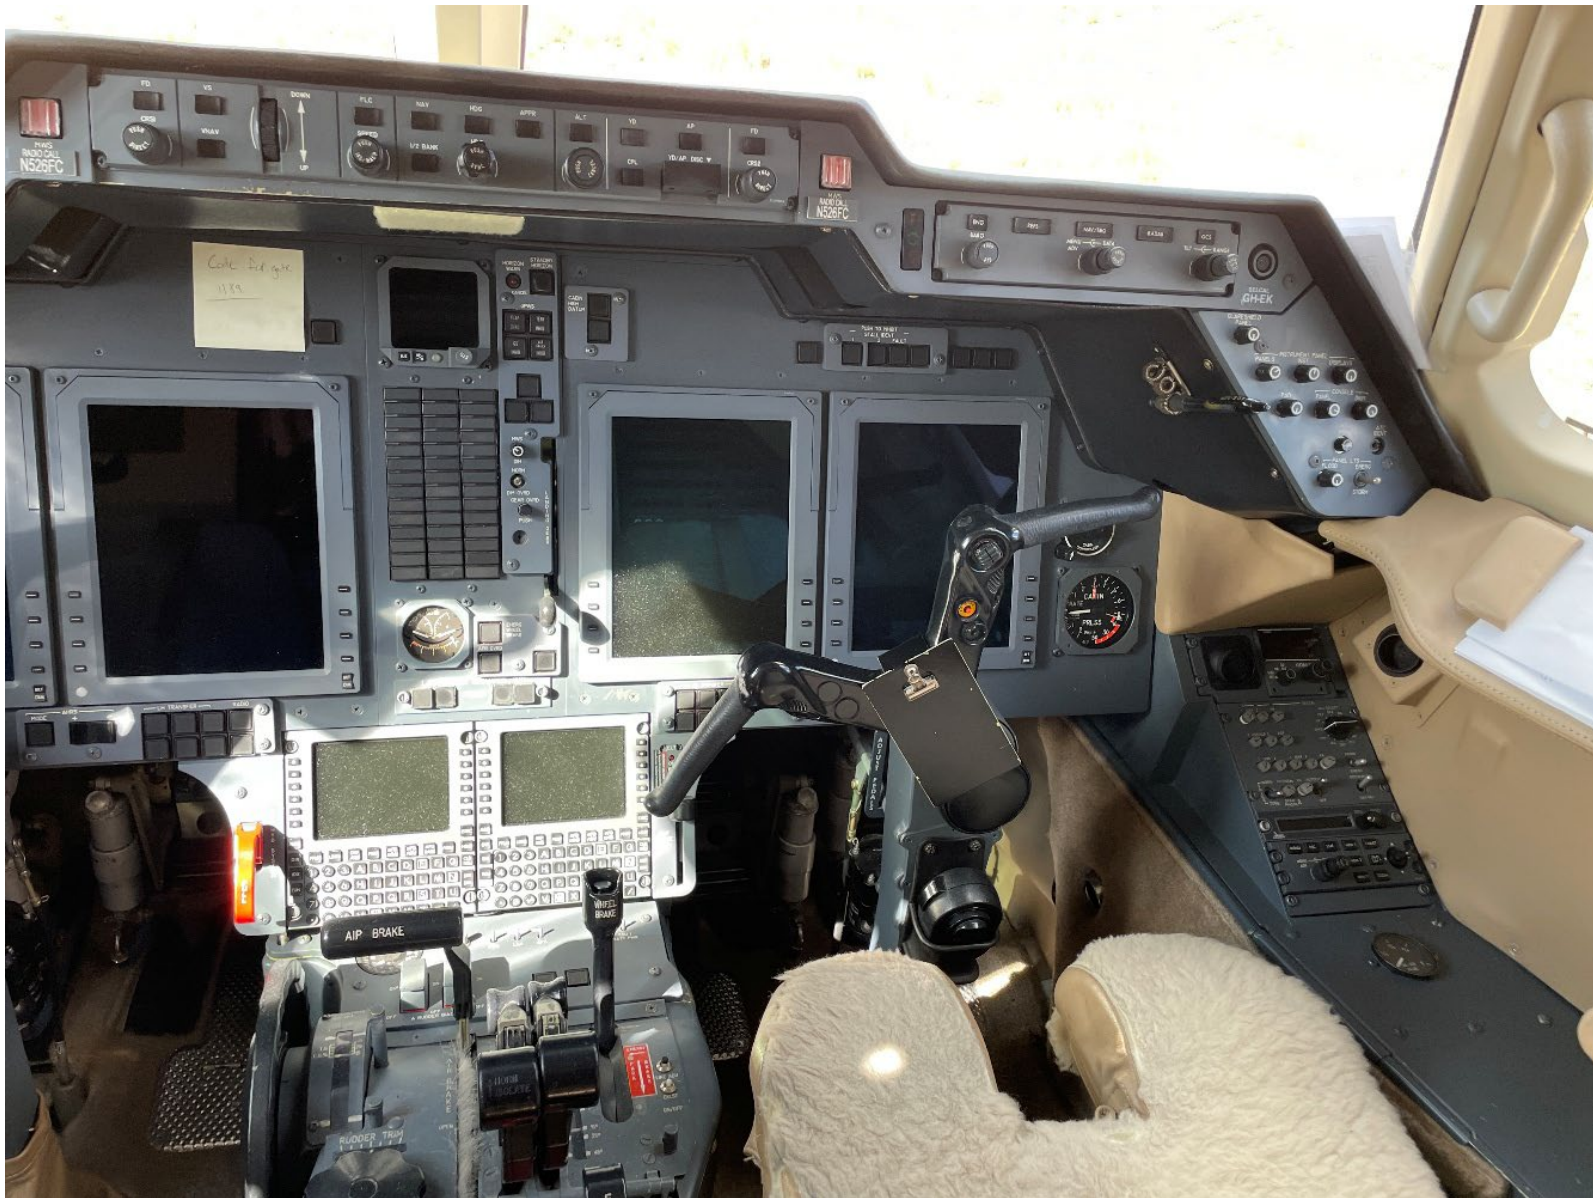
**Photograph 13 - View of the right side of the cockpit**

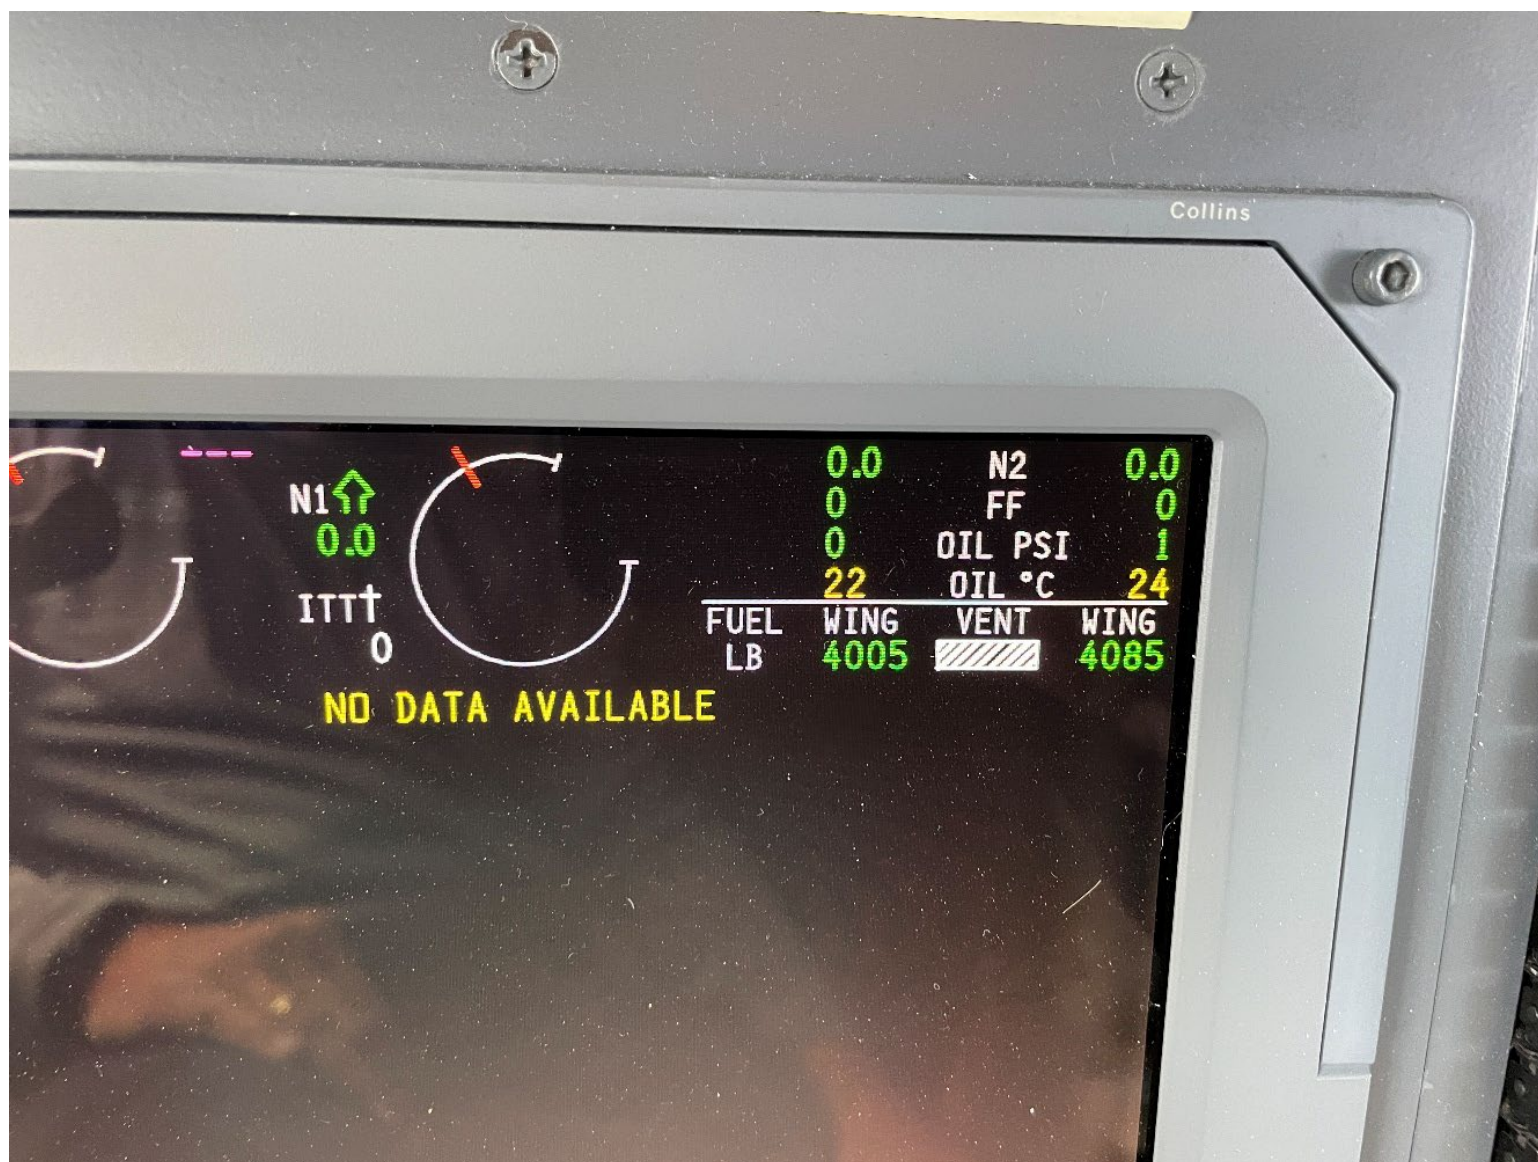
**Photograph 14 - View of an electronic cockpit display showing the fuel onboard after the accident**

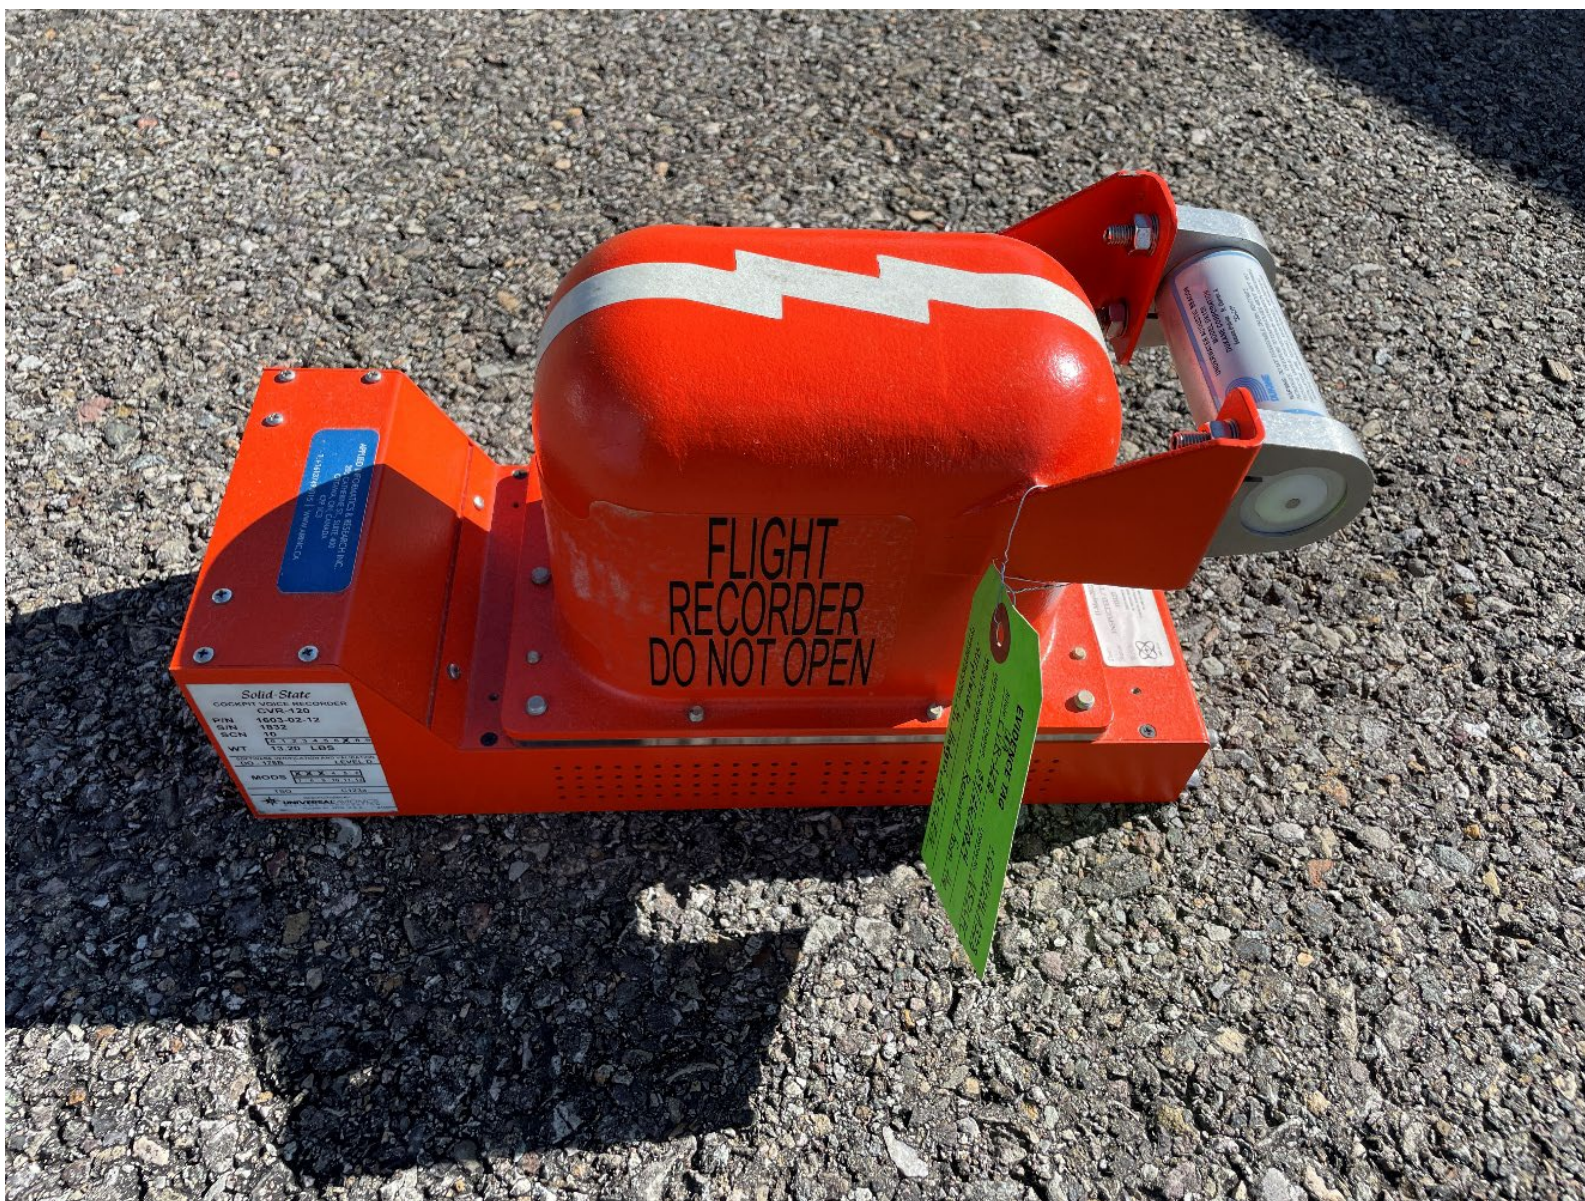
**Photograph 15 - View of the cockpit voice recorder removed from the airframe**
