CEN24LA330

## INVESTIGATION PHOTOGRAPHS

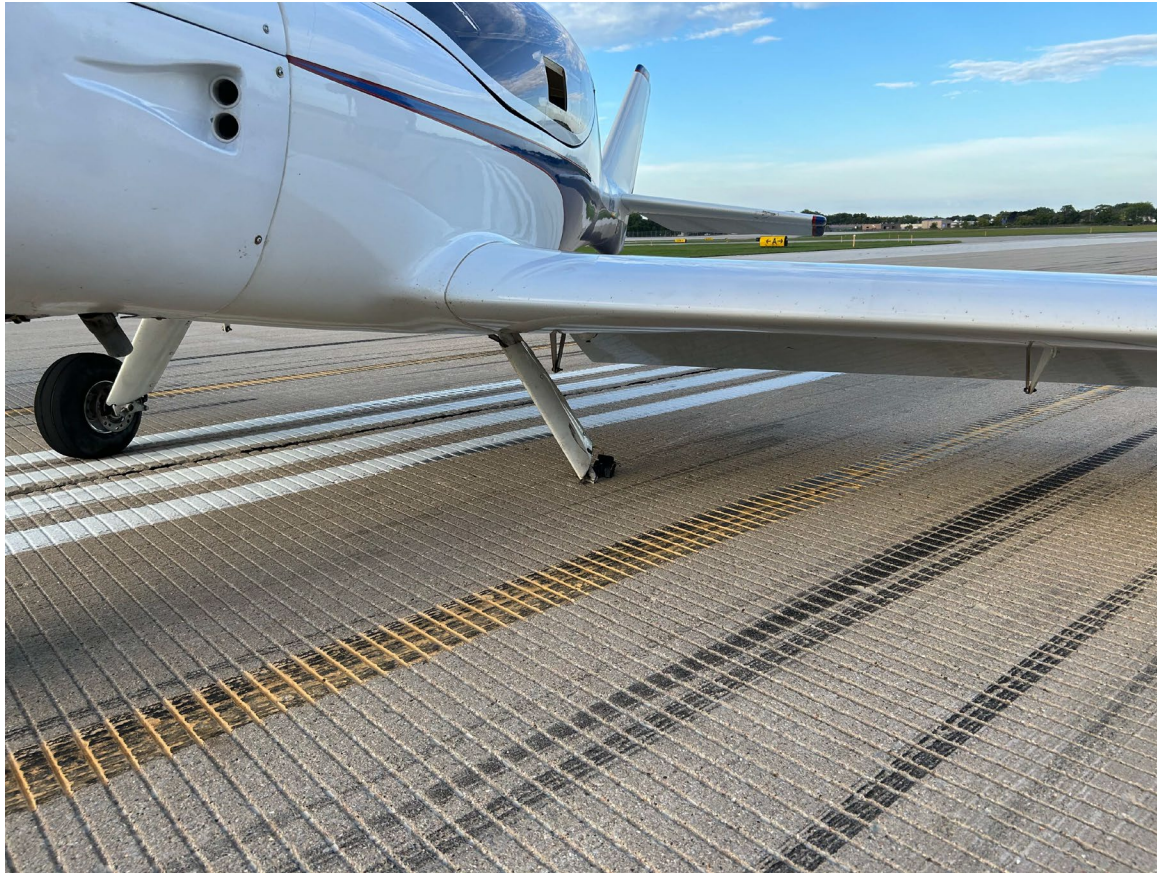
**Photograph 1 - Airplane on Runway (Courtesy of FAA)**

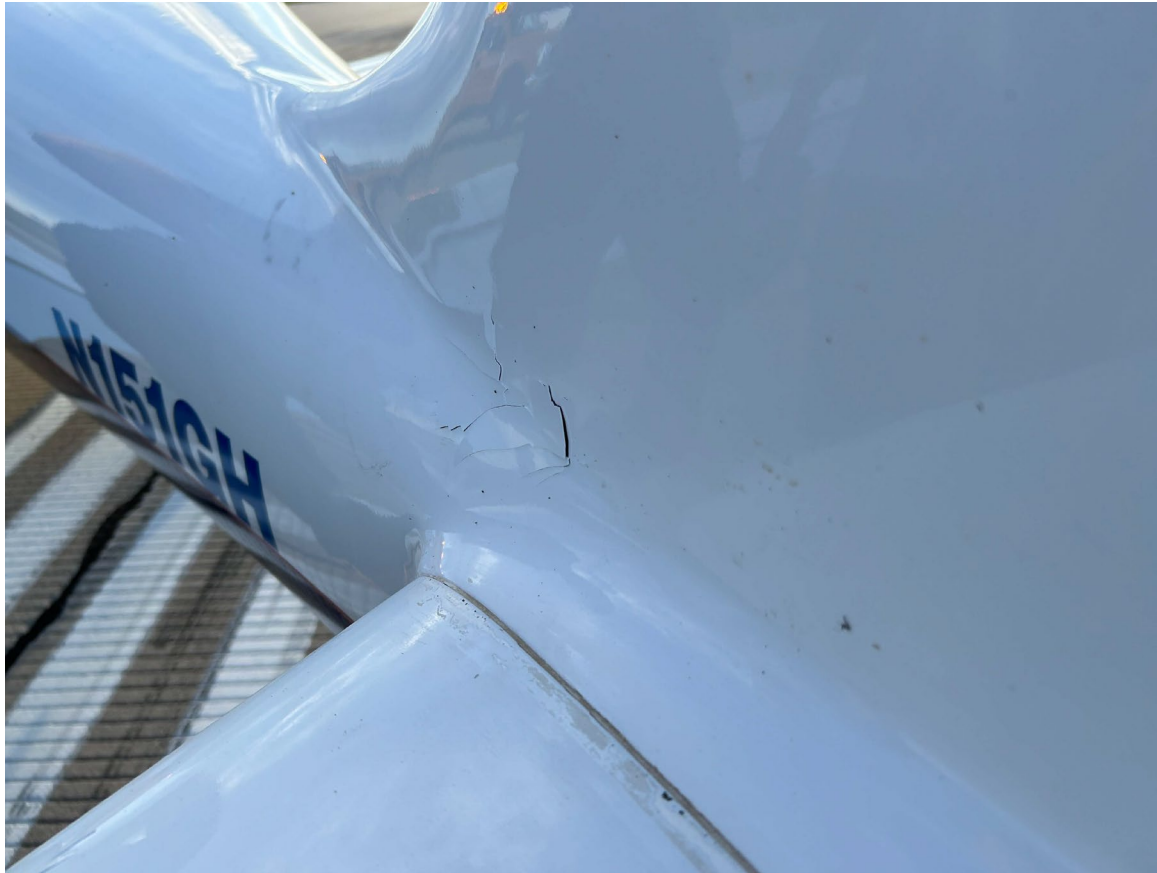
**Photograph 2 - Substantial Damage on Fuselage Adjacent to Left Horizontal Stabilizer  
(Courtesy of FAA)**

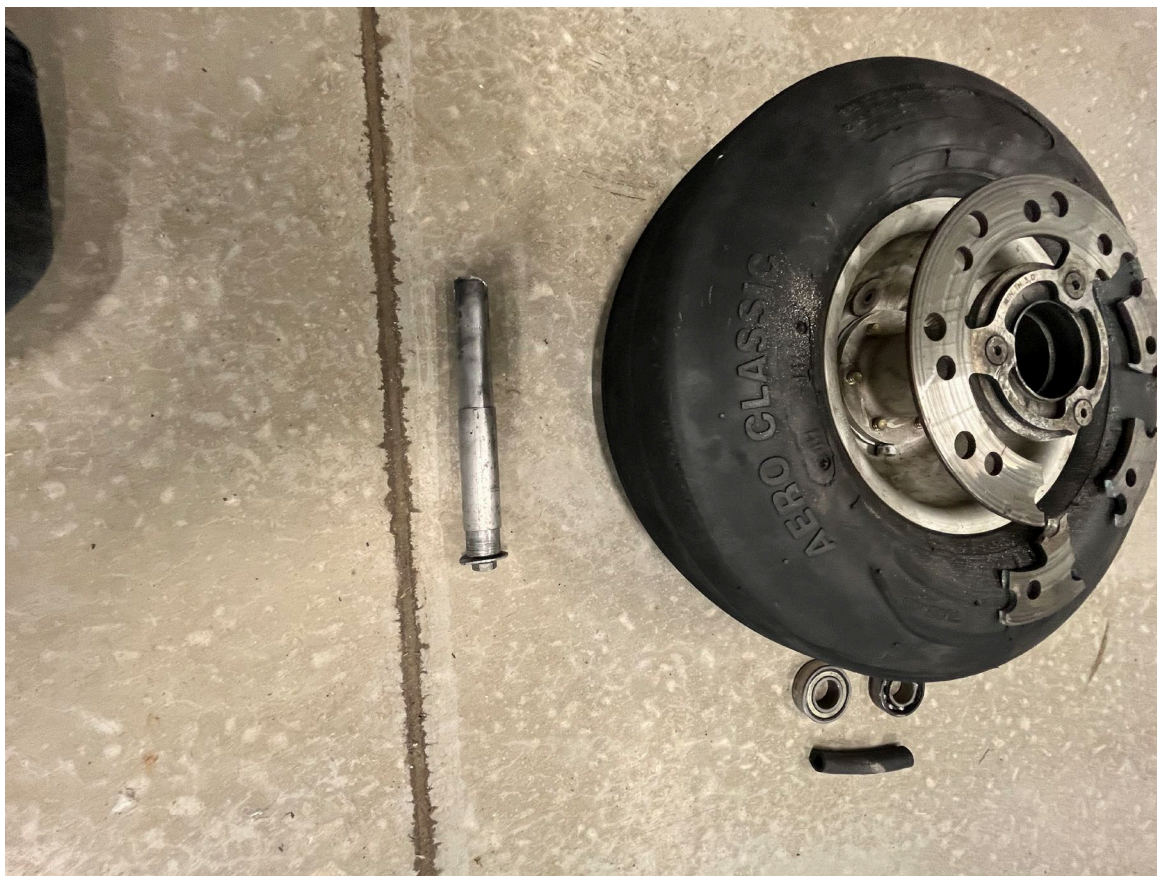
**Photograph 3 - Separated Left Wheel Assembly (Courtesy of FAA)**

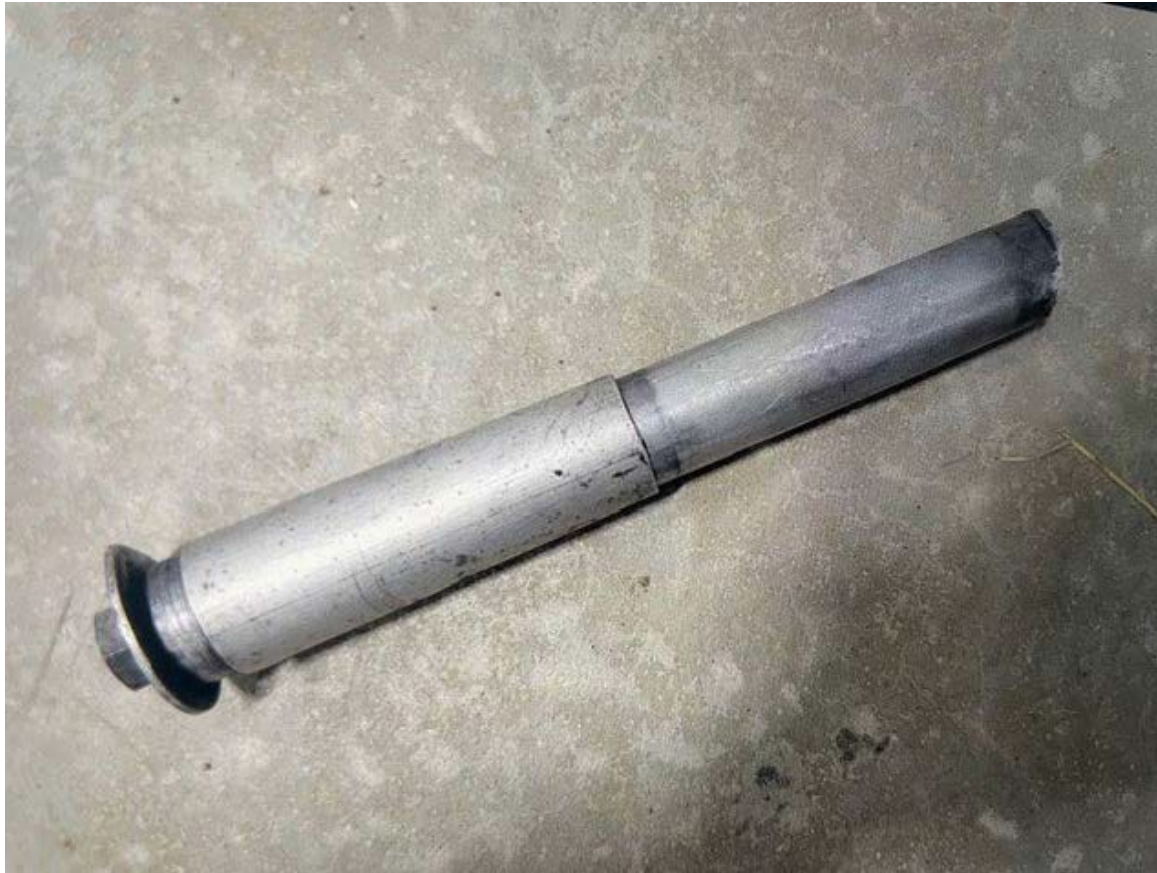
**Photograph 4 - Fractured Left Axle (Courtesy of FAA)**
