Alex Lemishko  
Senior Air Safety Investigator  
Central Region

**Date:** September 6, 2024

**Subject:** CEN24LA332

**Contact:** Bernard von Rentzell - FAA Inspector

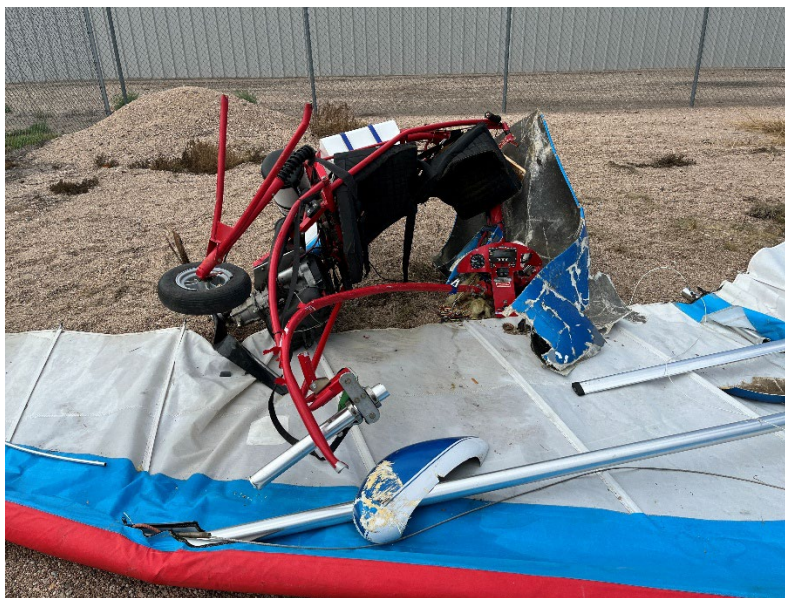
Figure 1. Main Wreckage (Provided by FAA)

Inspector Rentzell traveled to the Sheriff's Office impound yard to review the wreckage of the trike.

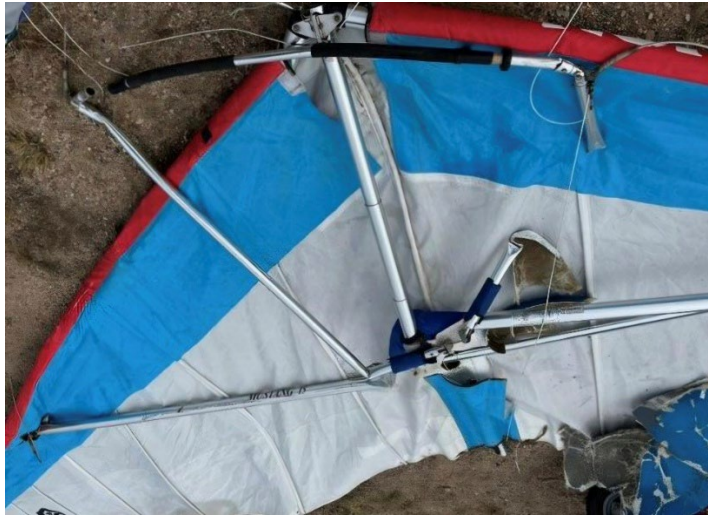
Figure 2. Control Bar and Sail (Provided by FAA)

The control bar was examined to ensure all of the bolts and attached cables were intact and were assembled correctly. Both control bar down tubes were bent and broken consistent with impact damage.

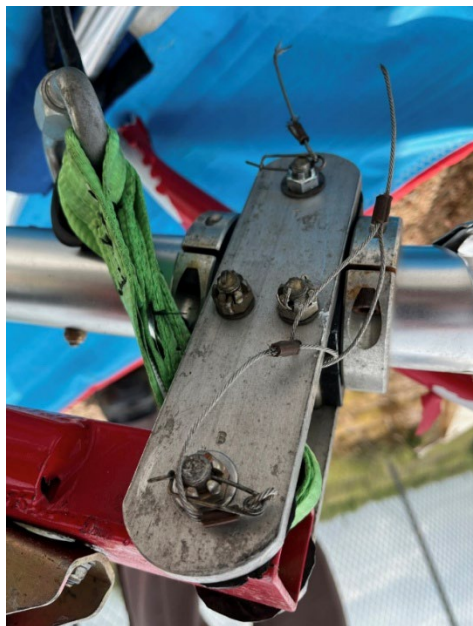
Figure 3. Hang Point Nuts and Bolts (Provided by FAA)

The hang point nuts and bolts were all in place and secured with cotter keys or quick release diaper pins. The hang point was positioned correctly between two locking collars in the center of the keel and attached to the red top of the mast.

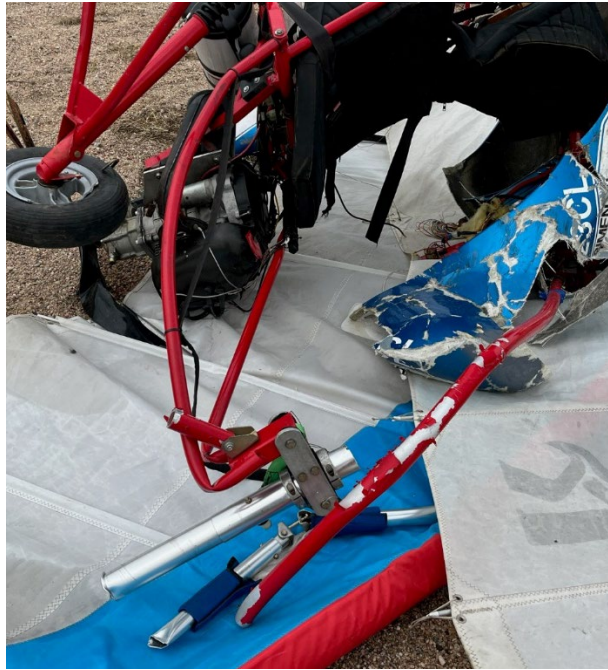
Figure 4. Hang Point and Mast (Provided by FAA)

The hang point was intact and connected to the two red tubes of the mast. The keel is shown broken or snapped at both ends. All applicable fasteners were in place.

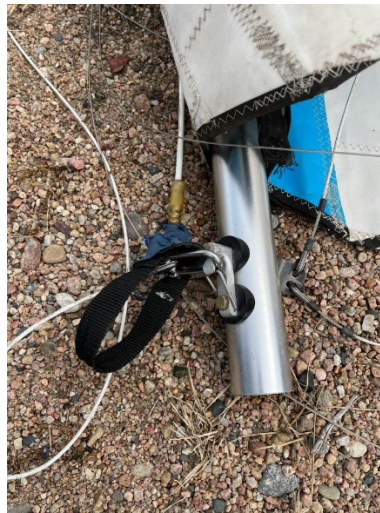
Figure 5. Back End of Keel (Provided by FAA)

The bolts and the locking mechanism of the crossbar tensioning cables attachment were intact and unbroken.

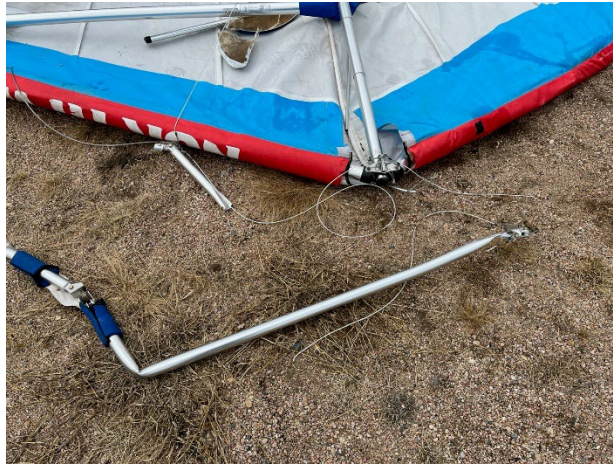
Figure 6. Sail (Provided by FAA)

The nose plates are shown between the two red parts of the sail. They were examined and all of the bolts and cables were secured and attached correctly. The down tubes are also pictured, and they were bent and snapped off at the joints. The bolts and cables were intact.

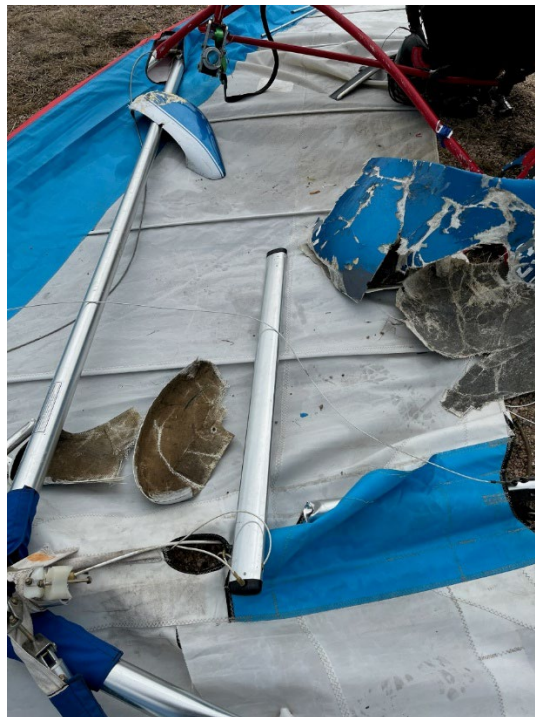
Figure 7. Kingpost and Sail (Provided by FAA)

The kingpost was completely intact and the cables were secure.

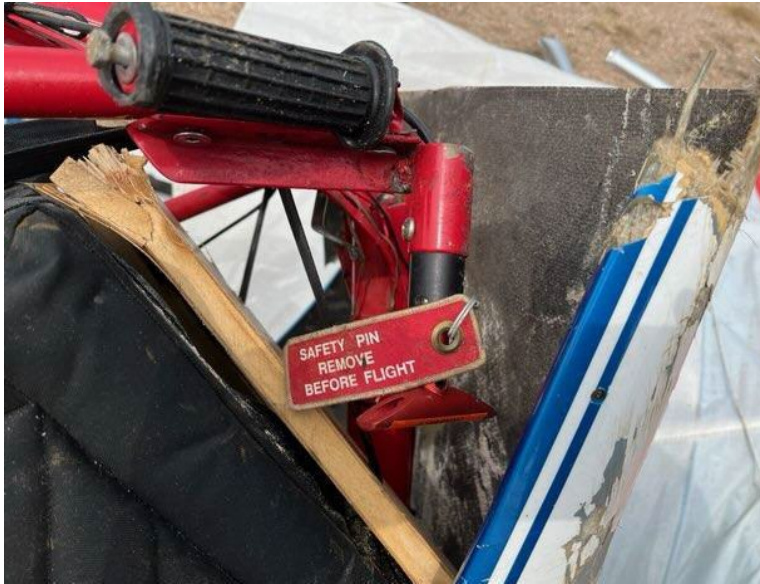
Figure 8. Ballistic Recovery System Safety Pin (Provided by FAA)

The aircraft was equipped with a Ballistic Recovery System. The safety pin was found installed.

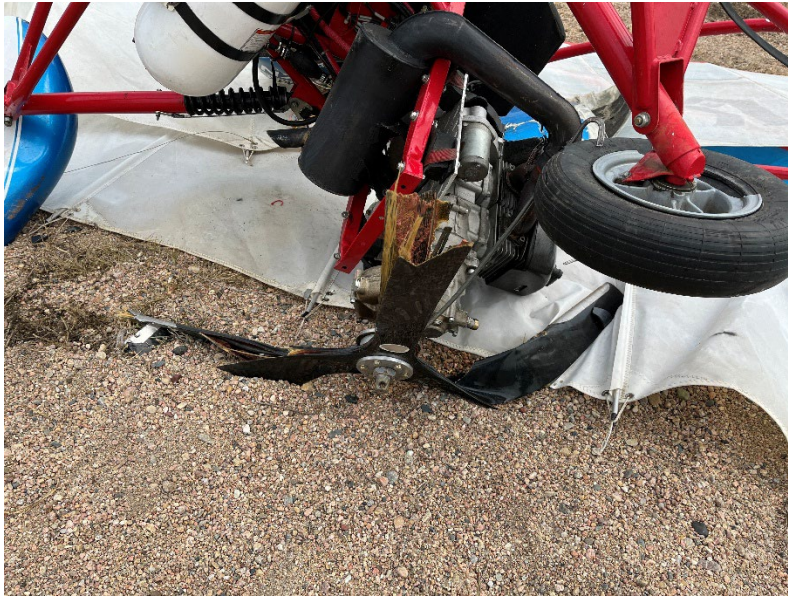
Figure 20. Engine and Propeller Assembly (Provided by FAA)

The engine remained attached to the fuselage. The 3-blade propeller assembly remained attached to the engine. All three propeller blades were impact-damaged and splintered about midspan.
