Engine runup report post-accident AGL1324039  
N32435  
East Troy, WI (57C)  
Inspector Michael J. Pieczynski MKE FSDO

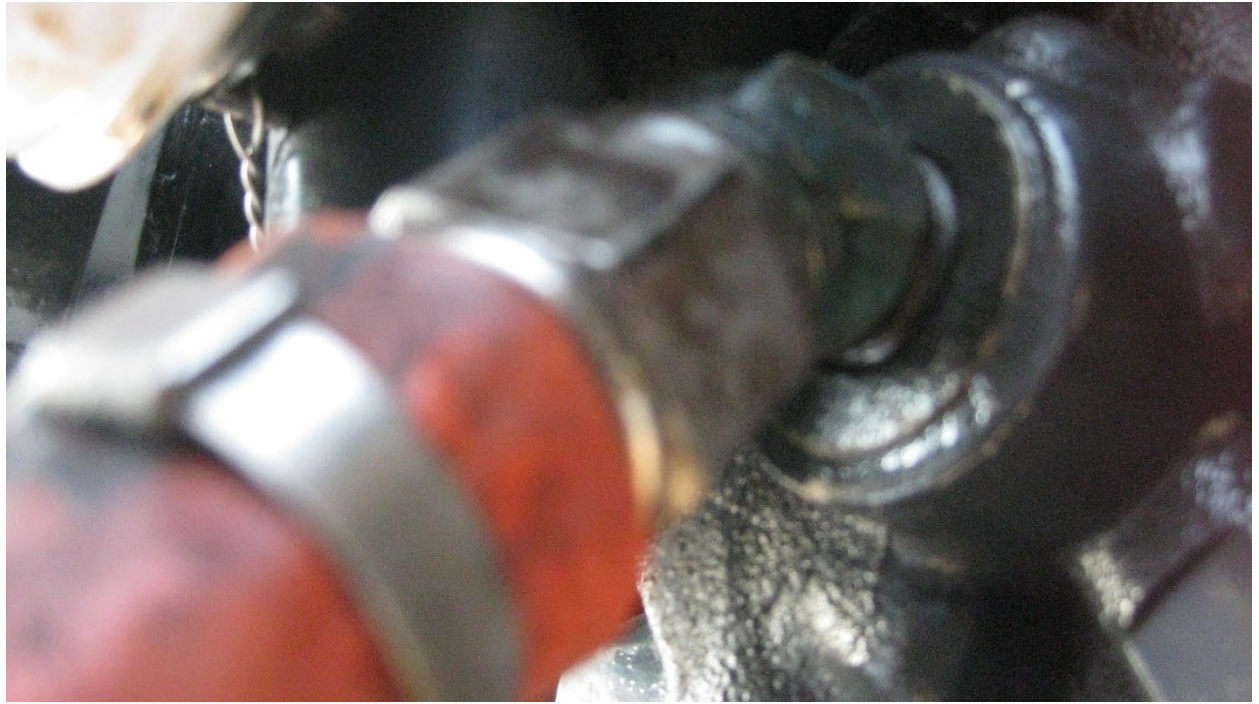
The initial start was unsuccessful due to a failed start solenoid. The owner was able to correct the problem. During this time, it was discovered the mechanical fuel pump suction line was loose and nearly fallen off. The suction line was resecured. The engine started with ease on the second start and was shaking due to the imbalance of the damaged propeller. Once the engine stabilized after warming up, the owner moved the throttles forward and increased the RPM for a moment. The engine appeared to operate normal.

It is this inspector's opinion that a contributing factor to the loss of power prior to the accident was the mechanical fuel pump fuel line was not completely secured. The records do show the owner (also an A&P IA) installed a new fuel pump prior to the day of the accident. After a discussion with the owner, he had stated he had the fuel pump off and on more than once because he was not sure if the pump was properly installed and that he may have forgot to torque the fuel line fitting to the pump.
