CEN24LA337

## INVESTIGATION PHOTOGRAPHS

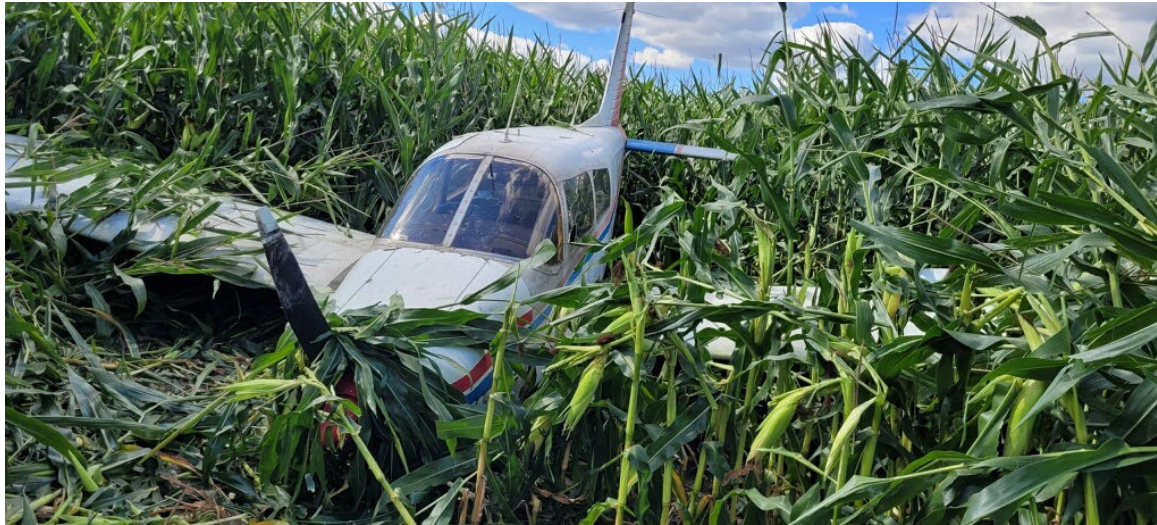
**Photograph 1 - Airplane at accident site (Courtesy of Pilot)**

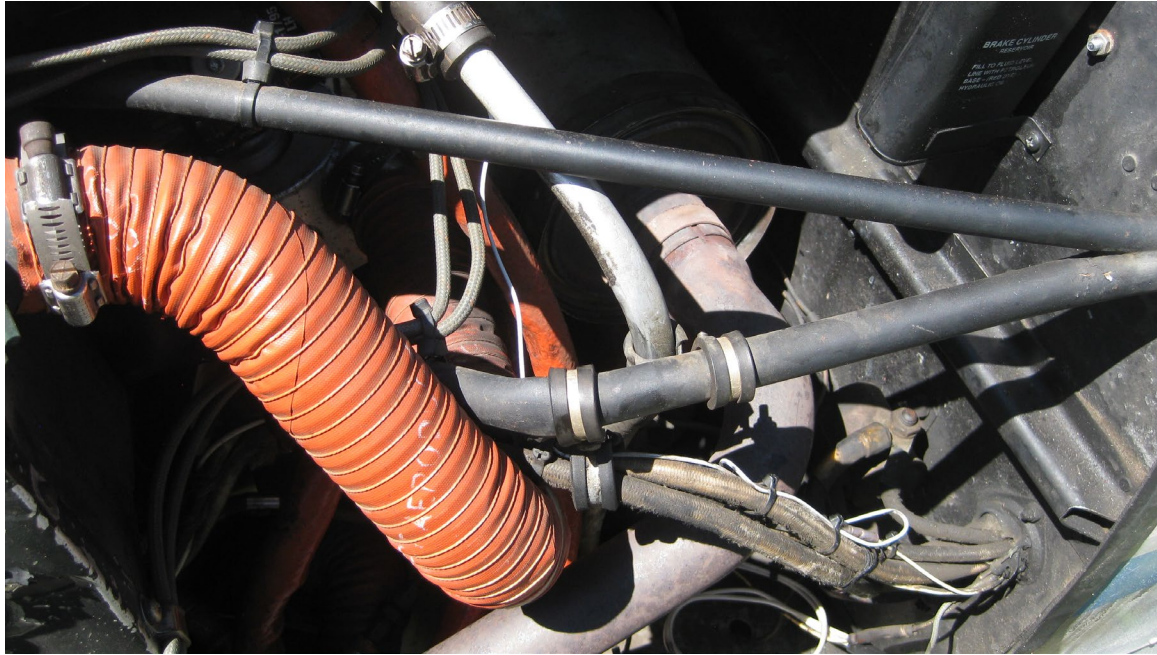
**Photograph 2 - Bent engine mount (Courtesy of FAA)**

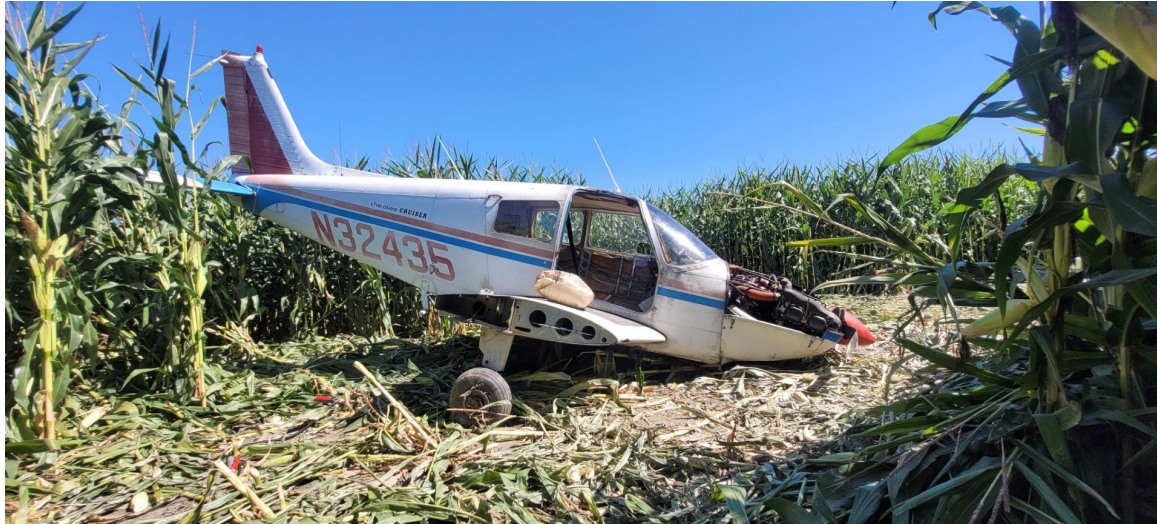
**Photograph 3 - Airplane during removal from accident site (Courtesy of Pilot)**

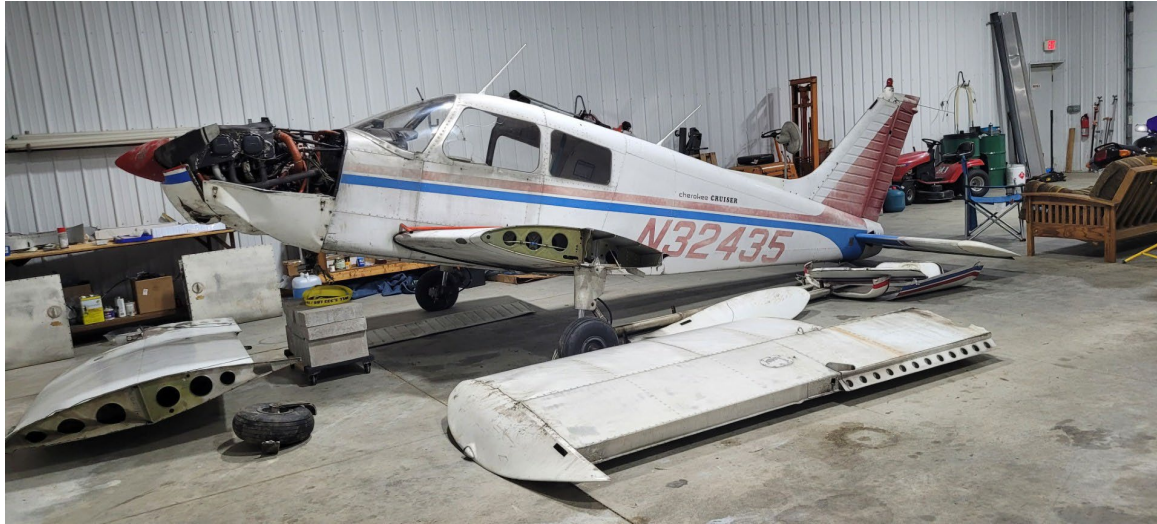
**Photograph 4 - Airplane after removal from accident site (Courtesy of pilot)**
